**Road Safety Audit Stage 1 & 2**

**Proposed Section 38 Works**

**Imberhorne Farm**

**Date: 23<sup>rd</sup> July 2025**

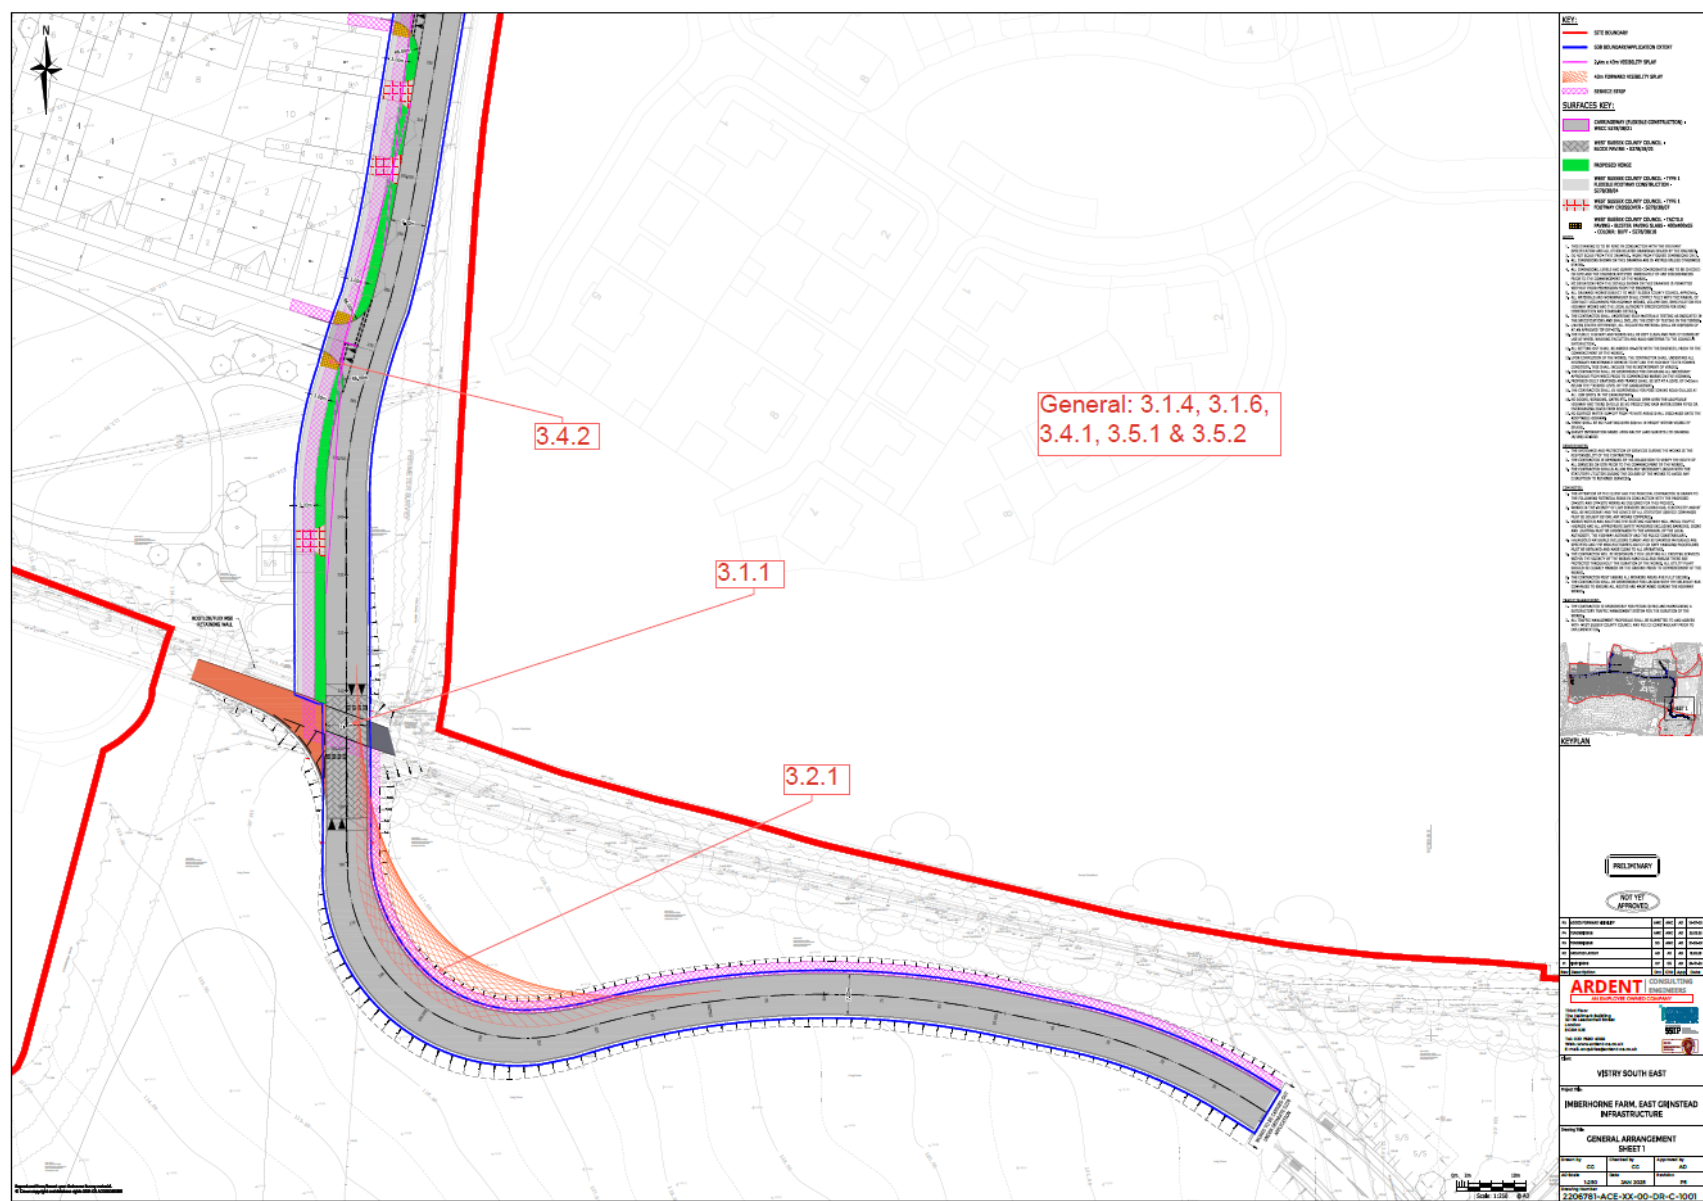
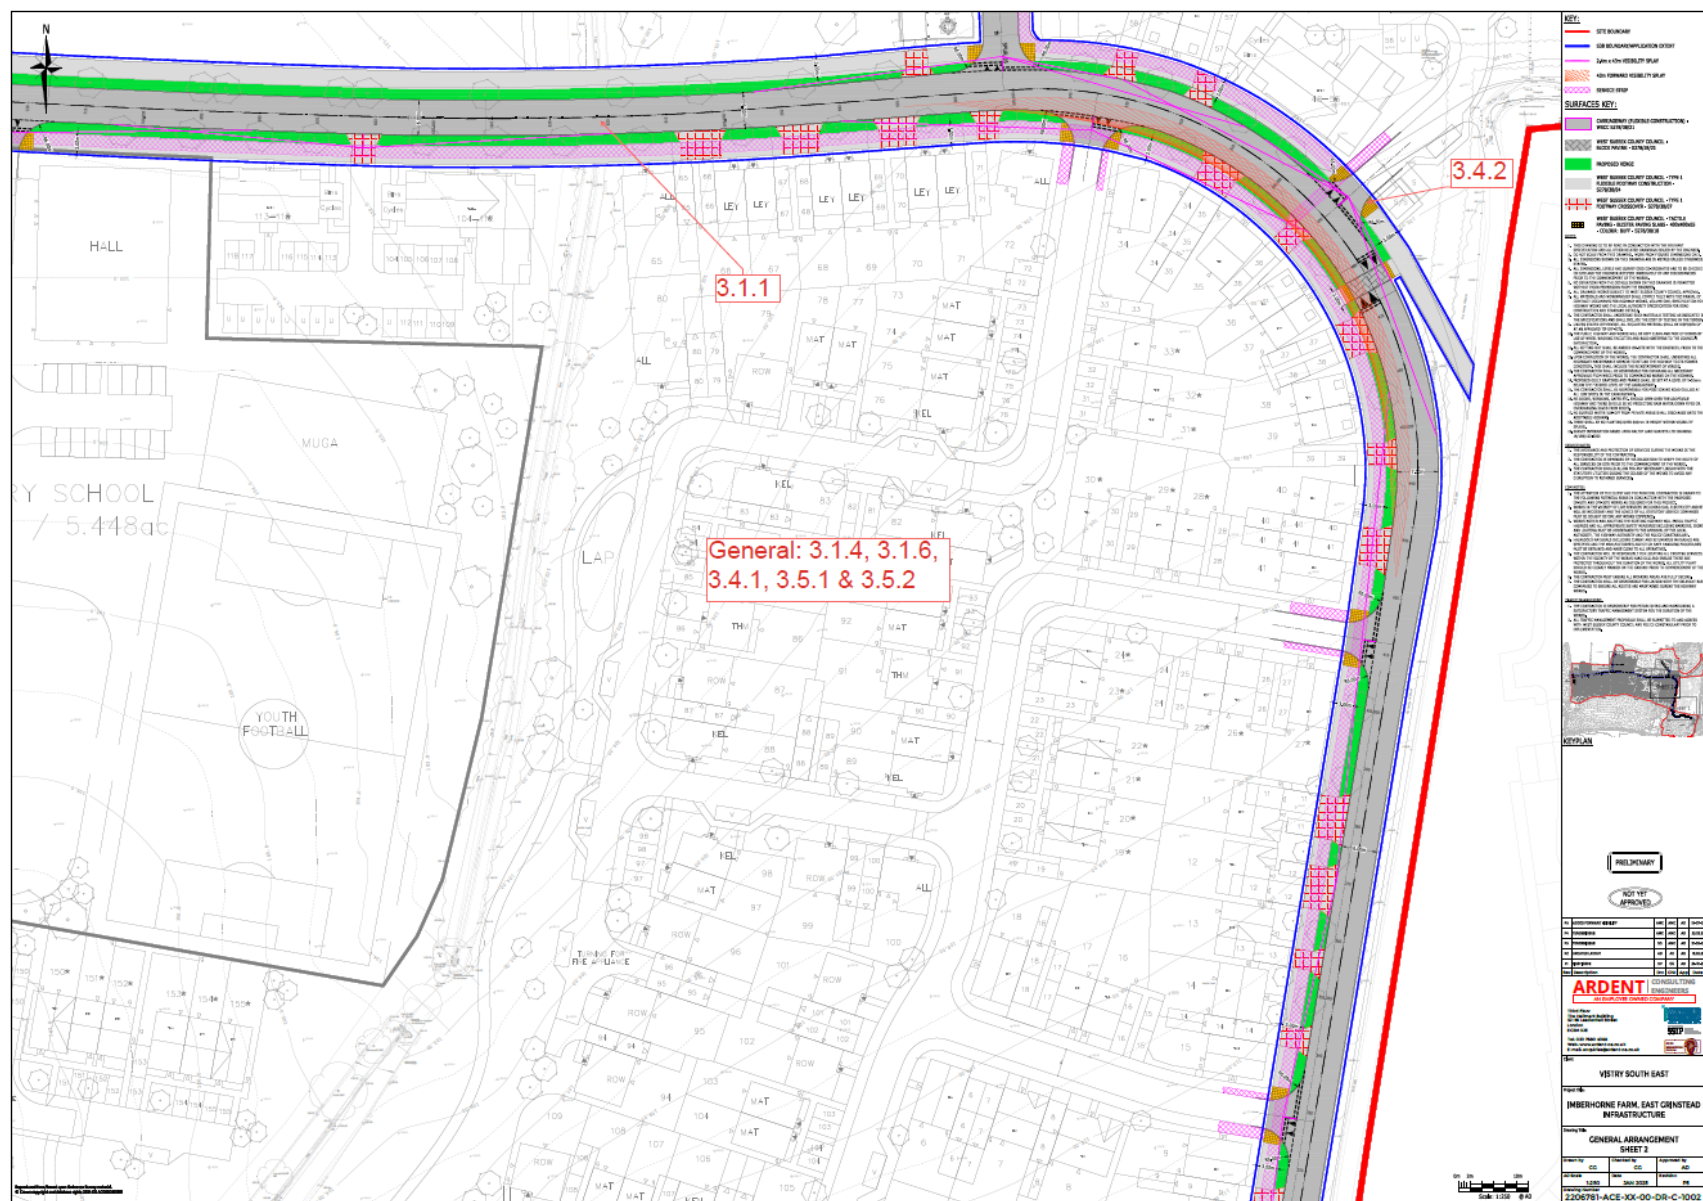
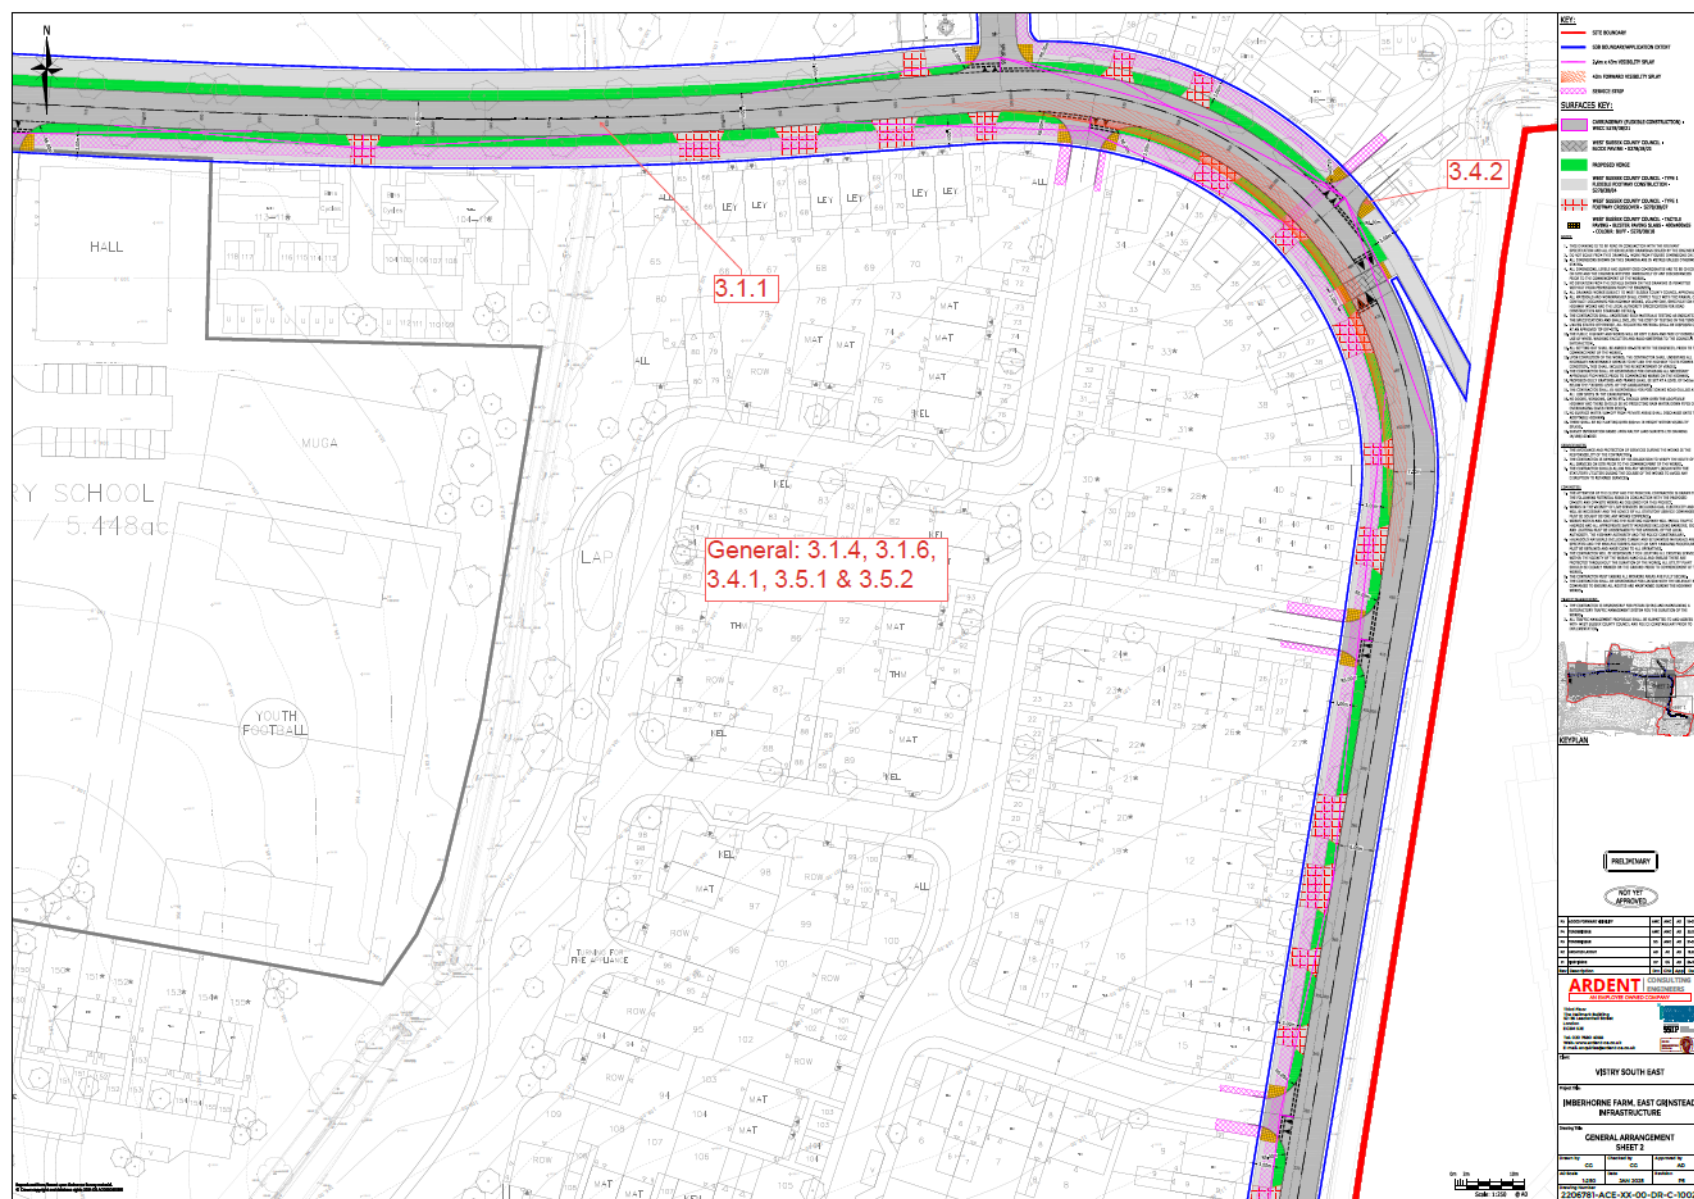
## **APPENDIX B**

Plan attached showing the locations of the problems identified as part of this audit (location numbers refer to paragraph numbers in the report).
