**Road Safety Audit Stage 1 & 2**

**Proposed Section 278 Works**

**Roundabout for Development Site Access**

**Imberhorne Lane**

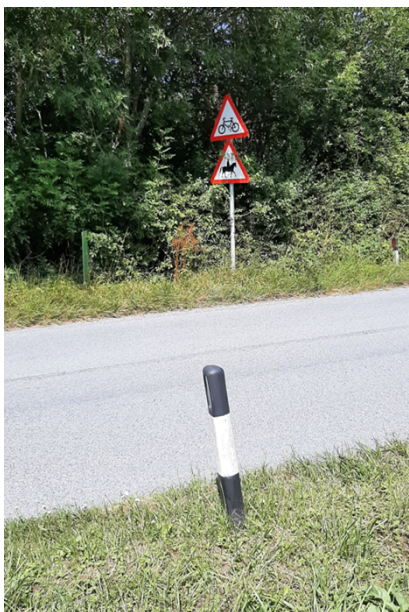
Figure 1: Existing signage near proposed roundabout.

There is existing signage to warn of horses and cyclist that is not detailed in the provided proposals, see figure 1 below. If the signage is not retained there is a risk that approaching vehicles may not be expecting cyclist and equestrian users to be crossing the road to access the bridleway and national cycle route, increasing the risk of vehicle to cyclist / equestrian collisions.

It is recommended that the scheme assess the existing local signage for incorporation into the proposed design and layout and where required new or relocated signs be provided to connect with surrounding hazards of the scheme.

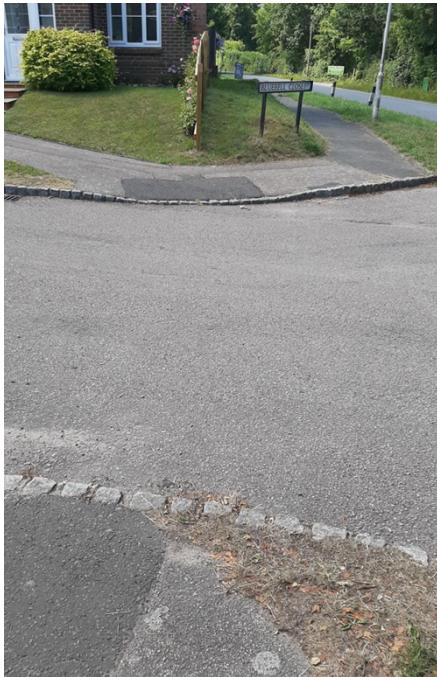
Figure 2: Existing alignment and upstand issues at crossing point.

The existing drop kerb crossing at the entrance to Bluebell Close has a significant upstand, see figure 2 below that poses a risk to pedestrian as a trip hazard. Additionally, the crossing point is misaligned.

It is recommended that the kerbing be flush and that tactile be provided in accordance with Department for Transport guidelines.
