## **Damp and Timber Survey Report**

### **Marshall's Manor**

High Street  
Cuckfield  
Haywards Heath  
West Sussex  
RH17 5EL

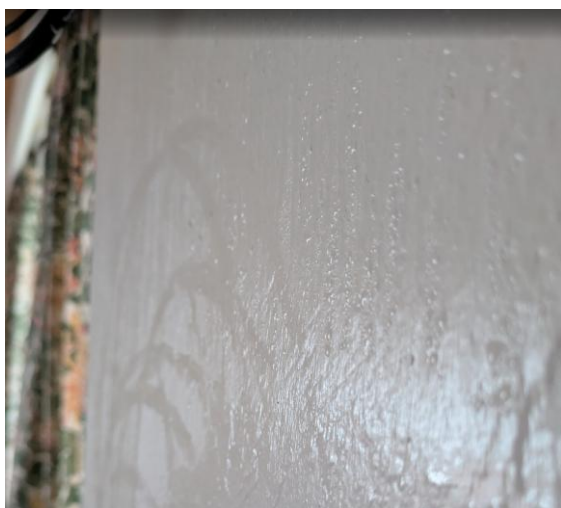
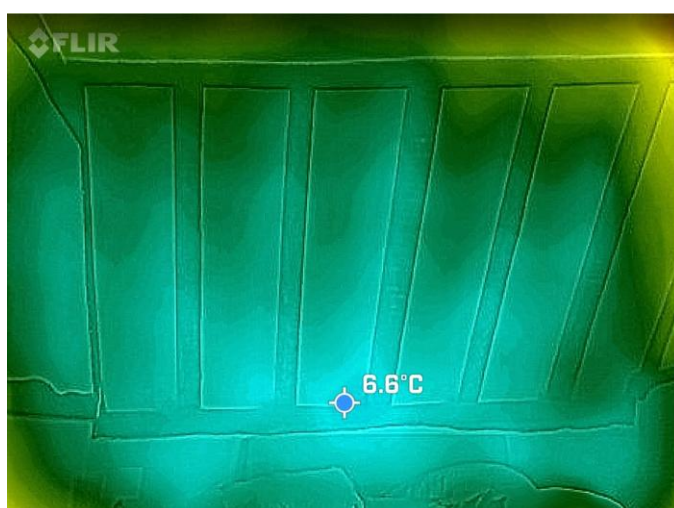
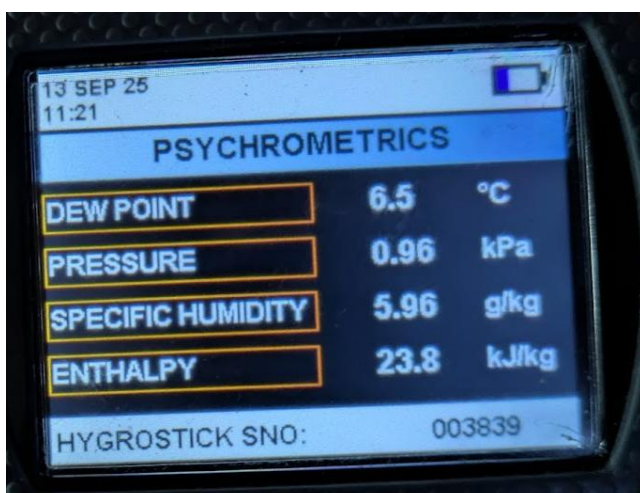
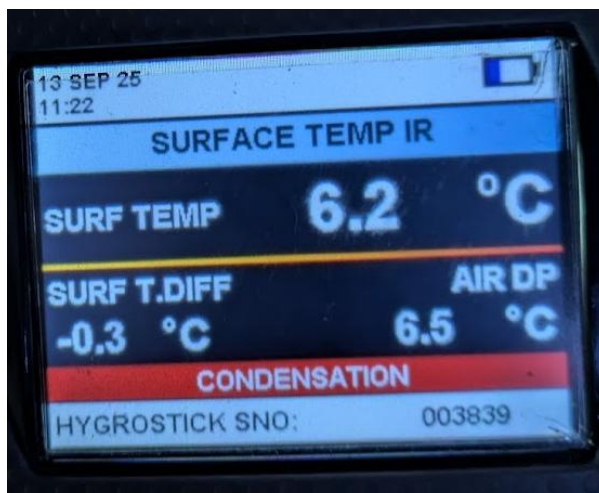
Atmospheric readings were taken in the main home and the annexe, where the air temperature ranged from 8.3 °C to 8.9 °C, with humidity between 85 % and just over 90 %. That is a very cold space holding a very high level of water in the air.

When air like this touches a cold wall, the water it is carrying settles out as liquid. The wall surfaces were measured at around 6 °C, which means condensation was always going to occur. It was not a possibility; it was physically happening at the time of inspection.

The majority of the surrounding brickwork in the annexe is a mix of cavity and 9" solid brickwork. The brick mortar has been removed and replaced with cement, and there are no provisions for cavity airflow or crossflow ventilation, which means the water inside the cavity stays trapped. The annex main roof void was also noted to have no insulation, which will cause significant temperature swings. This should be dealt with asap

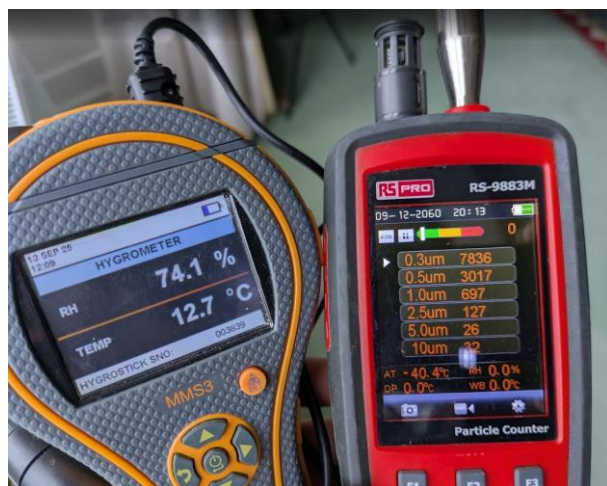
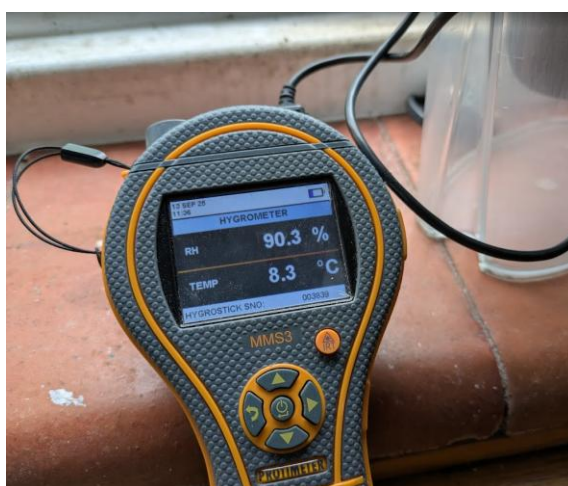
### Main House Conditions

Humidity levels in the main house remained at or above 70 % during the inspection. While this is lower than the annexe, it is still above the ideal winter range of 40 % to 60 % and indicates that the wider building is also carrying elevated levels of water in the air.

Prolonged rainfall and low external temperatures reduce the drying capacity of solid masonry. When ventilation is limited, internal humidity gradually rises, and the difference between the room temperature and the dew point decreases. This means surfaces cool to the condensation point more easily.

The annexe is responding more severely because it is less well insulated, the loft and walls, thus losing heat more quickly. However, the main house is influenced by the same external conditions, just to a lesser degree.

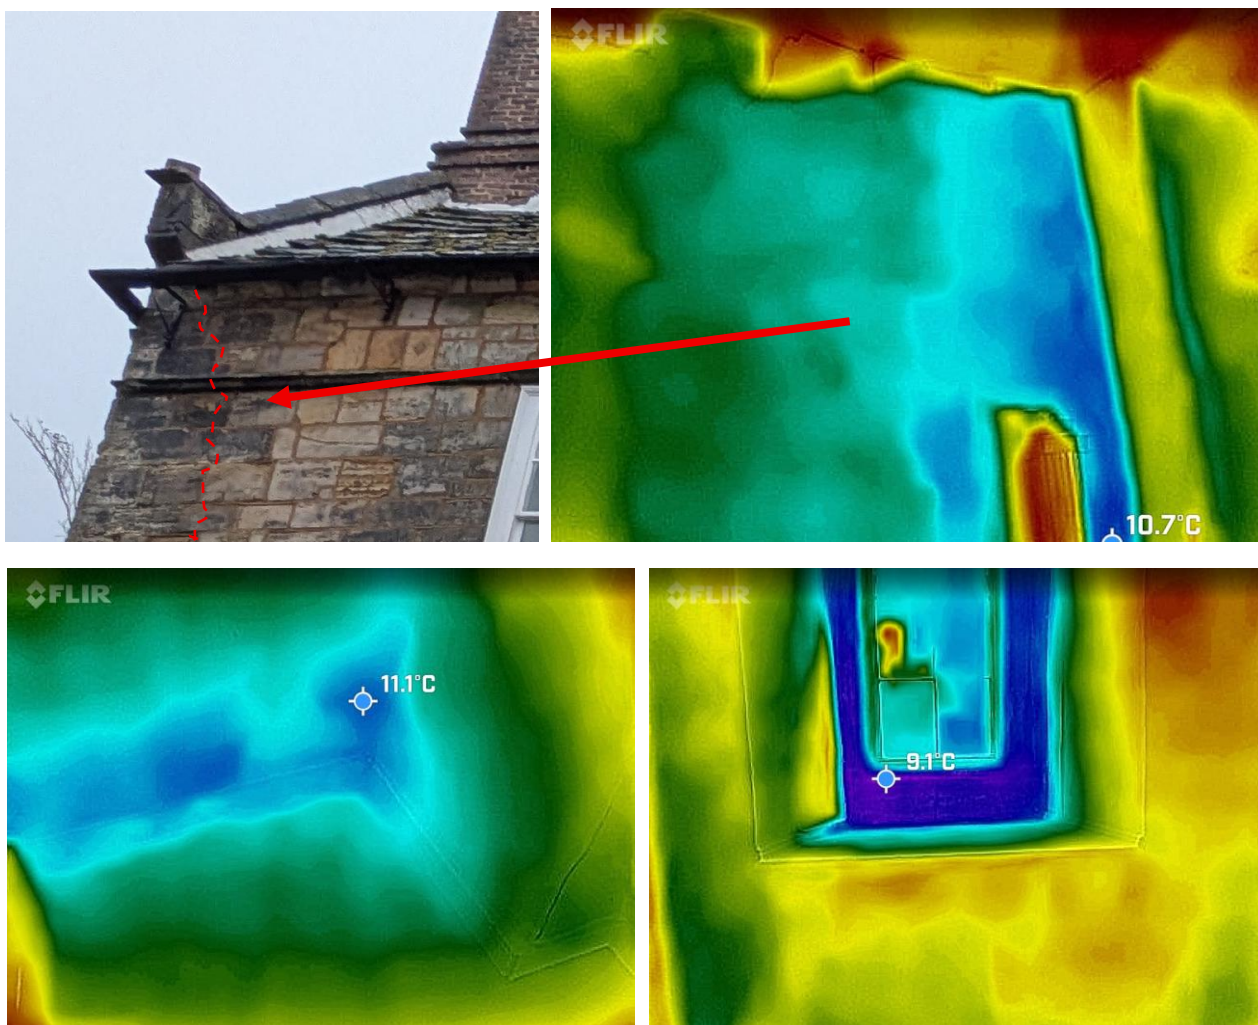
The damp symptoms in the master bedroom is being caused by a failure in the rainwater hopper above. During rainfall, water is discharging onto the wall rather than fully entering the downpipe, leading to repeated masonry saturation below. This is a localised rainwater issue, not a general damp condition.

The sandstone in this area readily absorbs water. Normally, lime mortar joints would allow that water to evaporate back out, helping the wall dry naturally. However, cement pointing has been used, reducing evaporation and allowing the wall to retain water for longer.

Internally, the wall is currently finished with gypsum board. The gypsum forms a relatively sealed surface, limiting drying from the inside. As a result, water becomes trapped within the wall and small cavity and migrates towards the internal surface, leading to blistering and paint failure. The completely wet surfaces are indicated in pink and blue.

The affected area is on the first floor and directly aligned with the defective hopper. There is no evidence of moisture travelling from anywhere else nearby.

Moisture readings confirm that the issue is confined to the hopper alignment zone.

The first step is to repair the hopper and ensure rainwater is properly directed into the drainage system. Cement pointing in the affected area should then be replaced with compatible lime mortar to restore outward drying.

Damaged internal plaster should be removed locally, and the wall allowed to dry naturally over time. Reinstatement should use breathable materials to prevent recurrence.

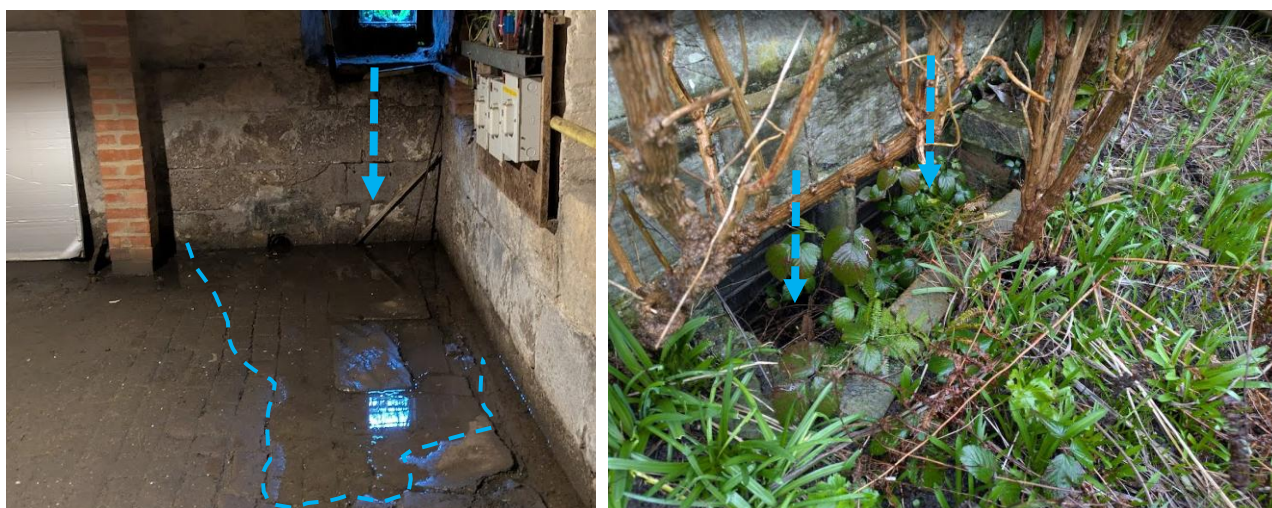
Standing water was observed in a corner of the basement floor, at a location corresponding to a historic drain outlet. The drain appears obstructed or partially collapsed, resulting in water accumulation during rainfall events. The water present is not under hydrostatic pressure through the wall face.

The mechanism is accumulation and evaporation rather than penetration. The image below shows the worst pooling area and the open coal shoot directly above it. This is allowing water to enter, while the blocked gully is preventing it from escaping.

The priority is to remove the standing water and restore drainage. Once liquid water is removed, mechanical ventilation must be introduced to keep the basement humidity below 65%. Until that source of airborne humidity is controlled, the upper floors will continue to feel its effects.

The basement drainage system requires formal investigation. A CCTV survey is recommended to determine whether the historic drain is obstructed, collapsed or disconnected. Clearance alone may be insufficient if structural failure is present. The objective is the complete elimination of standing water and reinstatement of reliable discharge.

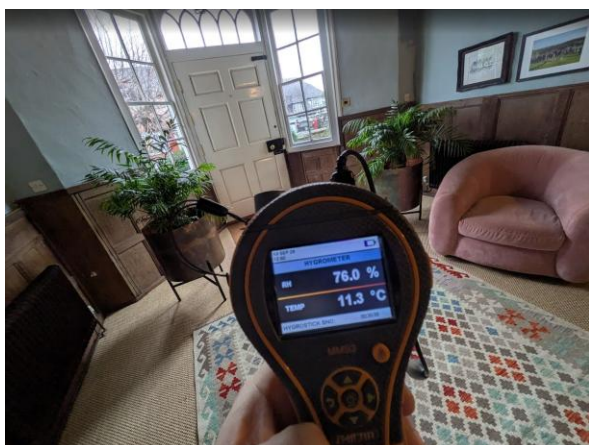
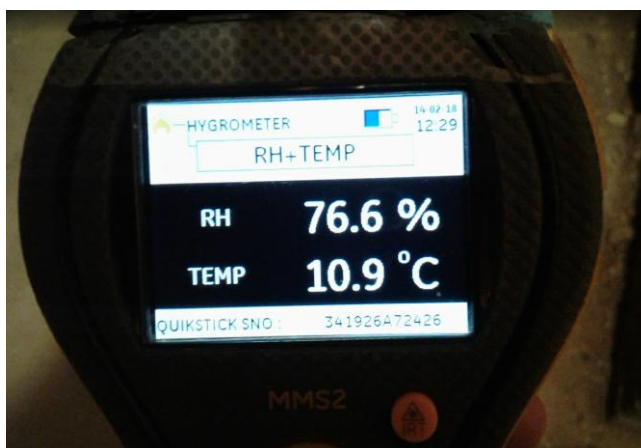
Readings taken in the hallway above the basement showed 76 % relative humidity at 11 °C. Under those conditions, surfaces that cool to around 7 °C will begin to form condensation, even if rain is not getting in. This means the wet basement is influencing conditions elsewhere.

The images below show the hallway and basement humidity levels; they are nearly identical.

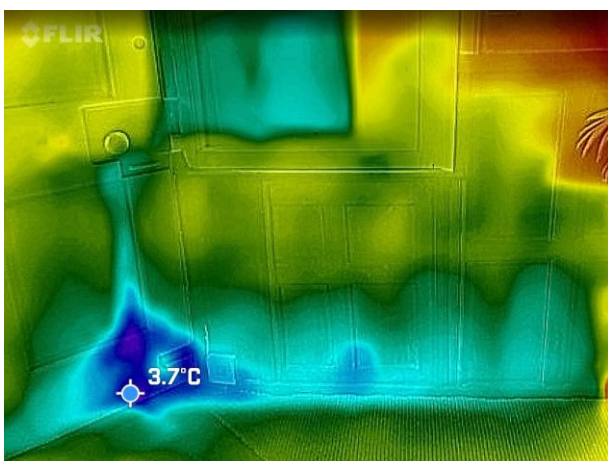
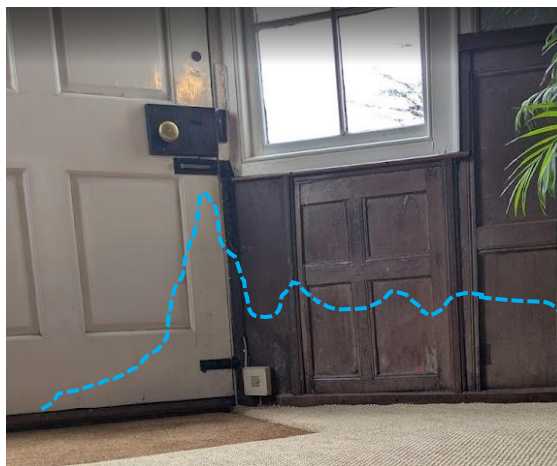
The trapped humidity from below is also causing the damp symptoms around the front door. The thermal images highlight this cause-and-effect. This is escaping humidity from below.

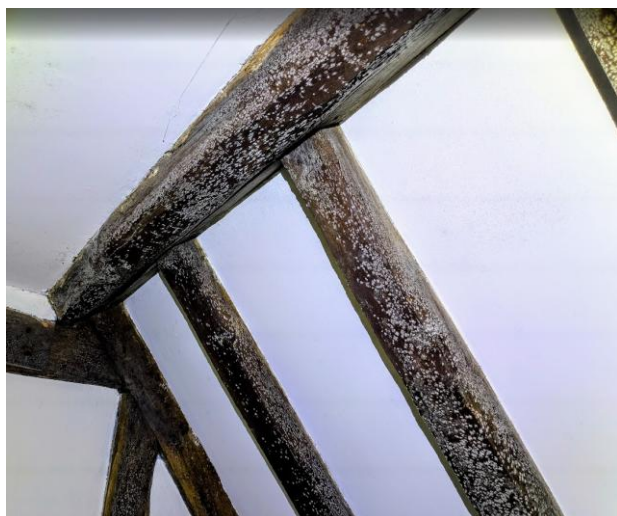
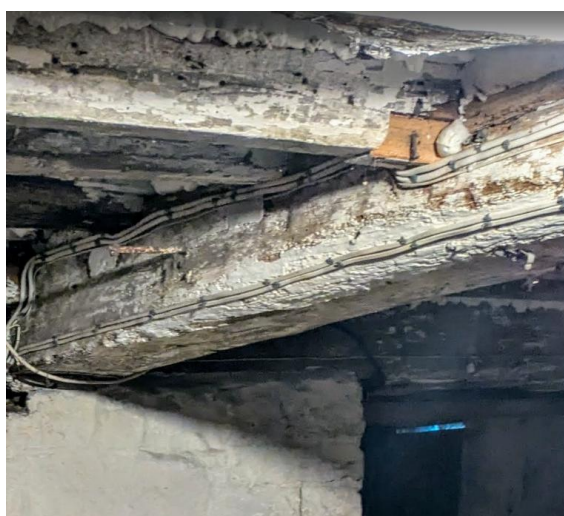
The annexe recorded relative humidity between 85 % and 90.3 % at temperatures below 9 °C. Under these conditions, timber in that space is not simply at cosmetic mould risk. It falls within an environmental range that, if sustained over multiple seasons, will gradually elevate its moisture content toward fungal viability thresholds.

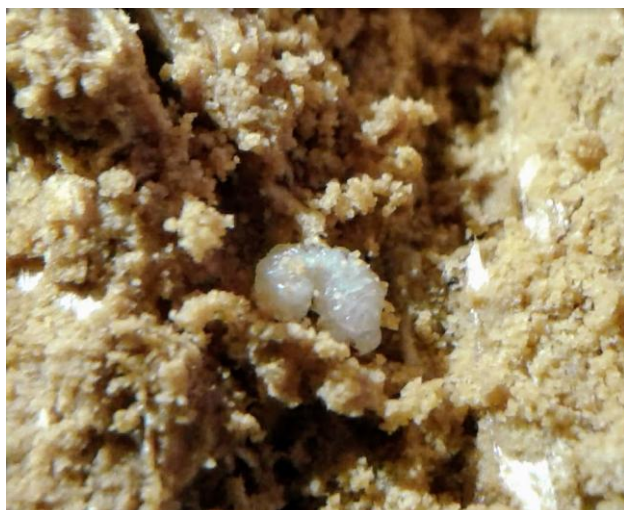
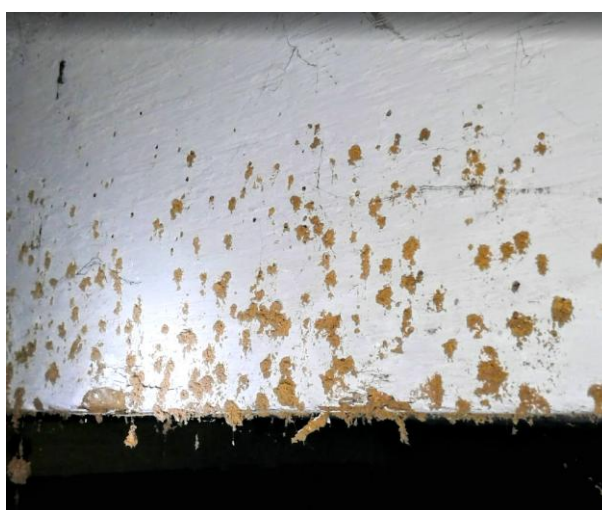
The basement presents the most significant timber risk within the building.

Standing water at floor level is generating continuous vapour within a confined environment. Relative humidity within the basement remains persistently elevated. Substructure timbers sit within this air mass for prolonged periods.

The basement timbers are already demonstrating signs consistent with a very damp environment. The environment is not seasonally dry. It is persistently moisture-laden. Timber exposed to such conditions will not stabilise below safe equilibrium levels unless the vapour source is removed.

Importantly, wood-boring insect activity was noted within this zone. Woodworm does not create damp timber. It selects damp timber. Active woodworm is an environmental indicator. It is evidence that the timber has been in a moisture condition suitable for insect viability over an extended period.

Wood-boring beetles require elevated timber moisture to complete their lifecycle. While exact species identification would require further sampling, the presence of activity confirms that the basement environment has supported elevated timber moisture for long enough to sustain insect habitation.

This is not a cosmetic issue. It is a signal of prolonged environmental dampness.
