JUSTIFICATION

RE-FACING OF MAIN CHIMNEY BREAST

107 HIGH STREET, LINDFIELD, HAYWARDS HEATH, RH16 2HR

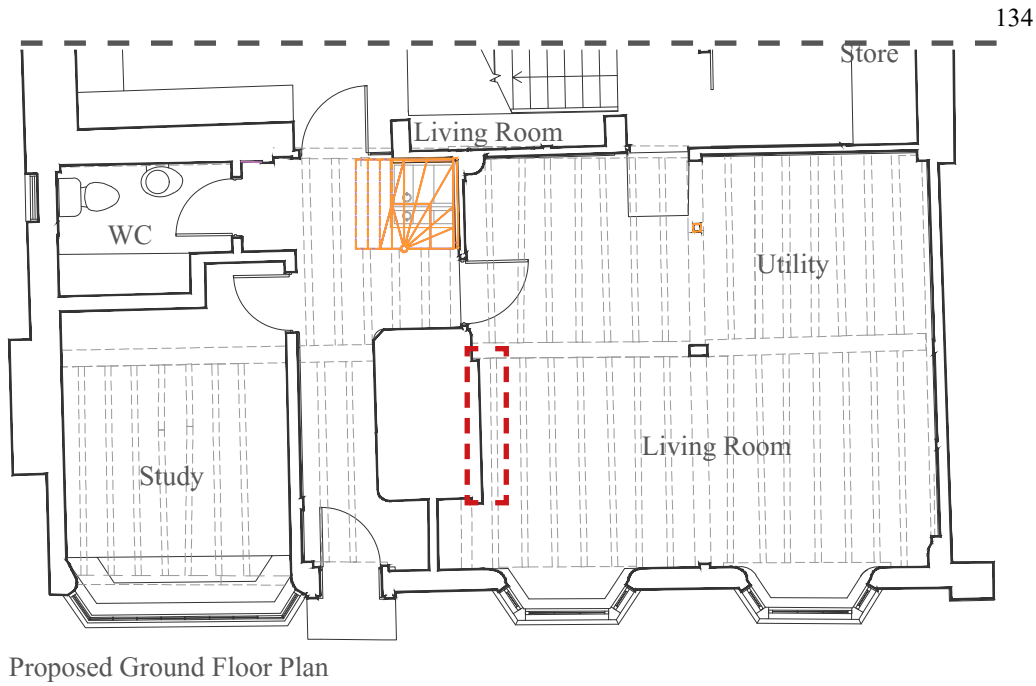
Ground floor living chimney breast under construction, prior to re-facing.  
Non-original blockwork wall infill exposed.

1. Initial, exploratory hole made on hallway side of chimney to visually investigate the construction of the chimney - blockwork was found to be located within the build ups

2. Existing blockwork removed from behind the existing hearth
3. Reclaimed brickwork cleaned where required across full extent of chimney prior to any repair works.

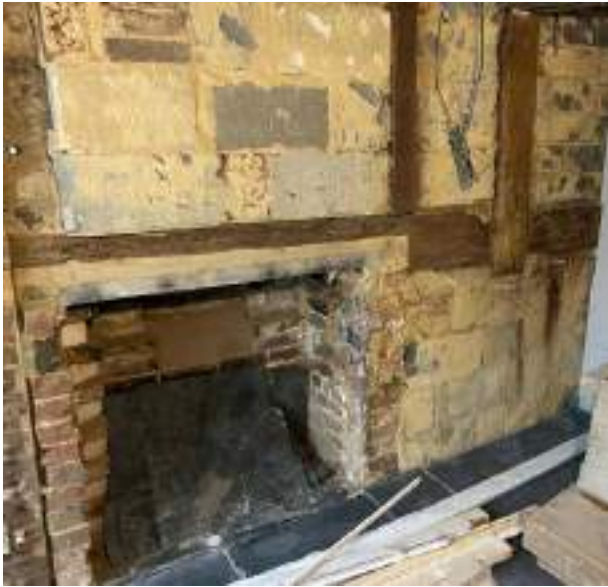
Ground floor living room re-faced chimney breast

4. Any serious erosion from spalled brickwork removed, then cleaned out and infilled with new brickwork and mortar mix with colour, texture and pointing to match existing.

5. Chipped or cement coated bricks removed, cleaned out and infilled with new brickwork and mortar mix with colour, texture and pointing to match existing.

6. Any open mortar joints, if not found to be a consequence of structural defects, cleaned out and infilled with new mortar mix with colour, texture and pointing to match existing.

7. New fireplace insert incorporated at ground floor.

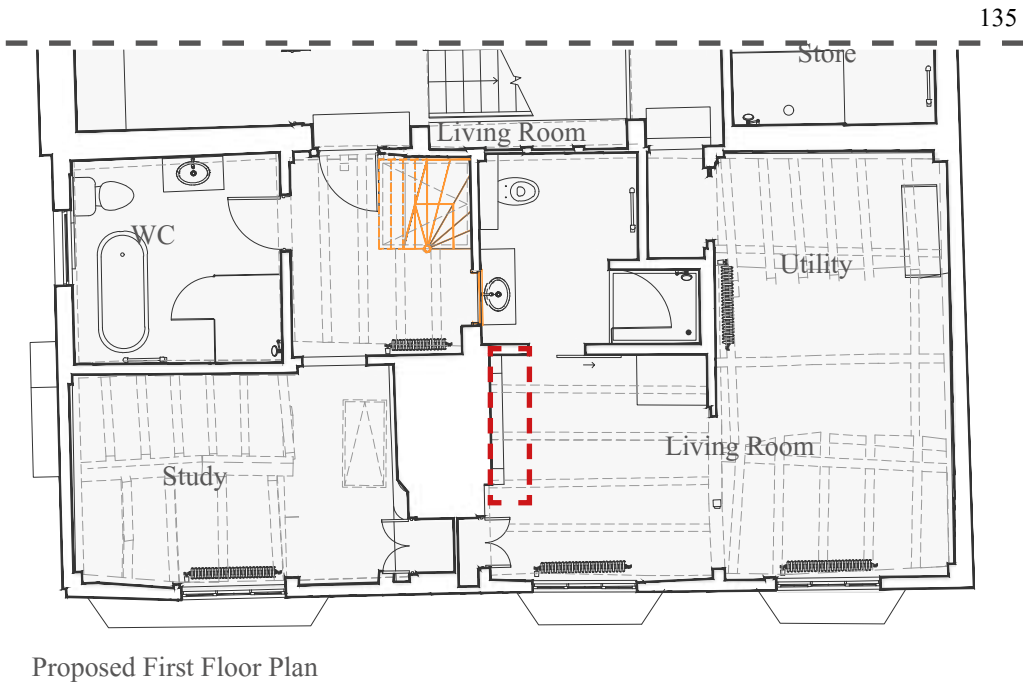
Original firebox blocked up

First floor bedroom fireplace and chimney breast before works

1. Existing fireplace insert removed
2. Brickwork infill around inserted fireplace removed to reinstate the historic firebox
3. Reclaimed brickwork cleaned where required across full extent of chimney prior to any repair works.
4. Any serious erosion from spalled brickwork removed, then cleaned out and infilled with new brickwork and mortar mix with colour, texture and pointing to match existing.
5. Chipped or cement coated bricks removed, cleaned out and infilled with new brickwork and mortar mix with colour, texture and pointing to match existing.
6. Any open mortar joints, if not found to be a consequence of structural defects, cleaned out and infilled with new mortar mix with colour, texture and pointing to match existing.
7. New timber mantle by Nick Cane of Cruck Frame Carpentry installed above the opening. Timber treated to match the floorboards.

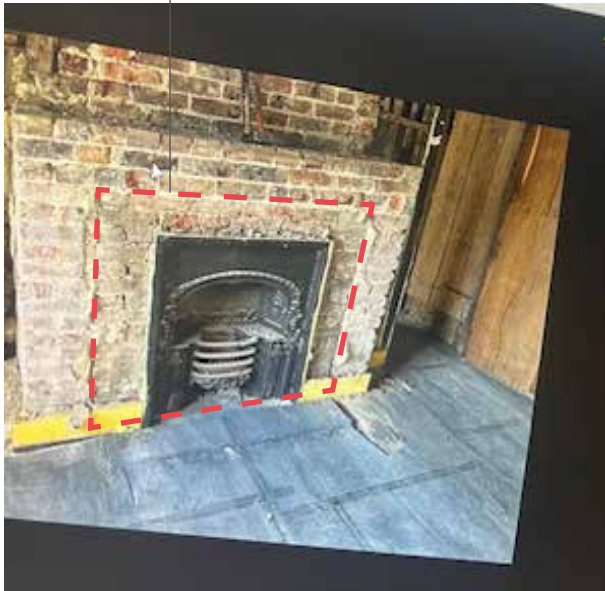
Original firebox retained

First floor bedroom re-faced chimney breast

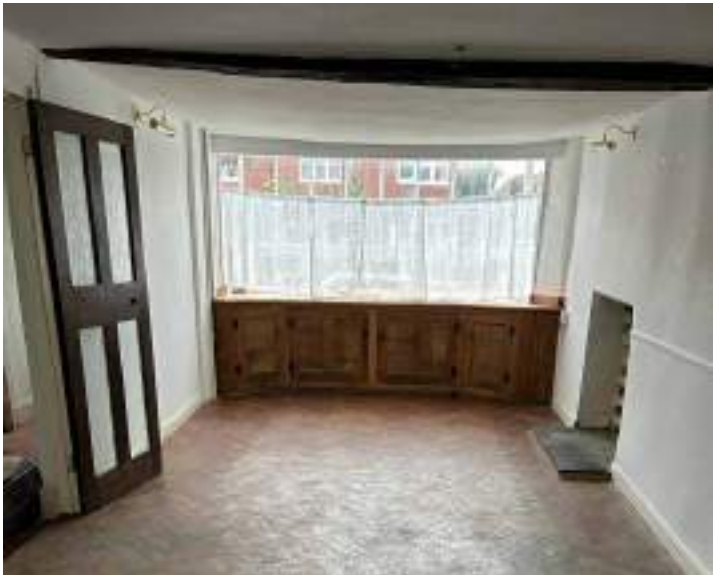
The fireplace opening in the ground floor study was blocked up prior to the construction works undertaken. As part of the works the opening was partially built up and electric fire was installed.

Ground floor study fireplace before works- opening on the right side

- 1. Previously blocked up firebox opened up
- 2. Firebox cleaned up, debris removed
- 3. Opening decreased in height - using masonry infill with lime plaster covering, decorated to match surrounding wall finish
- 4. New electric fireplace insert installed

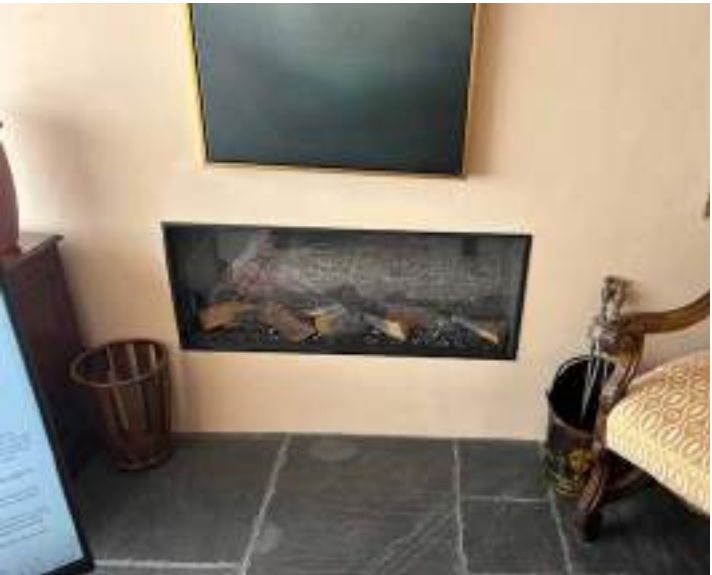
Ground floor study fireplace- electric fire place on the right side

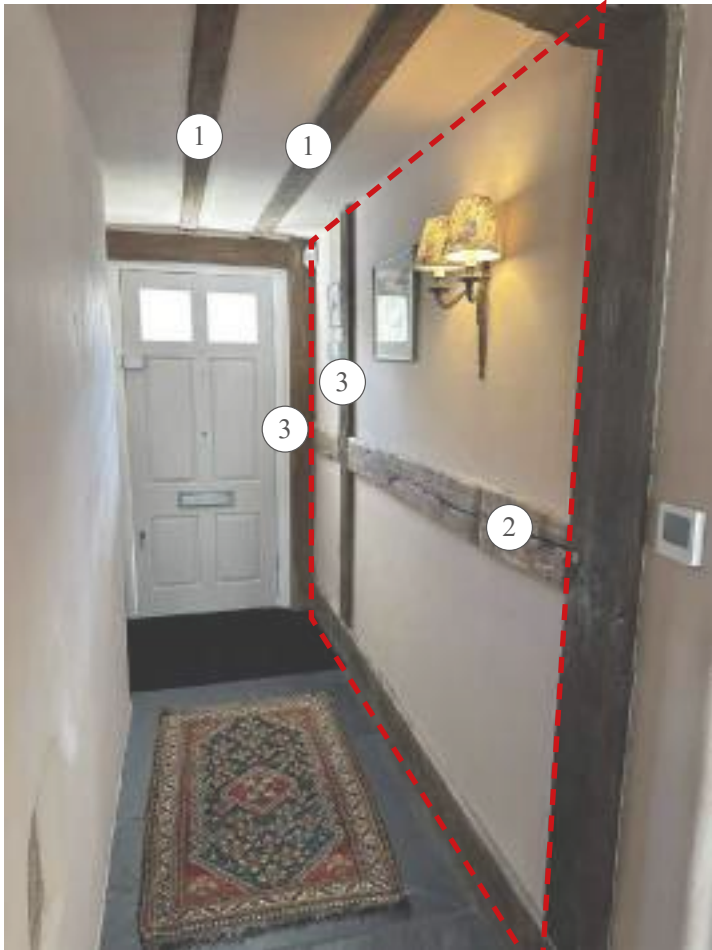
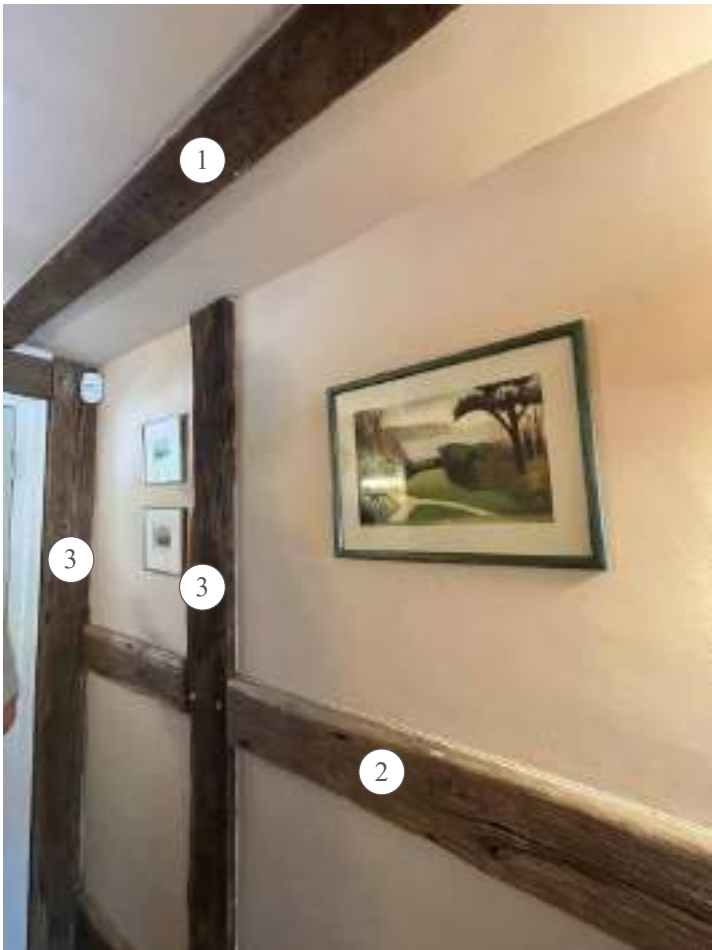
Existing timber framing to the southern wall in the entrance passage has been further exposed and carefully renovated during the engagement of heritage carpenter Nick Cain of Cruck Frame Carpentry. This sympathetic change reinforces the historic character of the main part of the house, which has been carefully restored. Additionally, small sections of oak panels were added to carefully complement the appearance of timber frame.

Recent photograph of the hallway wall

- 1. Comprehensive survey of the historic timber elements to assess the condition of the oak. Timbers checked for decay, insect damage, splits, warping, or structural weakness.
- 2. Timber renovated using historically appropriate techniques - gentle clean using soft bristle brush. Timber left are without any coatings. The timber’s patina, age marks, and tool finishes retained.
- 3. New elements created to restore the readability of the frame. Timber elements selected, cut to size, treated with wax to achieve colour and overall look of the historic elements. Installed without damage to the existing frame.

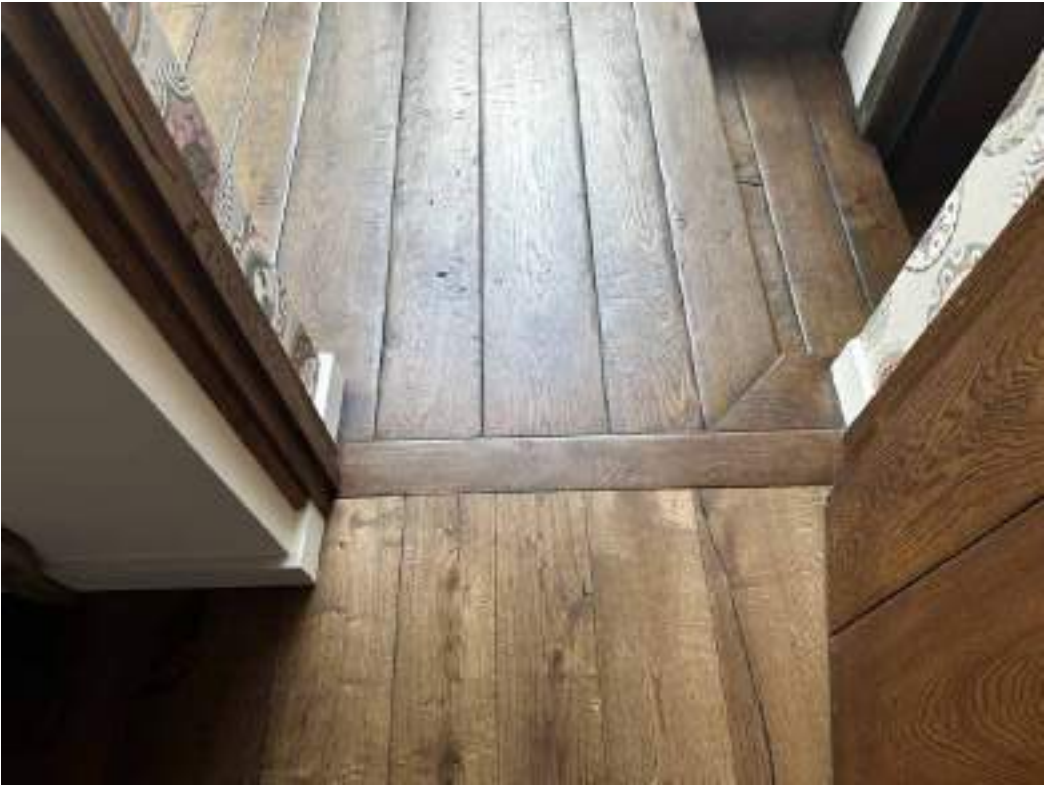
The floor boards have been retained and new traditional flooring overlaid using traditional methods. The existing floor boards substantially undulate and no floor in the original part of the building is level. If the new flooring was laid straight onto joists on a new substrate, it would be flat, but it’s not. The original joists and floorboards exist underneath and the extent of fixings into the floorboards is akin to the number required to lay a carpet over the floorboards. The owner is willing to lift areas of the new floor finish to demonstrate the presence and authenticity of the original floorboards below it which are being preserved in situ.

As-built oak flooring

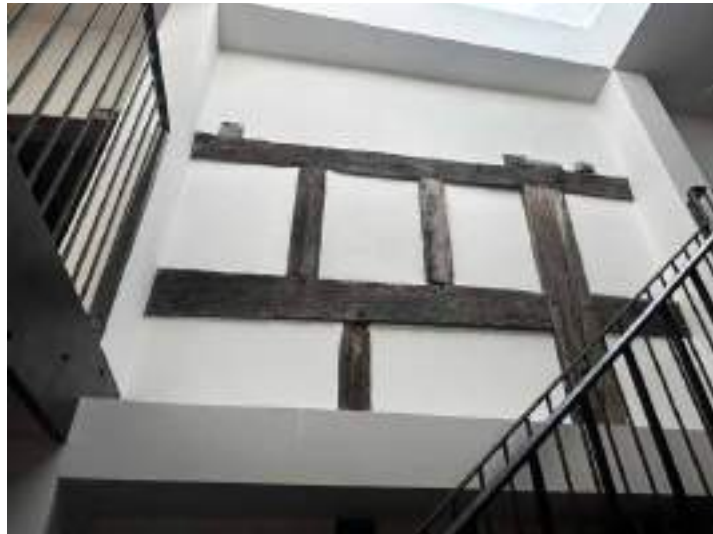
Recent photograph of west elevation wall with casement windows removed and openings filled in (first floor)

The windows were not original, added in 1990s and poorly detailed. After their removal the openings have been infilled with traditional fibrous wood wool boards faced in lime plaster. This change reveals and expressed the 15th century timber framing, which has been carefully repaired and renovated, which according to the supporting HCUK report is a significant heritage benefit.

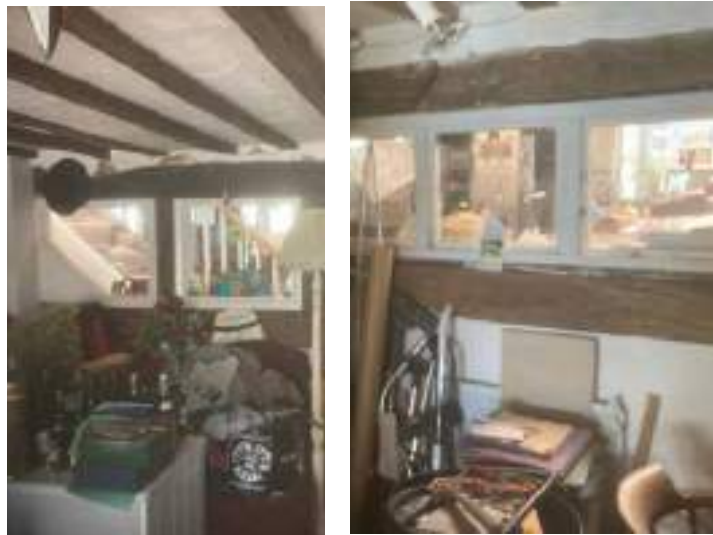
Pre-construction photograph of low quality casement windows, west facade (ground floor)

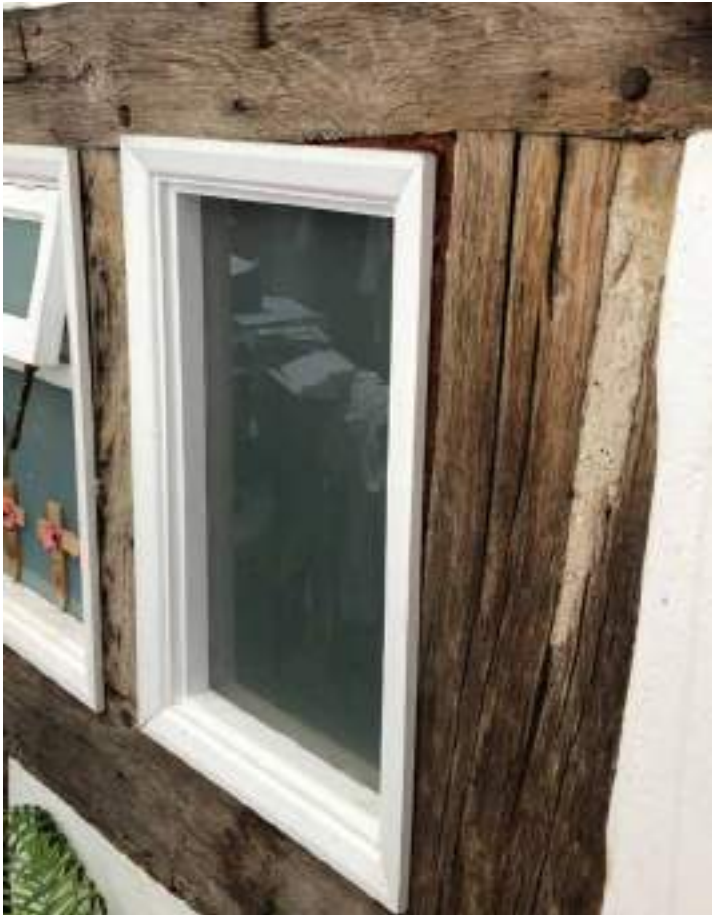
Pre-construction photograph of low quality casement window, west facade (ground floor). Foam around the frame visible.

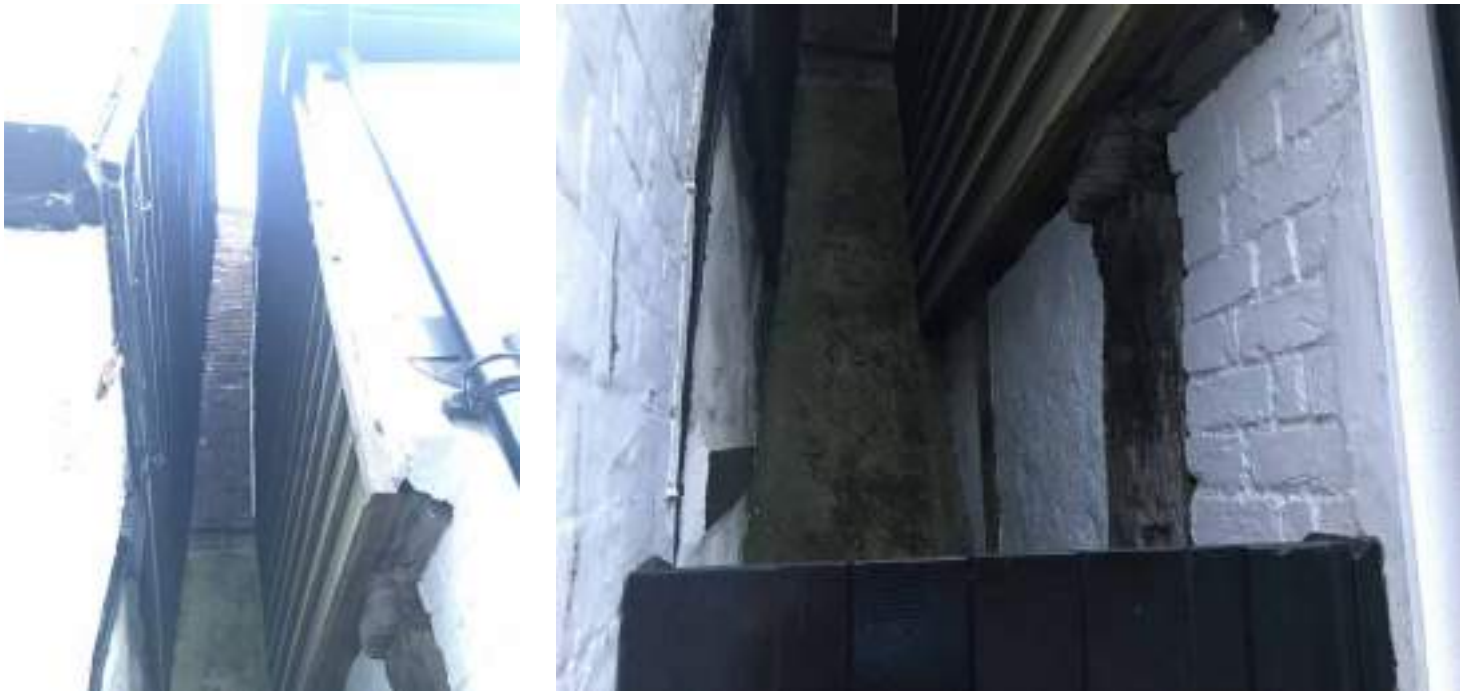
Leaving it as it is retains the legibility of a possibly truncated timber jetty as well as the exposed timber framing and brick nogging to this return elevation. Under-implementation of this change is preferable in heritage terms.

Recent photographs of timber weatherboarding

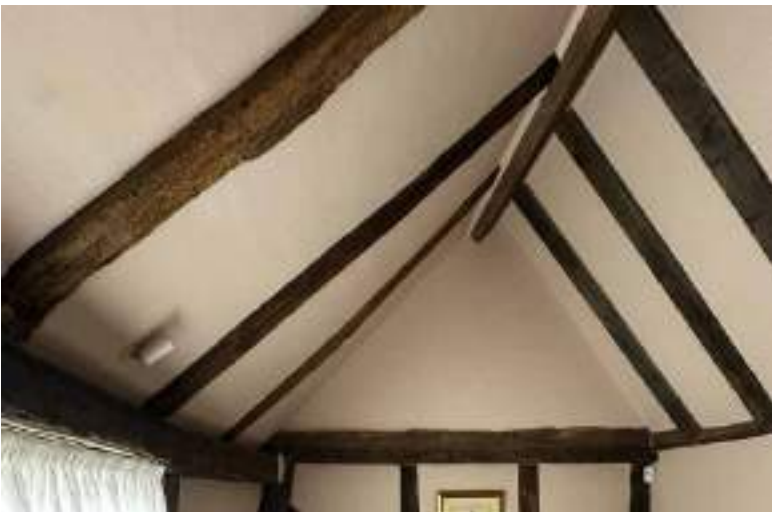
The modern ceiling build up with timber joists and gypsum plasterboard finish have been removed in the SE bedroom, with the creation of a vaulted ceiling. This has been created utilising reclaimed timber oak timber rafters with lime plaster infill. It is proposed to retain these works. The room was also covered in its entirety in garish wallpaper coverings that covered up and prevented the proper appreciation of the original timber frame of the property. The oak frame has been exposed in this space following the removal of modern materials and soot marks can now be appreciated within this space following the removal of the modern ceiling, providing an insight into the history of the building when it was once open.

Vaulted Ceiling in SE Bedroom

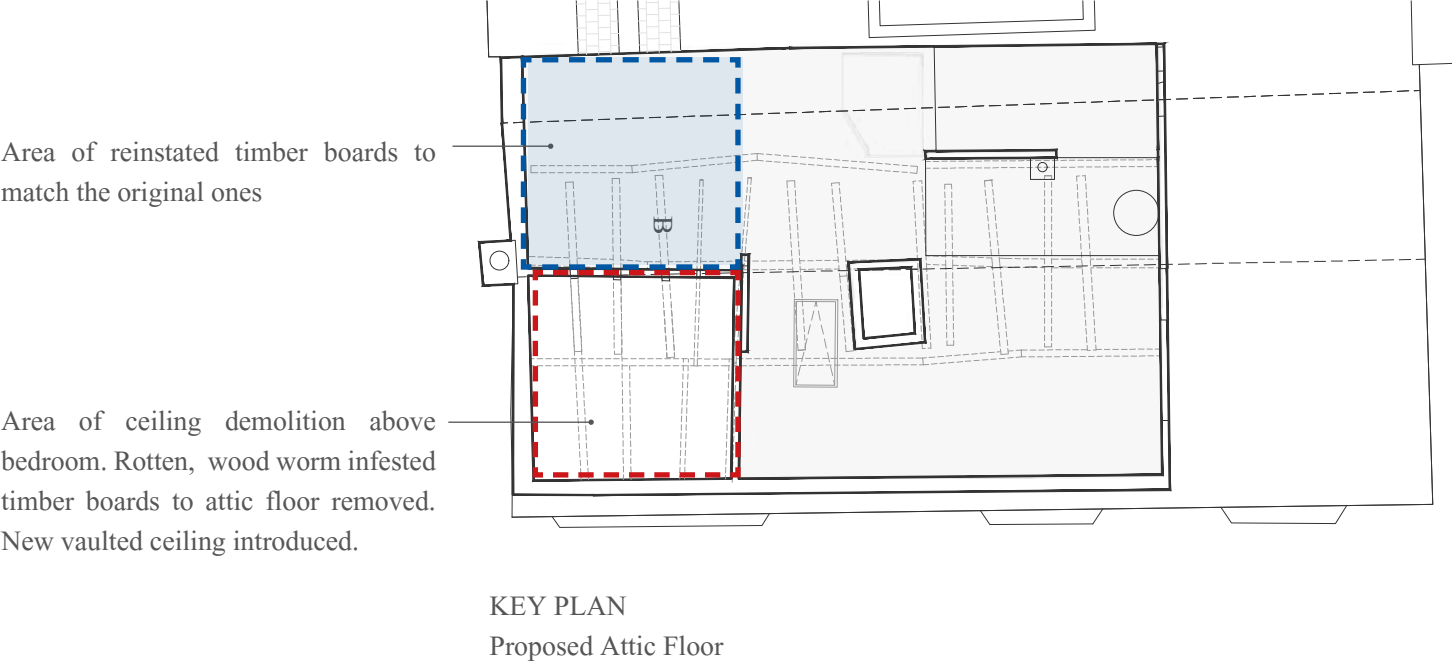
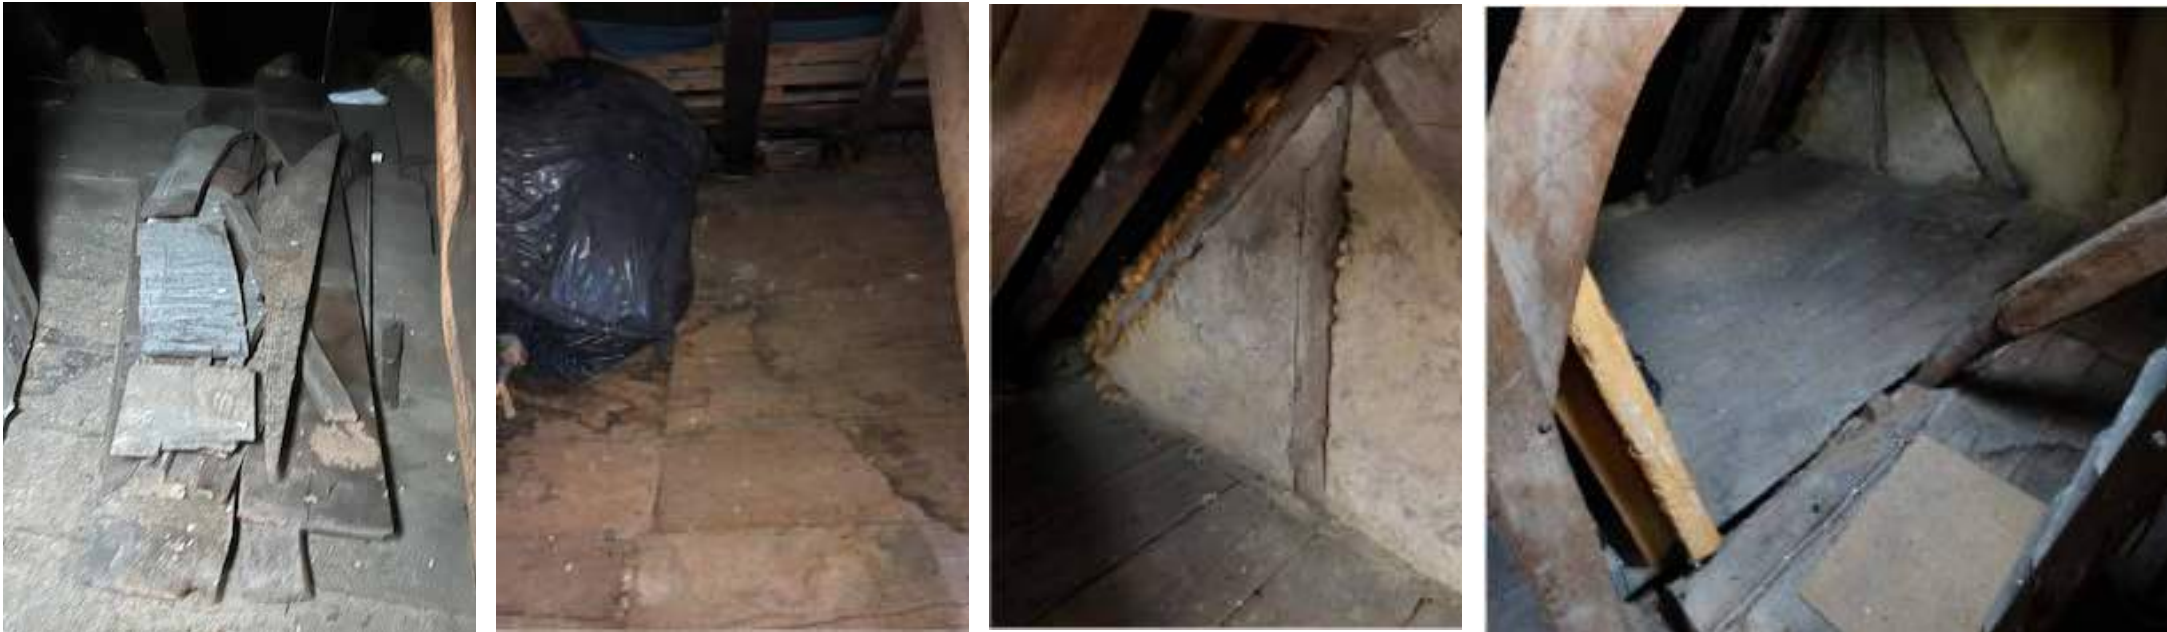
The 17th century floor boards above the south-east bedroom were excessively loose and instable located in the loft. The previous owner confirms many areas of the old flooring in the attic were in a very poor condition. A high percentage were badly stained and rotten. Furthermore, the Desbrulais report confirms in the photograph this attic area was already raised suggesting non-original elements being in place below the loose laid boards, perhaps the reason why they were loose laid in the first place.

Pre-construction photographs of attic floorboards in poor condition

Extract from Desbruslais Heritage Report - area of attic floor with historic floorboards loose laid

Once removed, the floor boards have been re-used (to form basement hatch, doors) in a sympathetic manner to give them use and meaning within the context of the modern elements of the property and the general / overall character of the property. It is therefore argued that their value has not been lost, but in fact realised.

As a measure of good will, the floor boards will be reinstated in the southern part of attic floor. They will be manufactured by the The West Sussex Antique Timber Co. Ltd.to match the existing in character, quality, tone, and texture. Refer to drawing 5029 for further information.

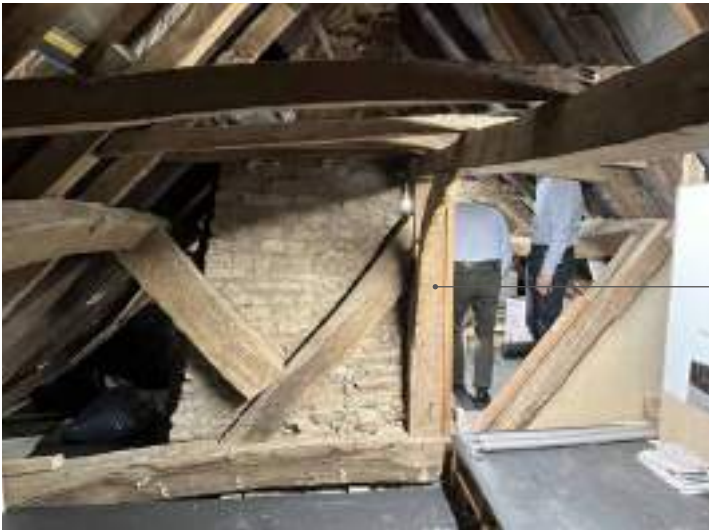
It is illustrated on the photographs below that the crown post was not removed.

Existing crown post in its historic place

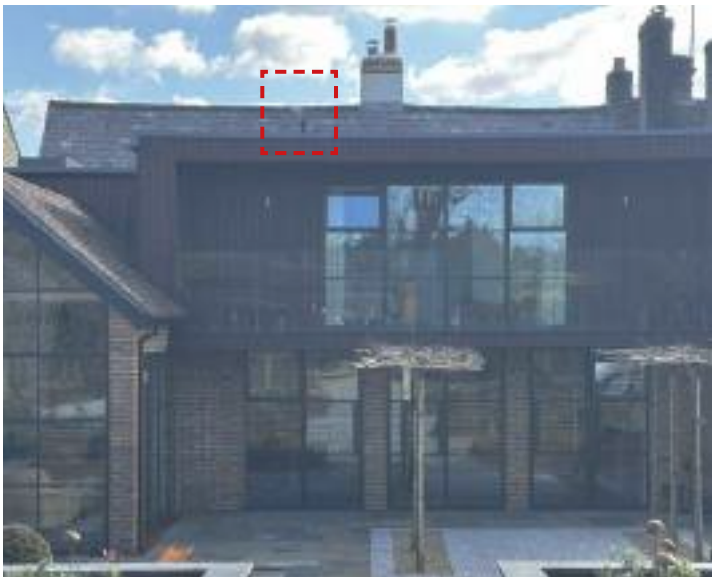
The flue is a 100mm diameter pipe penetrating through the roof with flashing around it to ensure watertightness. It projects up circa 300mm from the face of the roof tiles but not above the main ridge line and is not visible from the front elevation.

Recent photograph capturing the new boiler flue

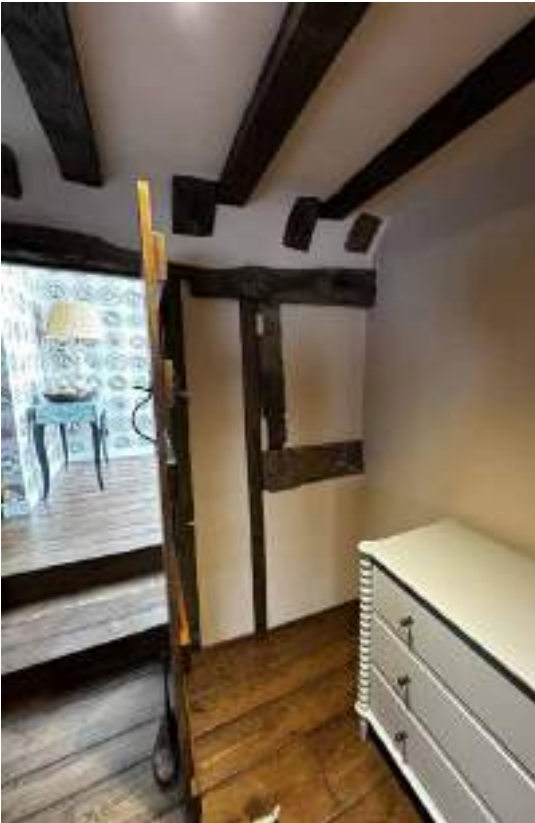
Timber frame was carefully cleaned and left untreated. There could have been some damage done by the previous owners as the Heritage Statement by Desbruslais confirms that the frame was cleaned on a regular basis. Additionally, many of the oak joists and bressummers have been oiled, as illustrated on the adjacent photograph.

Photographs of restored historic oak frame

- 1. Comprehensive survey of the historic timber elements to assess the condition of the oak. Timbers checked for decay, insect damage, splits, warping, or structural weakness.
- 2. Timber renovated using historically appropriate techniques - gentle clean using soft bristle brush. Timber left are without any coatings. The timber’s patina, age marks, and tool finishes retained.

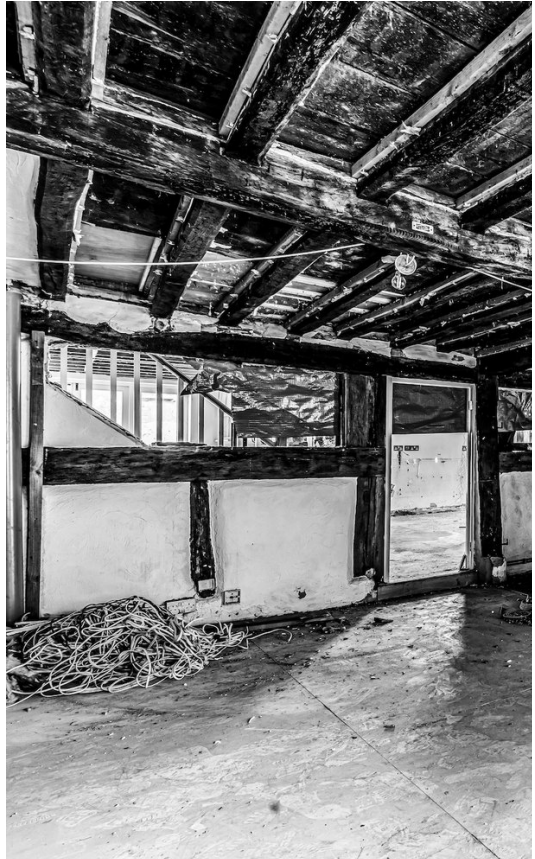
*‘Surface finishes are a range of materials from older lime based wall plaster, to modern plasterboard infilling. There have been attempts also to re-face older lath wattle with cement based plaster in places, which is heavily deteriorated. Much of the infilling between the various exposed ceiling joists is modern nailed board and Artex. Ground floor nib walls have excessive modern filler in numerous places and older material survival is patchy and inconsistent.’*

Photographs of historic oak frame prior to restoration
