## ARBORICULTURAL SURVEY

Survey Reference: CTS-GP-0YZ4-01

**23 Bridgersmill, Haywards Heath, West Sussex RH16 1TF**

Date of inspection: 24/11/2025

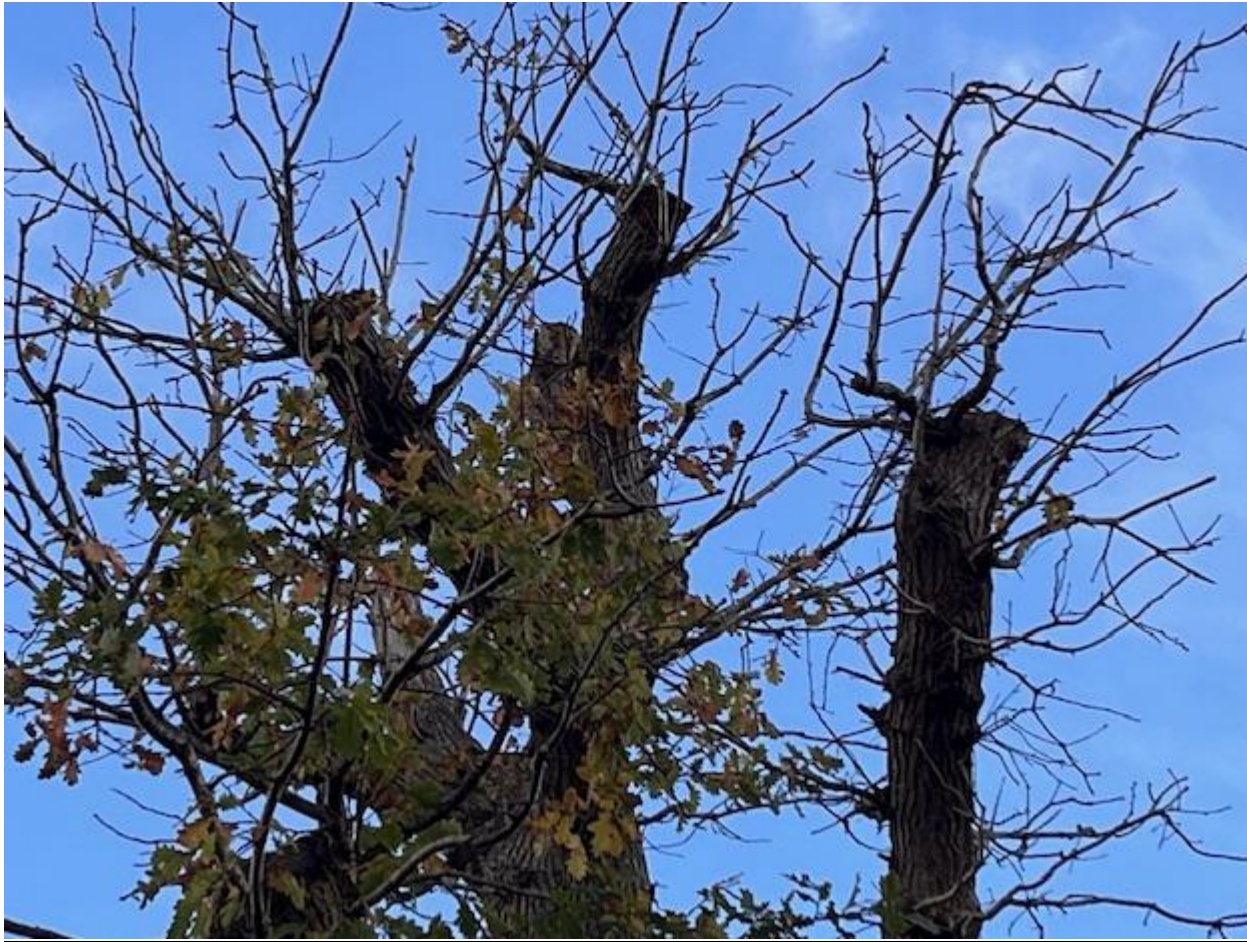
This tree has been managed in the past by way of crown reduction works due to the decline in the canopy, but it is evident from today's inspection that the tree is in a period of physiological decline with significant crown dieback and cambium necrosis noted throughout the remaining crown.

English oak tree with significant crown dieback

Due to the location of the tree and the significant decline in physiological health, I make recommendations for this tree to either be reduced down in height by approximately 50% to just under the crown break and maintained for wildlife benefit or full removal and a new tree of the same species planted as a replacement within a 6-month period from the date of this report.

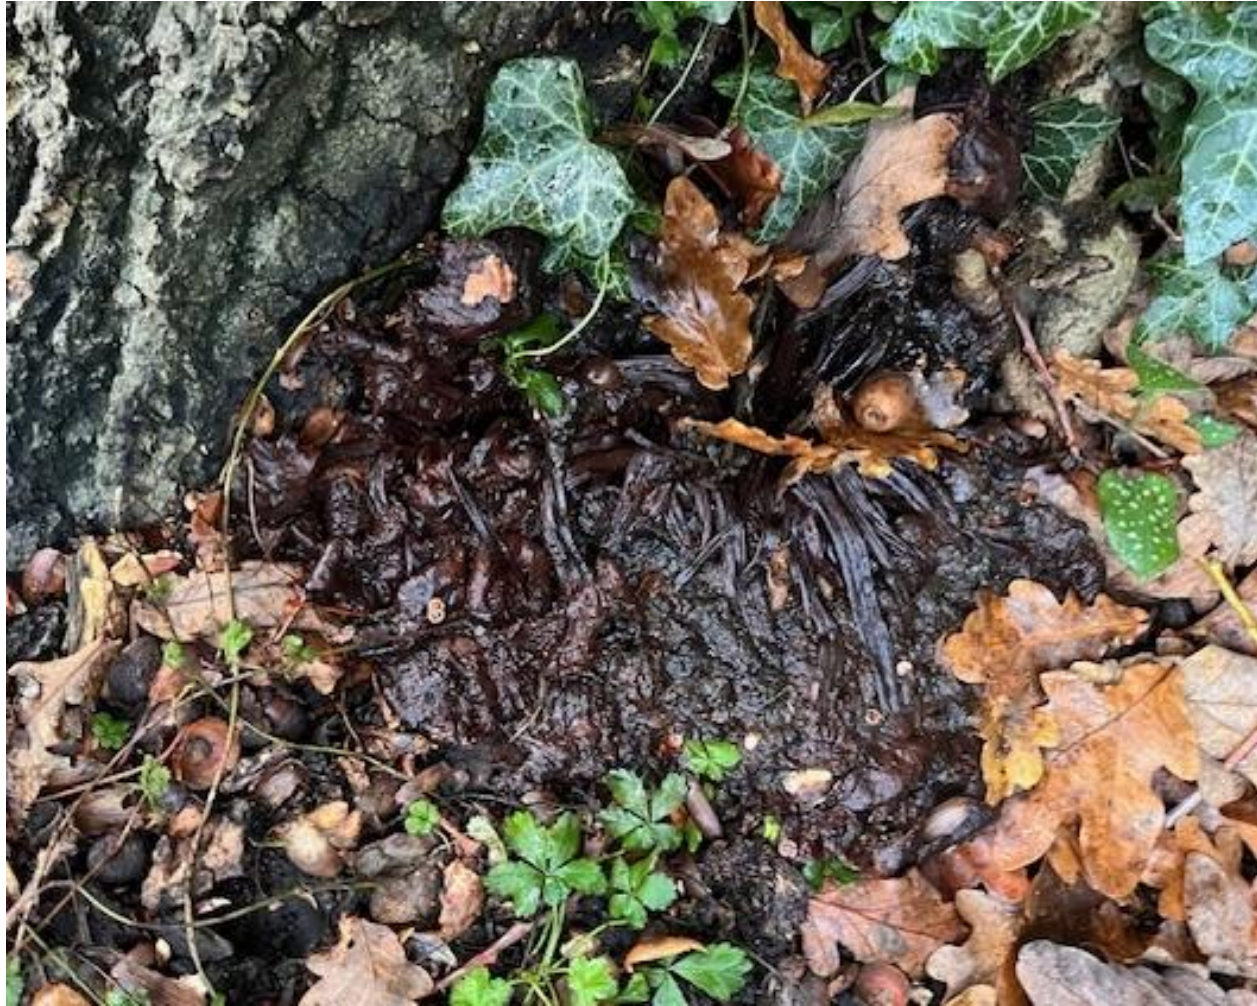
At the time of my inspection, there were visible fungi fruiting around the tree base on the northwestern, north and southwestern aspects of the stem. These fungi are what I believe to be Honey fungus (*Armillaria spp*). This fungi is generally considered pathogenic and able to enter via roots from the surrounding soil. Indicative of physiological stress and often a decline in vitality.

Area of Armillara noted at base of tree
