# **ARBORICULTURAL HAZARD EVALUATION SURVEY**

**54 Leylands Road  
Burgess Hill  
West Sussex  
RH15 8AL**

**Document date: 26<sup>th</sup> August 2025**

**Document ref: PJC/6936/25-01 Rev -**

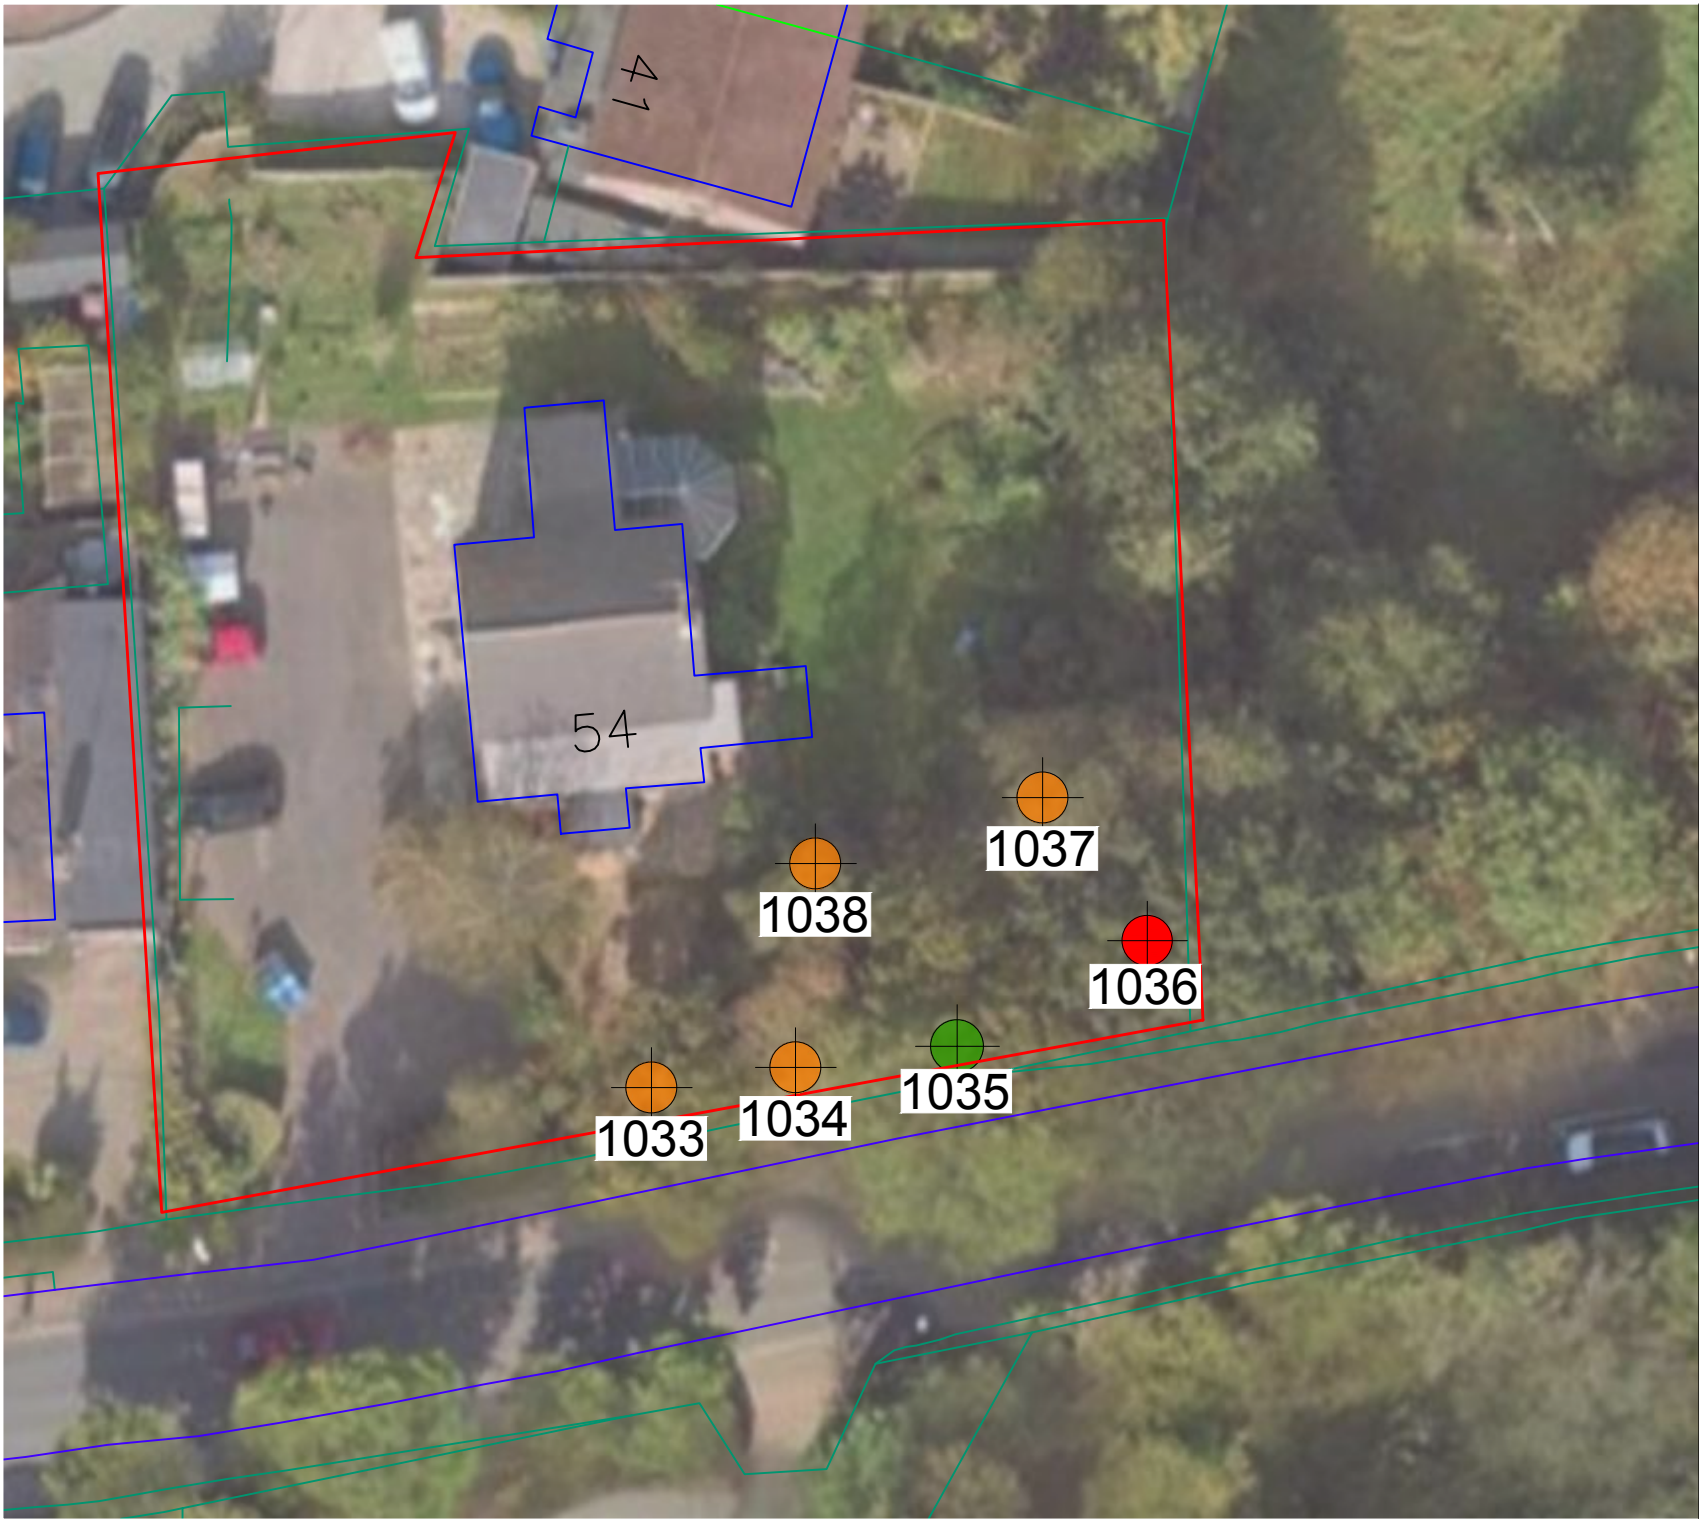
Drawing title: Tree Location Plan

| Tree No. | Species | Height (m) | Age class | Physiological condition | Structural condition | Frequency of use of target area | Target | Comments/Defects | Management Recommendation | Location | Priority |
|---|---|---|---|---|---|---|---|---|---|---|---|
| 1033 | Norway maple (Acer platanoides) | 15 | Mature | Good | Good | High | Leylands Road and footpath. | Deadwood within upper crown. | Remove deadwood over 75mm in diameter or 1m in length. | ///cave.punt.senses | Amber |
| 1034 | Horse chestnut (Aesculus hippocastanum) | 14 | Mature | Good | Fair | High | Leylands Road and footpath. | Minor damage in south of crown. Historically reduced to 4m and now lapsed in formal pruning. Included bark within the new growth unions potentially compromising the structural integrity of the tree, as the included bark may create weak points where the branches unite. | To enhance the structural integrity of the trees and mitigate the effects of wind on their crowns, it is recommended to reduce the canopy by approximately 30%. This reduction will help to diminish the sail effect created by the tree crowns, which can place undue stress on the included unions—areas where branches or stems are closely joined. | ///apple.solo.soak | Amber |
| 1035 | Ash (Fraxinus excelsior) | 16 | Mature | Good | Good | High | Leylands Road and footpath. | Crown bias over road and power cables. No major visible defects. | It is advisable to conduct a lateral reduction of the southern crown aspects by 3 meters, trimming back to appropriate growth points. This action aims to mitigate the encroachment on power cables and ensure safer passage for vehicular traffic. While this task is not deemed critical for safety, it is recommended to proceed with it if the budget permits. | ///overnight.voting.station | Green |

| Tree No. | Species | Height (m) | Age class | Physiological condition | Structural condition | Frequency of use of target area | Target | Comments/Defects | Management Recommendation | Location | Priority |
|---|---|---|---|---|---|---|---|---|---|---|---|
| 1036 | Pedunculate oak (Quercus robur) | 17 | Mature | Fair | Fair | High | Leylands Road and footpath. | Sparse crown with minor deadwood. Several large pruning points at 6, 8 and 10m from recent limb drop. Recent fallen limb displays internal decay is present combined with sounding hammer indicating hollowing in stem. Over extended 4m south limb has small cavity on underside of main union. | To address the significant stress and strain on the internal branches of the tree, it is advisable to perform a crown reduction of approximately 40%. This measure is particularly important given the recent dry conditions, which have exacerbated existing weaknesses within the tree's structure, alongside the presence of internal decay. By reducing the crown, the overall weight and load on the compromised branches will be lessened, thereby promoting better health and stability for the tree. This proactive approach not only mitigates the risk of branch failure but also enhances the tree's resilience against environmental stressors, ultimately contributing to its longevity and vitality. | ///normal.letter.thanks | Red |
| 1037 | Horse chestnut (Aesculus hippocastanum) | 15 | Mature | Fair | Fair | Moderate | Garden | Dual stemmed from 2m with minor bark inclusion. Sounding hammer indicates some hollowing within stem. Historic fail point at 6m north. Small hazarded beam at 6m north above fail point. | Remove deadwood over 75mm in diameter or 1m in length and remove limb with hazarded beam at 6m north. | ///fries.grants.spell | Amber |
| 1038 | Sycamore (Acer pseudoplatanus) | 14 | Semi mature | Fair | Fair | High | Dwelling, garden. | Minor deadwood within upper crown. | Remove deadwood over 75mm in diameter or 1m in length. | ///voters.area.dirt | Amber |
