26/08/2025  
PJC Ref: 6936/25

**RE: Arboricultural Condition Assessment -54 Leylands Road, Burgess Hill, West Sussex, RH15 8AL.**

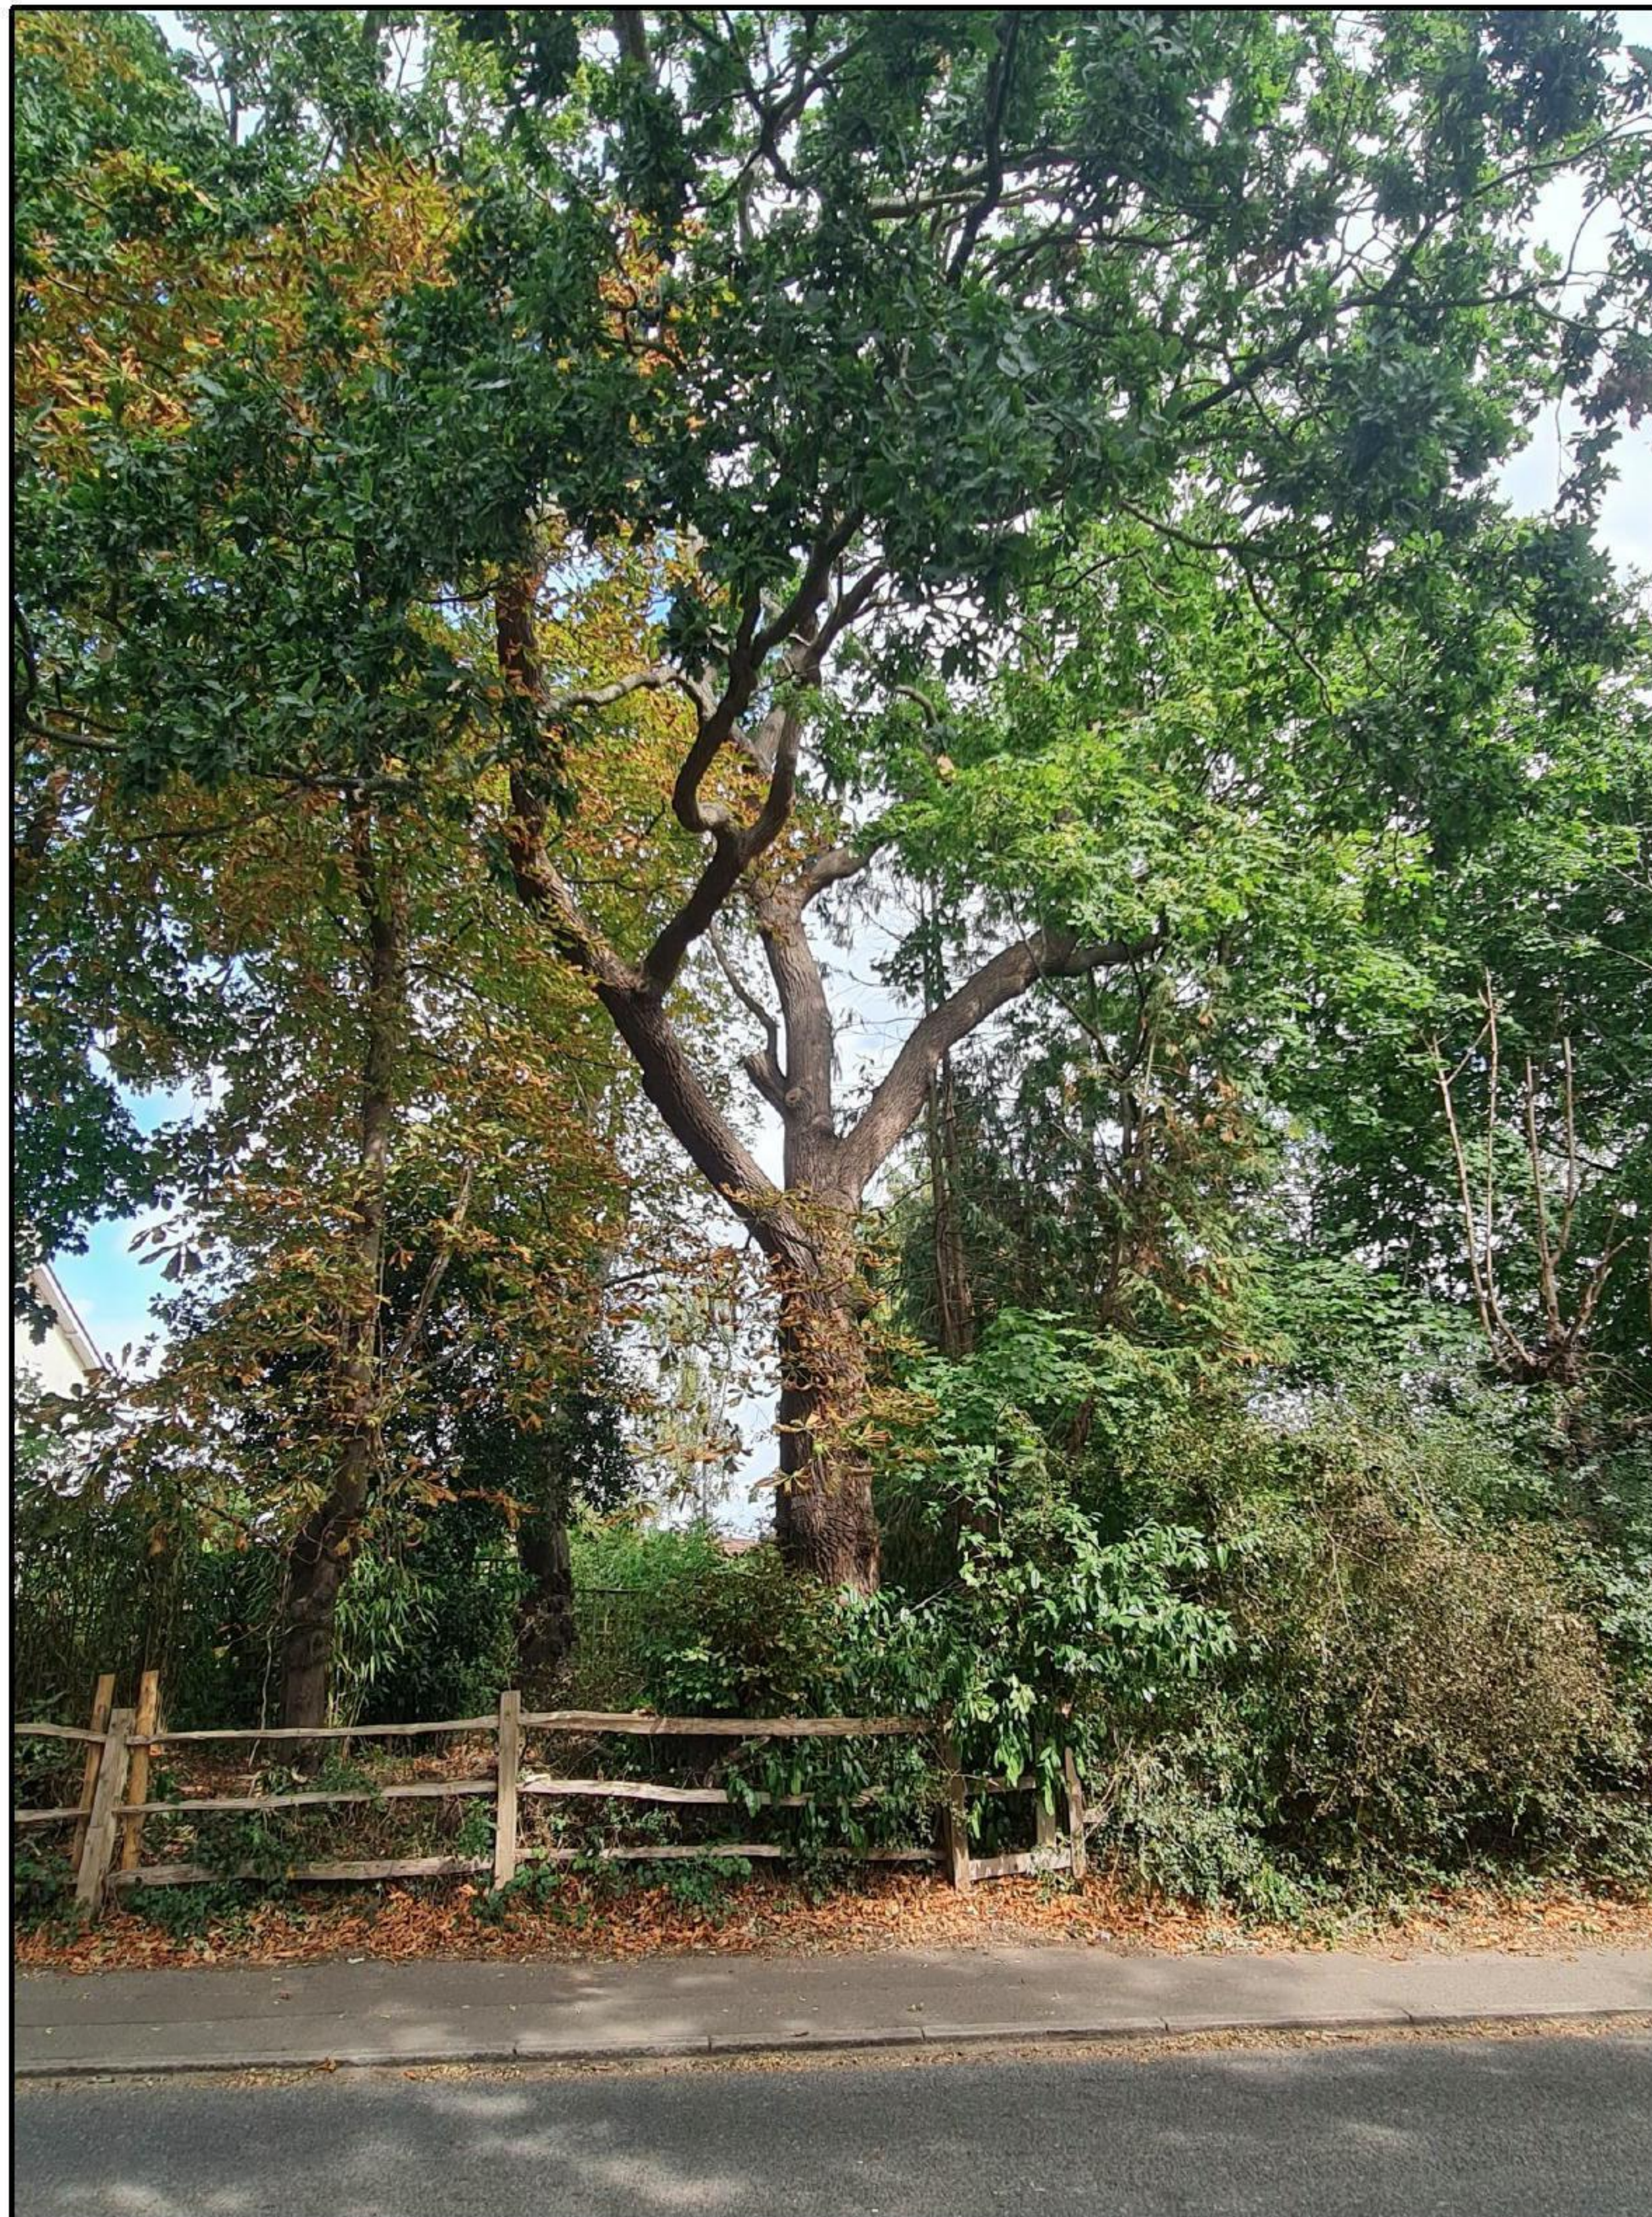
*Figure 2. Picture taken in August 2025 of oak tree from Laylands Road.*

The oak tree reaches a height of 16 meters, exhibiting a crown spread that averages between 5 to 8 meters, while maintaining a ground clearance of 6 meters above Leylands Road. Its crown displays an asymmetric shape and is assessed to be in fair physiological health, characterised by a sparse foliage density and the presence of minor deadwood. The structural integrity of the tree's scaffold is also deemed to be in fair condition, although it bears several recent pruning wounds resulting from the dropping of limbs

To address the significant stress and strain on the internal branches of the tree, it is recommended to undertake a crown reduction of approximately 40%. This measure is particularly important given the recent dry conditions, which have exacerbated existing weaknesses within the tree's structure, alongside the presence of internal decay. By reducing the crown, the overall weight and load on the compromised branches will be significantly diminished, thereby promoting better health and stability for the tree. This proactive approach not only mitigates the risk of further branch failure but also enhances the tree's resilience against environmental stressors, ultimately contributing to its longevity and vitality. It is advised that the tree be subject to an arboricultural inspection once every two years to review the ongoing management strategy.

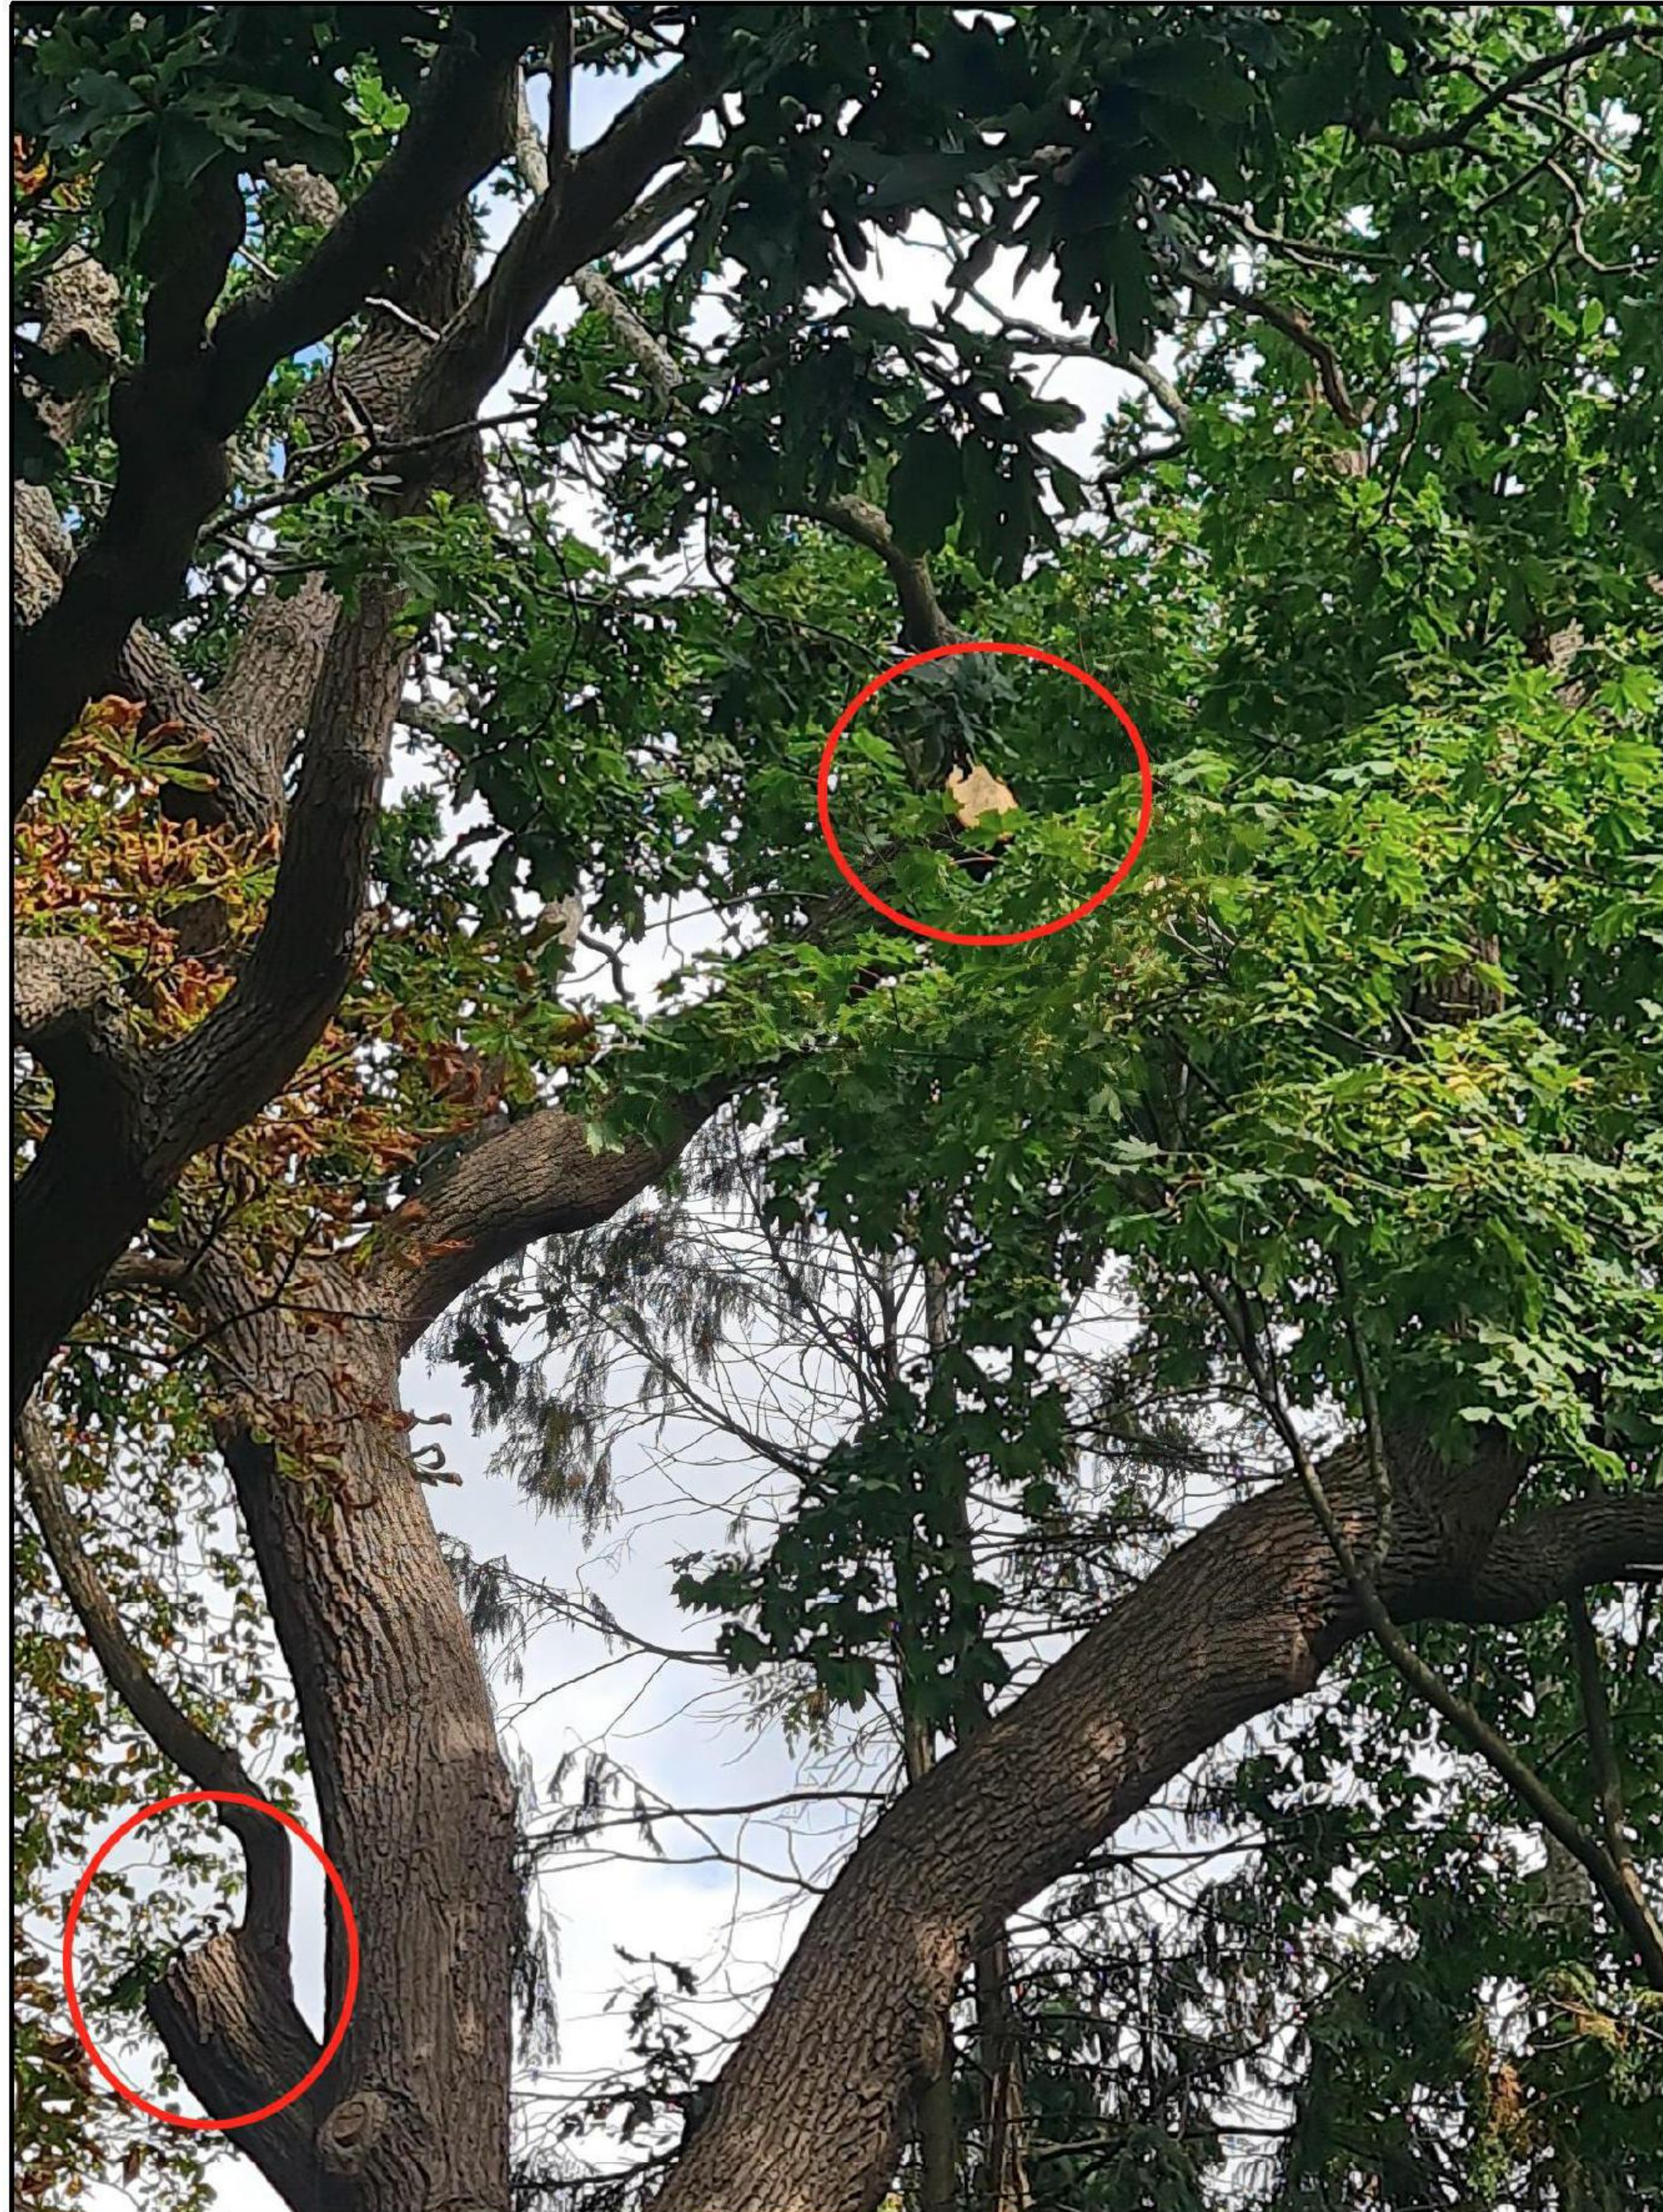
Recent limb drops have occurred at 6, 9 and 10m, two of which can be seen in figure 3. The recent occurrence of limb drops in the oak tree is attributed to a phenomenon known as Sudden Oak Limb Drop, or Summer Branch Drop. This condition is characterized by the unexpected shedding of large branches from seemingly healthy, mature oak trees, often occurring without any apparent cause, even during calm weather conditions. It is believed that these branch failures are linked to internal weaknesses within the wood, as illustrated in figure 4, which shows a section of a fallen limb exhibiting signs of internal decay. The situation has likely been aggravated by an extended period of drought, which can lead to increased stress on the branches, resulting in internal cracking. Additionally, the presence of long, horizontal limbs that extend across Laylands Road contributes to the problem, as these branches bear excessive weight, particularly when burdened with summer foliage or acorns. This added weight further heightens their susceptibility to failure, making it crucial to monitor the health and structural integrity of these trees.

Figure 3: Picture taken in August 2025 showing two locations of recent limb drop.

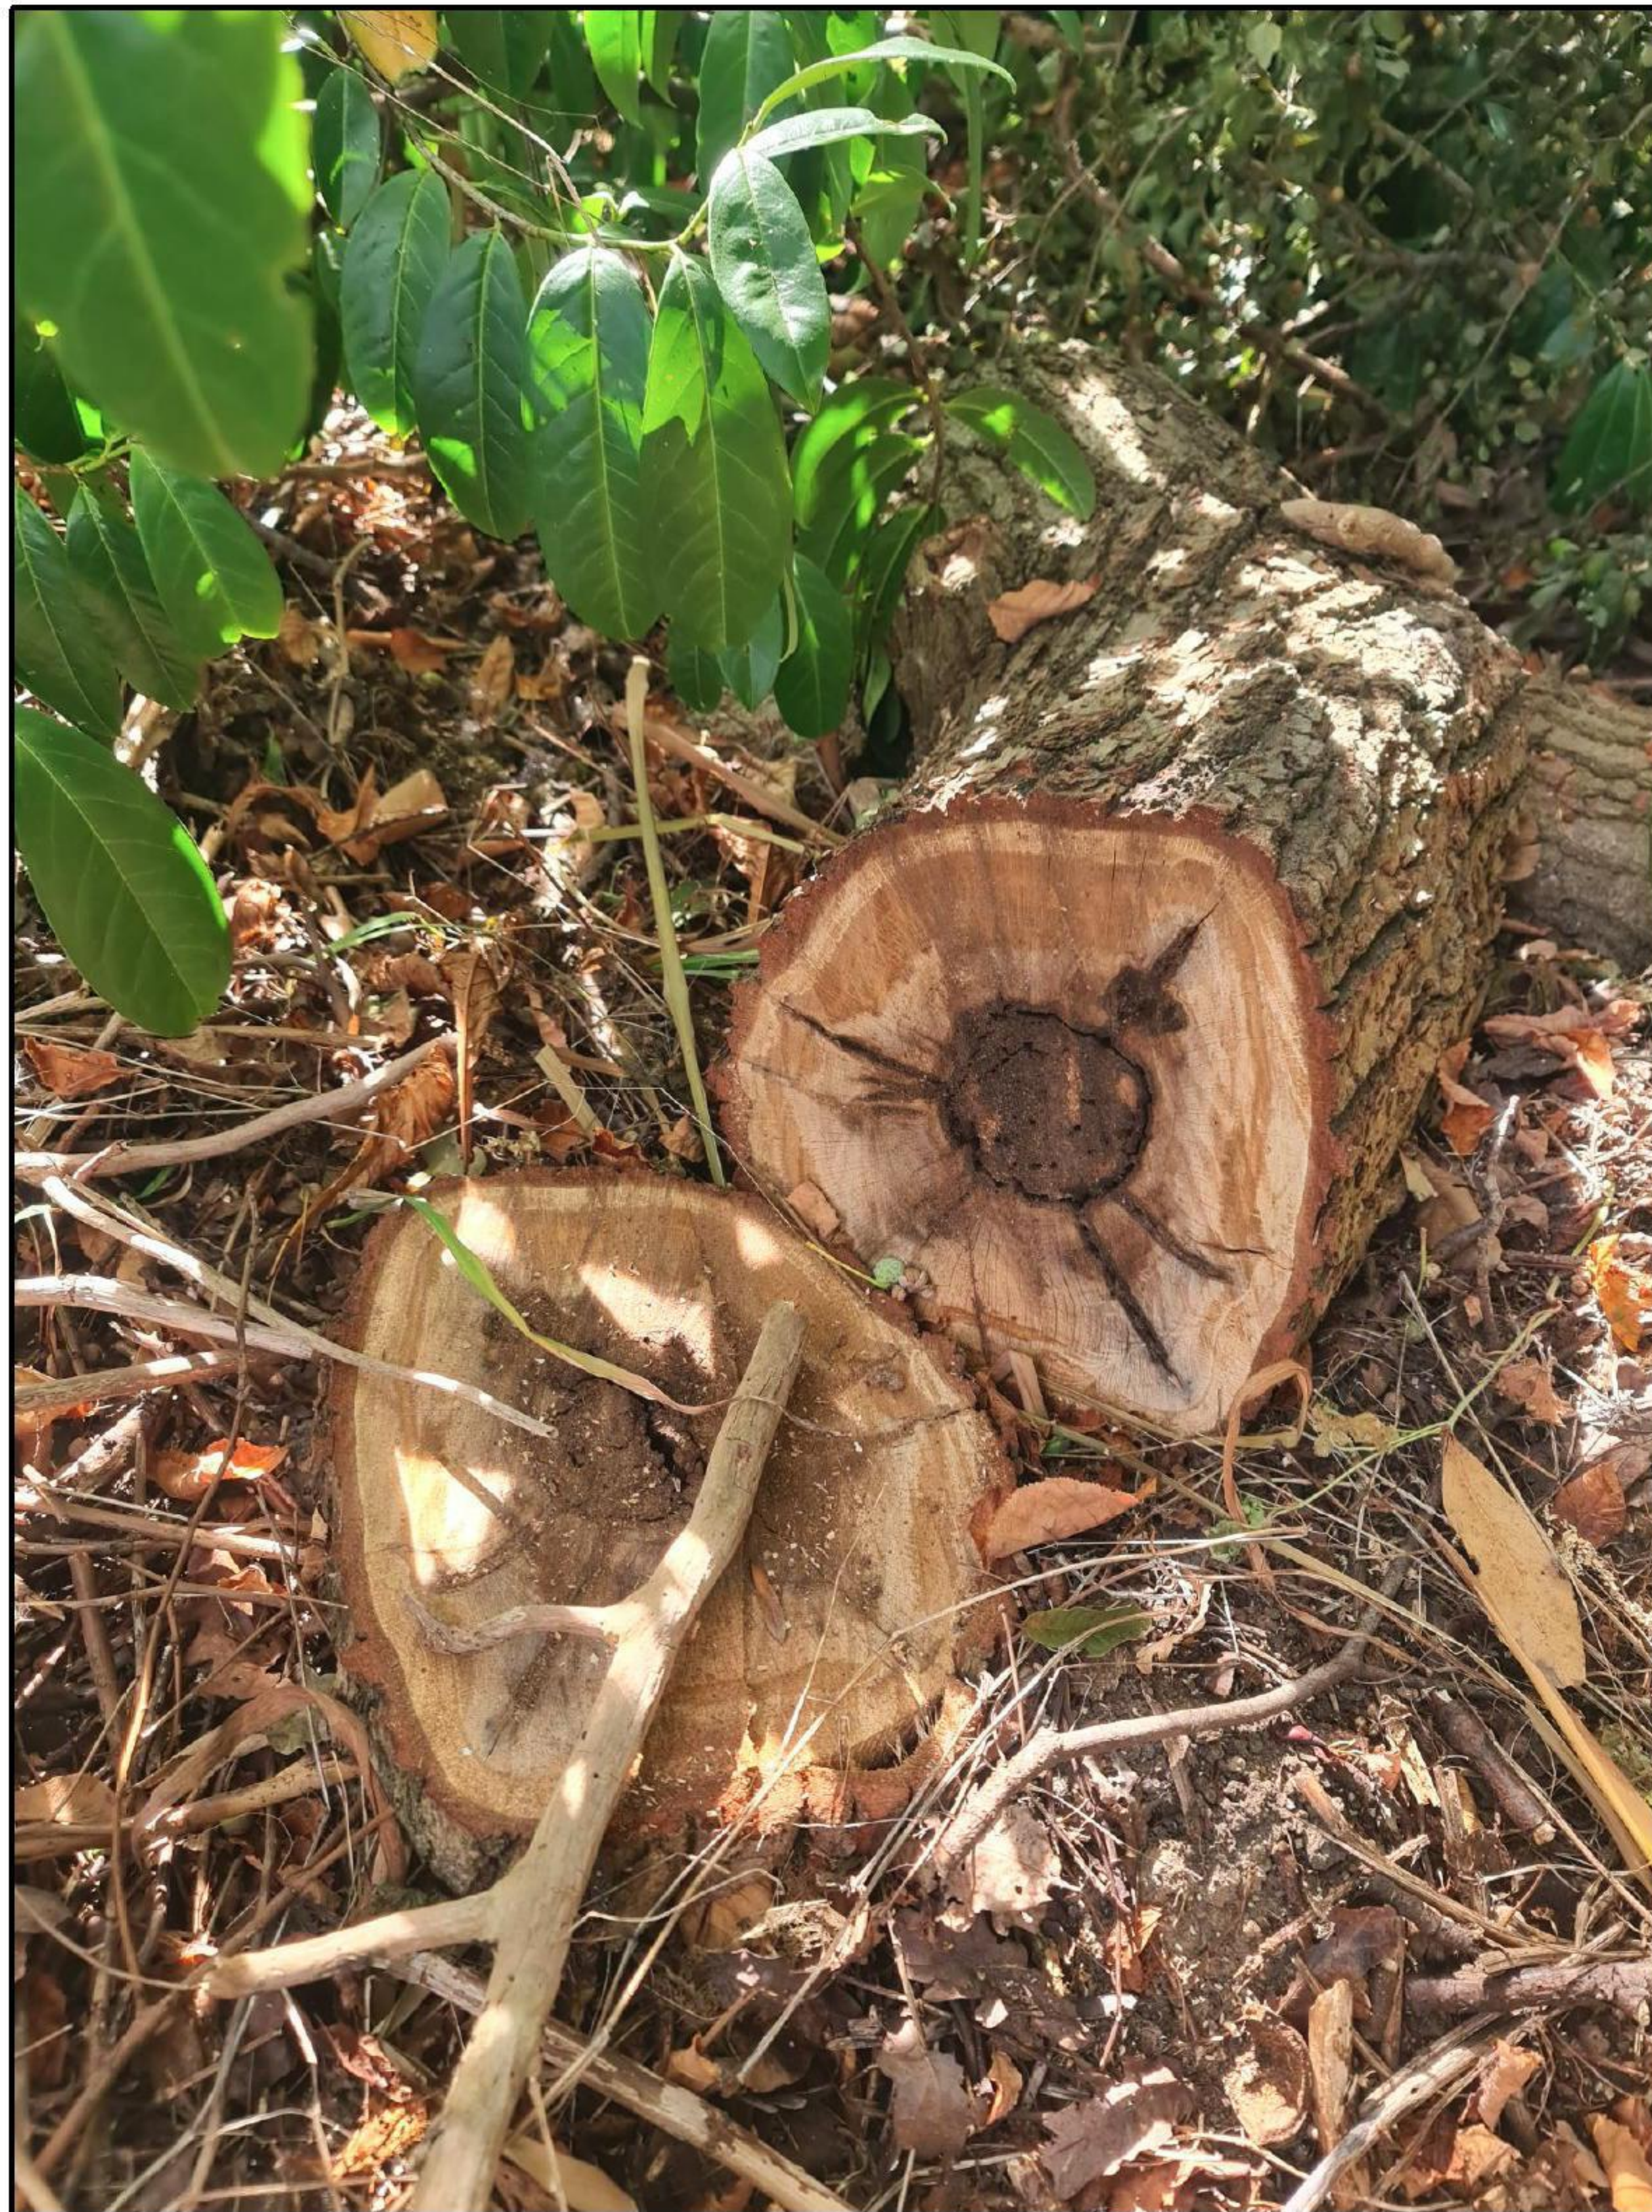
The sound produced by hammers striking the oak tree's stem suggests the presence of internal hollows, indicating potential decay or structural weakness within the tree. However, it is important to recognize that a thorough evaluation of the tree's internal condition, particularly at the junction where branches meet the trunk, cannot be accurately determined through external visual inspection alone. This limitation underscores the necessity for more invasive diagnostic methods, such as imaging techniques or core sampling, to gain a comprehensive understanding of the tree's health.

*Figure 4: Picture taken in August 2025 of internal decay within fallen limb.*
