### Crack and Level Monitoring

Date of Issue: 31/10/2024

Address: 22 Wheatsheaf Close, Burgess Hill, West Sussex, RH15 8UT

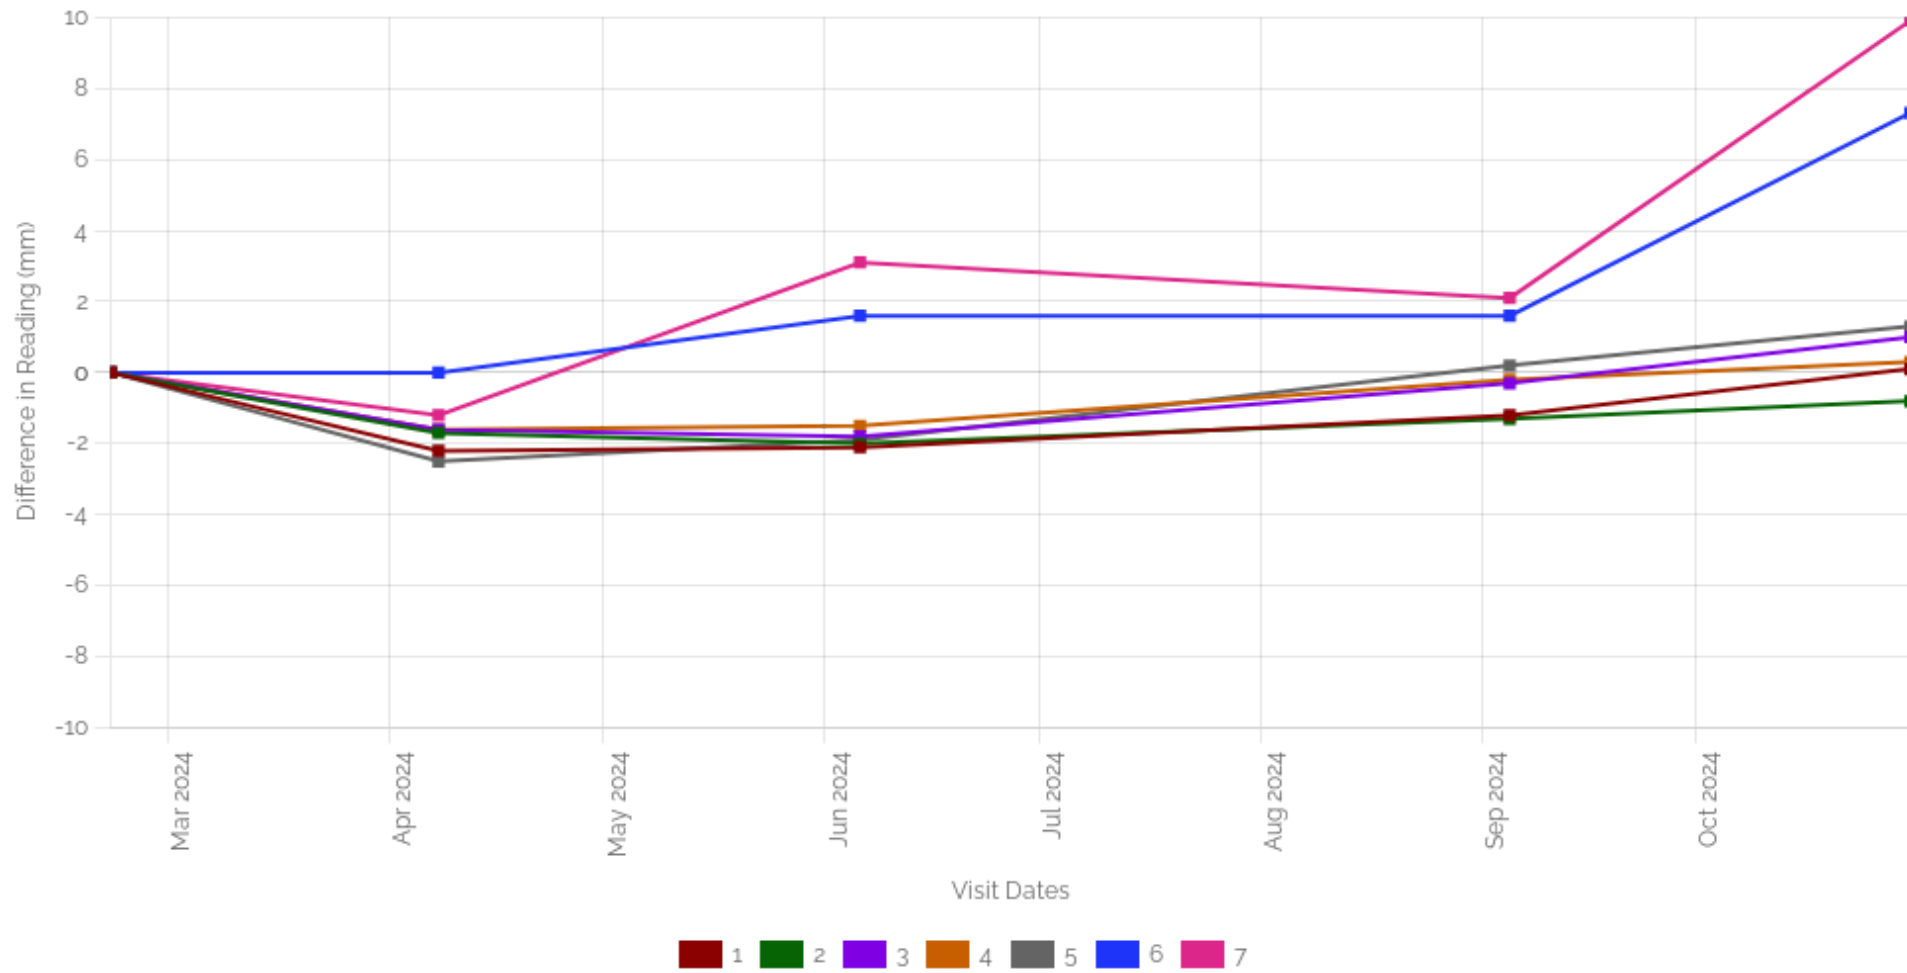
## Level Readings Chart (Points 1 - 7)

| Visit | Surveyors Note |
|---|---|
| Visit 5 | points 6 and 7 on the conservatory have been double checked |

| | Visit 1 | Visit 2 | Visit 3 | Visit 4 | Visit 5 | Visit 6 | Visit 7 | Visit 8 |
|---|---|---|---|---|---|---|---|---|
| 6 | 0 | 0 | +1.6 | +1.6 | +7.3 | | | |
| 7 | 0 | -1.2 | +3.1 | +2.1 | +9.9 | | | |

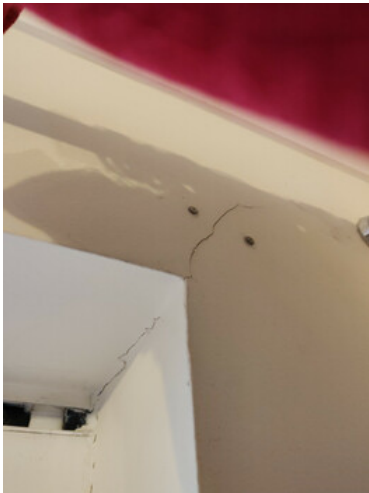
INT - Rear elevation in rear lounge - Visit #2

| | Visit 1 | Visit 2 | Visit 3 | Visit 4 | Visit 5 | Visit 6 | Visit 7 | Visit 8 |
|---|---|---|---|---|---|---|---|---|
| H | 0.22 | 0 | 0.34 | 0.42 | 0.48 | | | |

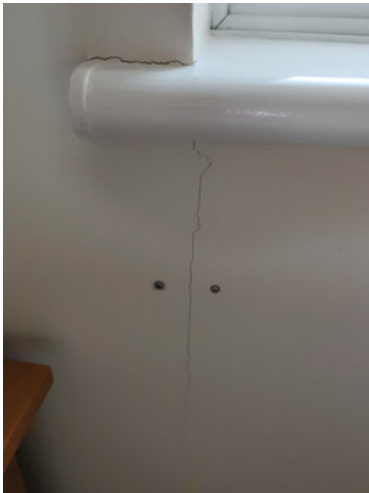
INT - Rear elevation in rear bedroom - Visit #2

| | Visit 1 | Visit 2 | Visit 3 | Visit 4 | Visit 5 | Visit 6 | Visit 7 | Visit 8 |
|---|---|---|---|---|---|---|---|---|
| H | 0.19 | 0 | 0.31 | 0.51 | 0.53 | | | |

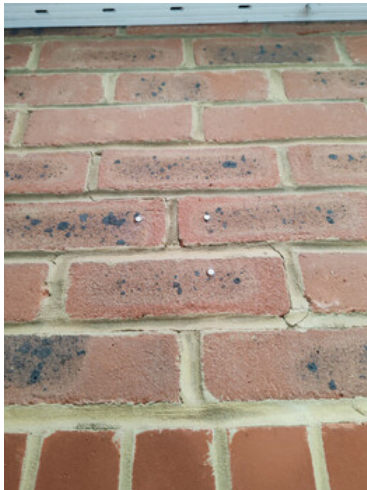
EXT - Rear elevation above patio door into house - Visit #2

| | Visit 1 | Visit 2 | Visit 3 | Visit 4 | Visit 5 | Visit 6 | Visit 7 | Visit 8 |
|---|---|---|---|---|---|---|---|---|
| H | 0.03 | 0 | 0.52 | 0.93 | 0.89 | | | |
| V | 0.14 | 0 | 0.26 | 0.63 | 0.62 | | | |
| D | 0.07 | 0 | 0.2 | 0.24 | 0.35 | | | |
