**CUCKFIELD GOLF CENTRE**

**DRAINAGE STATEMENT**

Tumu Consulting have been appointed by Arena Global Management Ltd (AGM) to produce a drainage design to discharge Condition 5 and 6 of the Appeal Decision, REF APP/D3830/W/22/3310444. This development in comprises *“Change of use of land to storage in association with golf club and proposed erection of a storage barn for equipment and vehicles incorporating staff welfare facilities”* at Cuckfield Golf Centre, Staplefield Rd, Cuckfield, Haywards Heath, RH17 5HY.

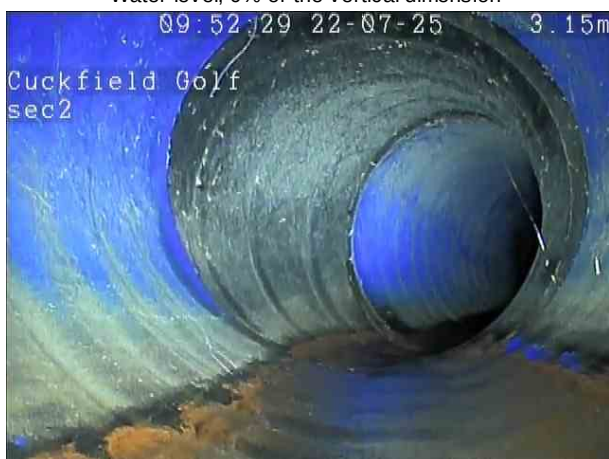
Line deviates right, sharp bend

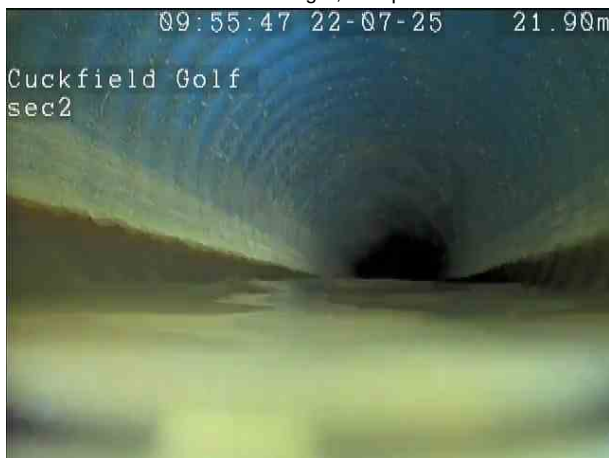
Water level, 20% of the vertical dimension

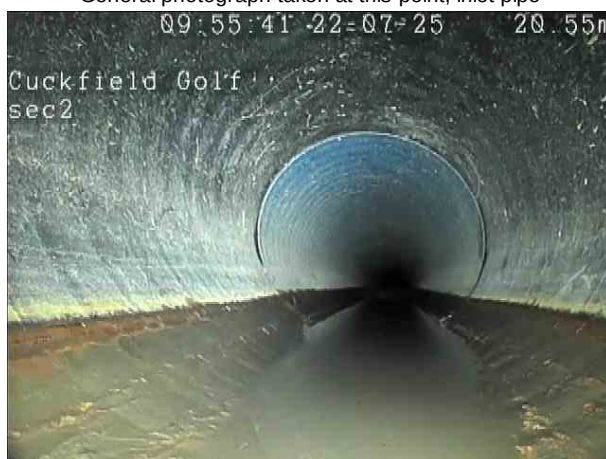
Water level, 15% of the vertical dimension

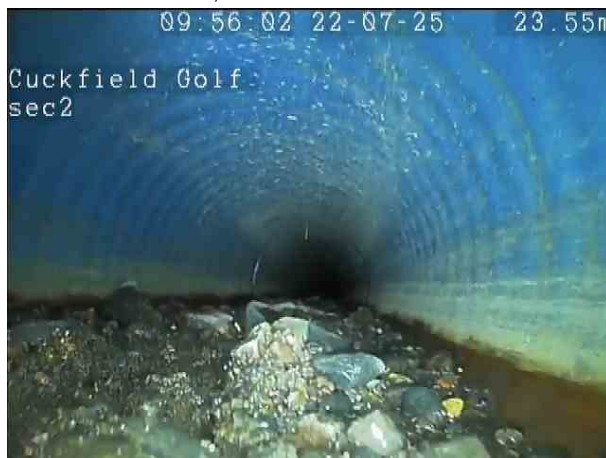
Settled deposits, hard or compacted, 30% cross-sectional

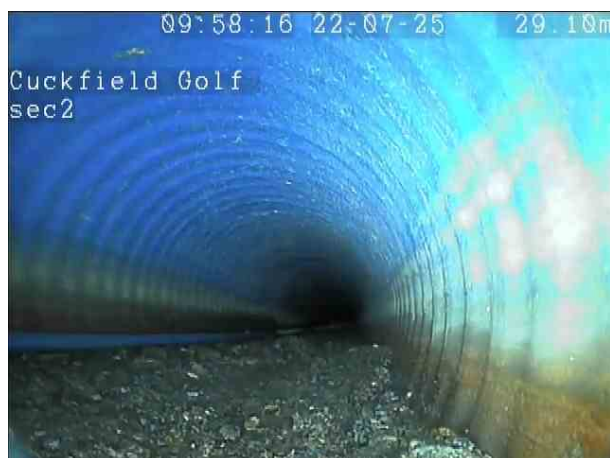
Settled deposits, fine, 30% cross-sectional area loss

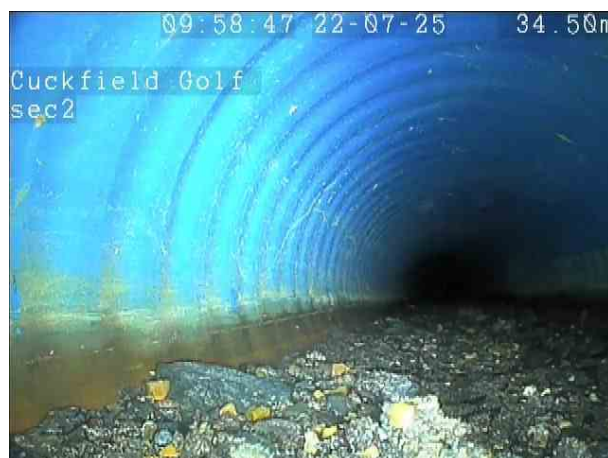
Settled deposits, fine, 35% cross-sectional area loss

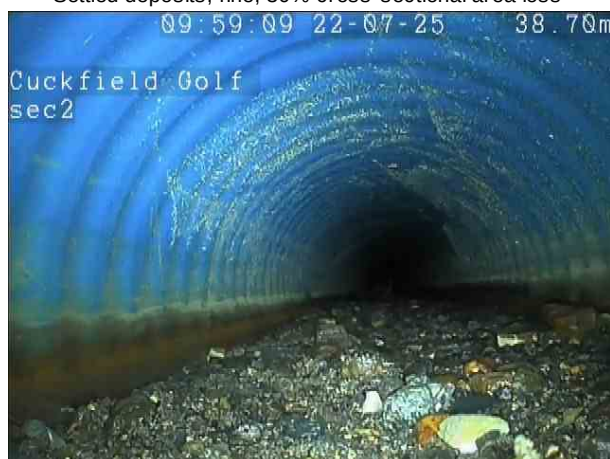
Settled deposits, hard or compacted, 35% cross-sectional

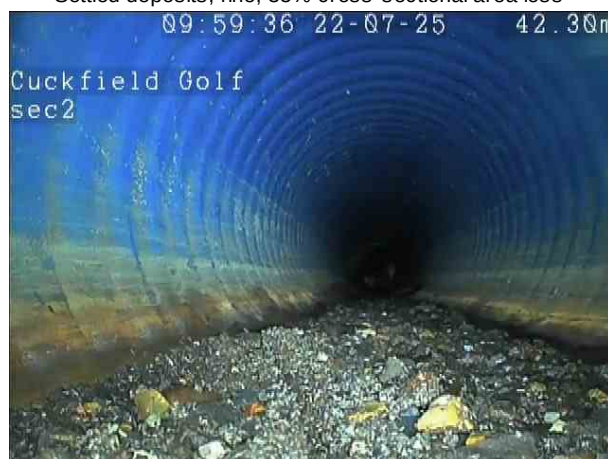
Settled deposits, hard or compacted, 25% cross-sectional

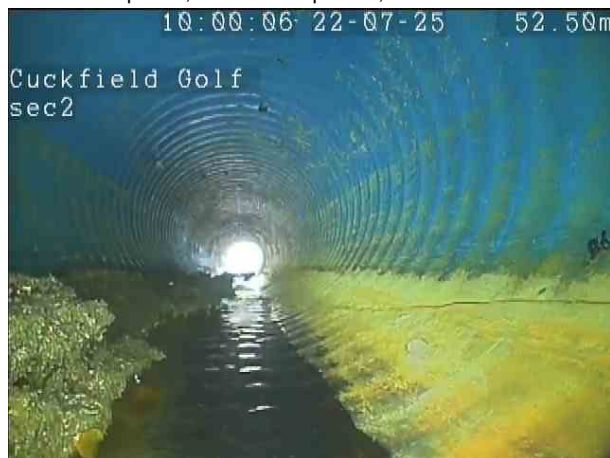
Settled deposits, fine, 20% cross-sectional area loss

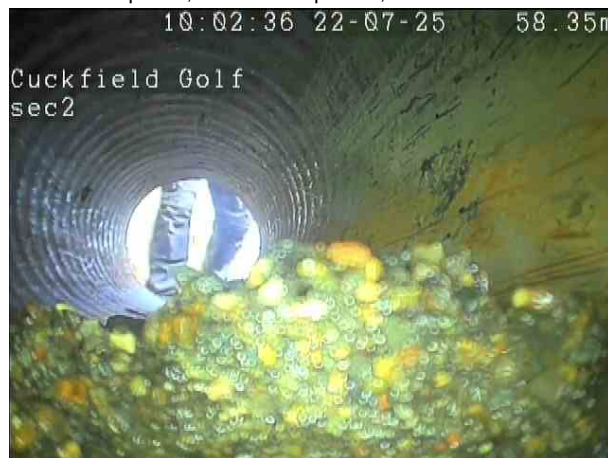
Settled deposits, fine, 20% cross-sectional area loss

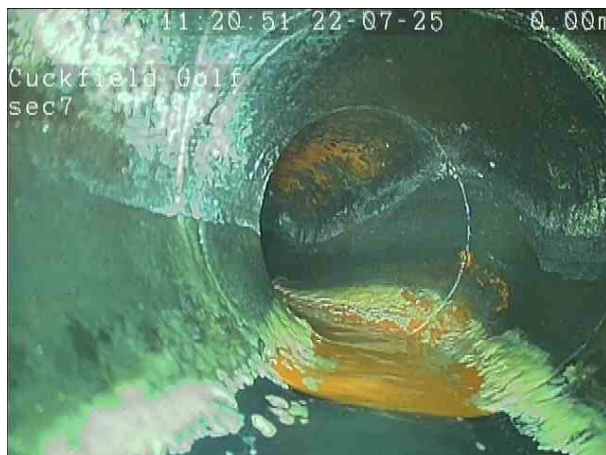
Line deviates left, sharp bend

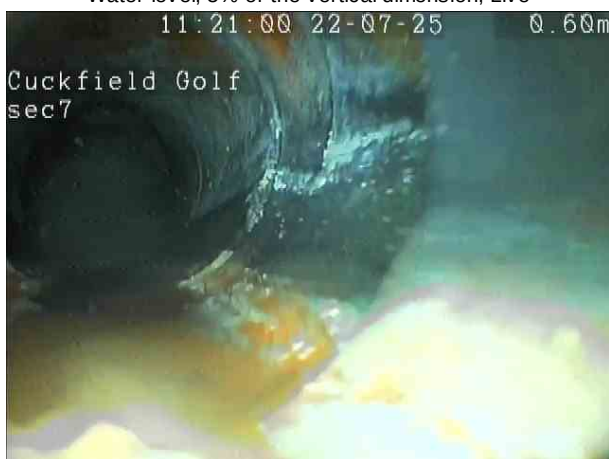
Line deviates left, sharp bend

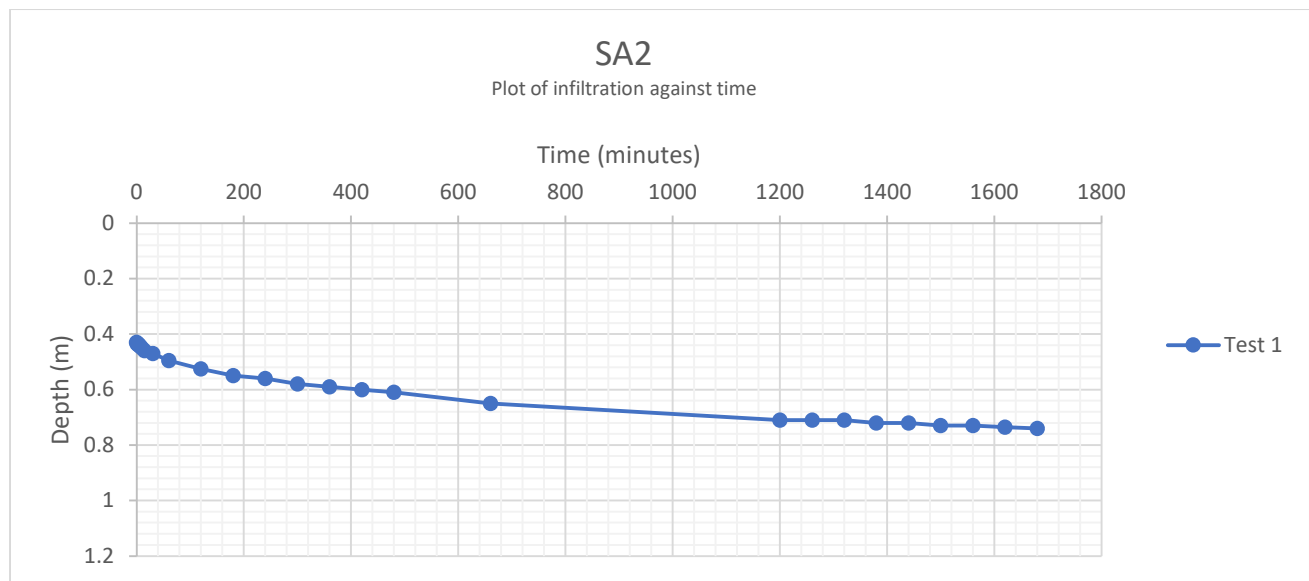
**Unable to calculate an infiltration rate due to insufficient drainage.**
