9 Riddiford Drive, Burgess Hill, RH15 8RJ

Brookworth Homes

11th February 2026

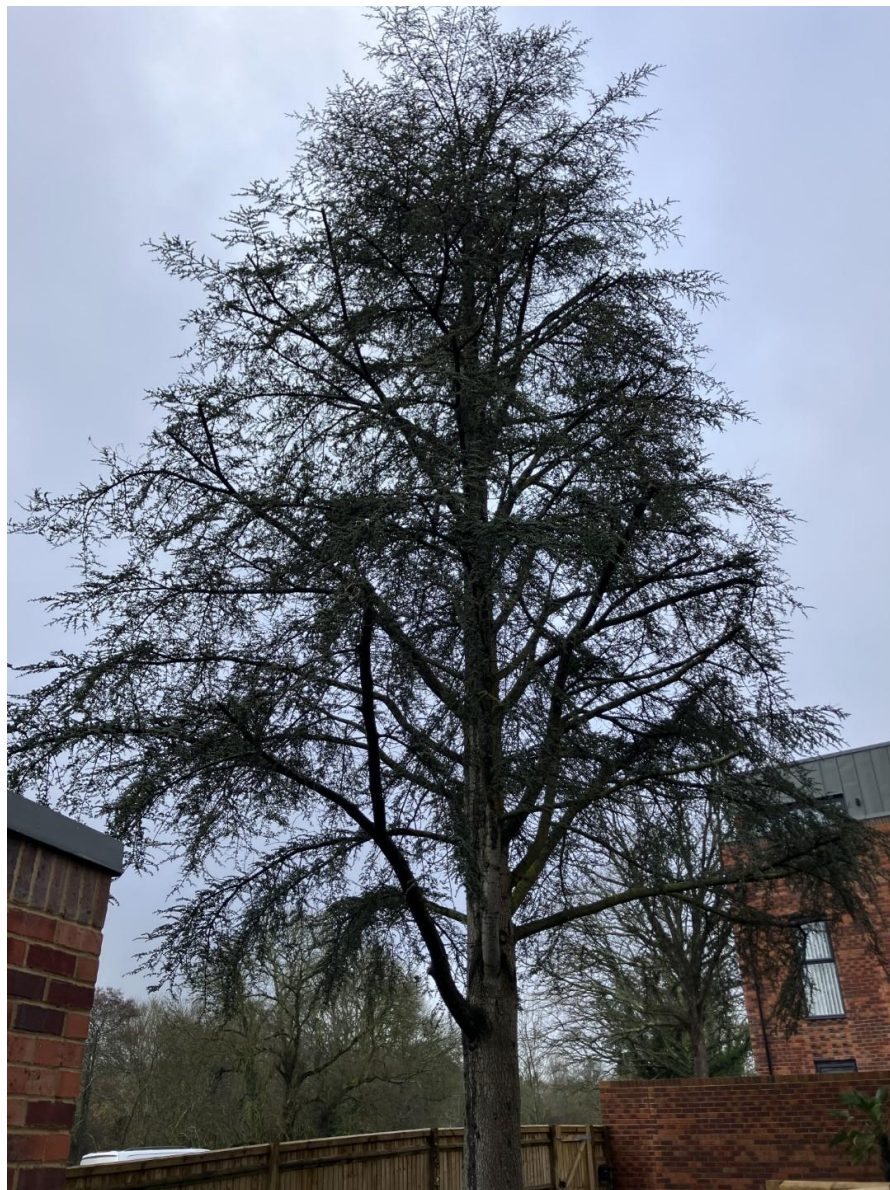
<p>The crown has been reduced on the north side by approximately 3m and has a 3m clearance to the building to the north.</p>
<p>Foliage/Outer Crown:</p>	<p>Minor deadwood scattered within the crown, slightly more than expected for the species.</p> <p>The crown was found to be sparse by approximately 45% from normal for the species.</p> <p>Needle length was found to be significantly reduced. Estimated to be only 60% of its normal healthy size.</p> <p>The sparse crown and reduced needled length indicate a significantly reduced vitality.</p>

Photo 1: Crown overview looking west.

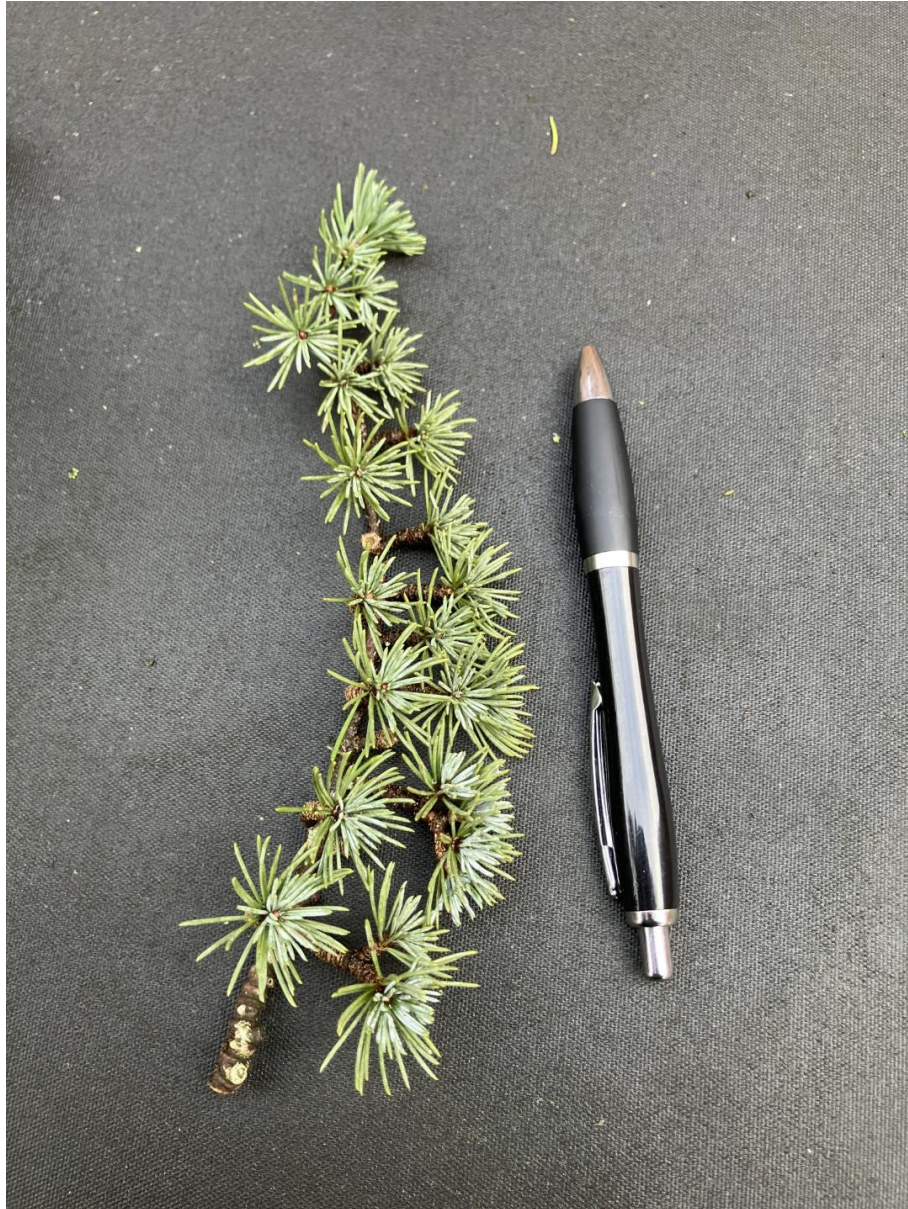
Photo 2: Photos of needles – 14cm long pen for size comparison.

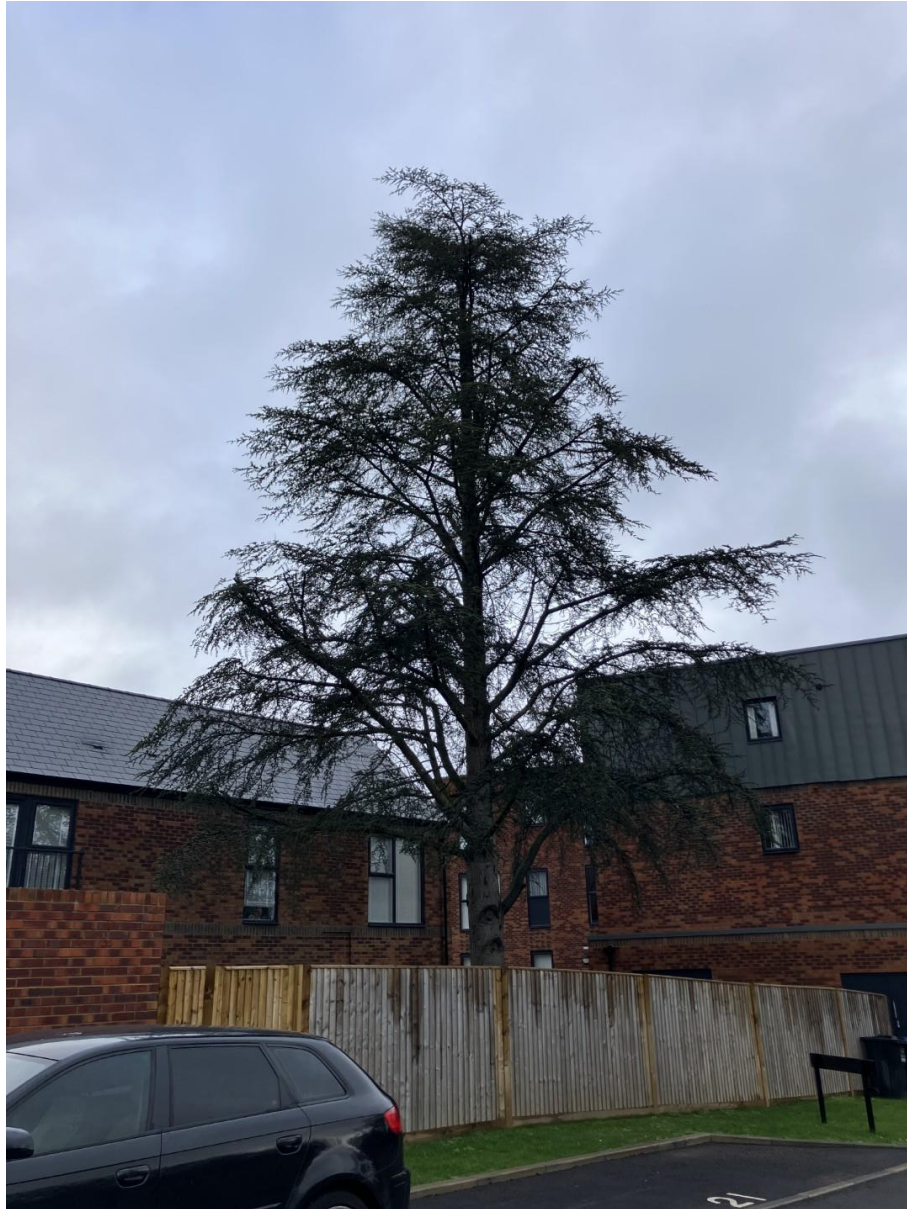
Photo 3: Further view of crown looking northeast.
