Photos of existing roof condition

Dwg No. 25053-P-201 A

**Drawing Title** Proposed Rooflights  
**Address** Wykehurst House  
**Client** M Blencowe  
**Scale** 1:20 @A3  
**Stage** Planning  
**Drawn by** ah  
**Checked by** ns

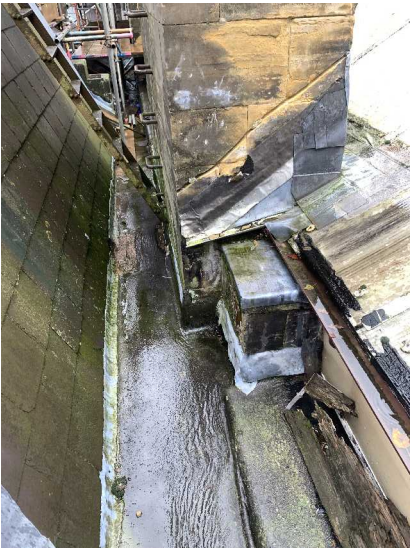
1 - View towards chimney stack central to existing pitched polycarbonate roof. Membranes have deteriorated, lead flashing incorrectly installed, guttering detail poor. Elements of timber upstand deteriorated and coming loose.  
2/3 - View towards end of existing polycarbonate roof. Lead flashing incorrectly installed. Generally materials deteriorated and not fit for purpose.  
4 - Flashing detail to head of polycarbonate roof with vegetation and broken guttering.
