# GeoShield Verification Report 1

GEO104739

Land to Rear of 67 Sunte Avenue,  
Lindfield,  
Haywards Heath,  
RH16 2AB

The Old Yard, Plot - Infills

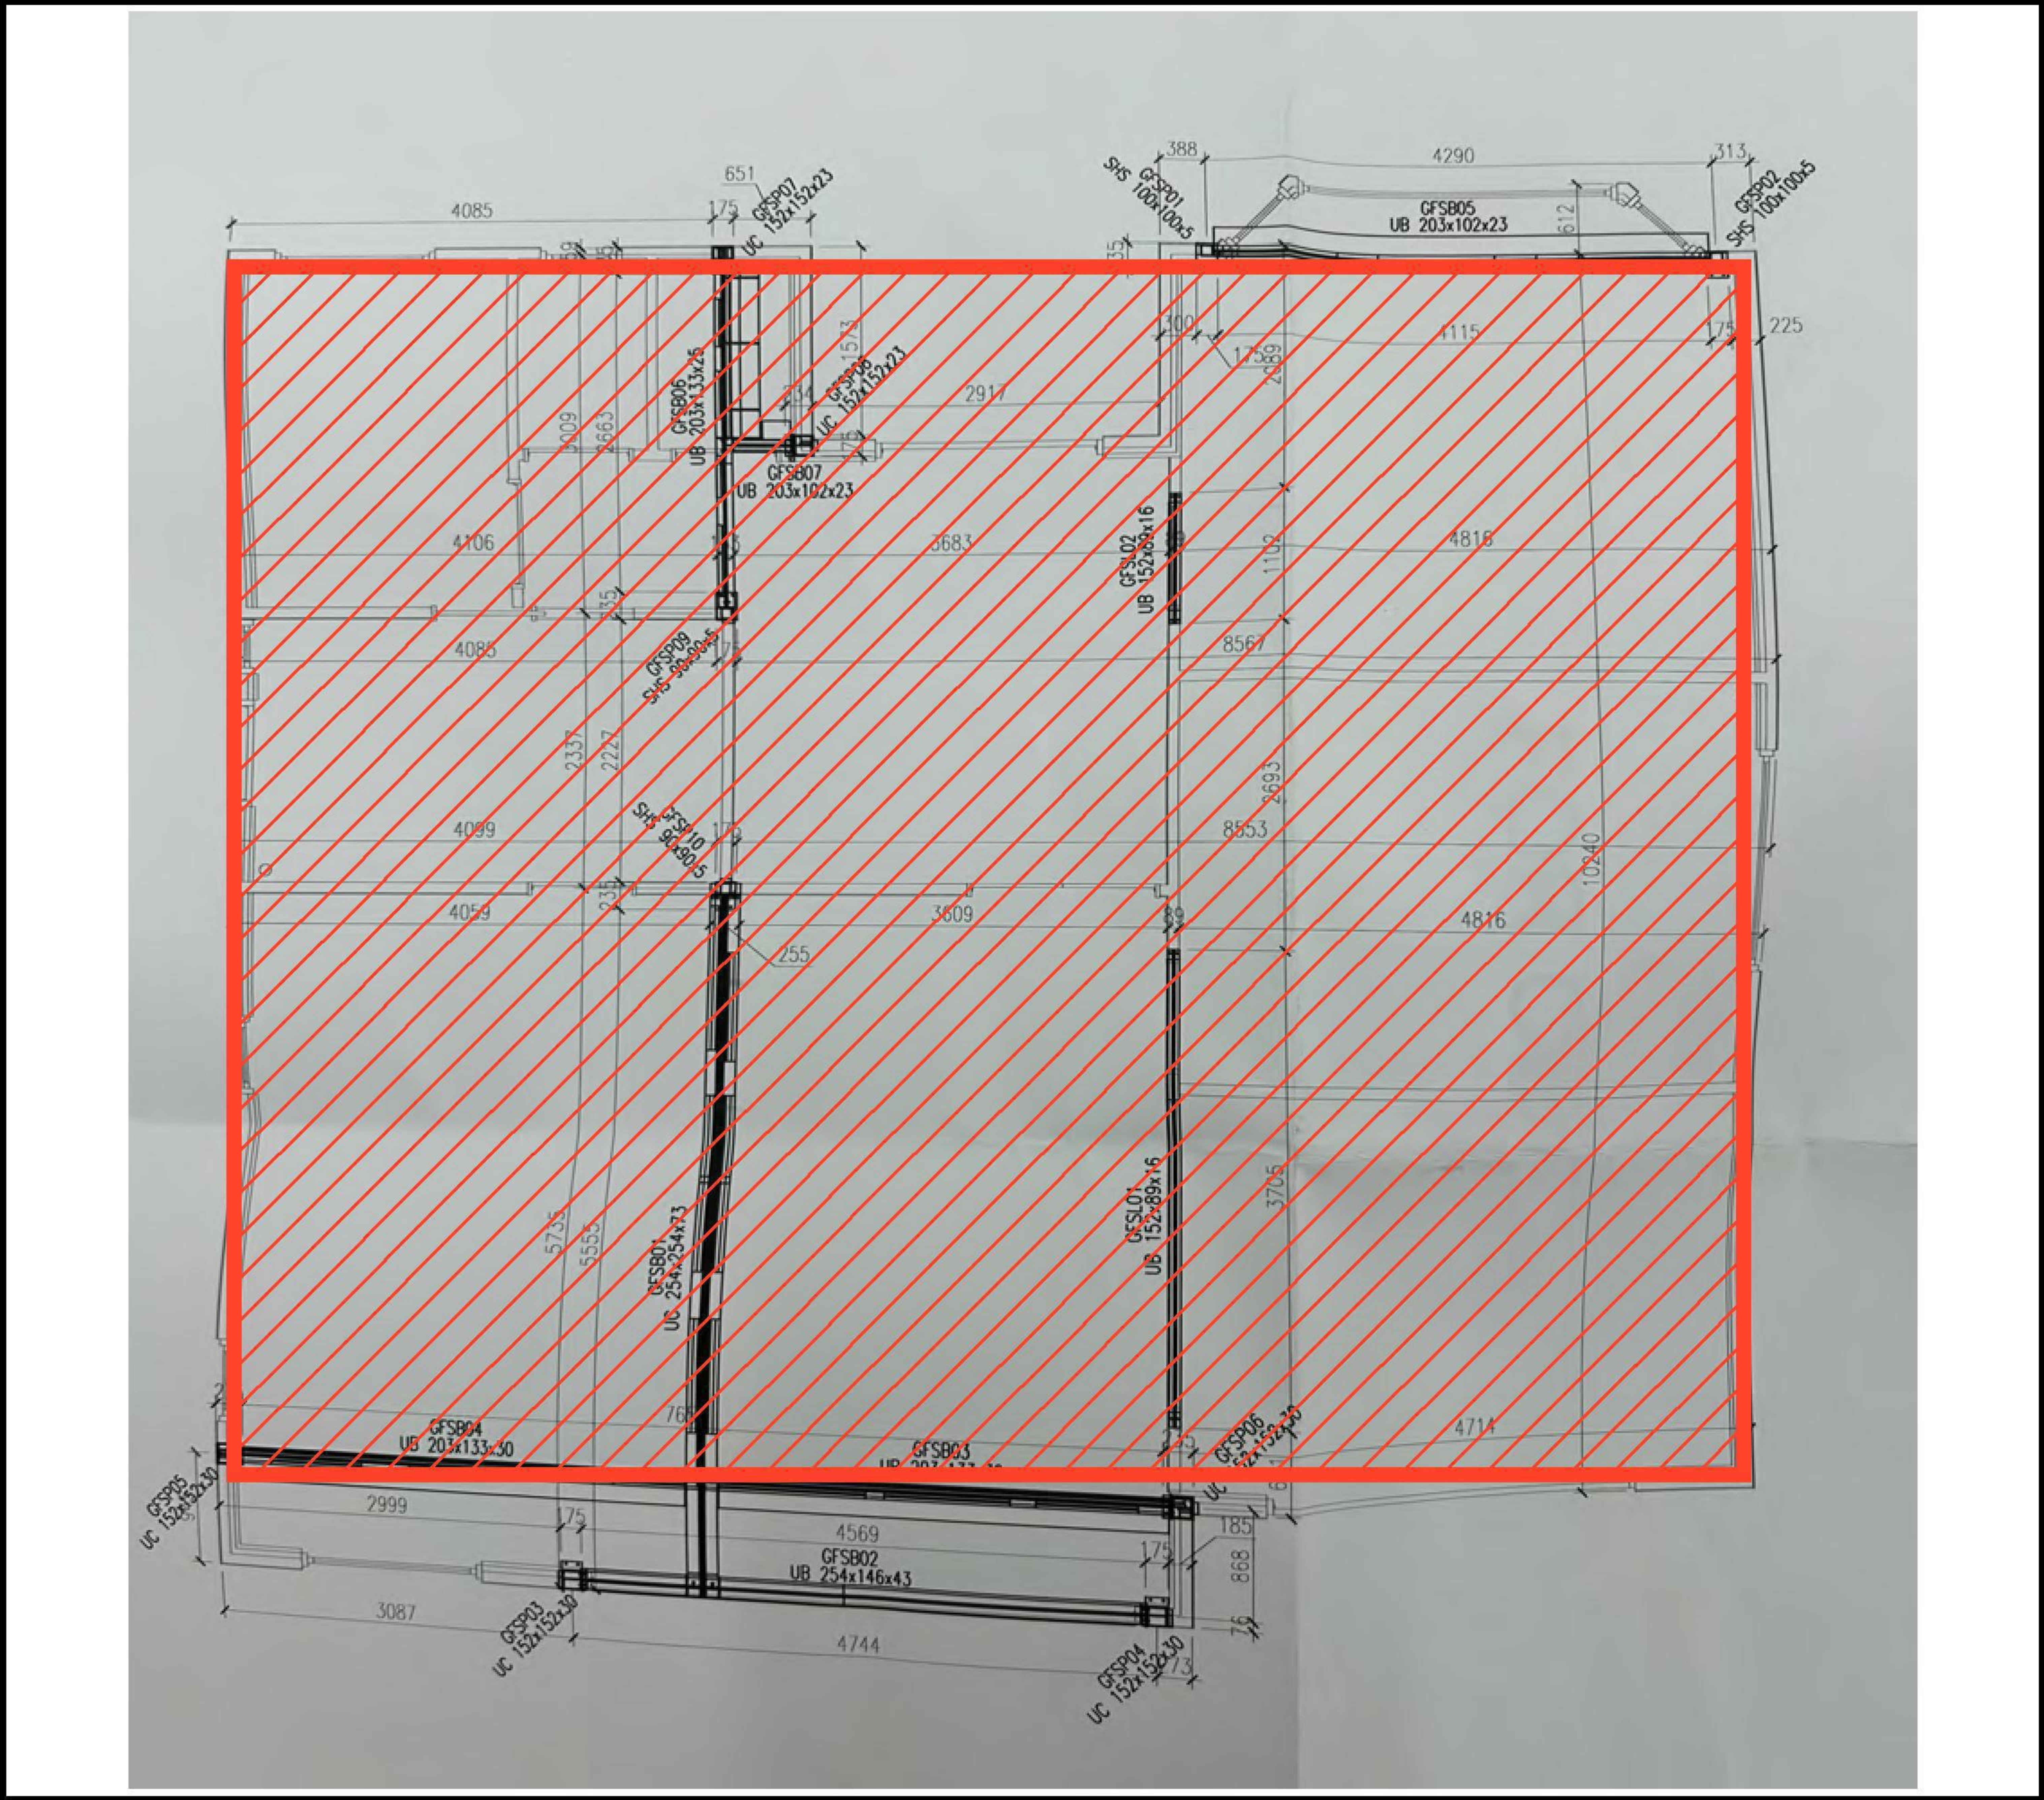
The photograph above shows a floor plan of the plot. The infill installation took place to the highlighted area and is where the verification inspection took place on site today.

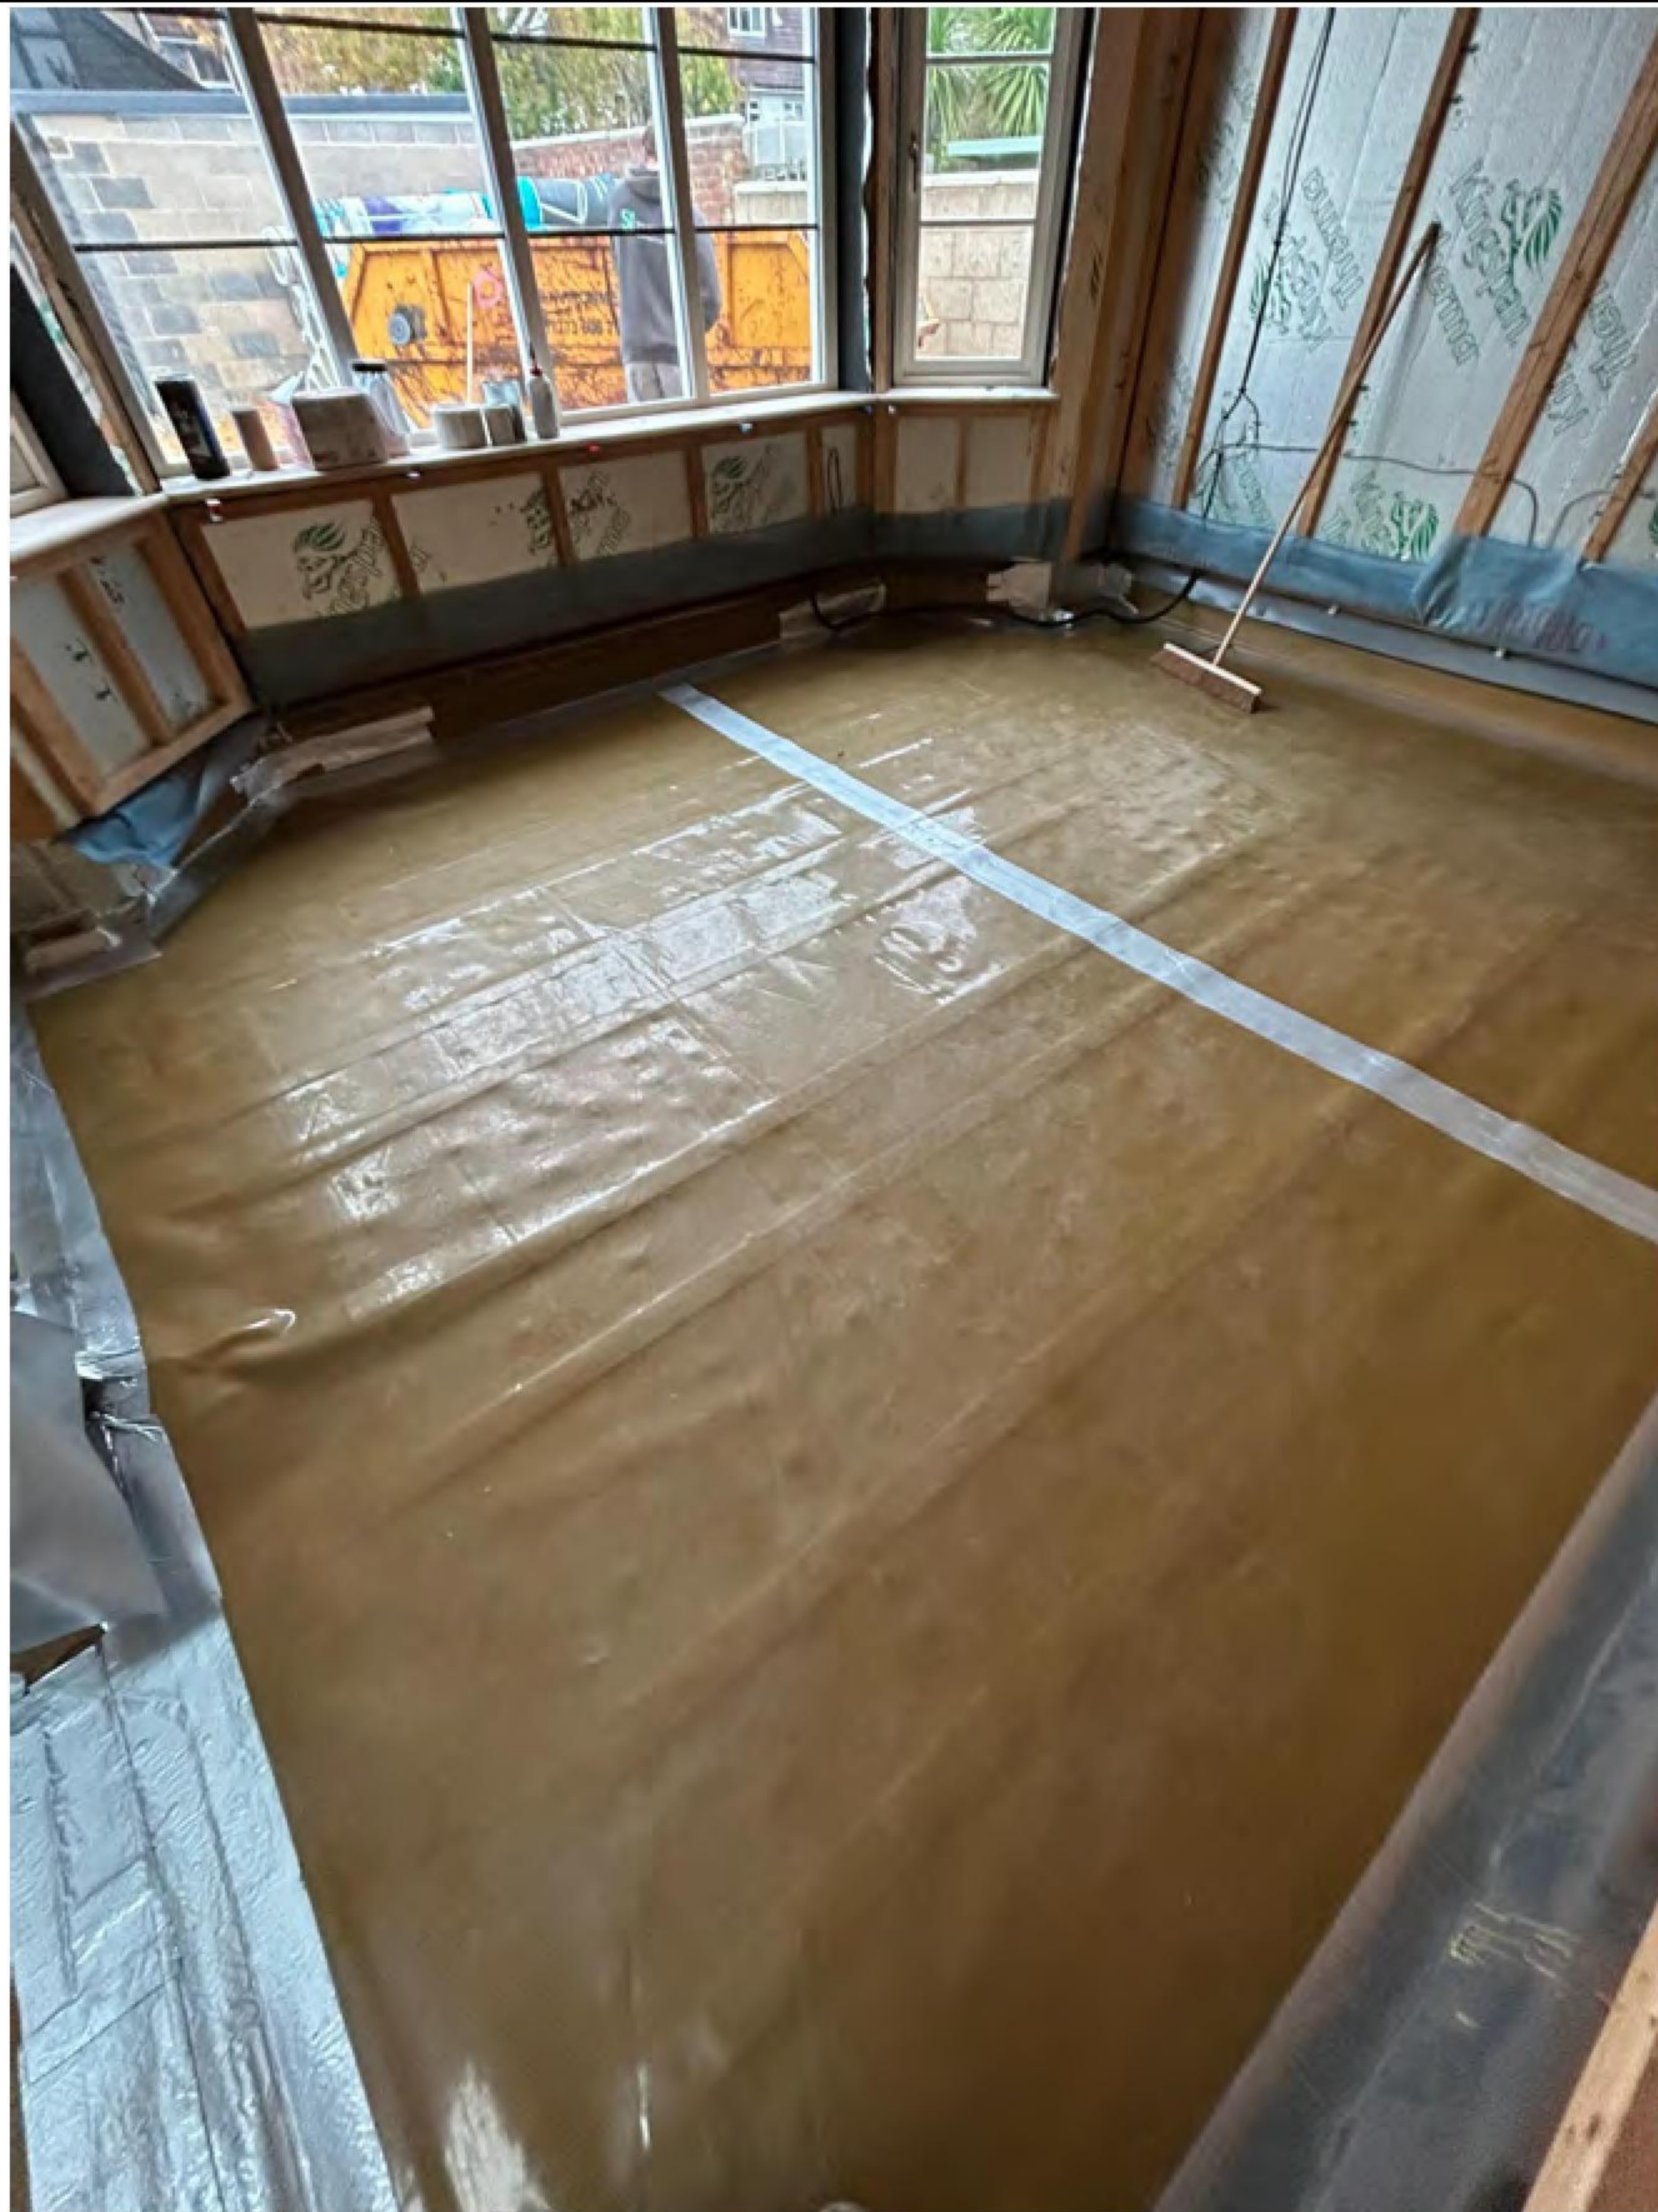
The photograph above displays an overview of the infill installation to one of the rooms where today's verification inspection took place on site.

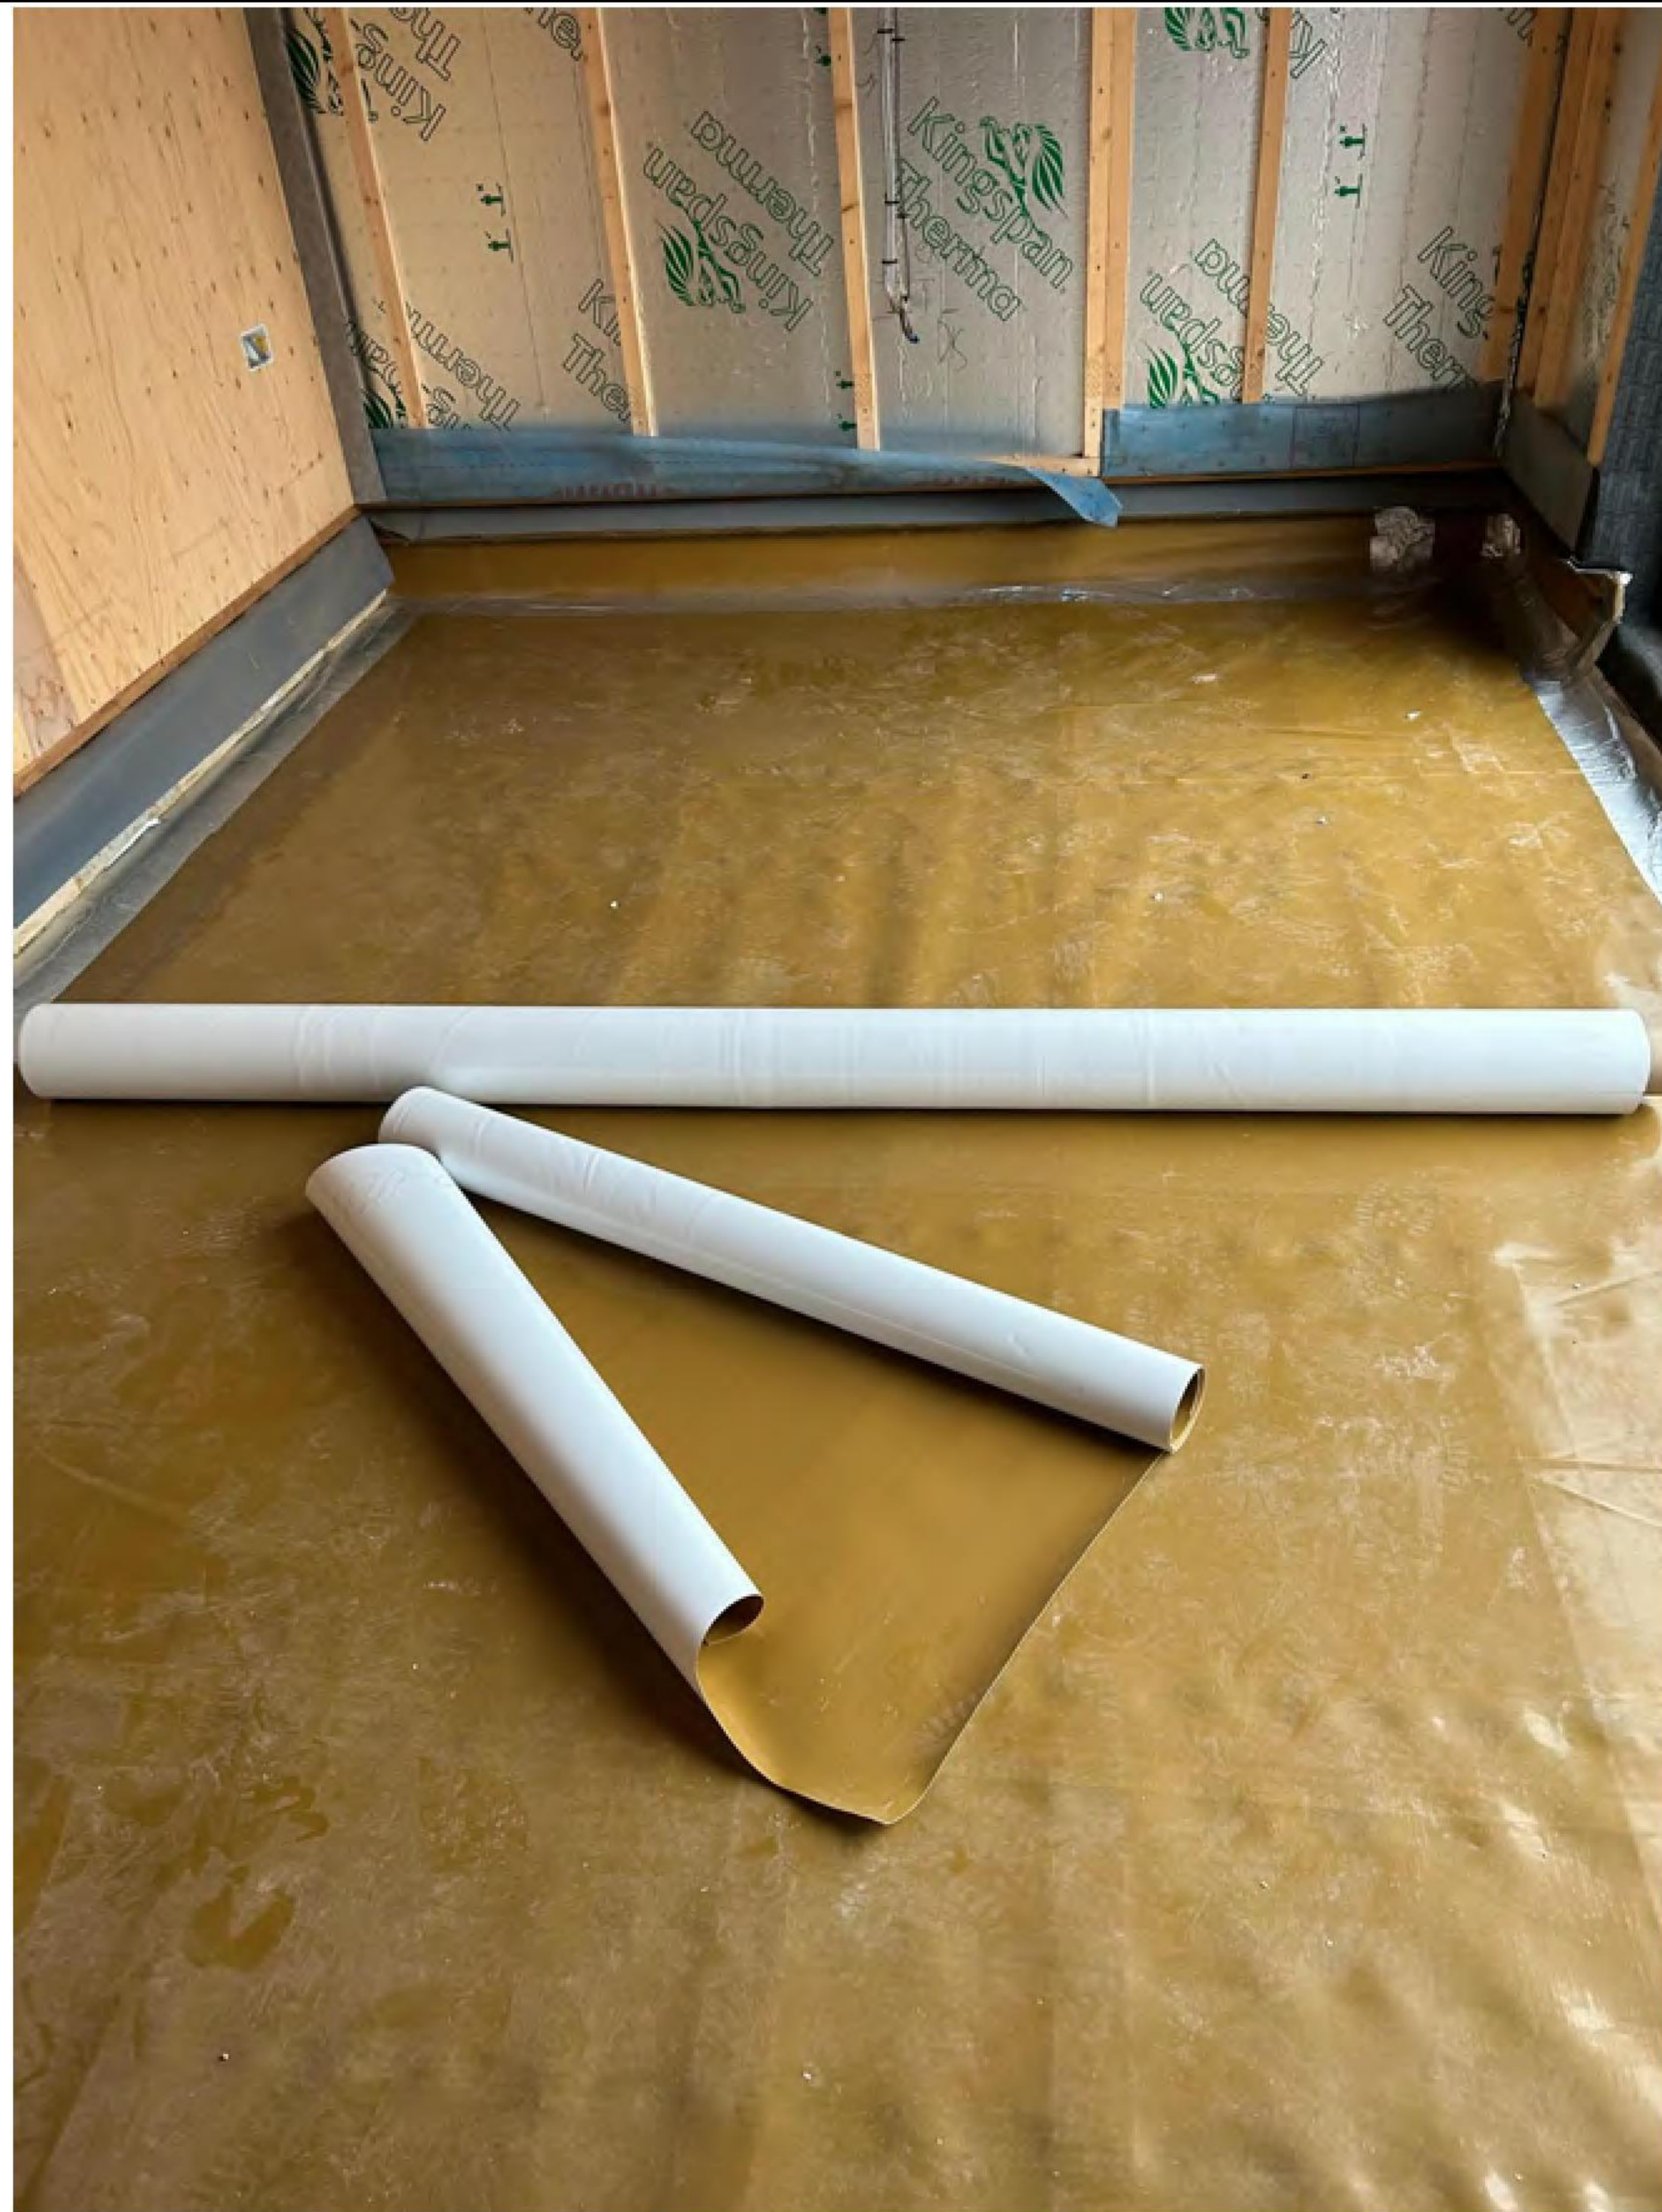
The photograph above displays an overview of the infill installation to one of the rooms where today's verification inspection took place on site.

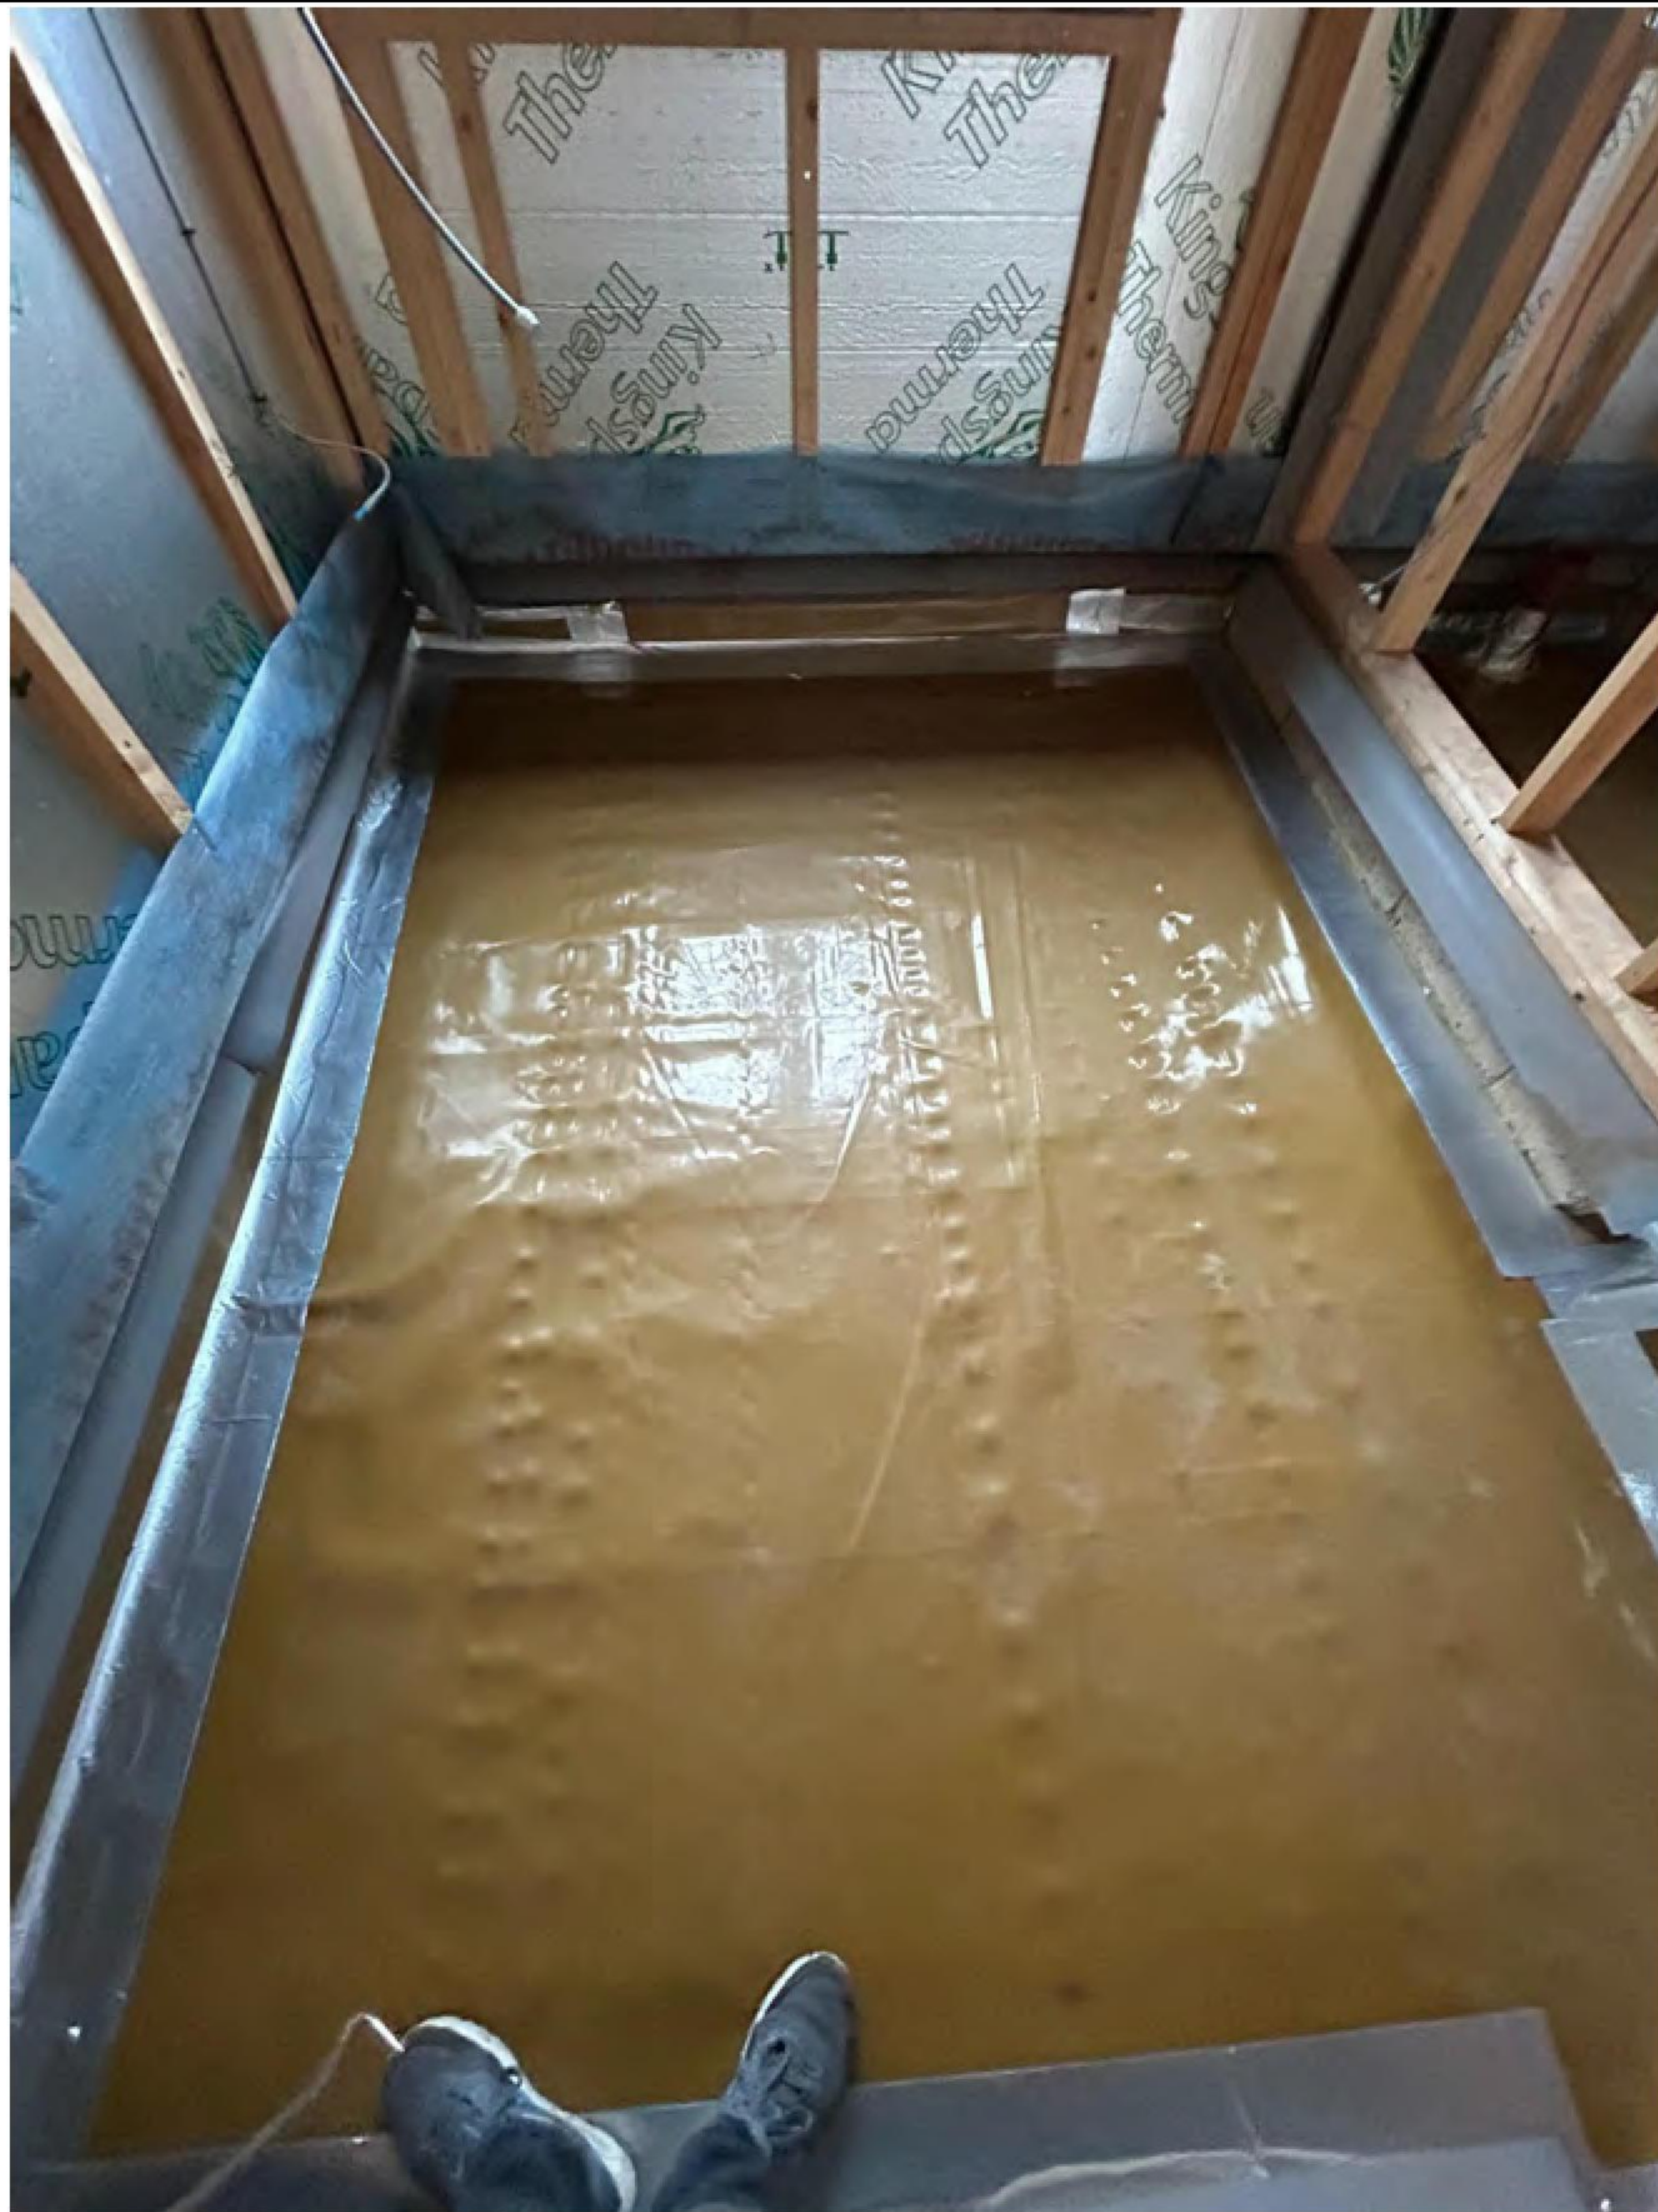
The photograph above displays an overview of the infill installation to one of the rooms where today's verification inspection took place on site.

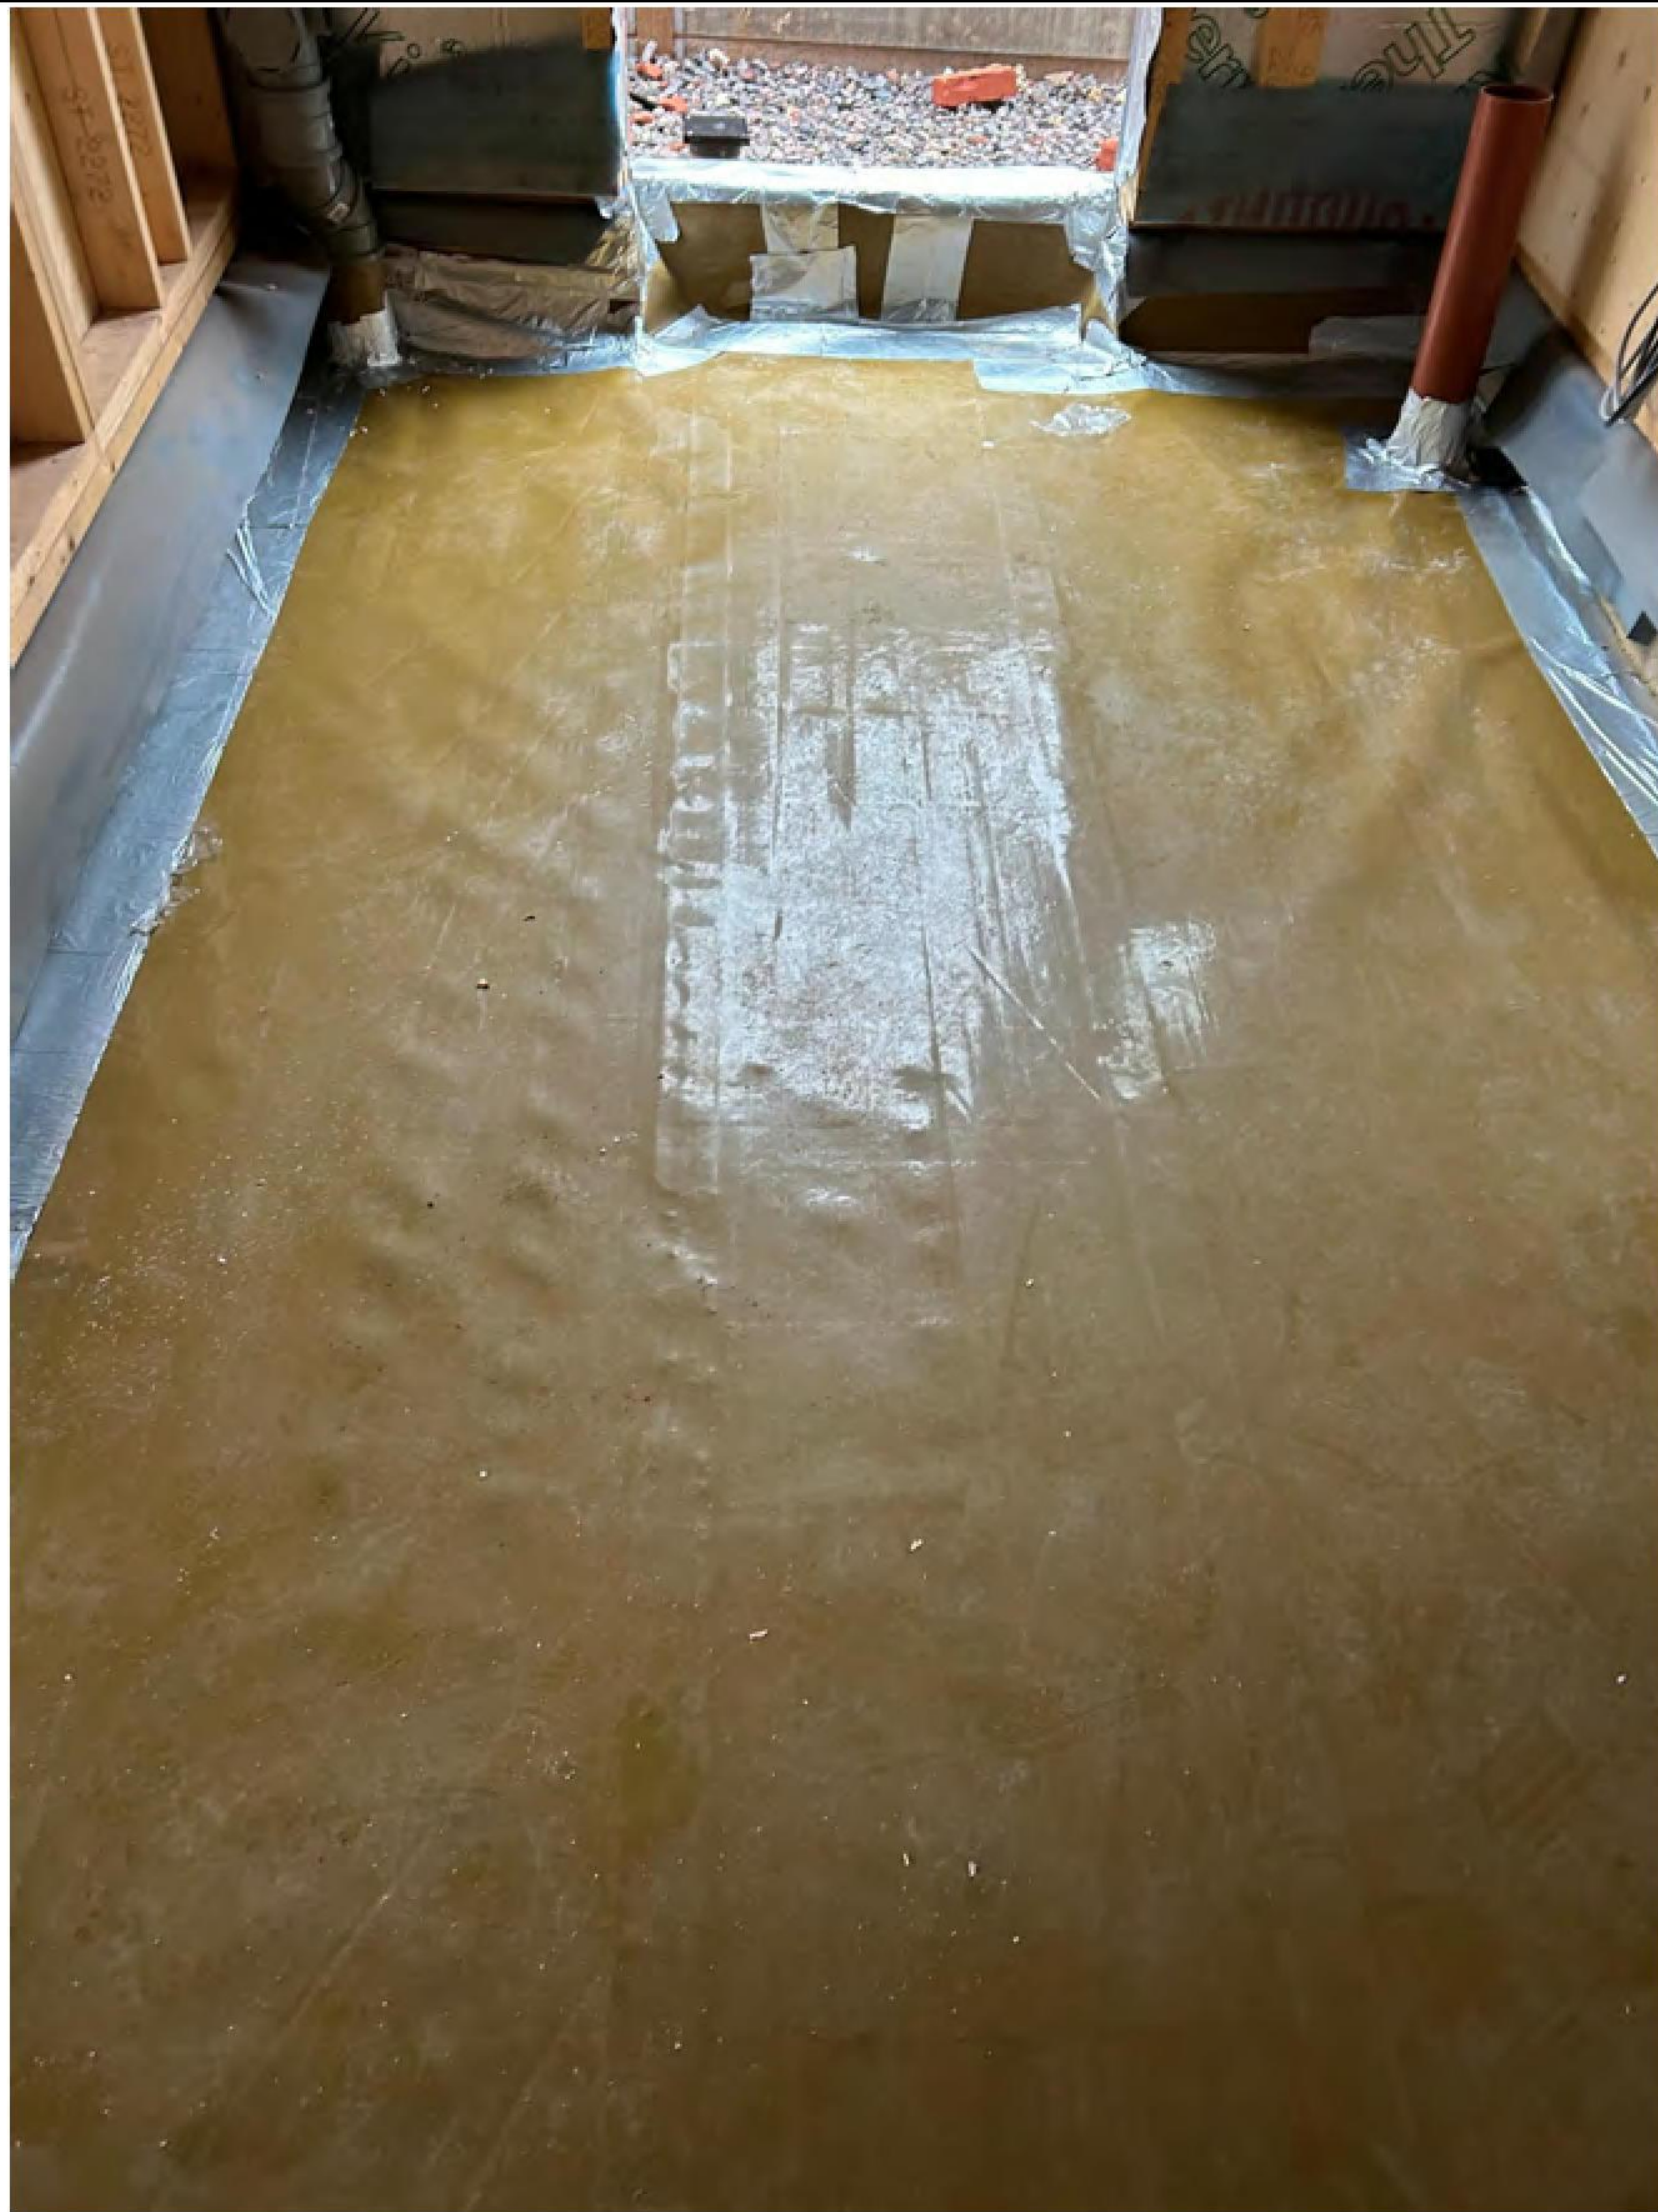
The photograph above displays an overview of the infill installation to one of the rooms where today's verification inspection took place on site.

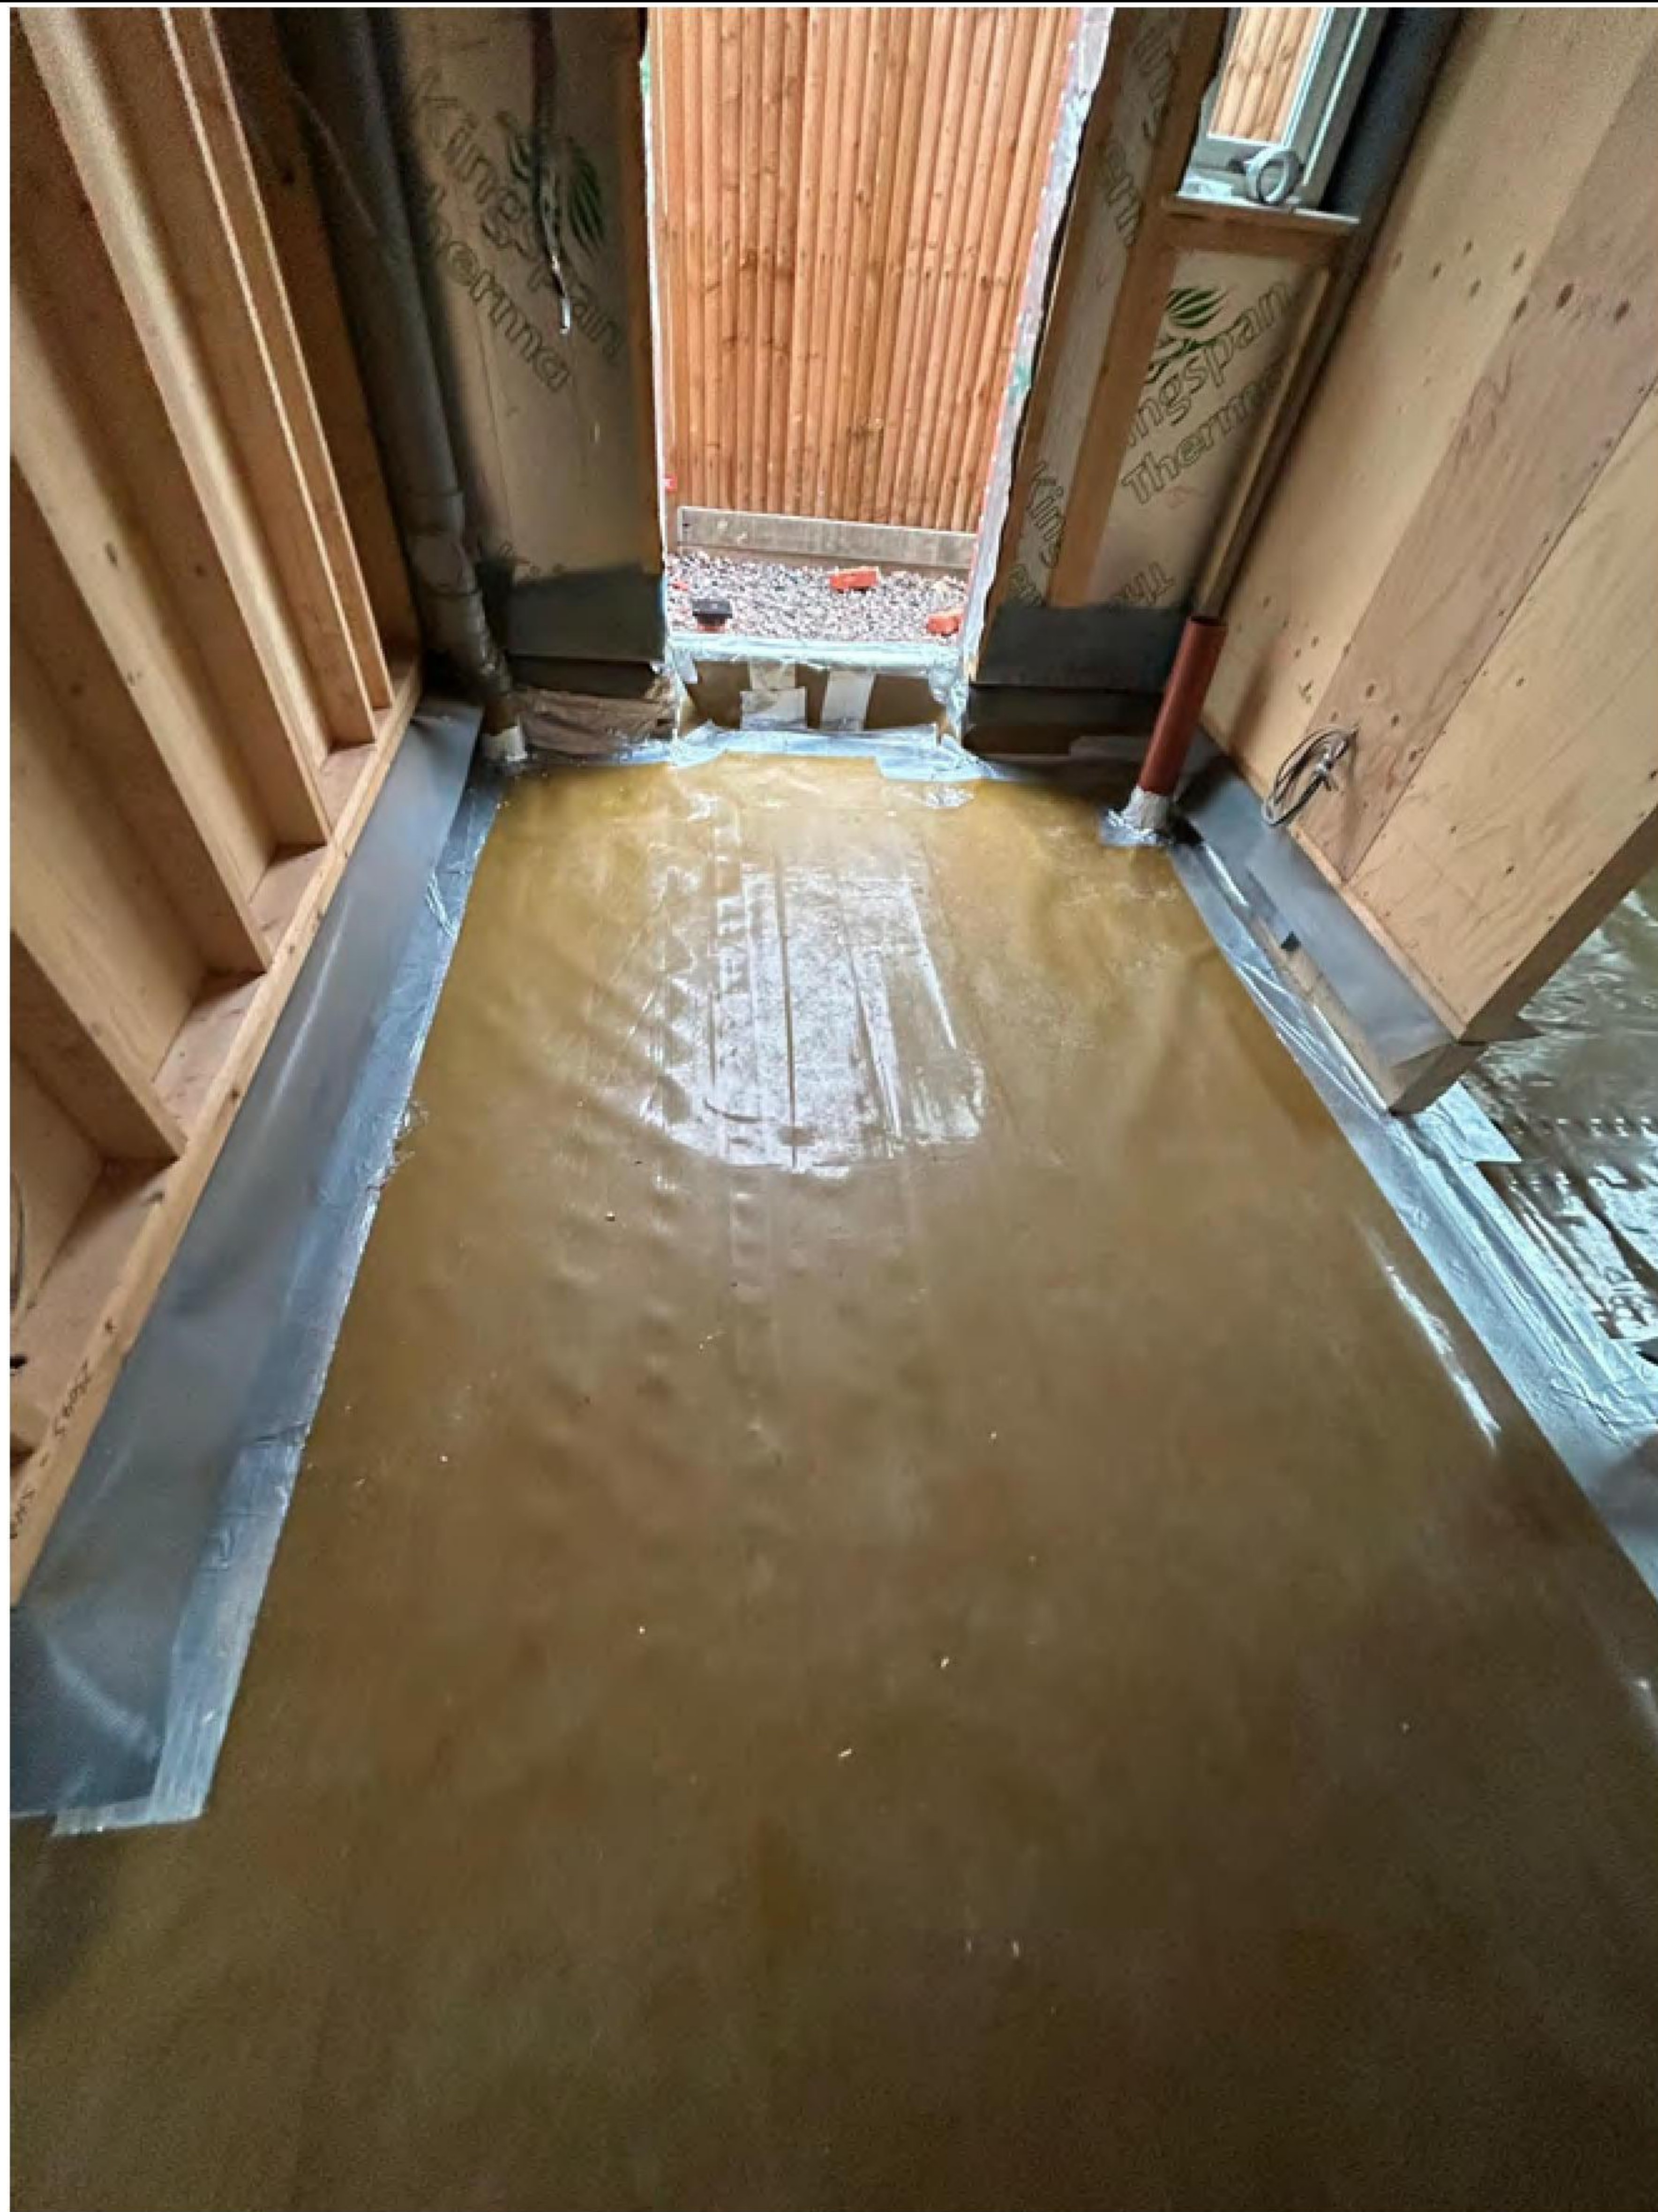
The photograph above displays an overview of the infill installation to one of the rooms where today's verification inspection took place on site.
