# GeoShield Verification Report 1

GEO104739

Land to Rear of 67 Sunte Avenue,  
Lindfield,  
Haywards Heath,  
RH16 2AB

The Old Yard, Plot - Infills

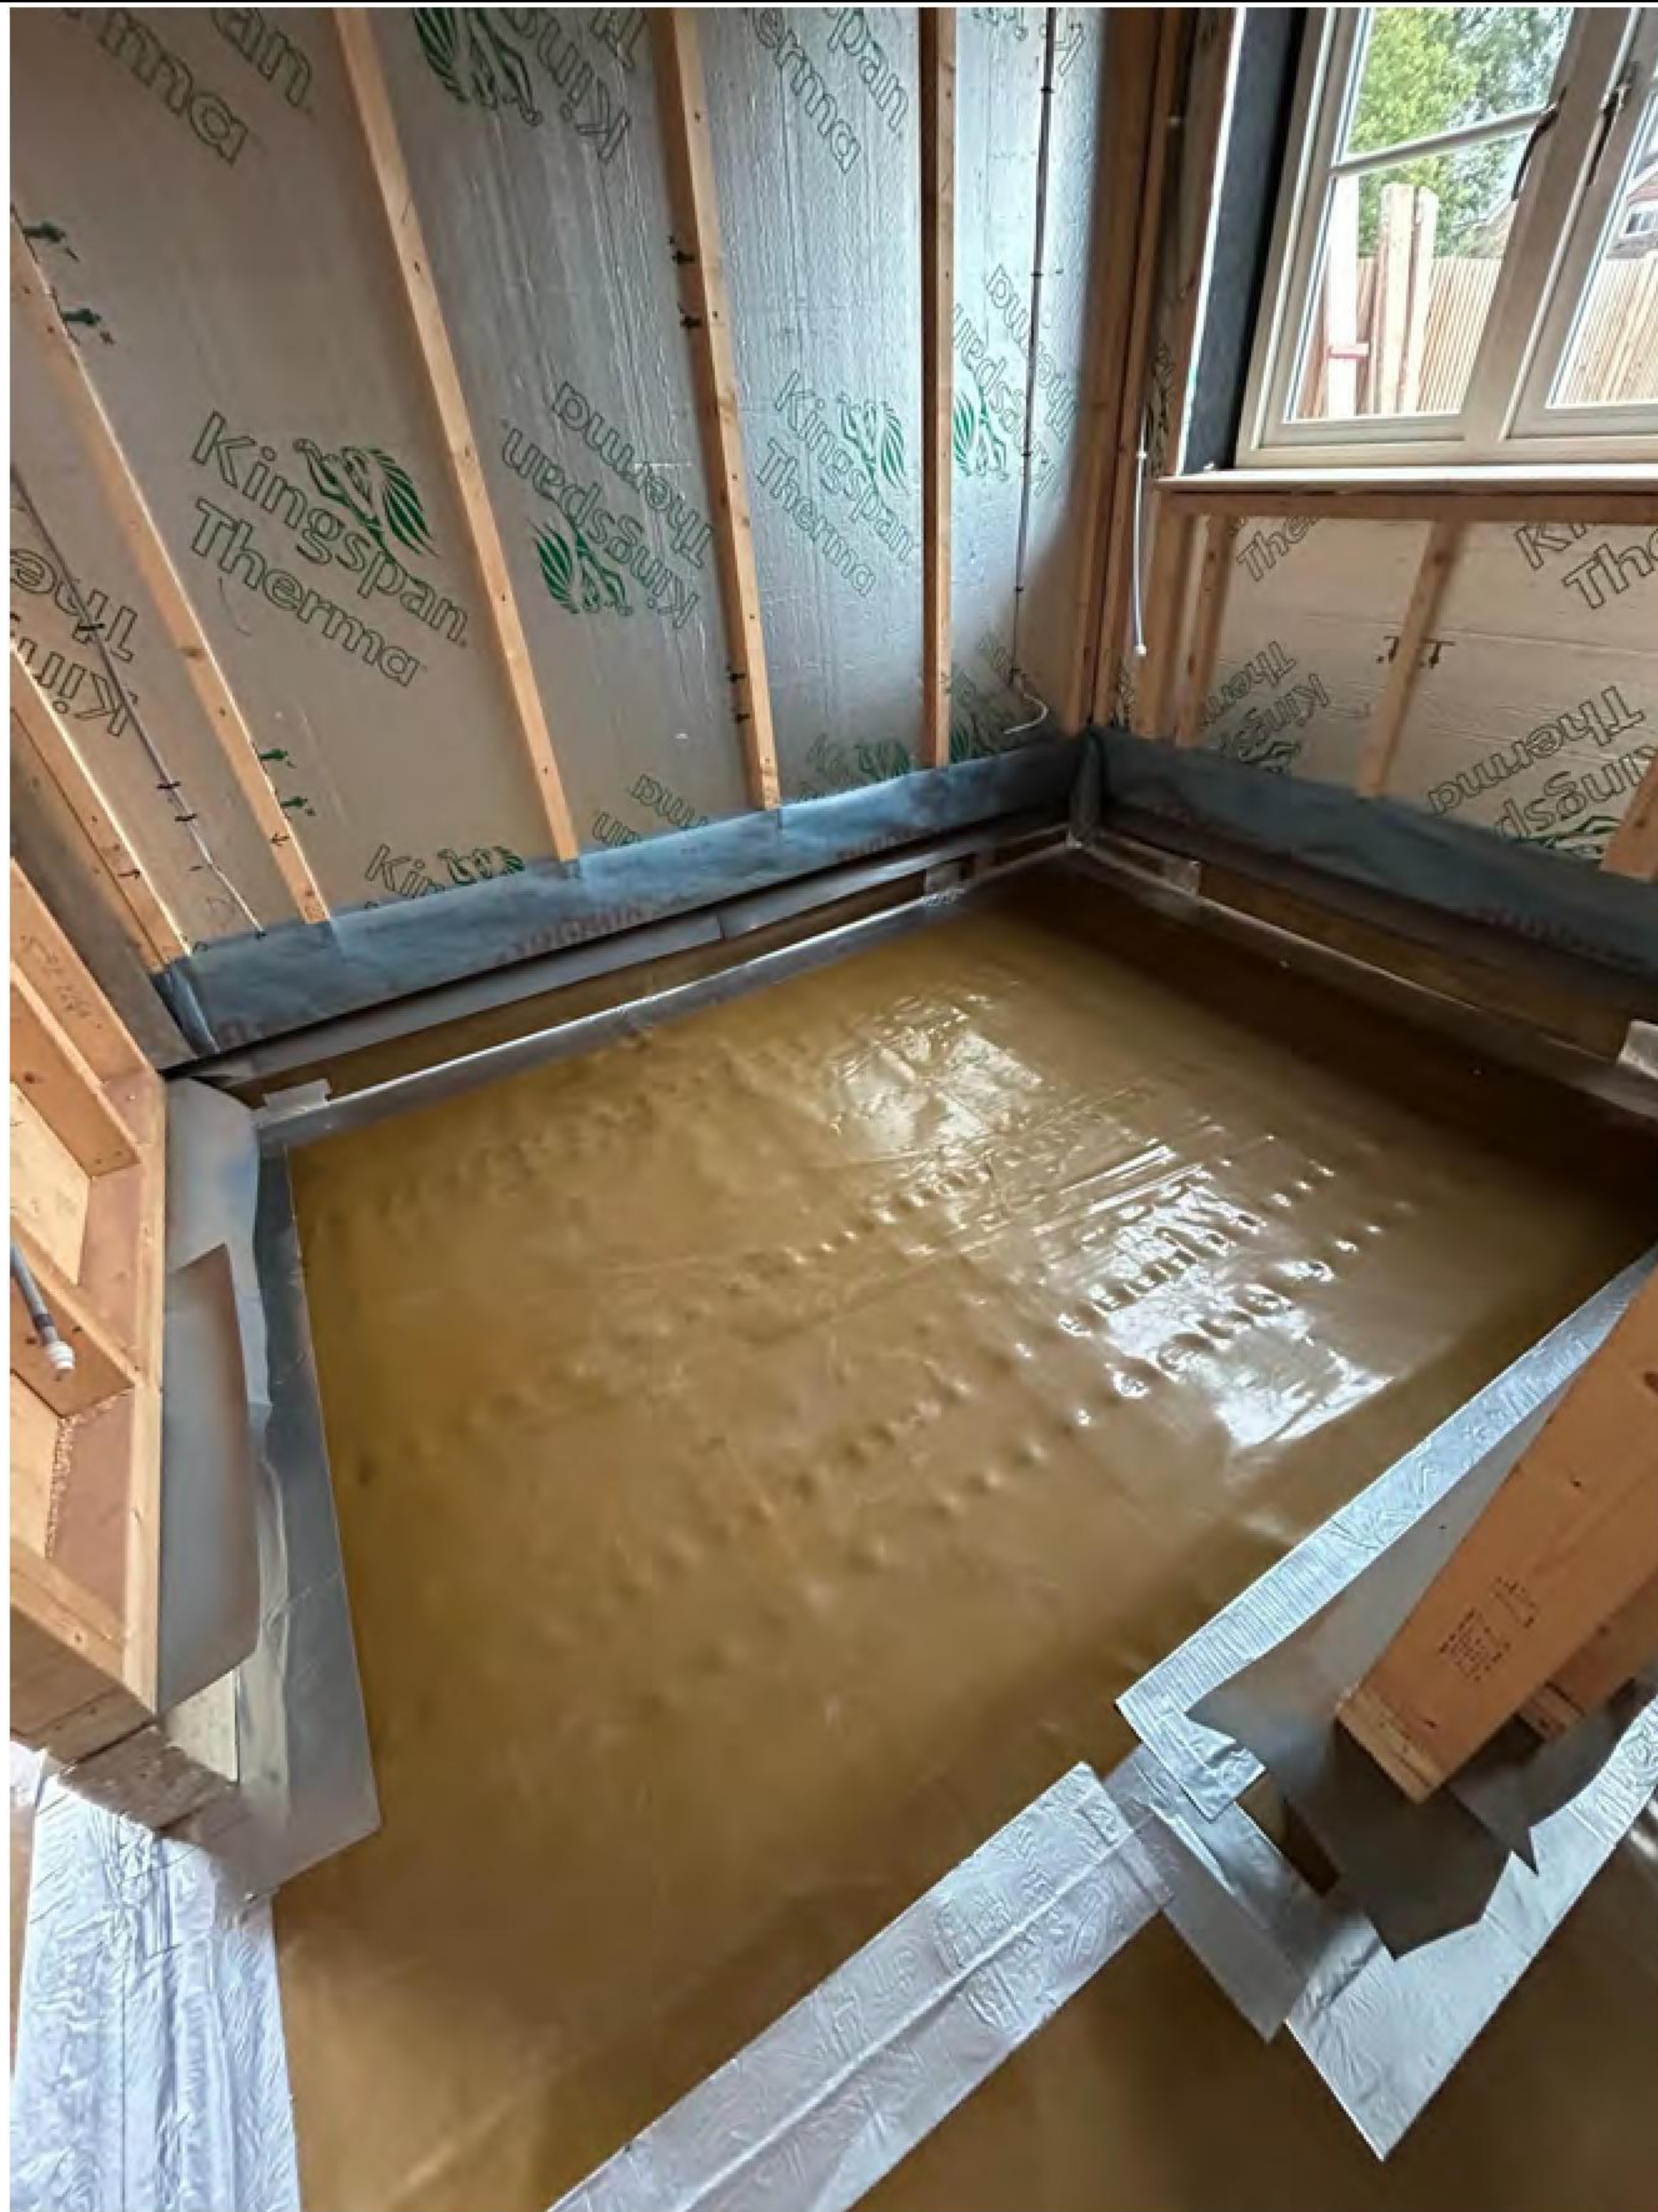
The photograph above displays an overview of the infill installation to one of the rooms where today's verification inspection took place on site.

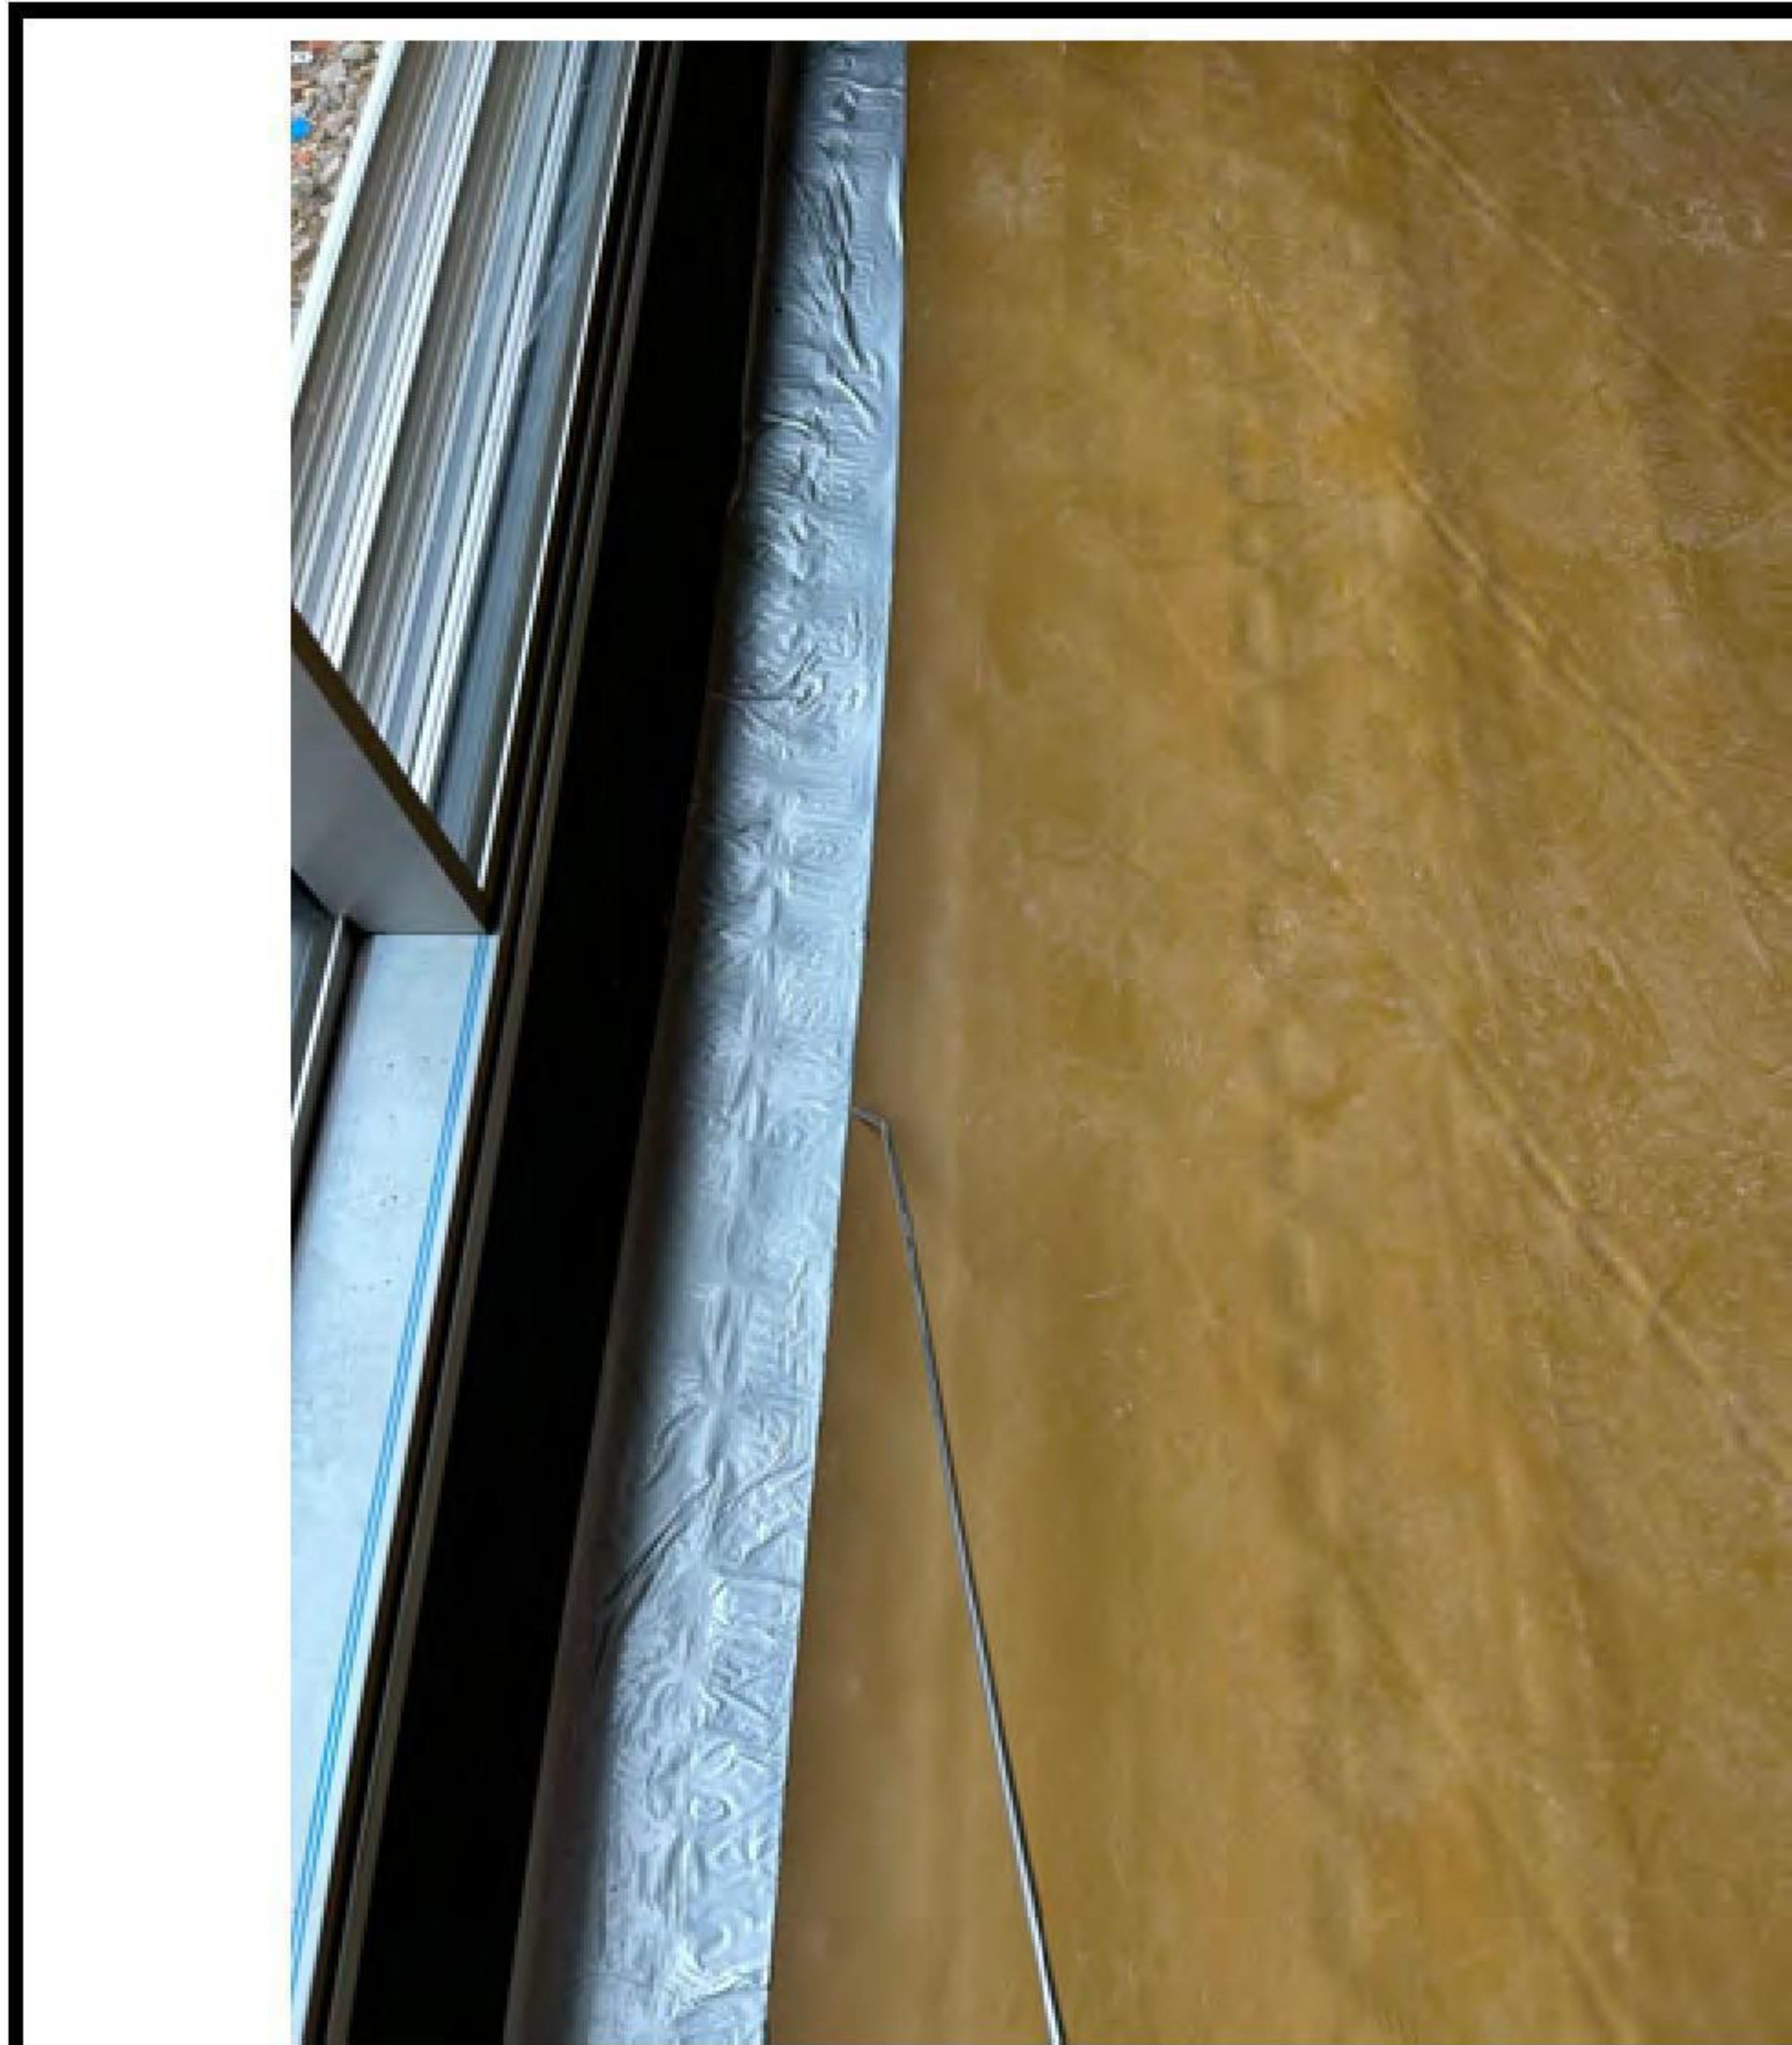
## VERIFICATION ITEM ONE

Visqueen Ultimate HC Blok has been installed across the footprint of the referenced area, in the form of an infill installation. The Visqueen Ultimate HC Blok has been lined out across the entirety of the area and sealed onto the existing perimeter edges and internal party walls using Visqueen Double Sided Butyl Tape.

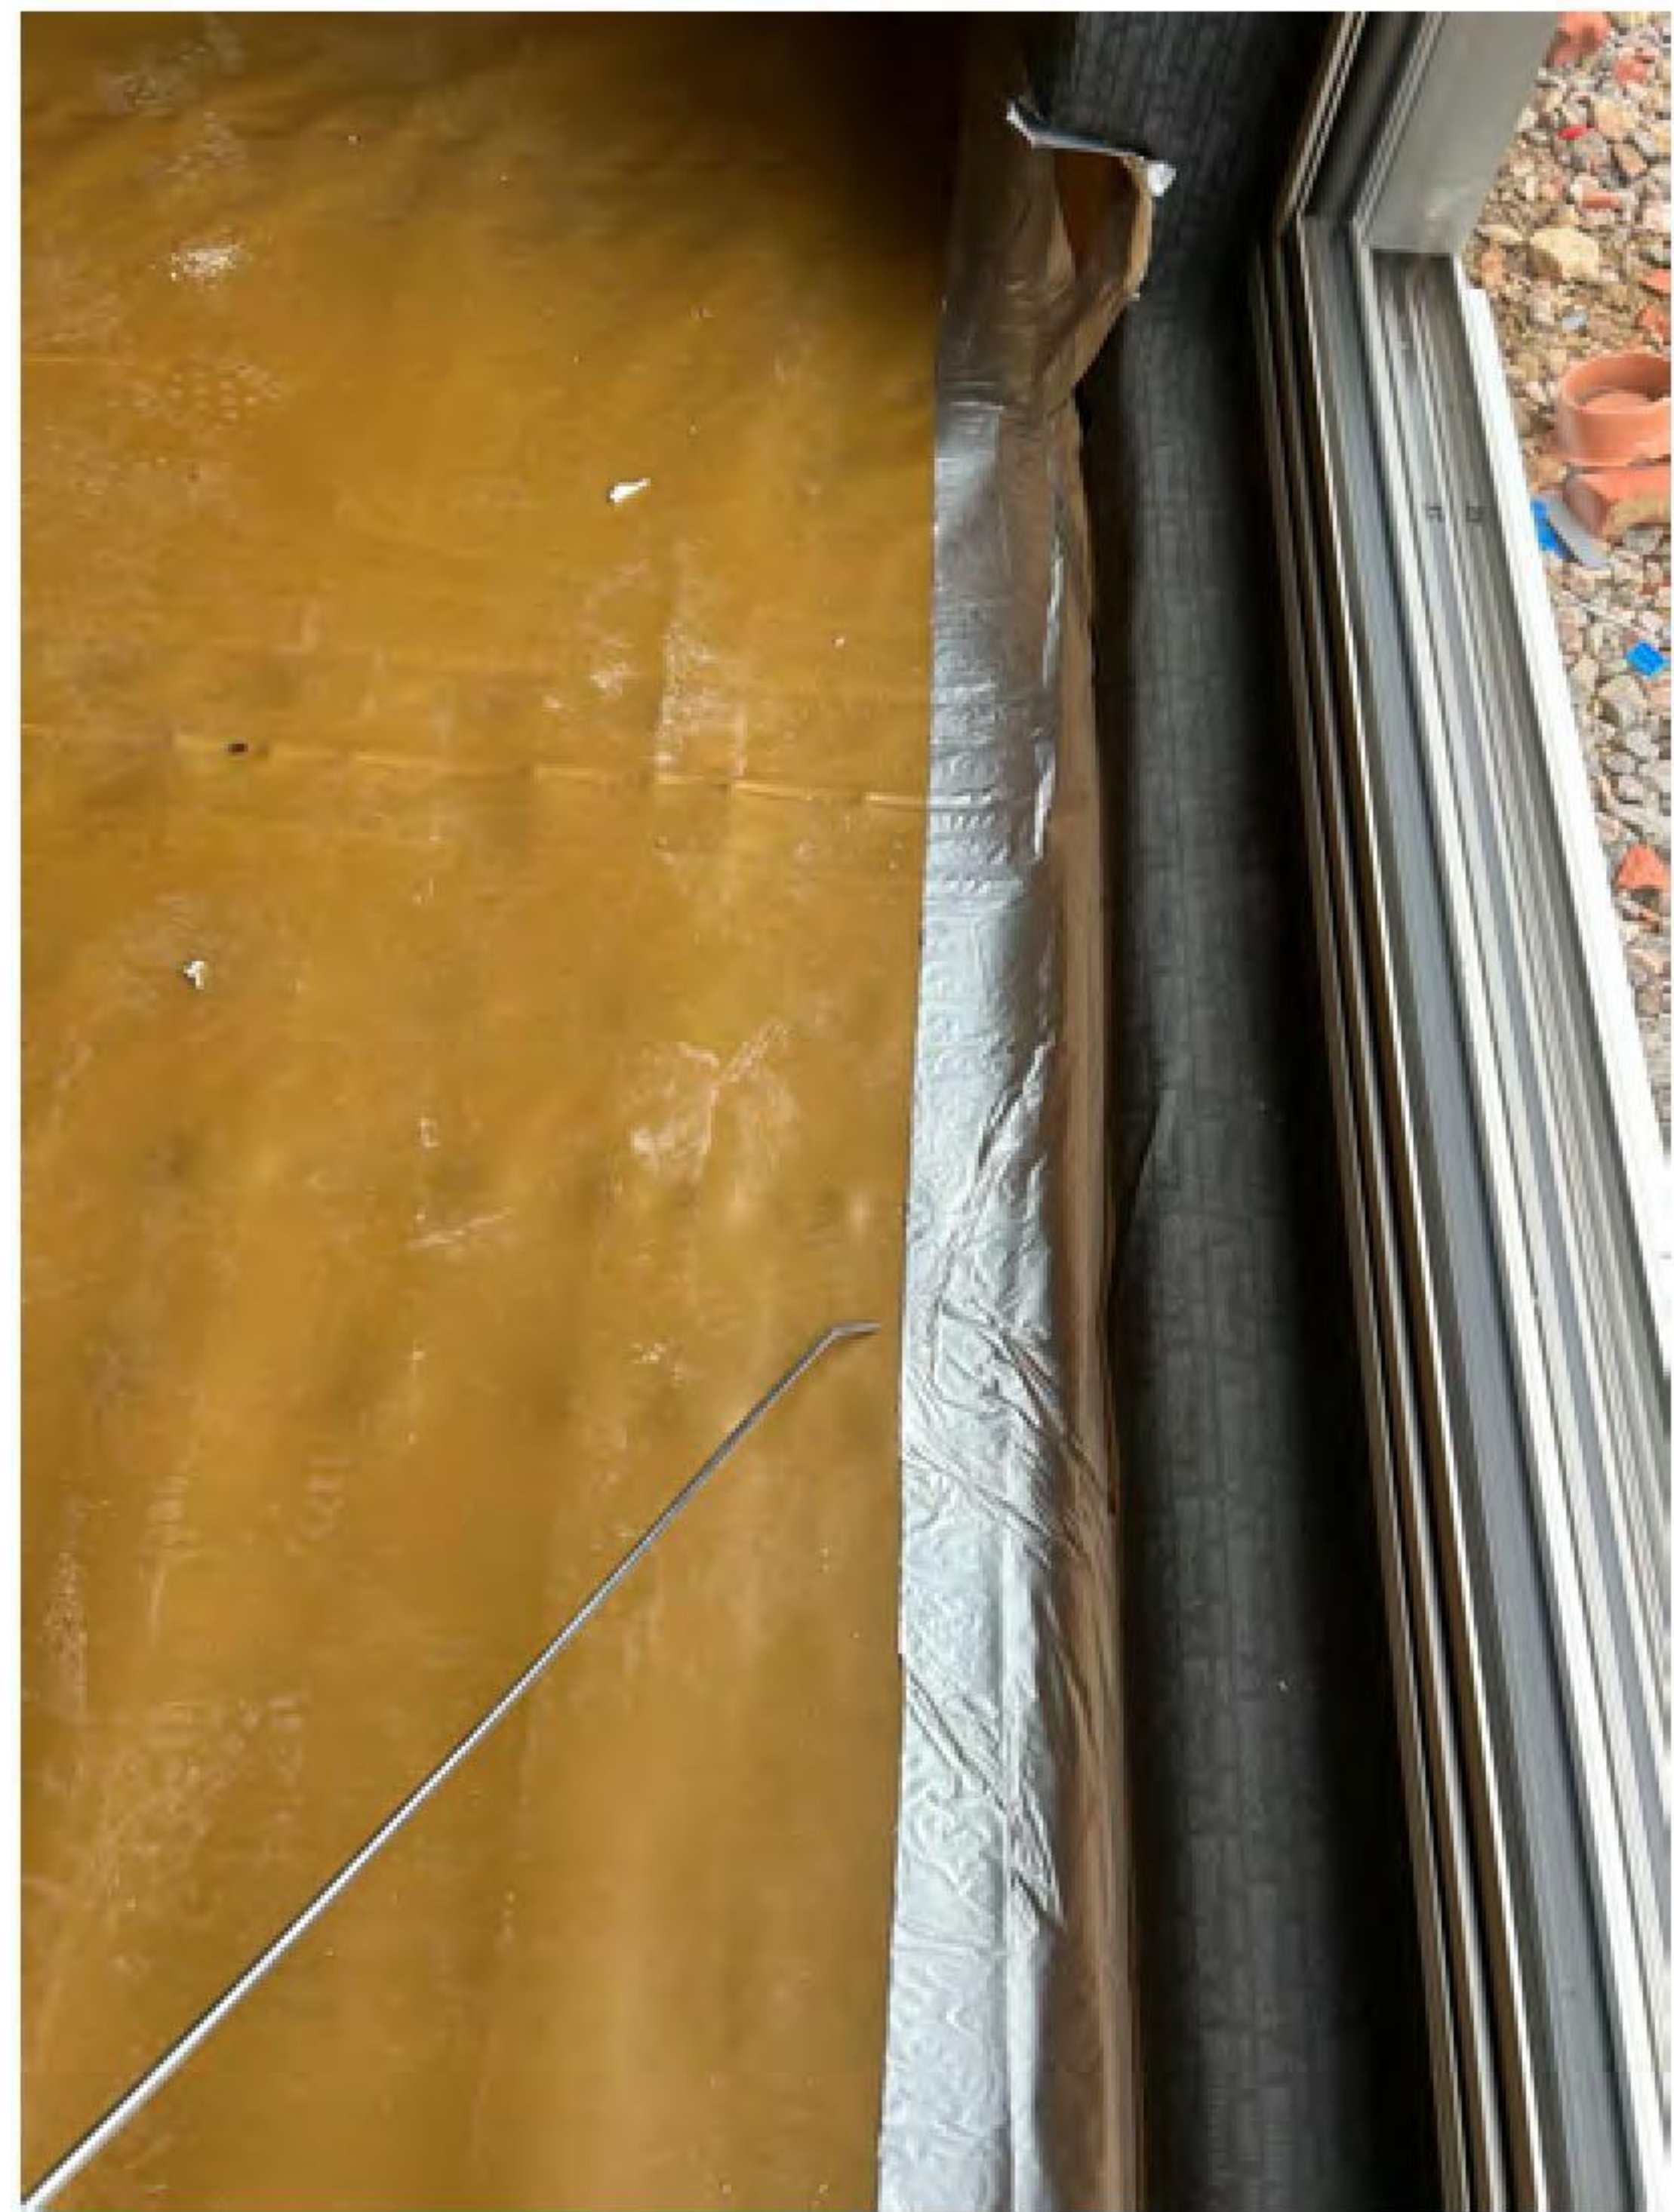
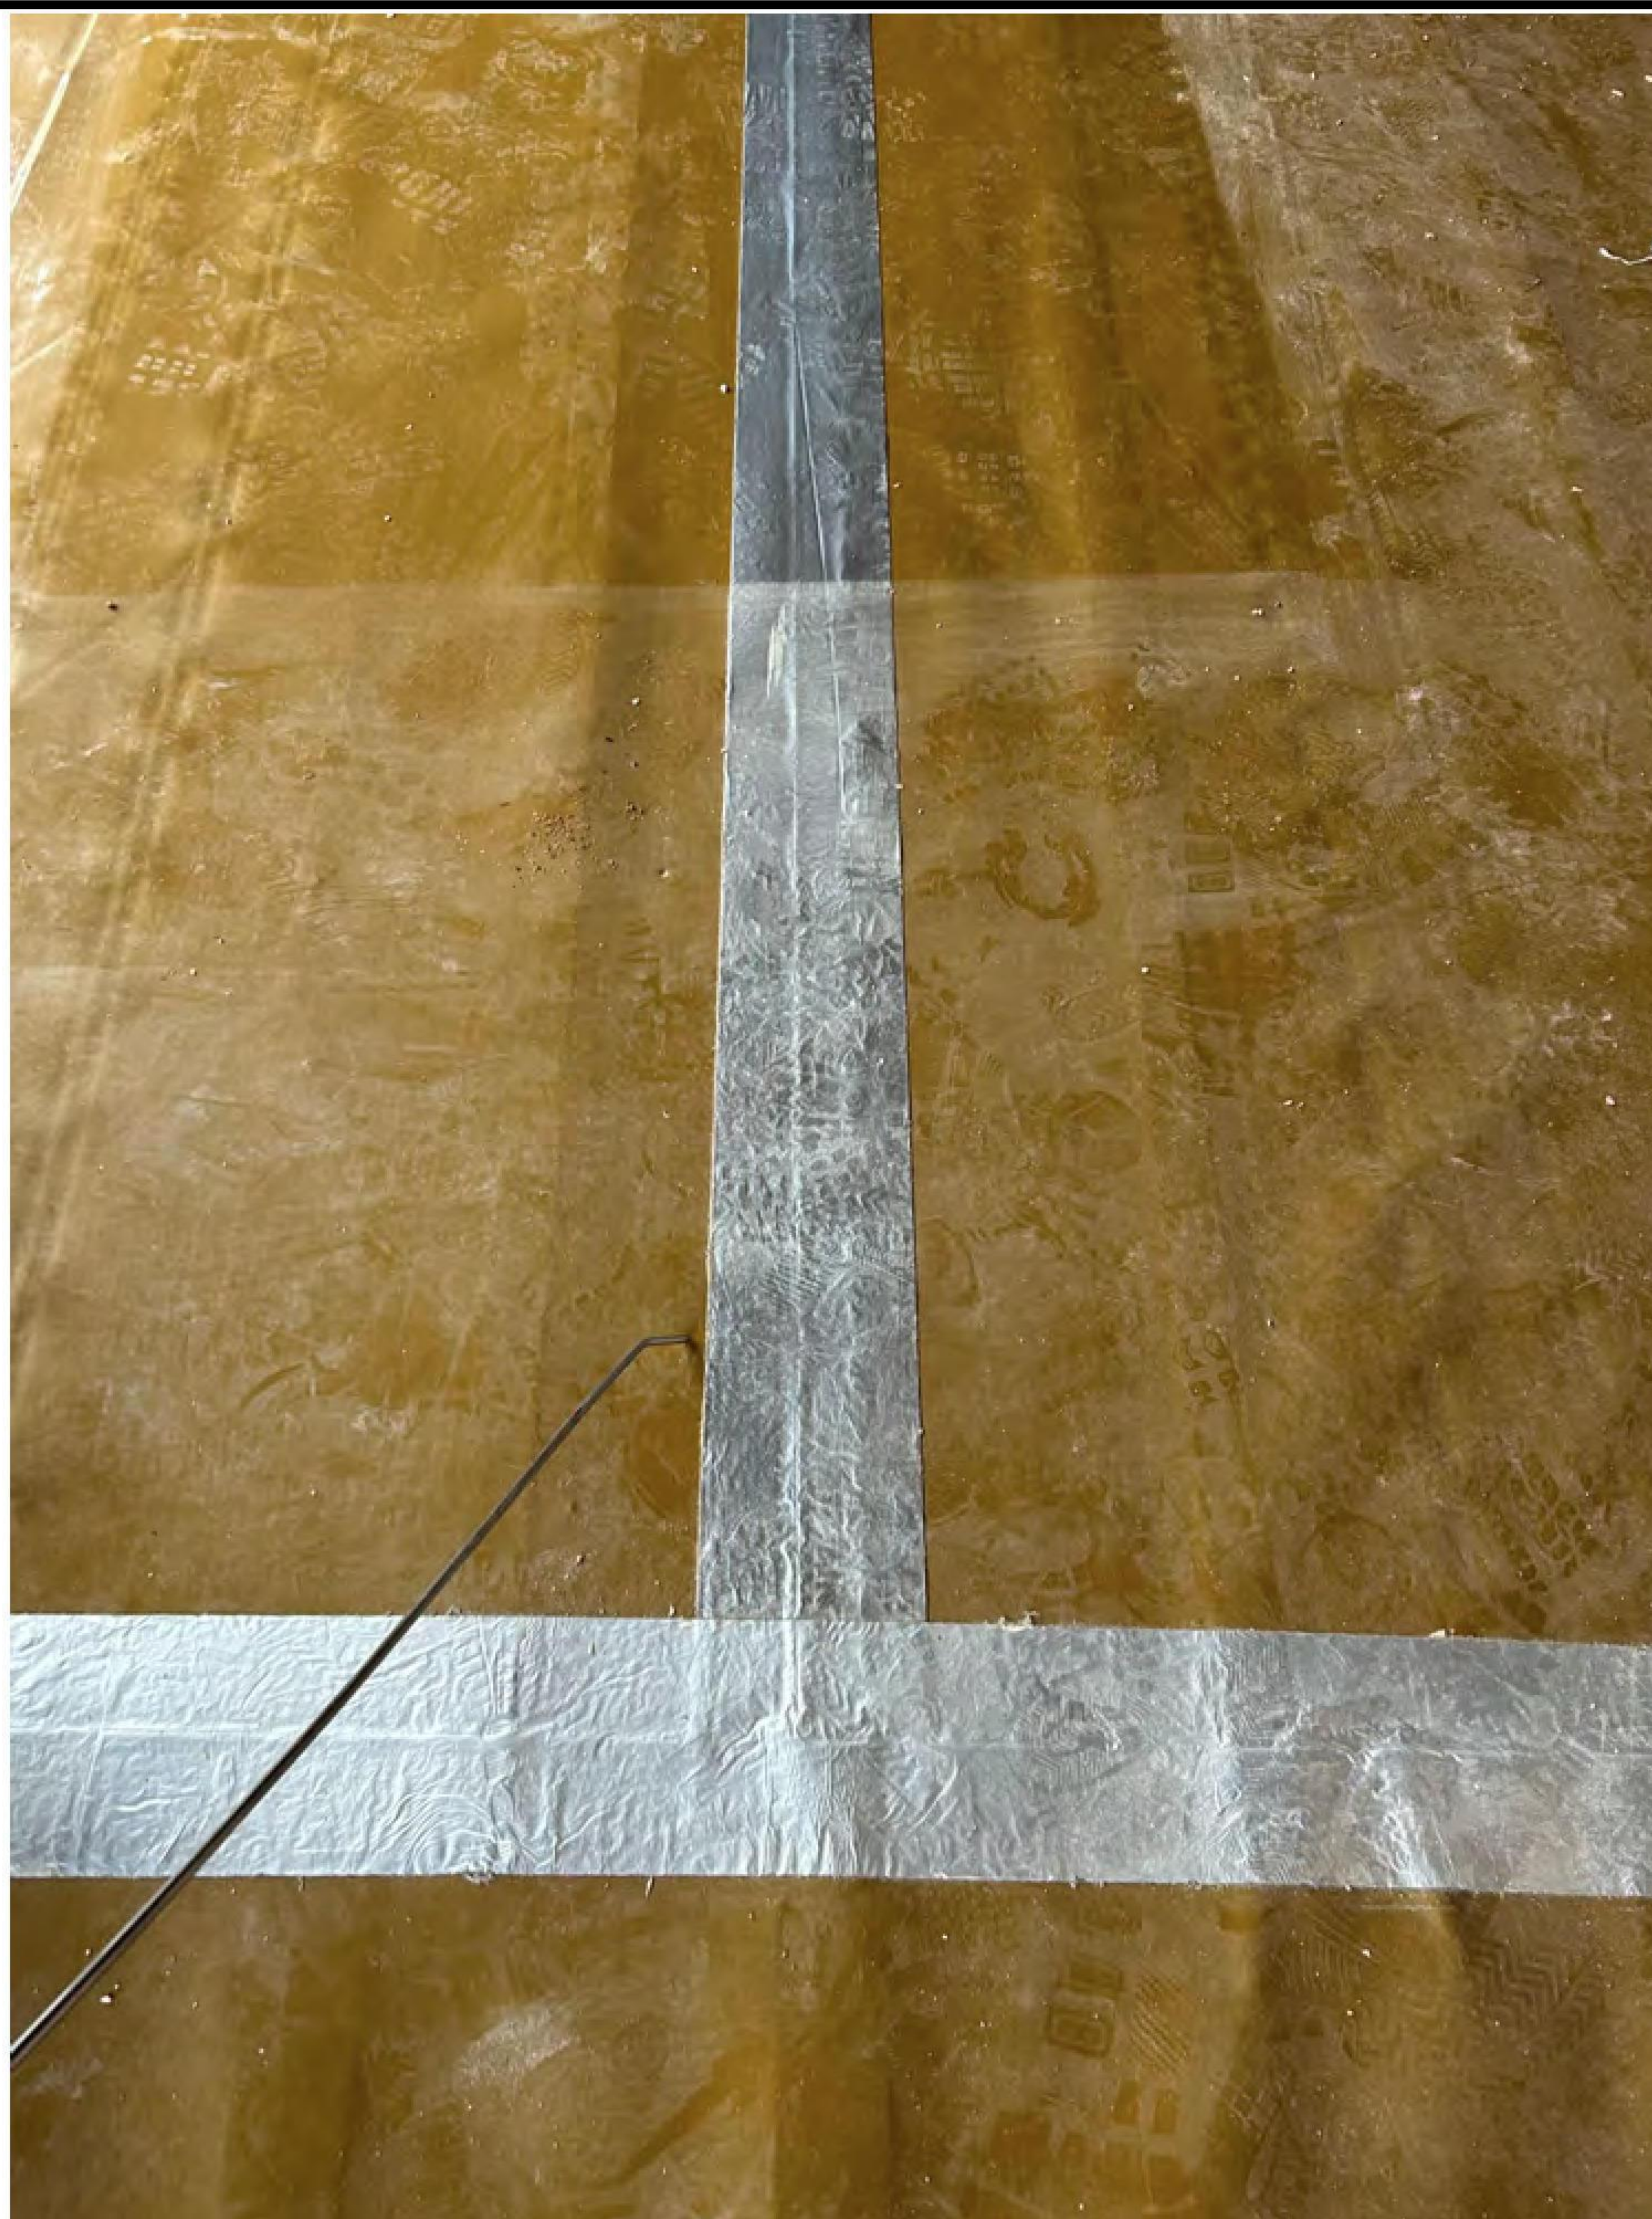
All overlaps between adjacent sheets of Visqueen Ultimate HC Blok have been overlapped a minimum of 100mm, conforming to manufacturer's specifications. All overlaps have been dual taped using Visqueen Double Sided Butyl Tape and over-taped using Visqueen Pro Detailing Strip, which is a gas resistant self

adhesive membrane. Sufficient rolled pressure has been applied to the Visqueen Pro Detailing Strip to ensure a continuous gas resistant seal is achieved. Thorough visual inspections, supported by mechanical point stress testing and non destructive air lance integrity testing were conducted upon all taped overlaps throughout the area. A total of two faults were identified.
