# GeoShield Verification Report 1

GEO104739

Land to Rear of 67 Sunte Avenue,  
Lindfield,  
Haywards Heath,  
RH16 2AB

The Old Yard, Plot - Infills

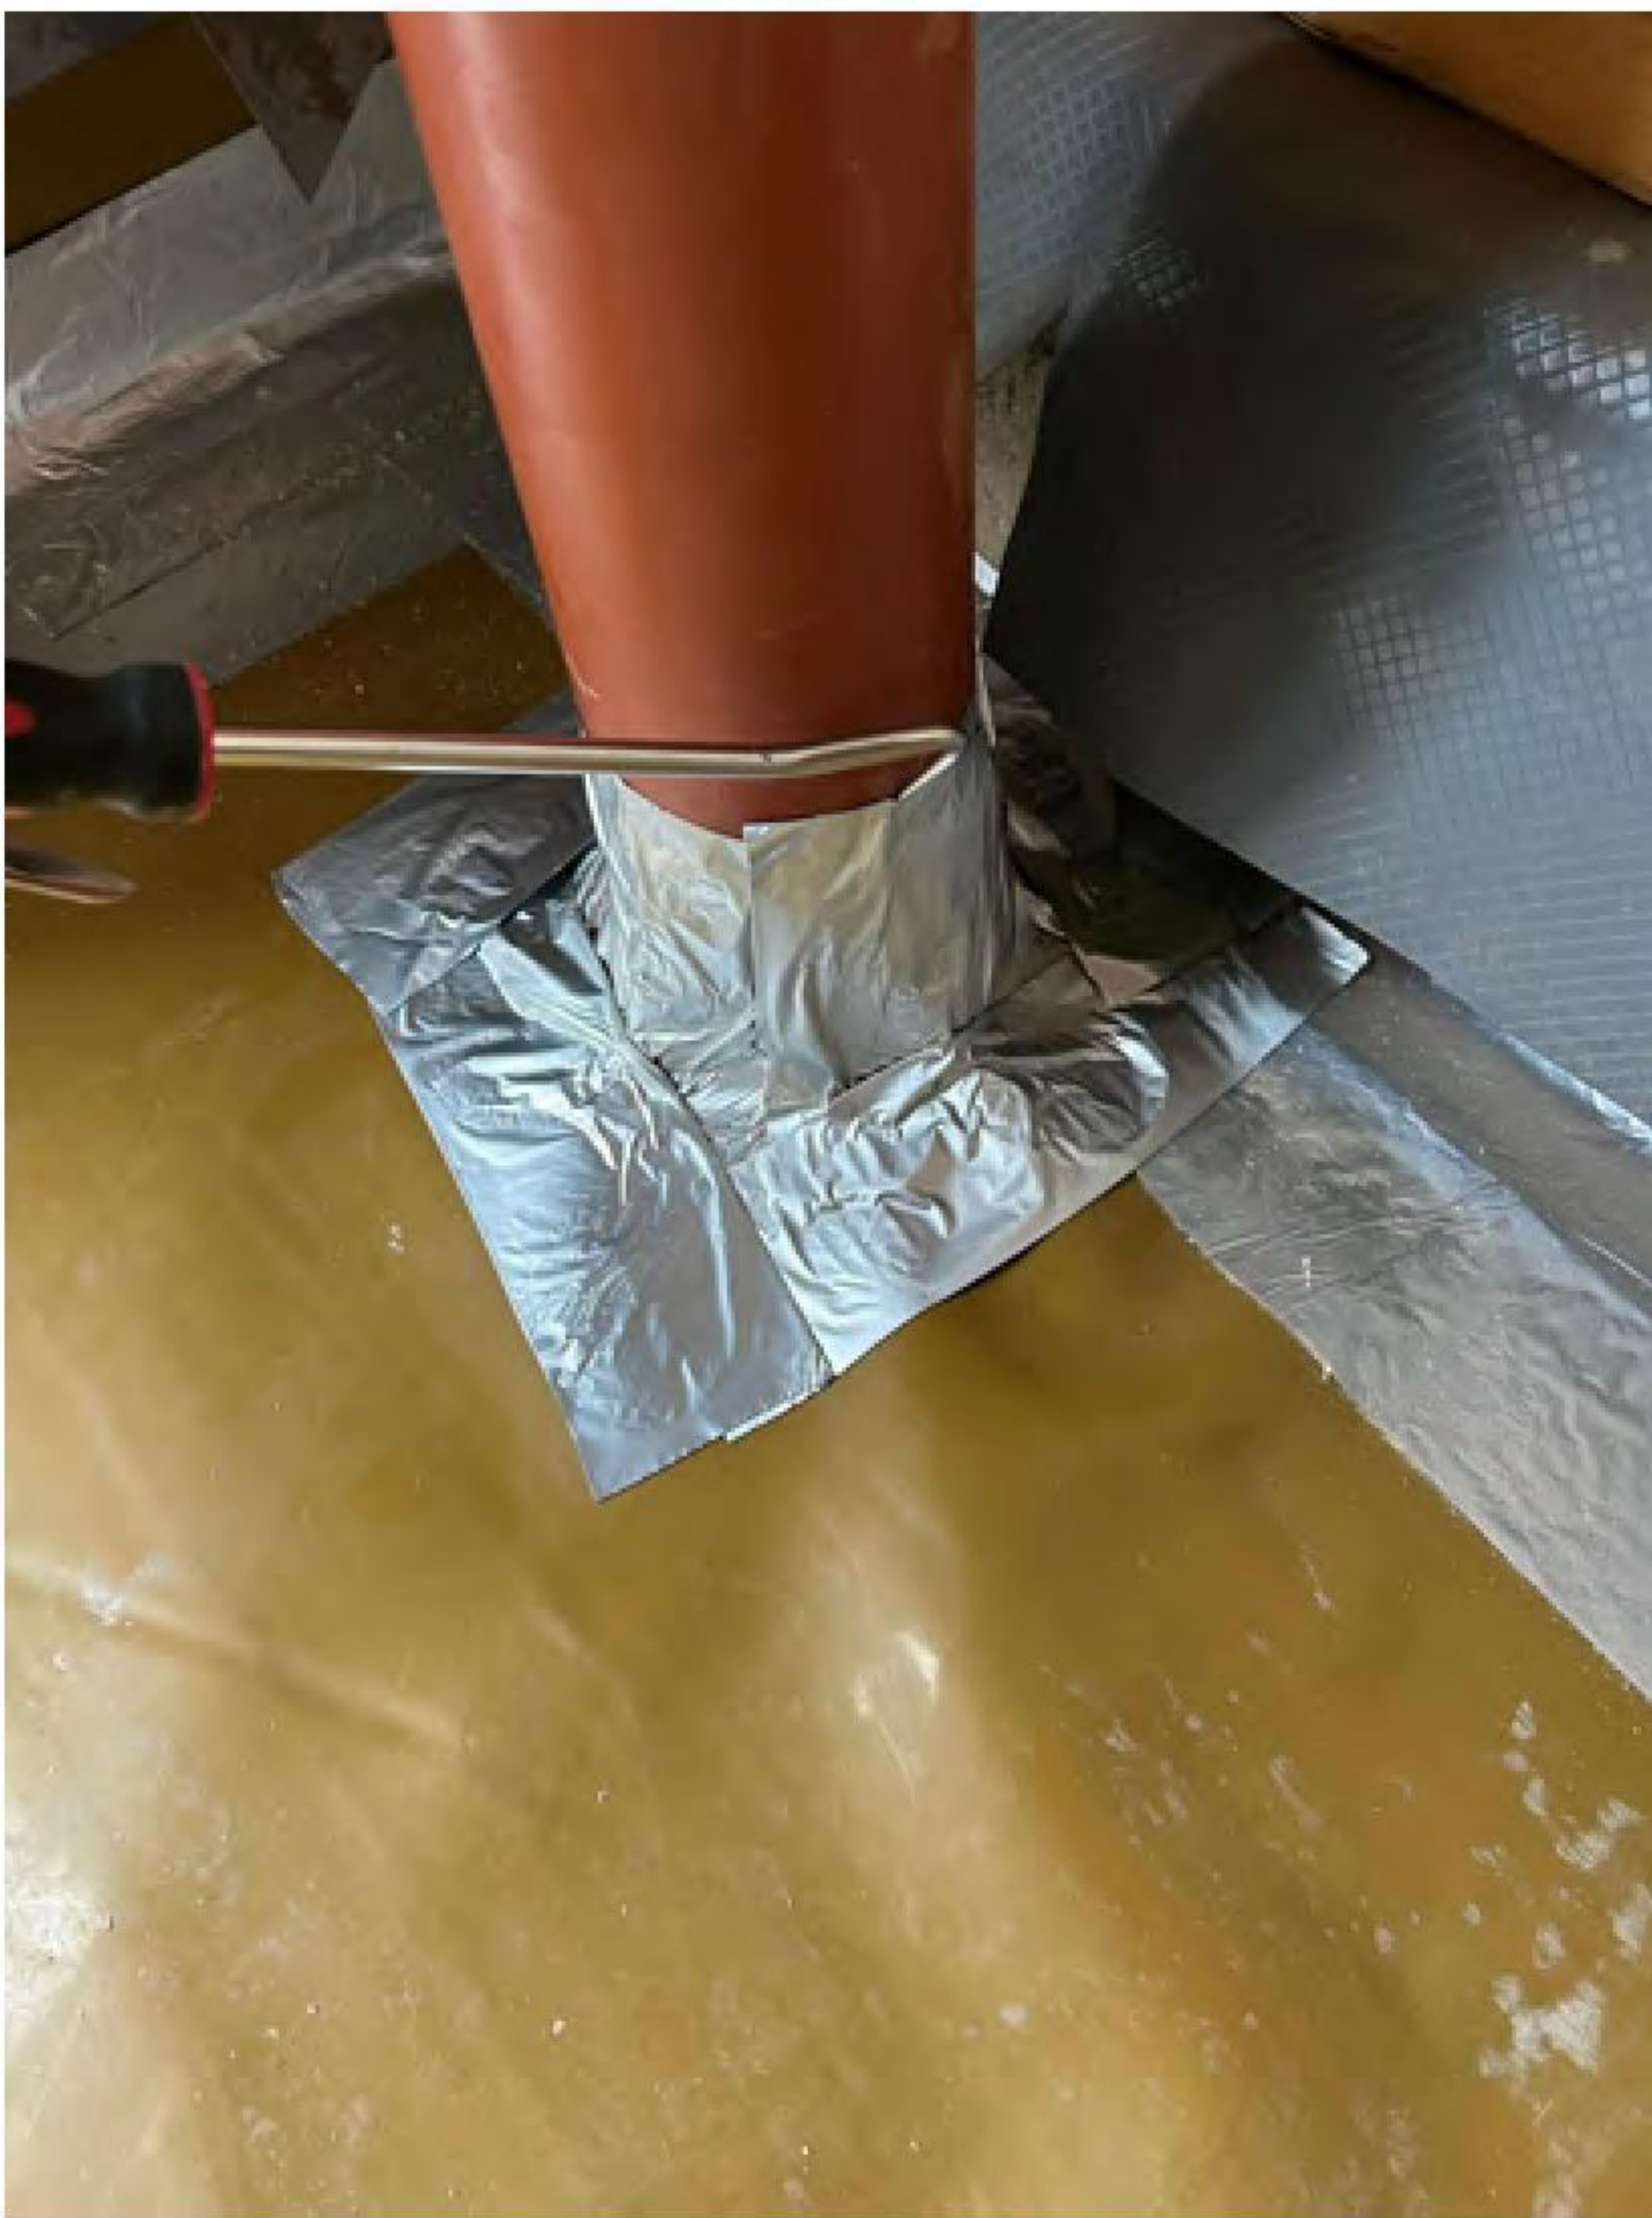
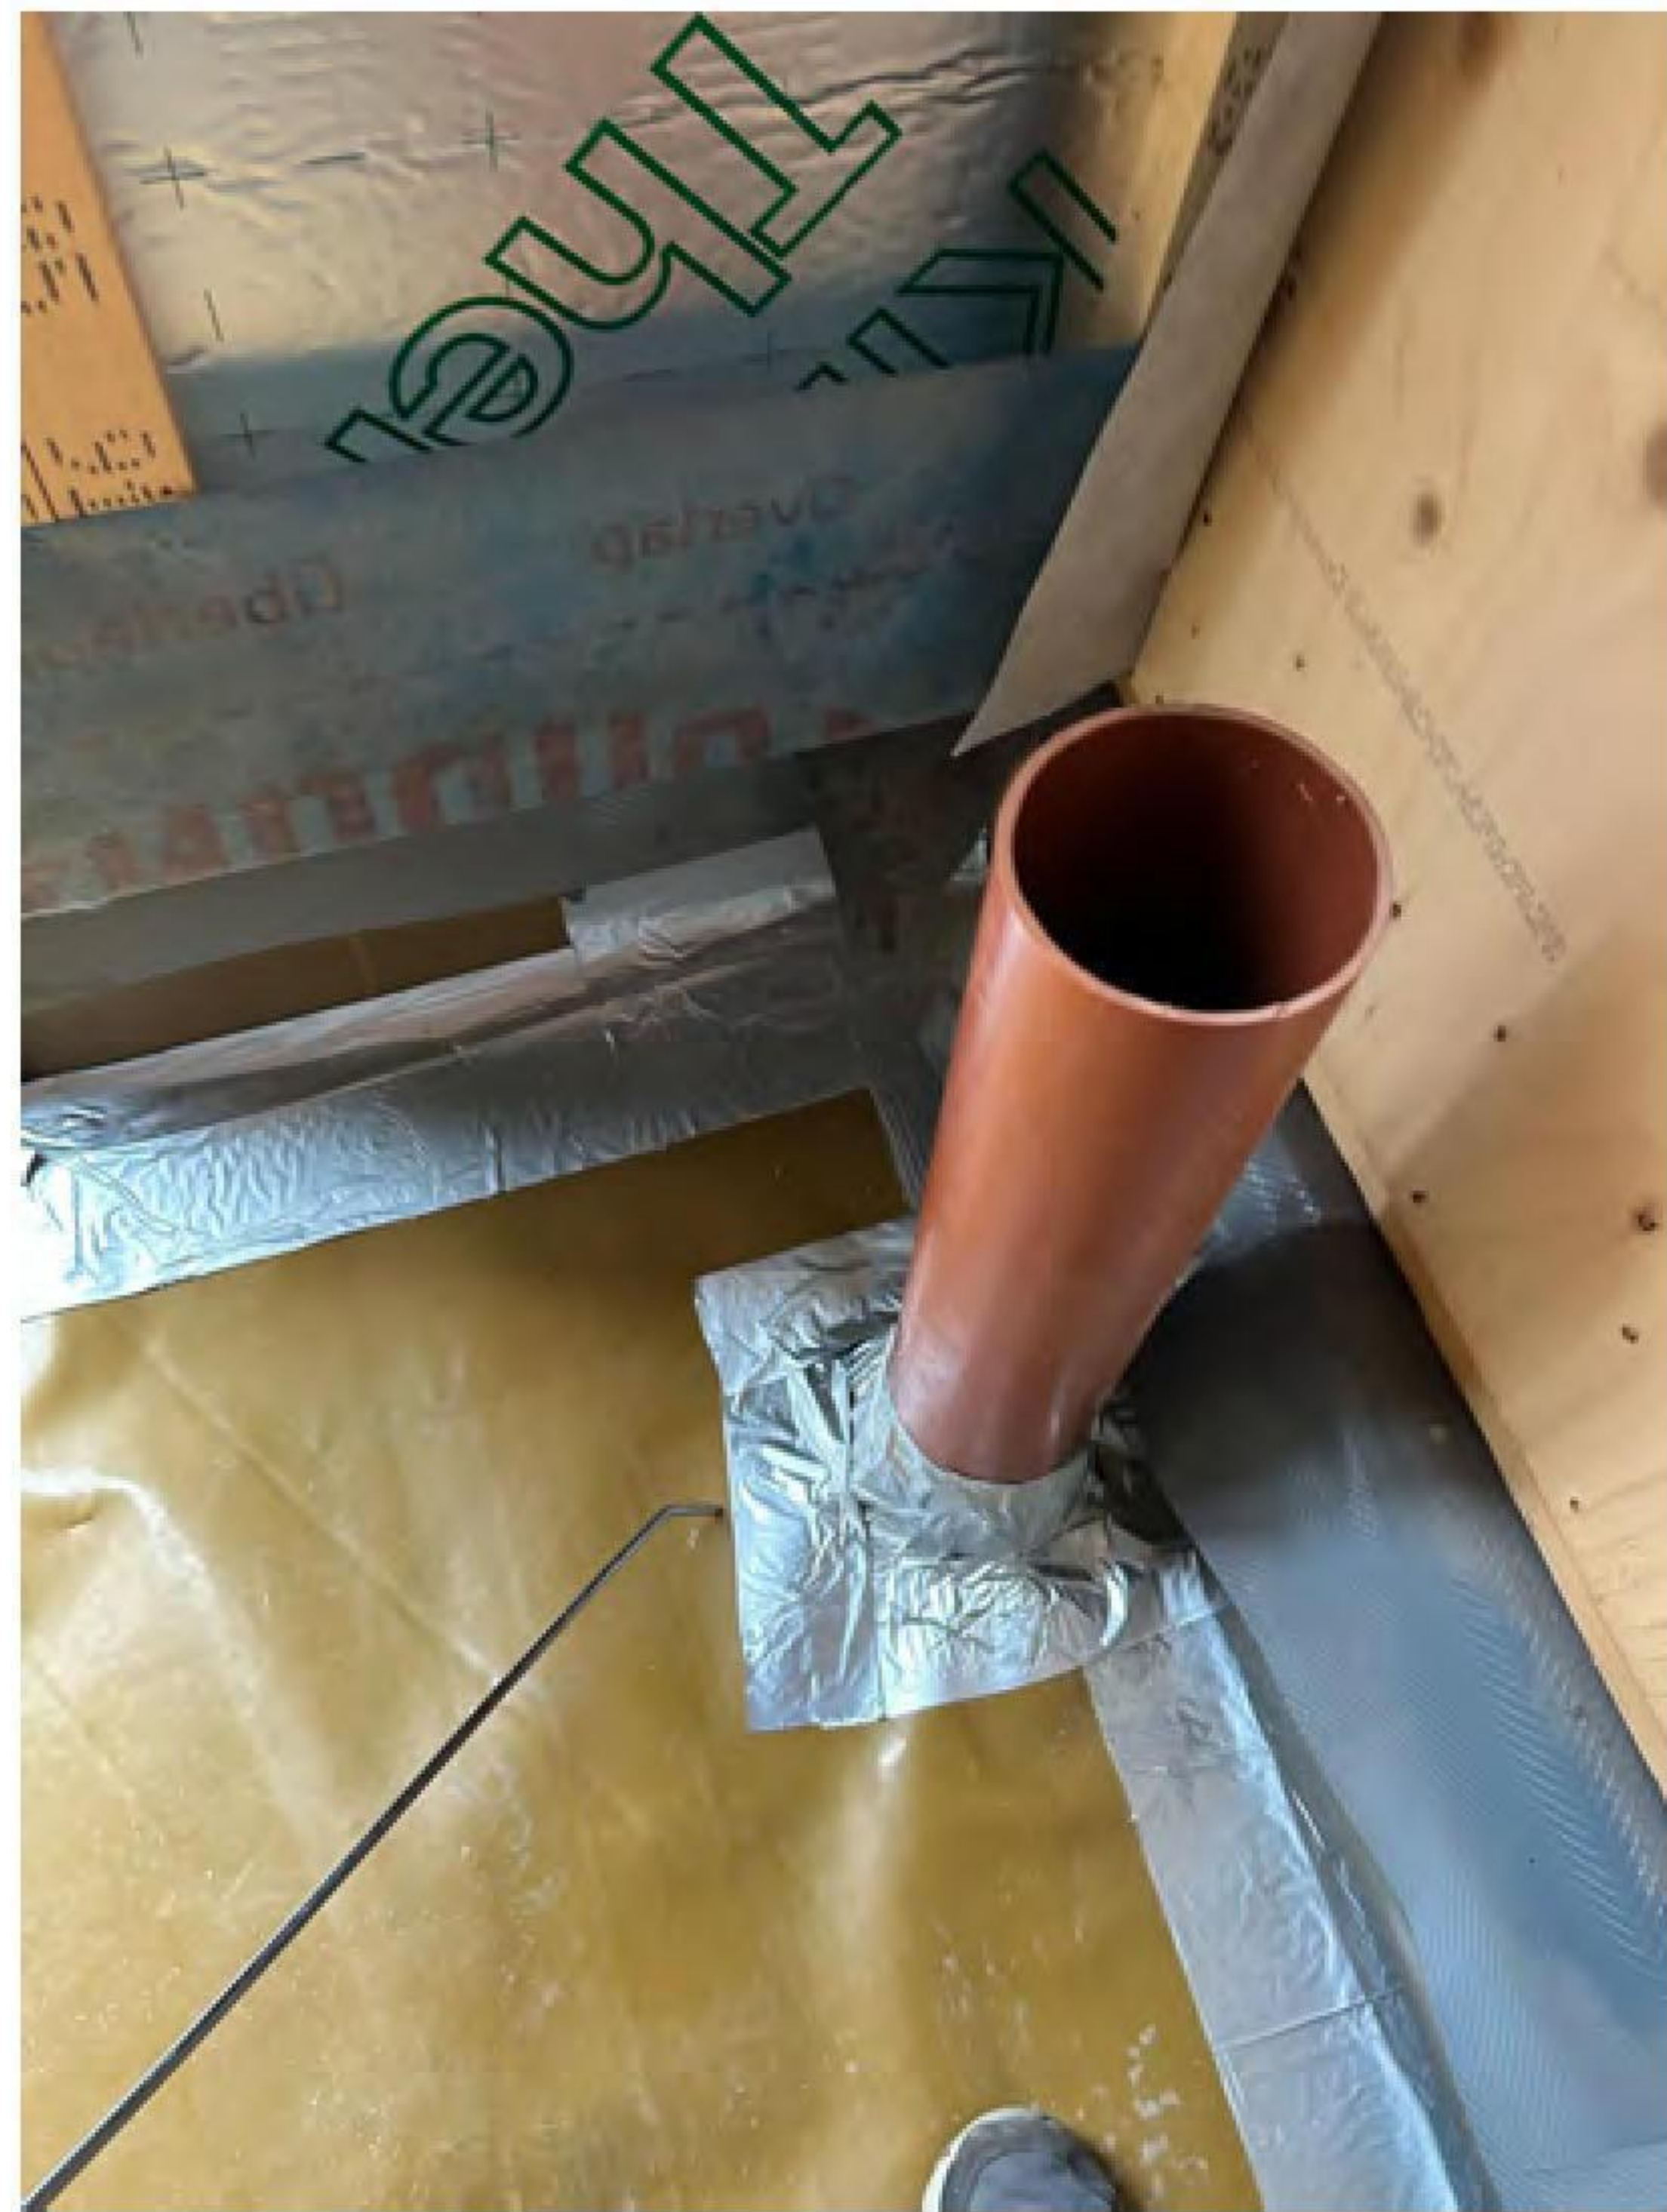
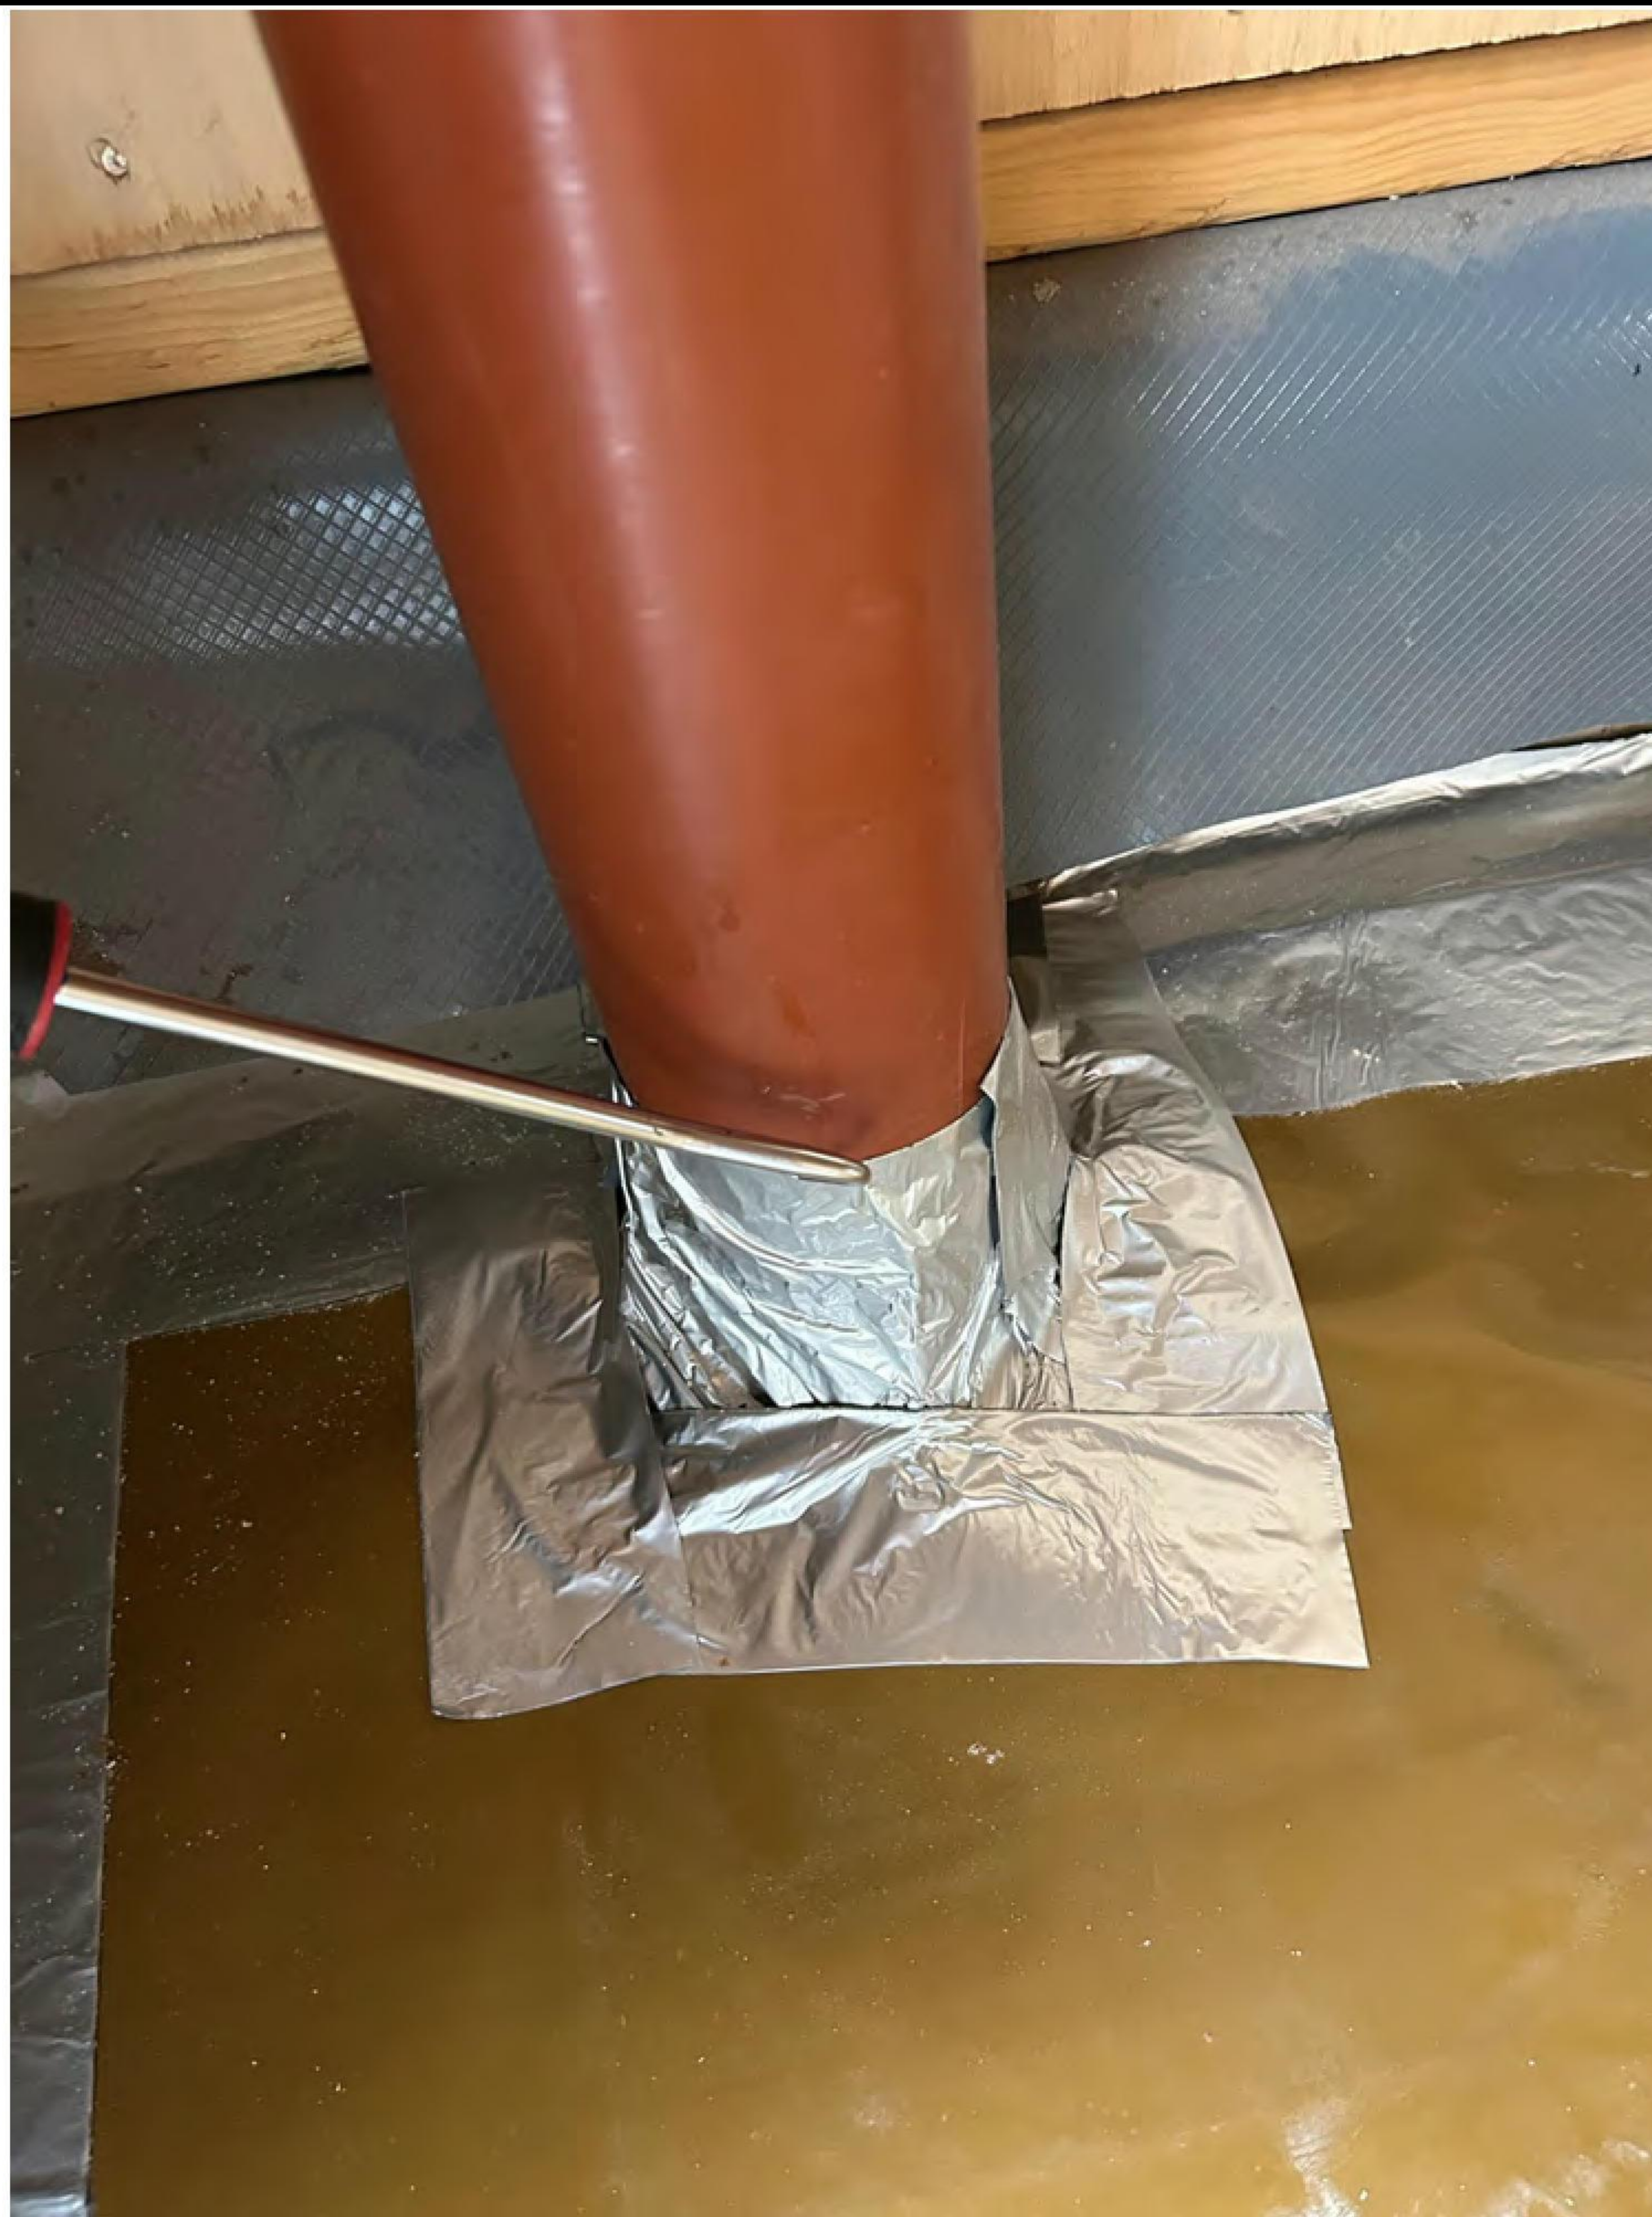
## VERIFICATION ITEM TWO

Throughout the Visqueen Ultimate HC Blok installation to the referenced area, there were a number of pipe penetrations that have been sealed in accordance with manufacturer's specifications. This has been achieved using Visqueen Pro Detailing Strip. The installers have first cut the Visqueen Ultimate HC Blok tight

around the base of each pipe penetration to minimise voided areas. Next, strips of Visqueen Pro Detailing Strip are placed intricately around the pipe penetration, onto the Visqueen Ultimate HC Blok. Heat and rolled pressure are applied to the Visqueen Pro Detailing Strip, creating a secure bond between the pipe penetration

and the Visqueen Ultimate HC Blok. All pipe penetrations were subjected to visual inspections, mechanical point stress testing and non destructive air lance integrity testing. No faults were identified.

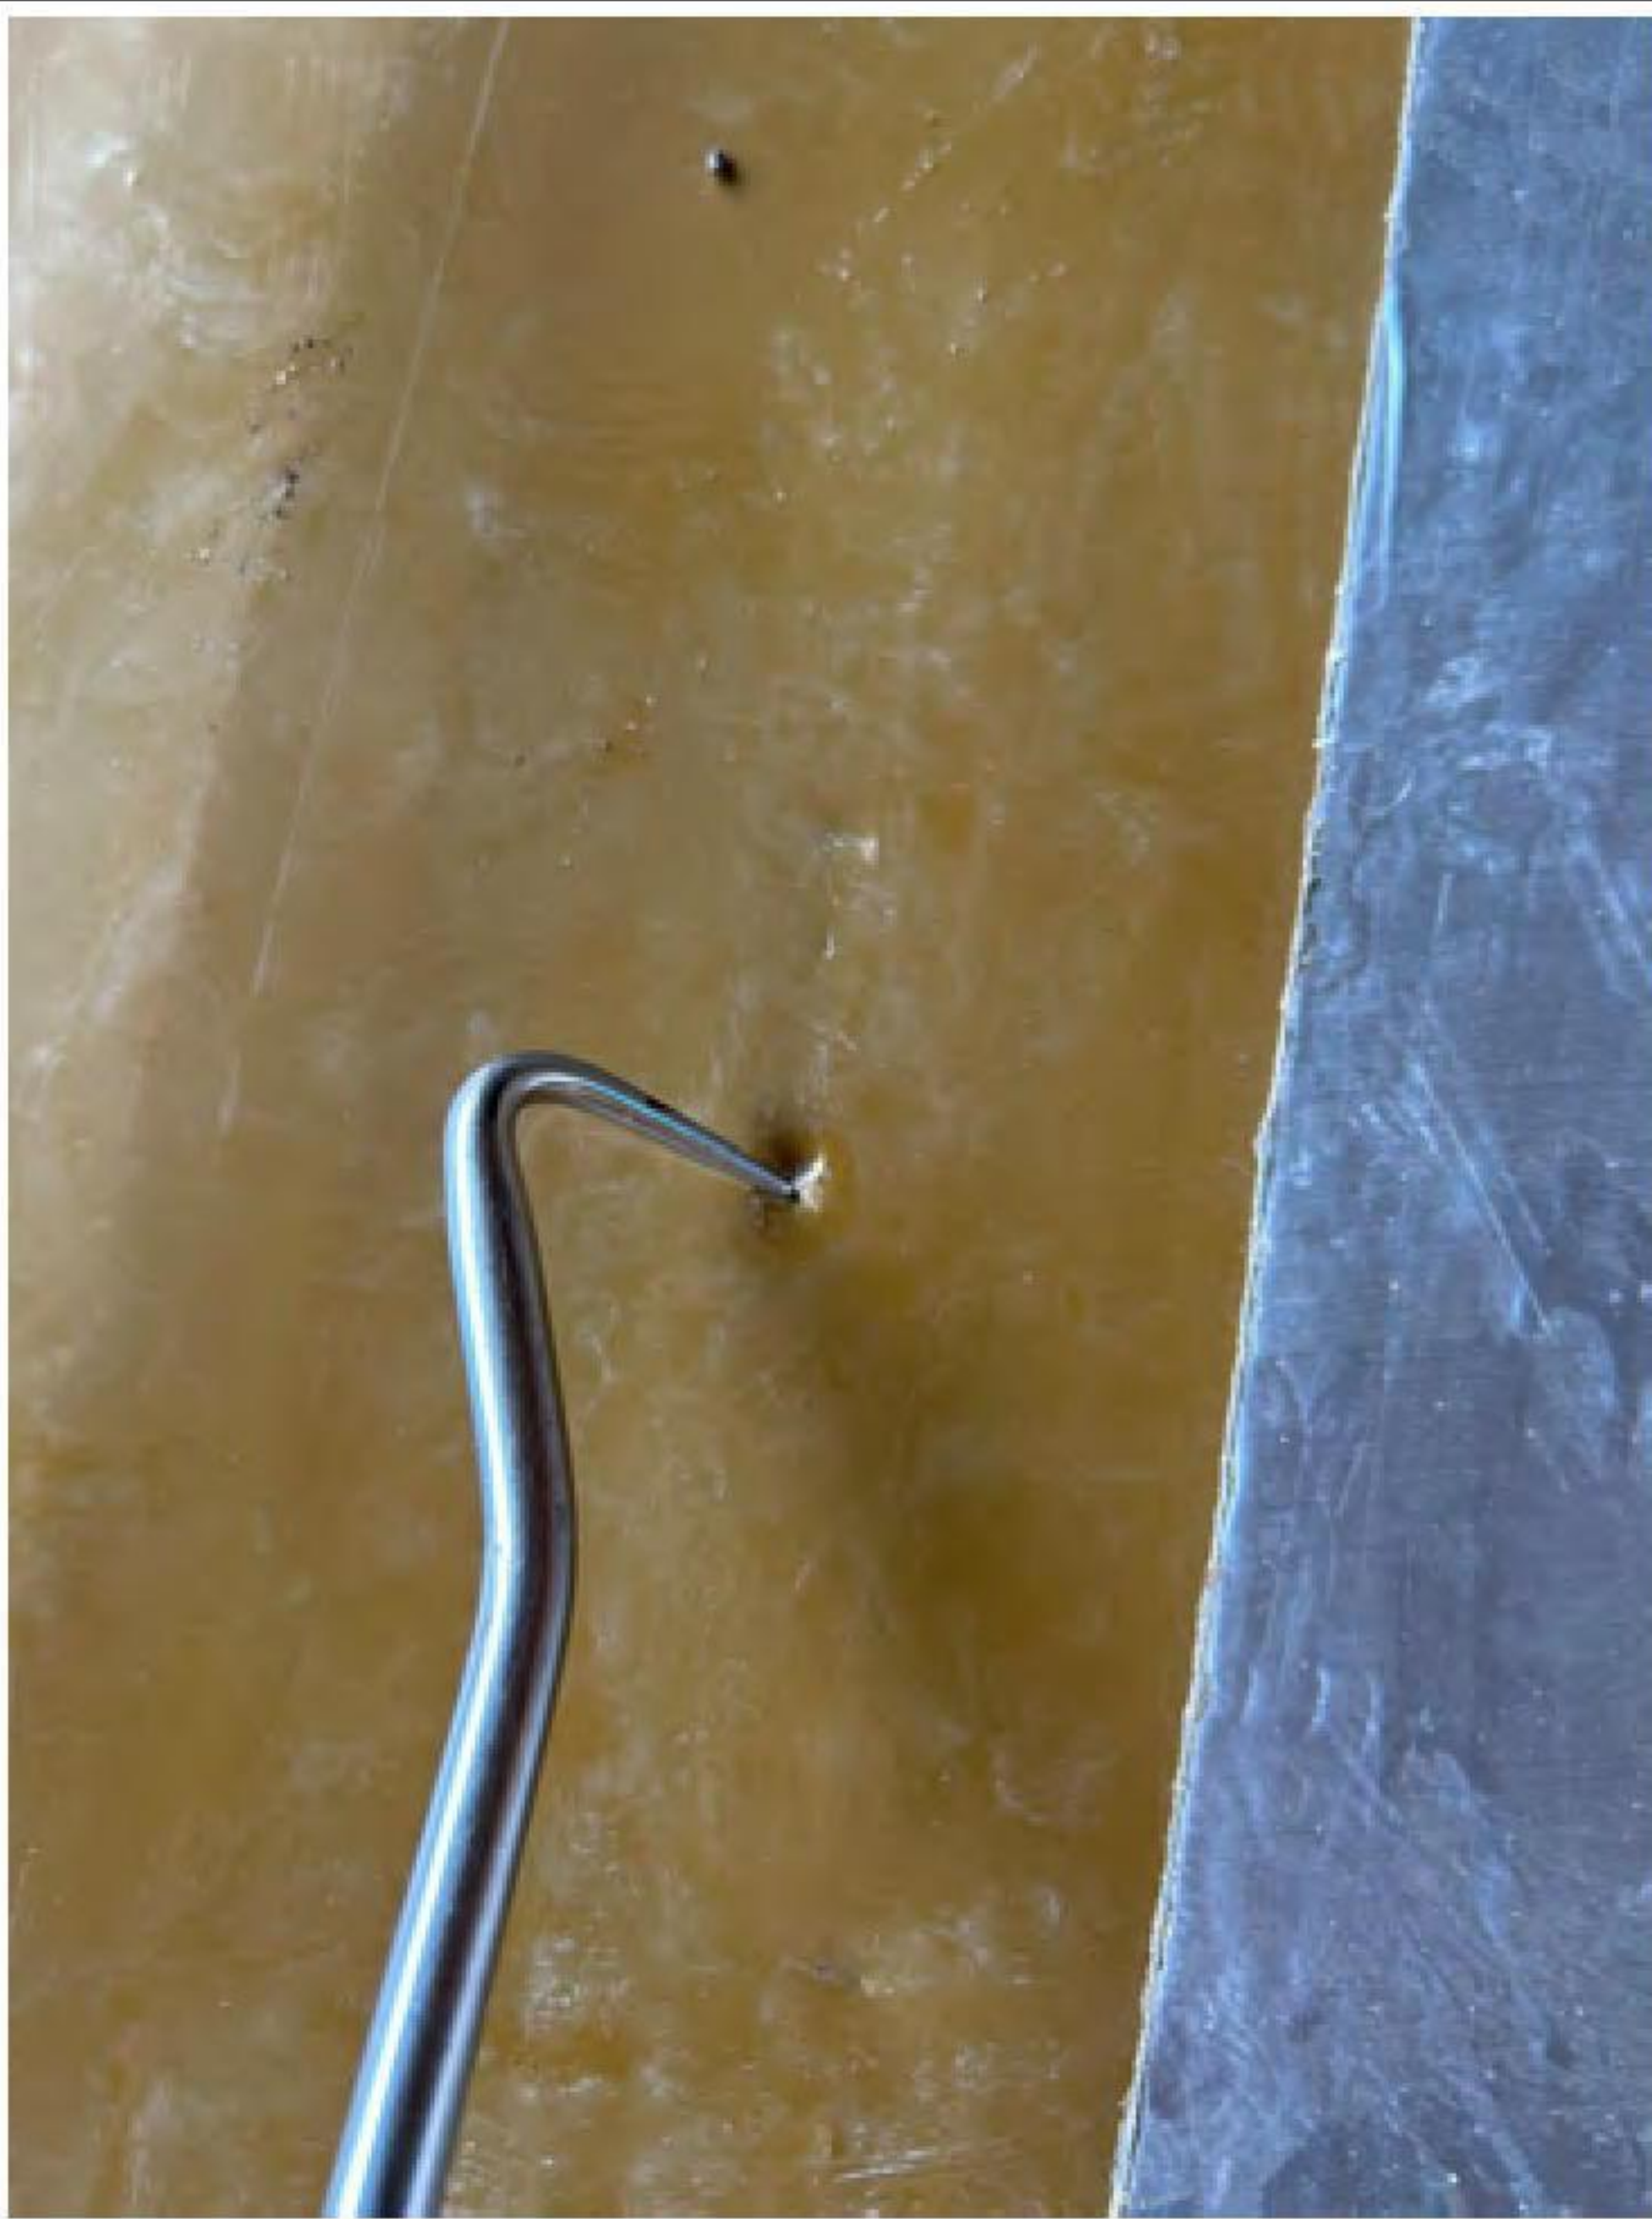
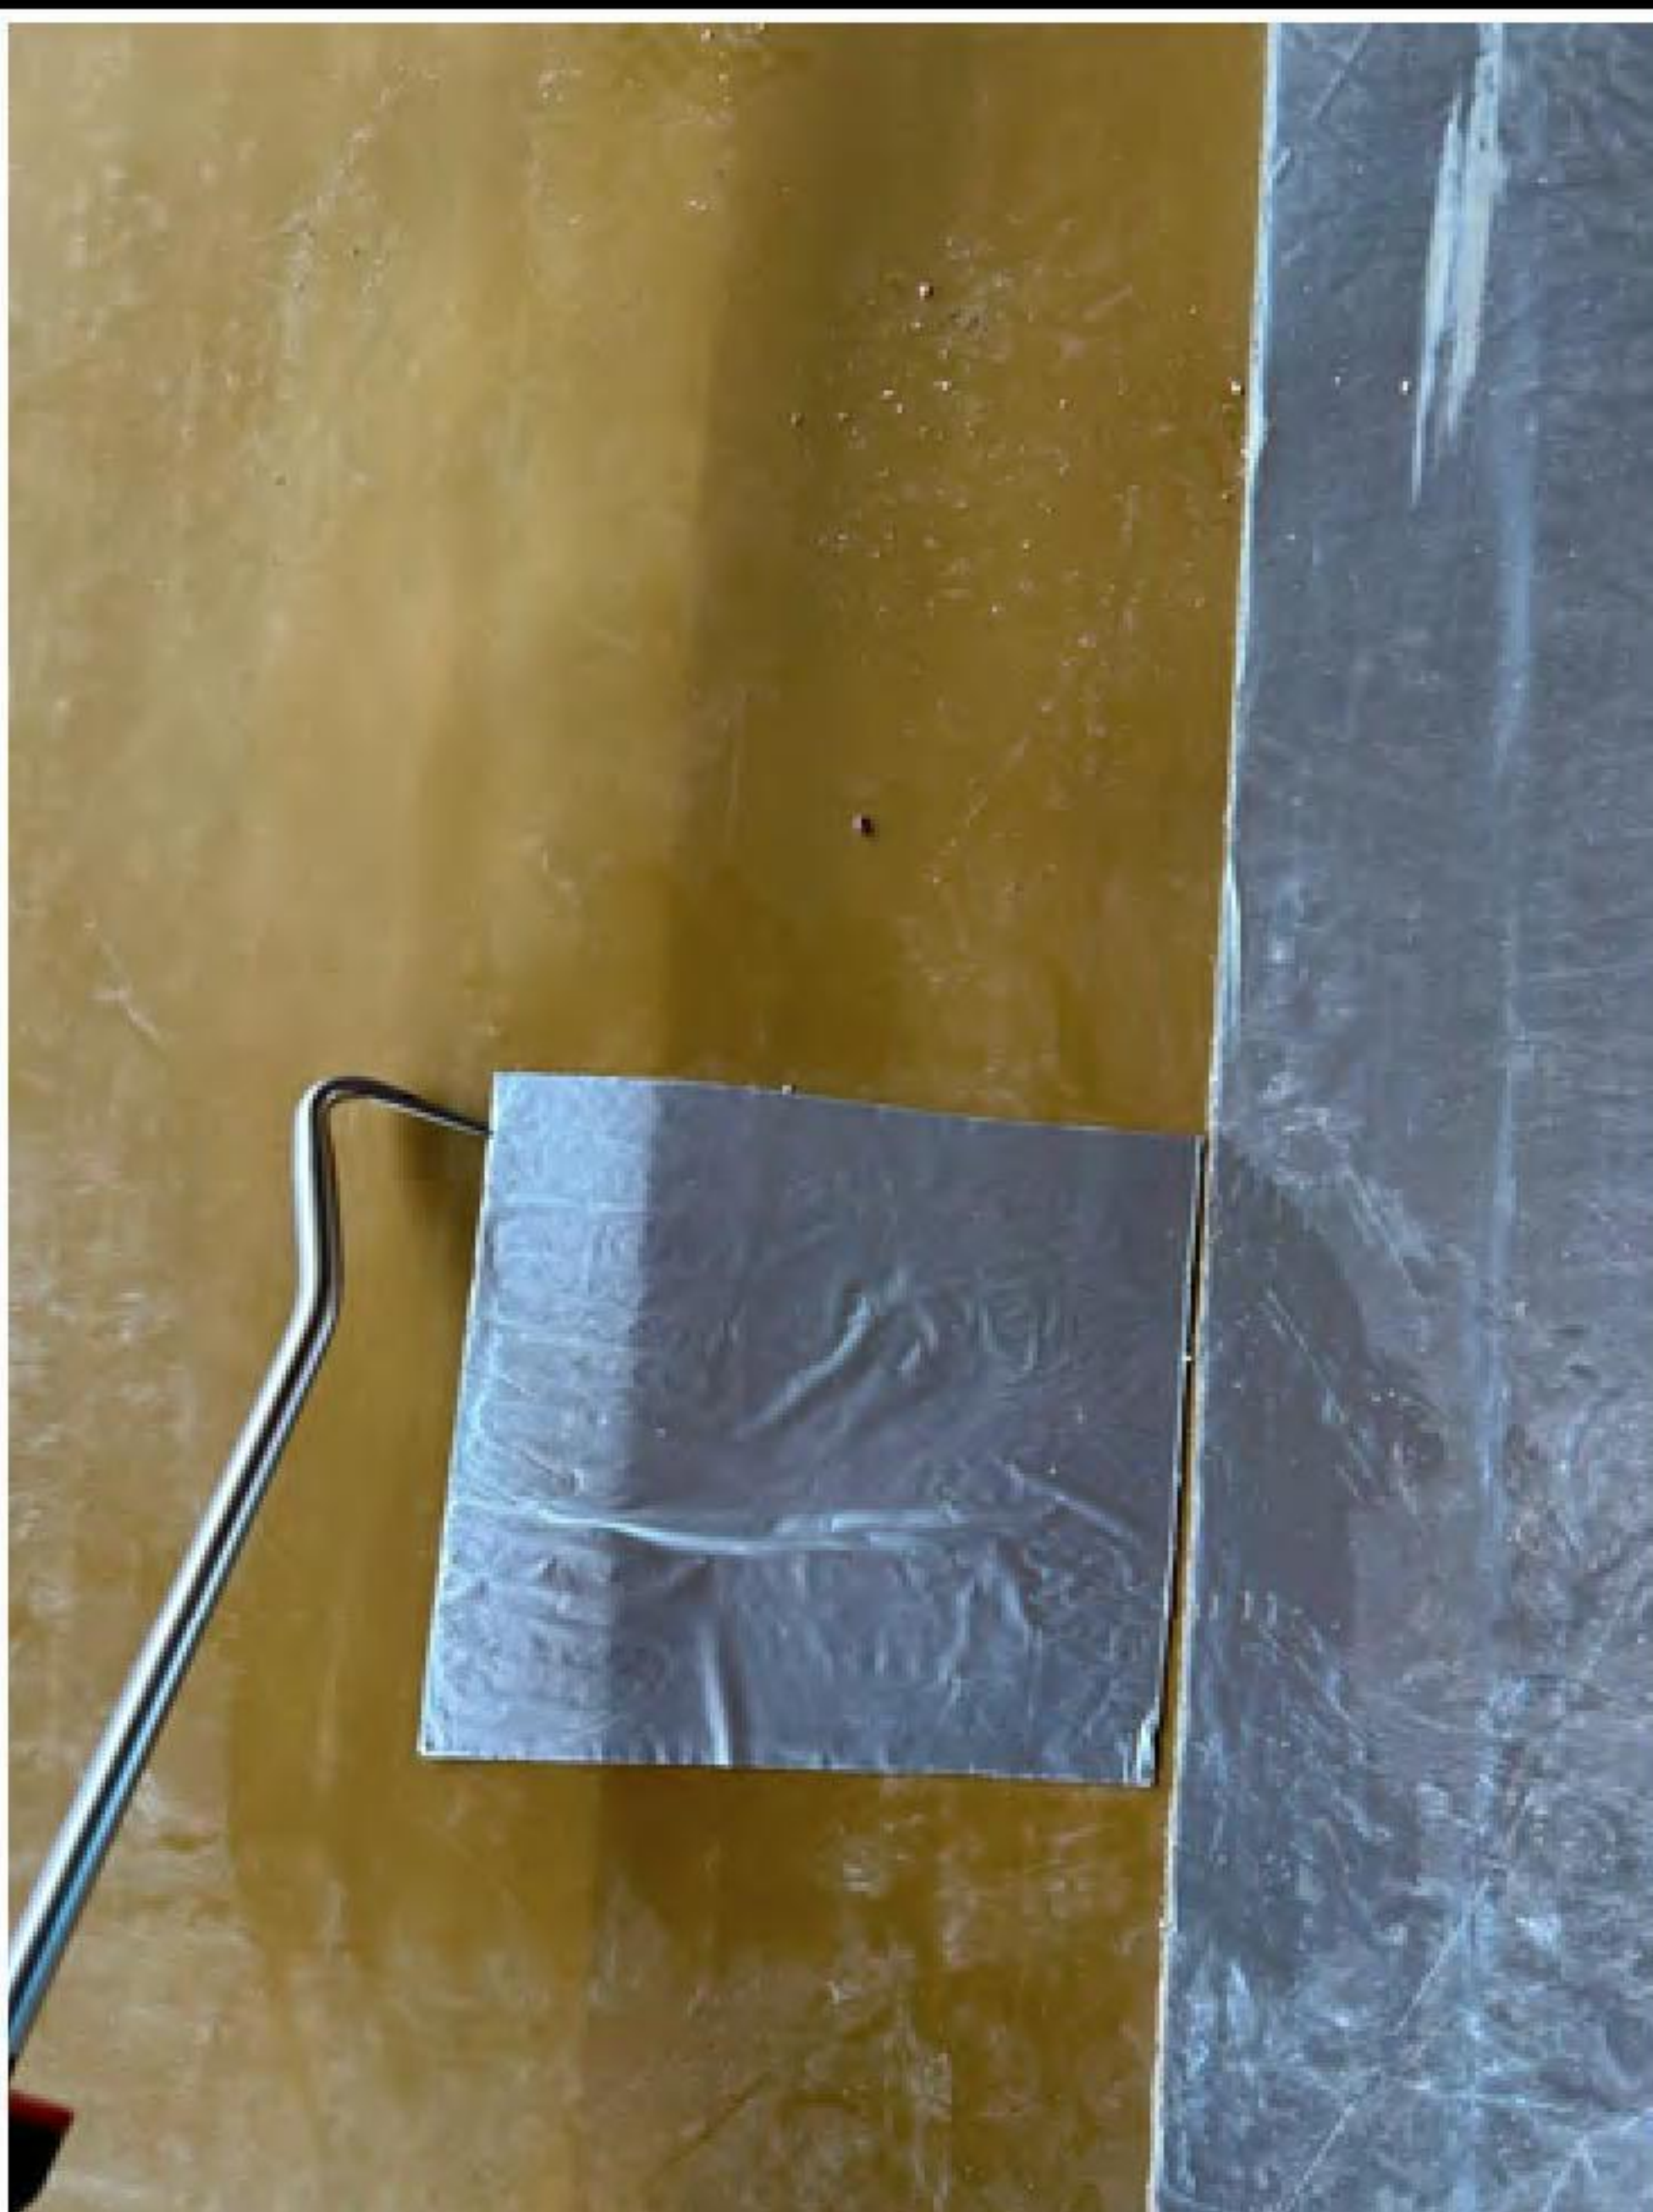
### Faults Identified & Remediated

As mentioned, two faults were identified during the testing procedures conducted upon all aspects of the installation. The faults were brought to the attention of the installers and remediated during the visit, in the presence of GeoShield.

The faults were remediated by applying 150mm patches of Visqueen Pro Detailing Strip over the affected areas with heat and rolled pressure applied to activate the bitumen backing. No further faults or defects were identified during the testing of the remedial work.

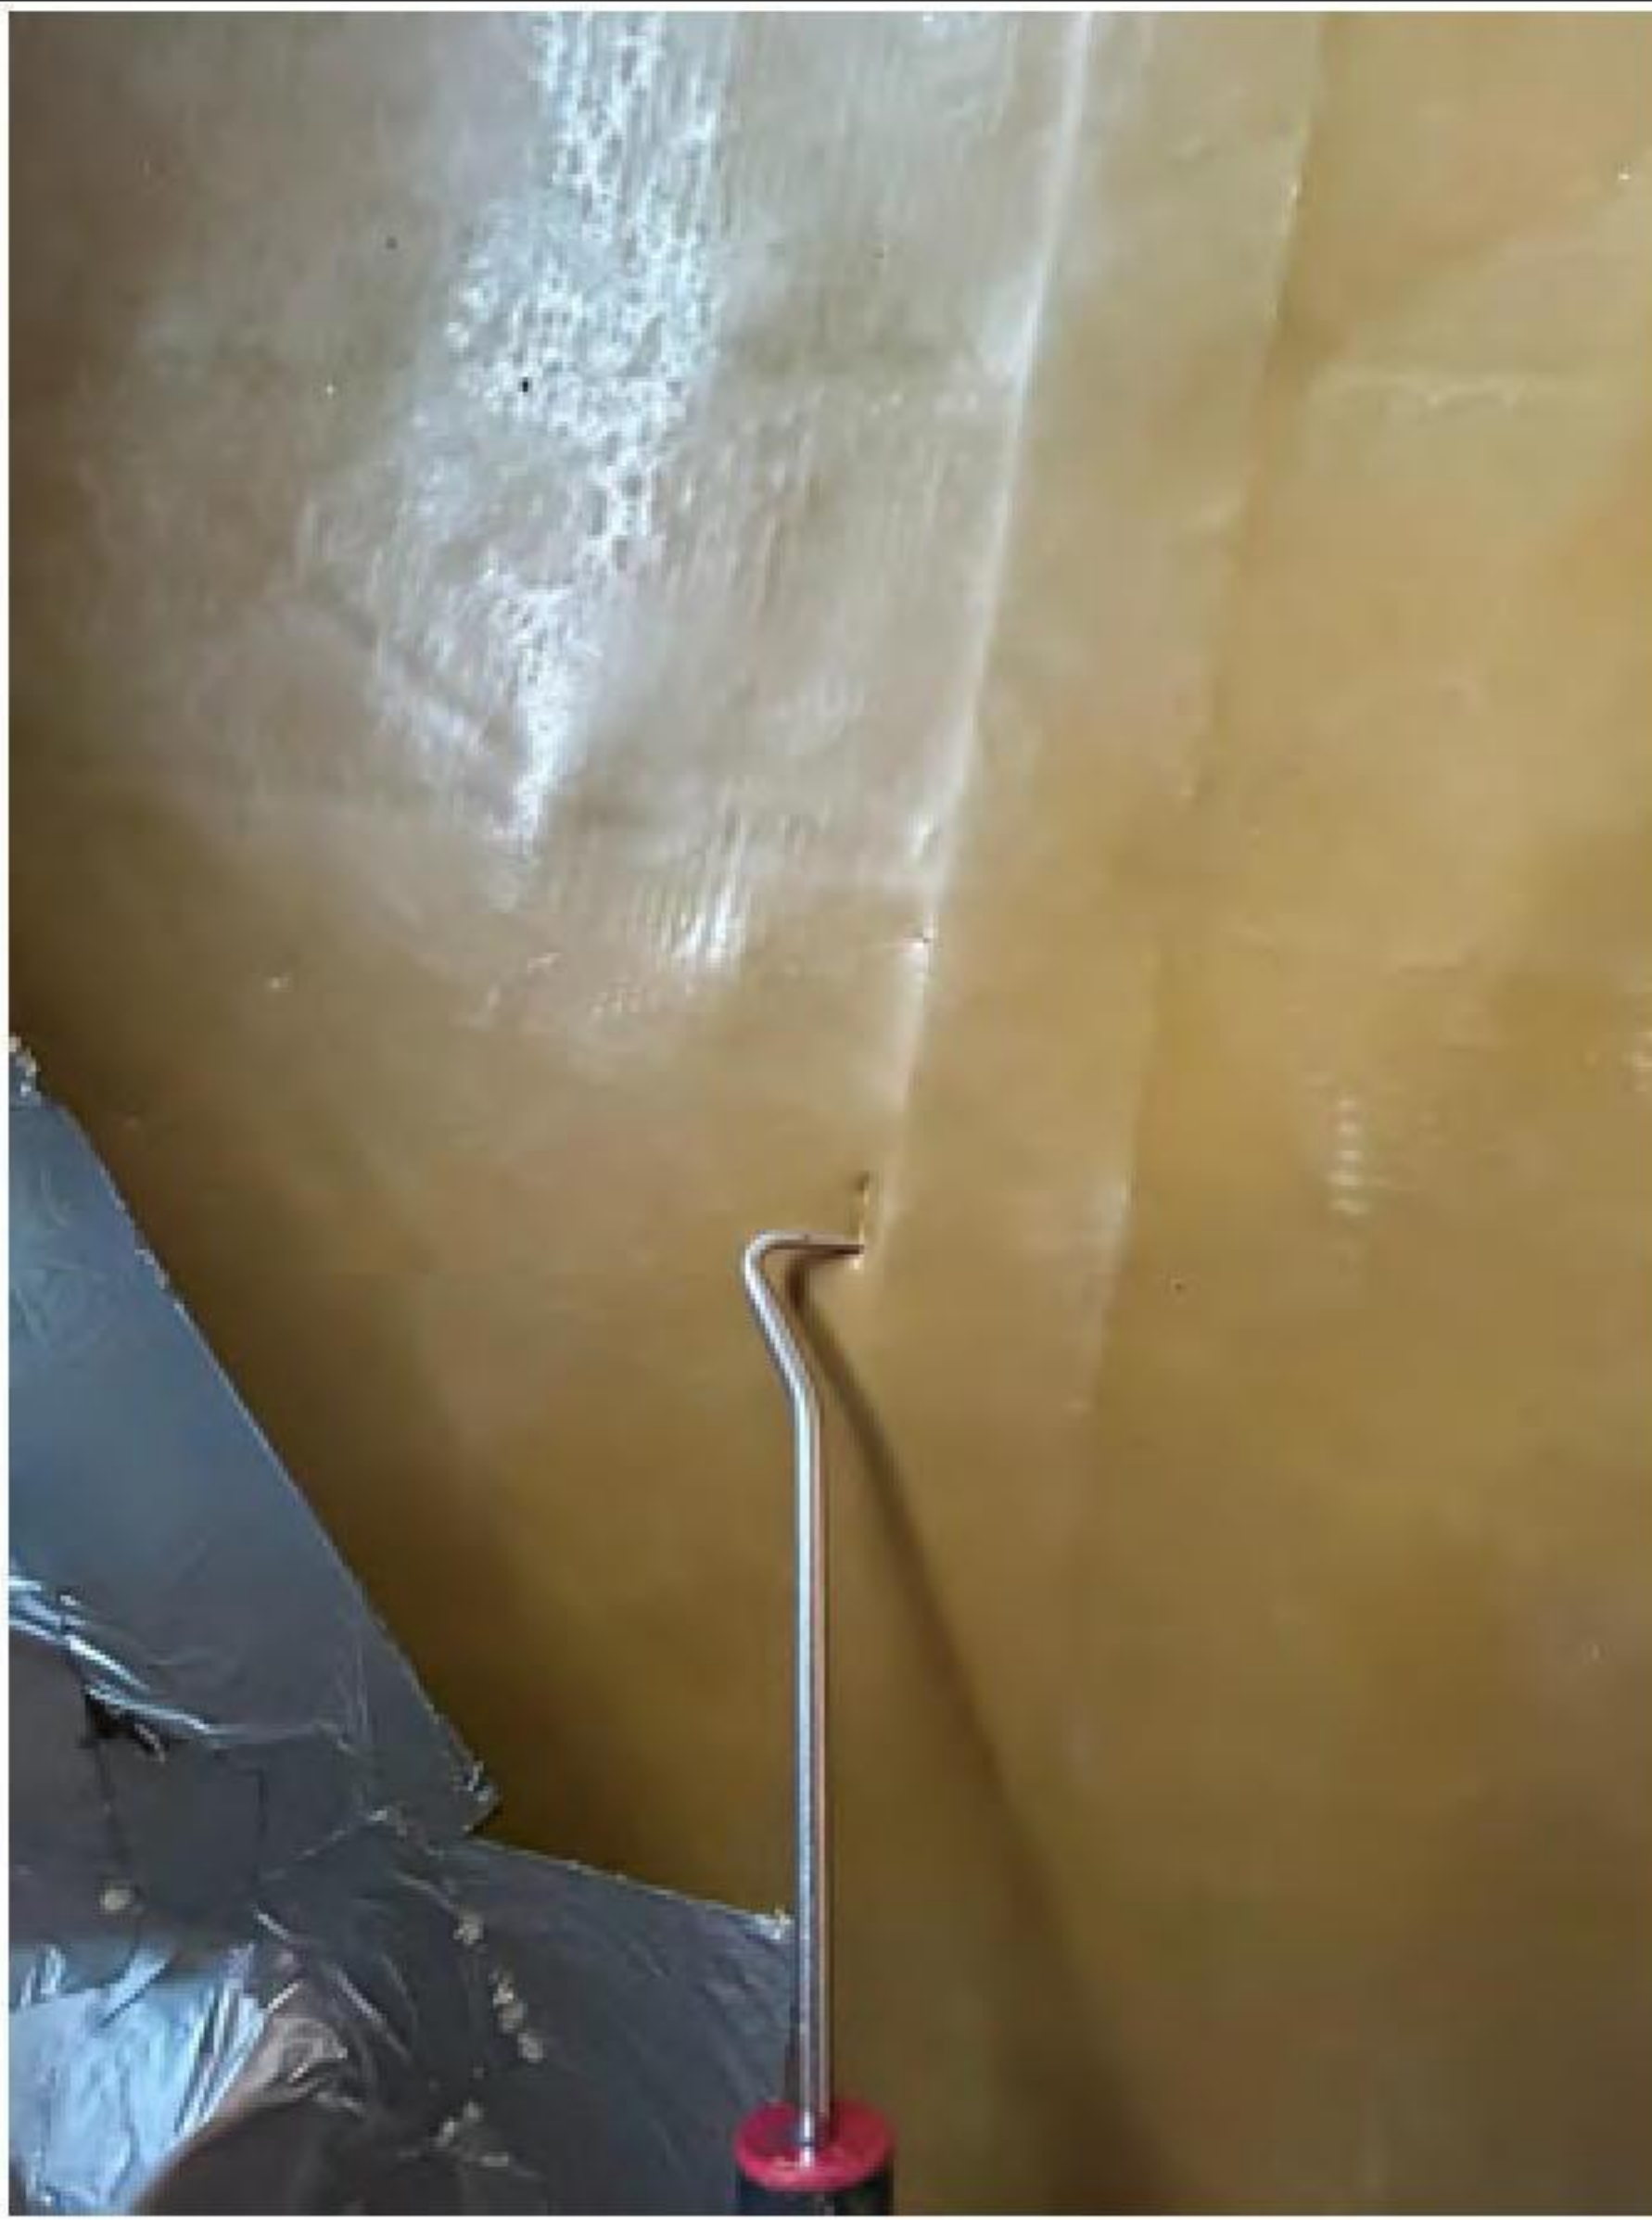
A fault identified.
