# GeoShield Verification Report 1

GEO104739

Land to Rear of 67 Sunte Avenue,  
Lindfield,  
Haywards Heath,  
RH16 2AB

The Old Yard, Plot - Infills

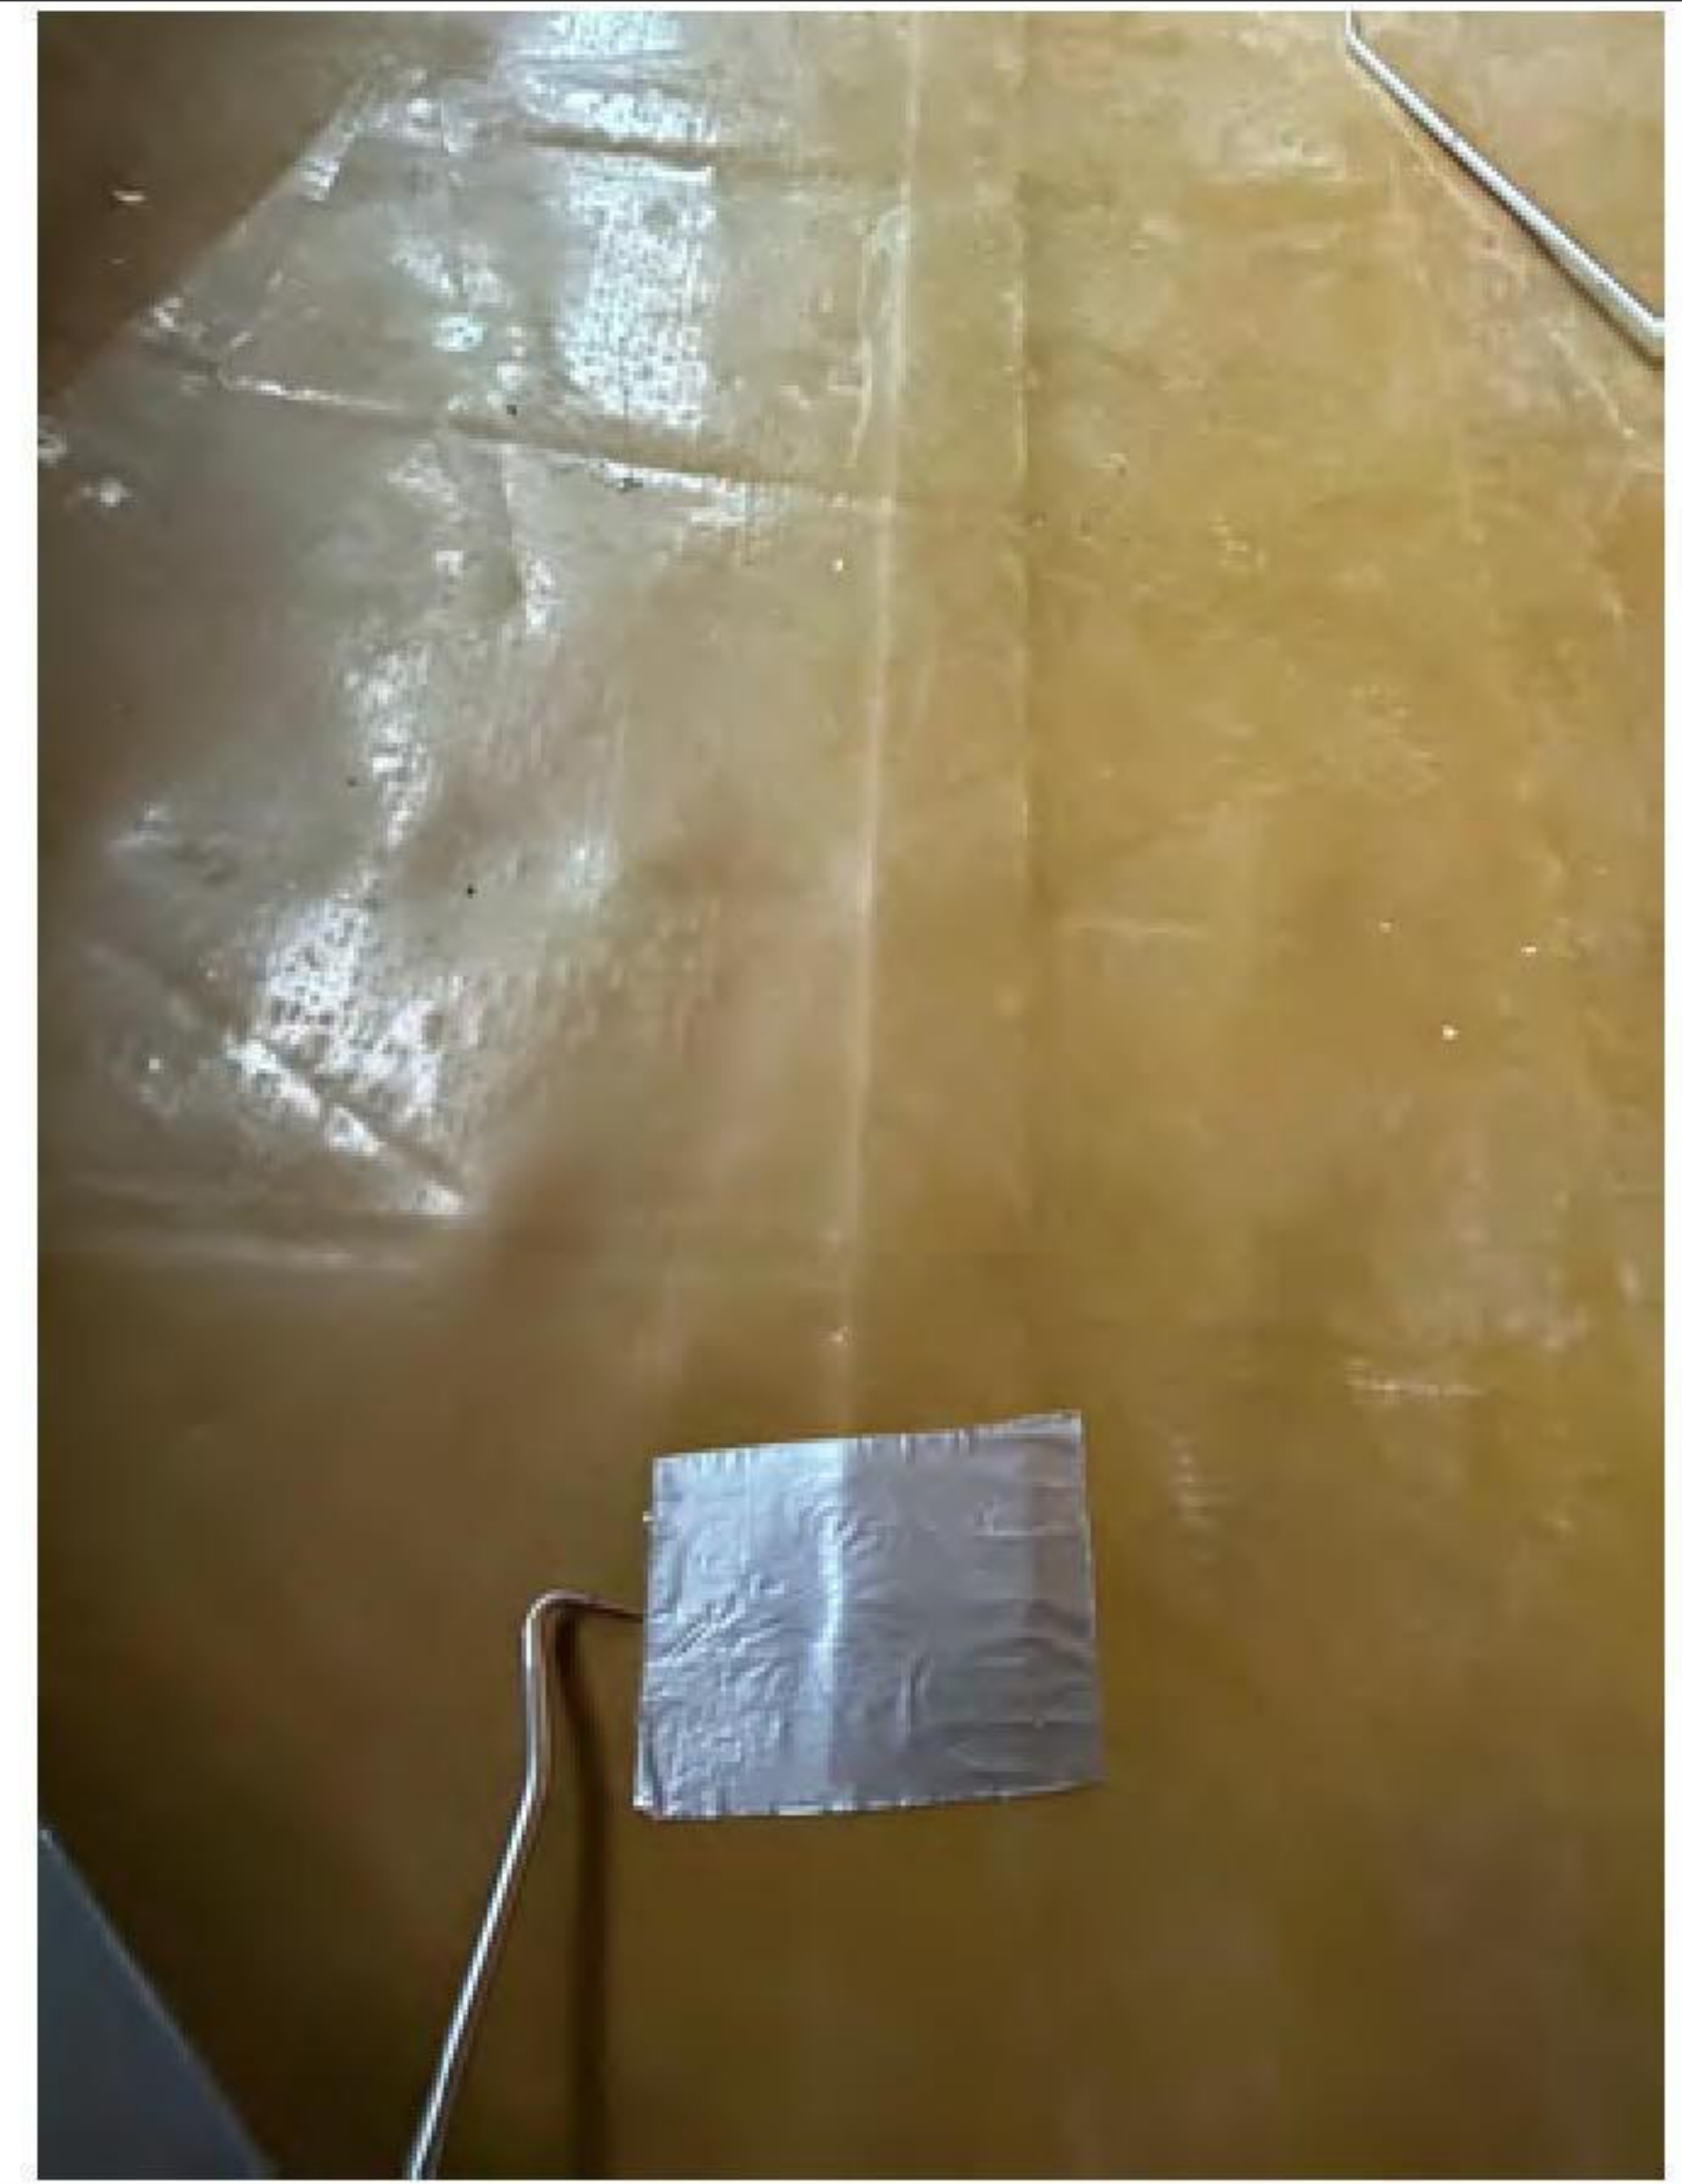
A mechanical point stress test being conducted upon the fault, remediated using Visqueen Pro Detailing Strip.

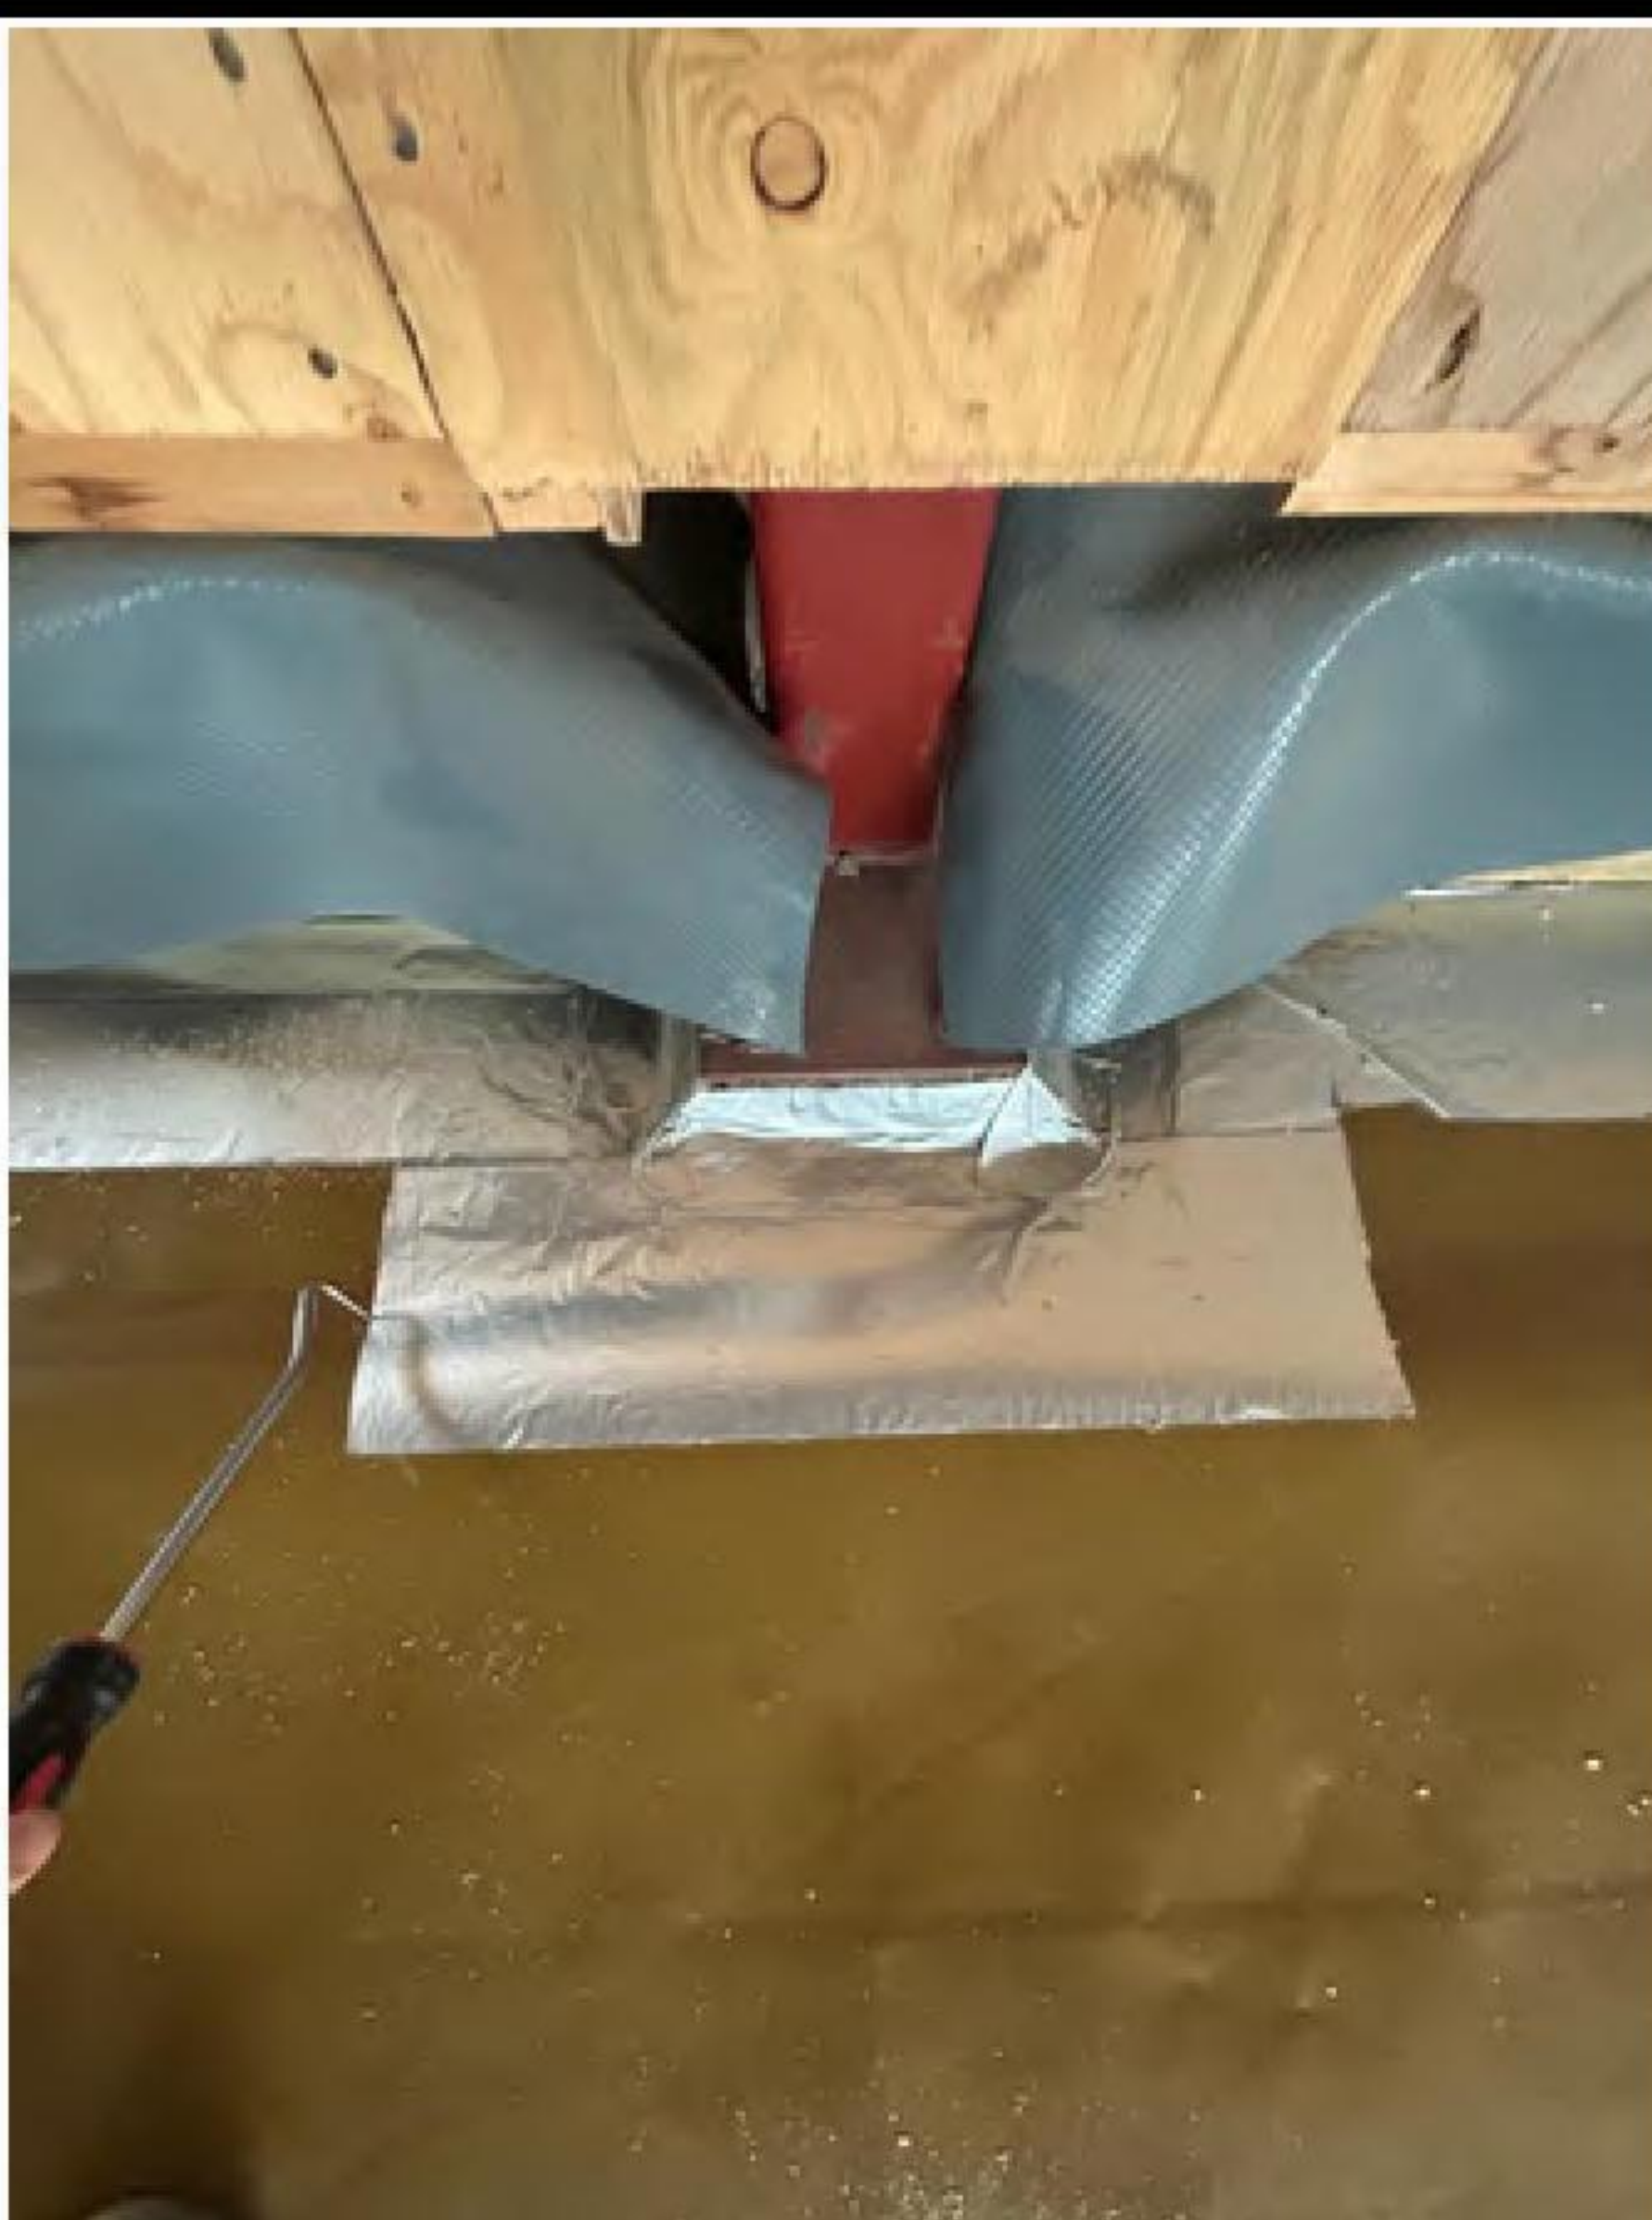
A mechanical point stress test being conducted upon a column, sealed with Visqueen Pro Detailing Strip.

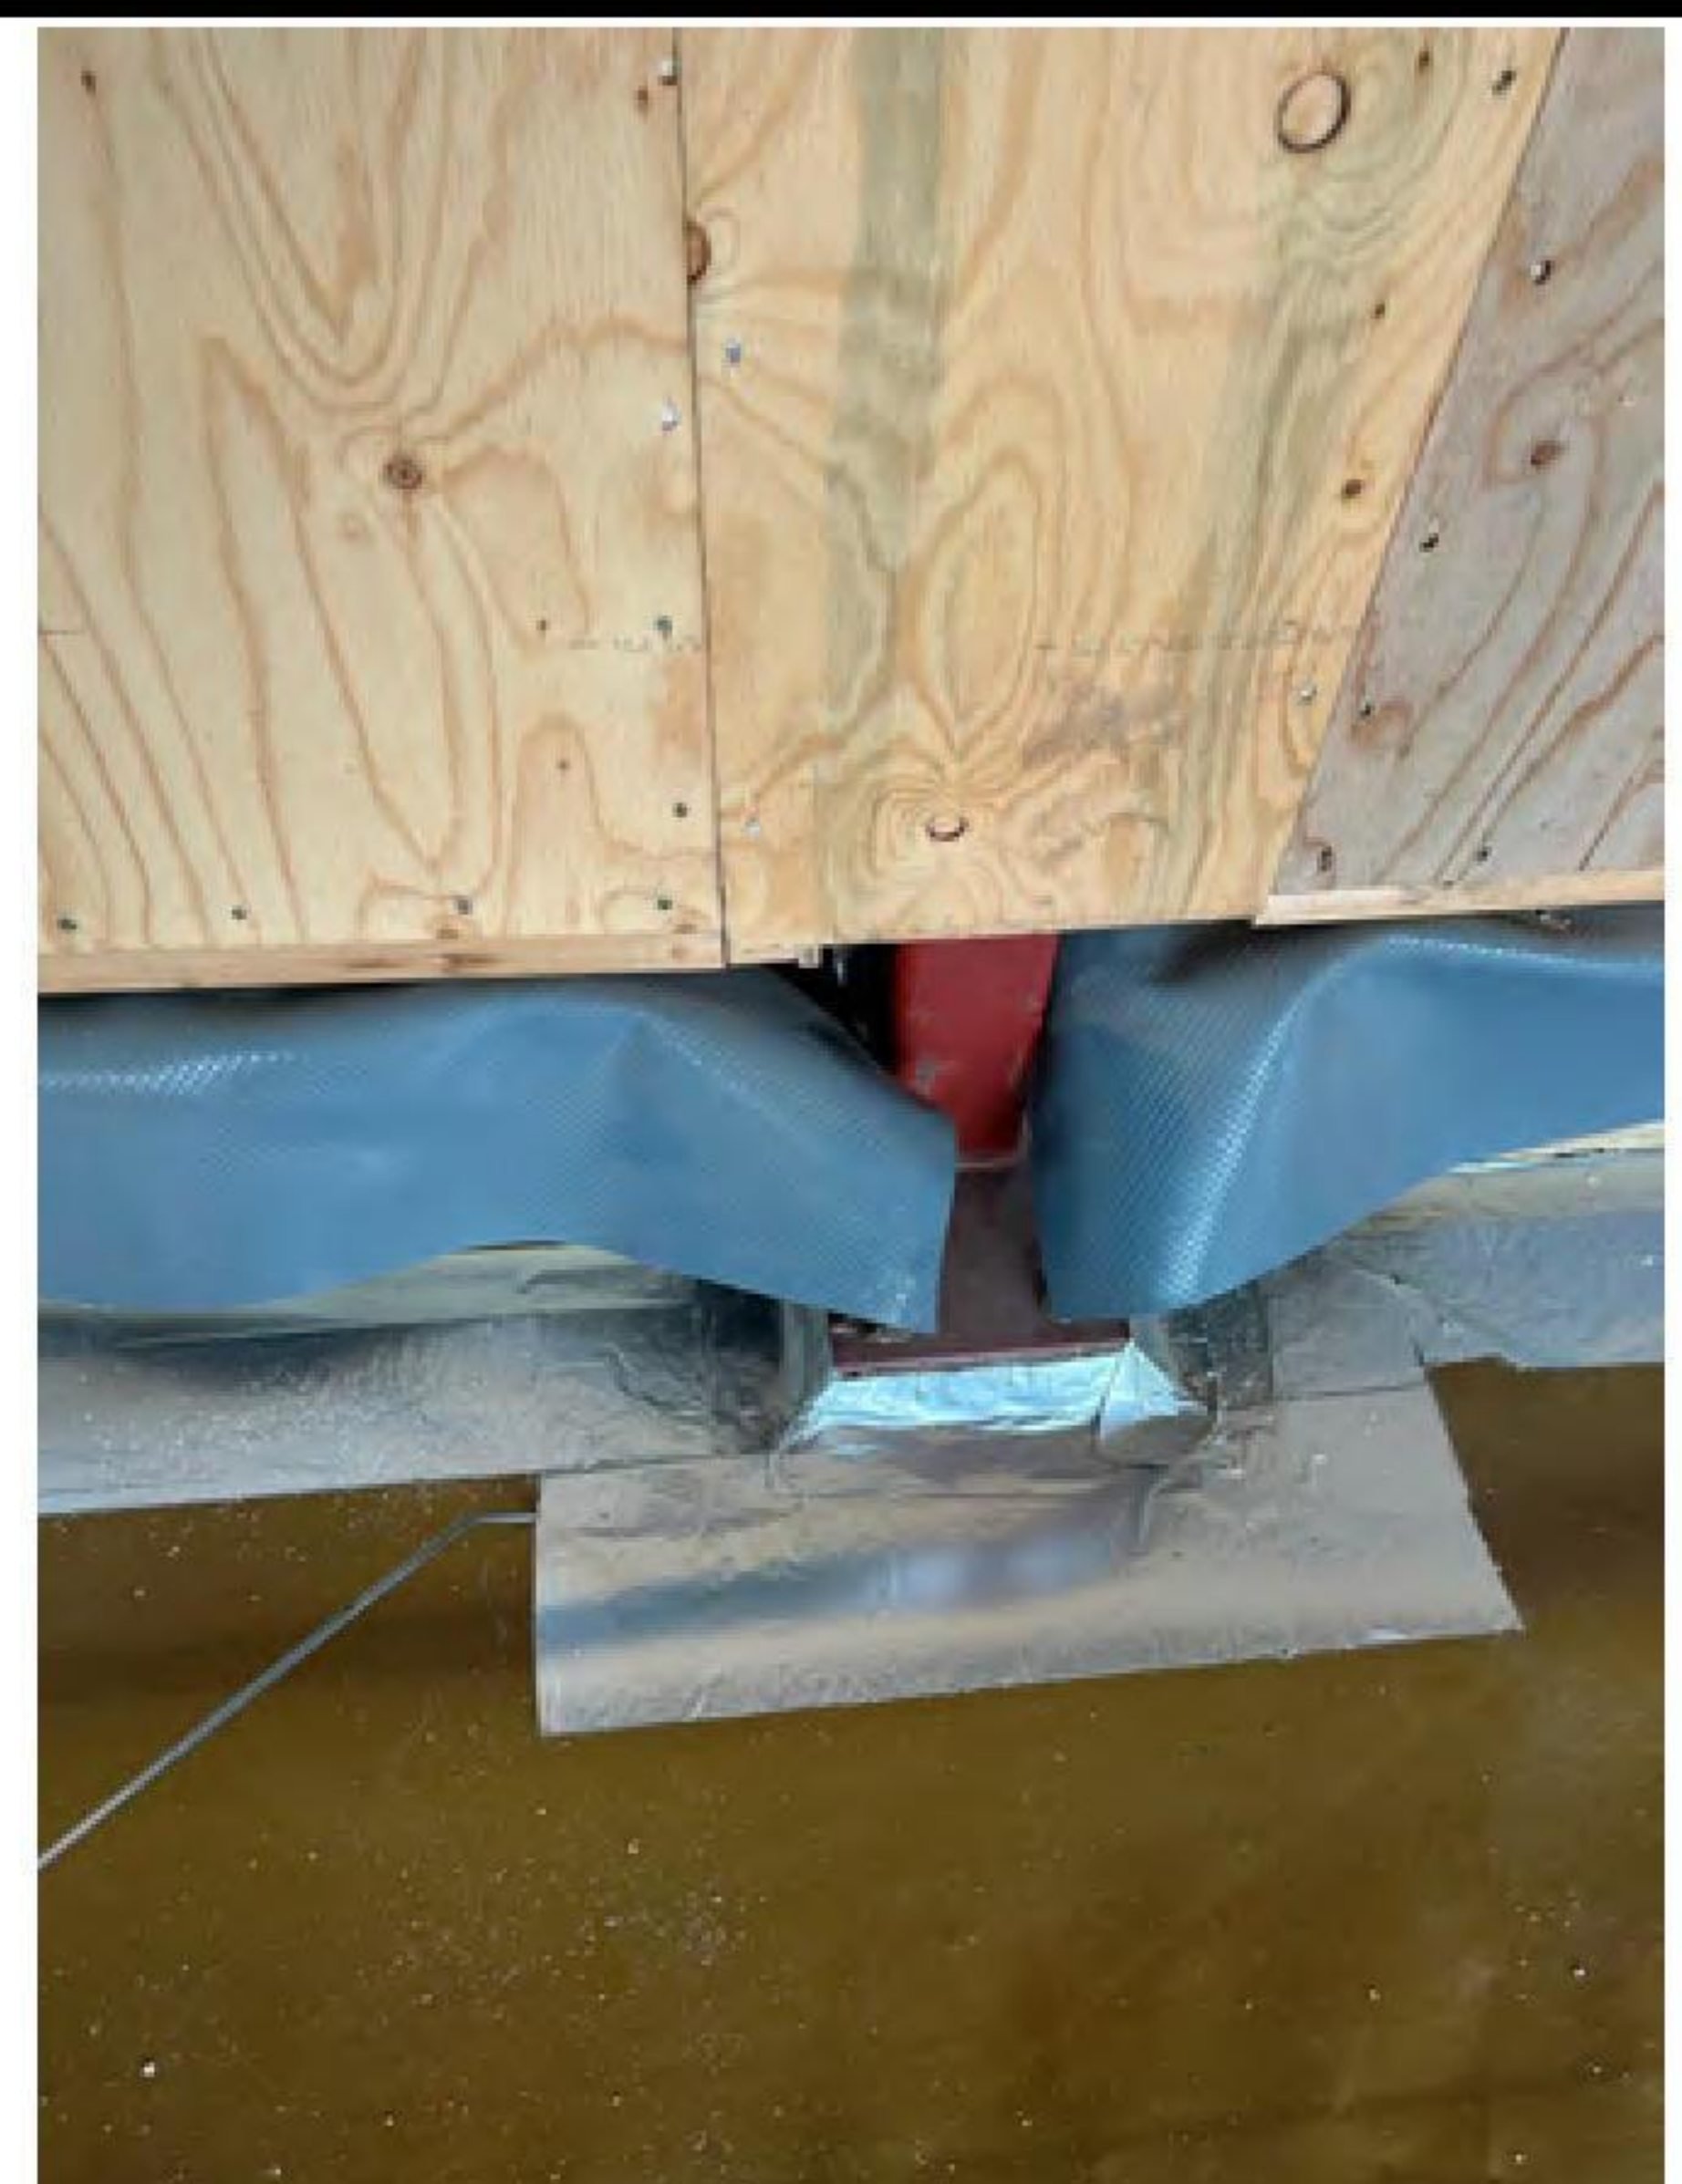
A non destructive air lance integrity test being conducted upon a column, sealed with Visqueen Pro Detailing Strip.

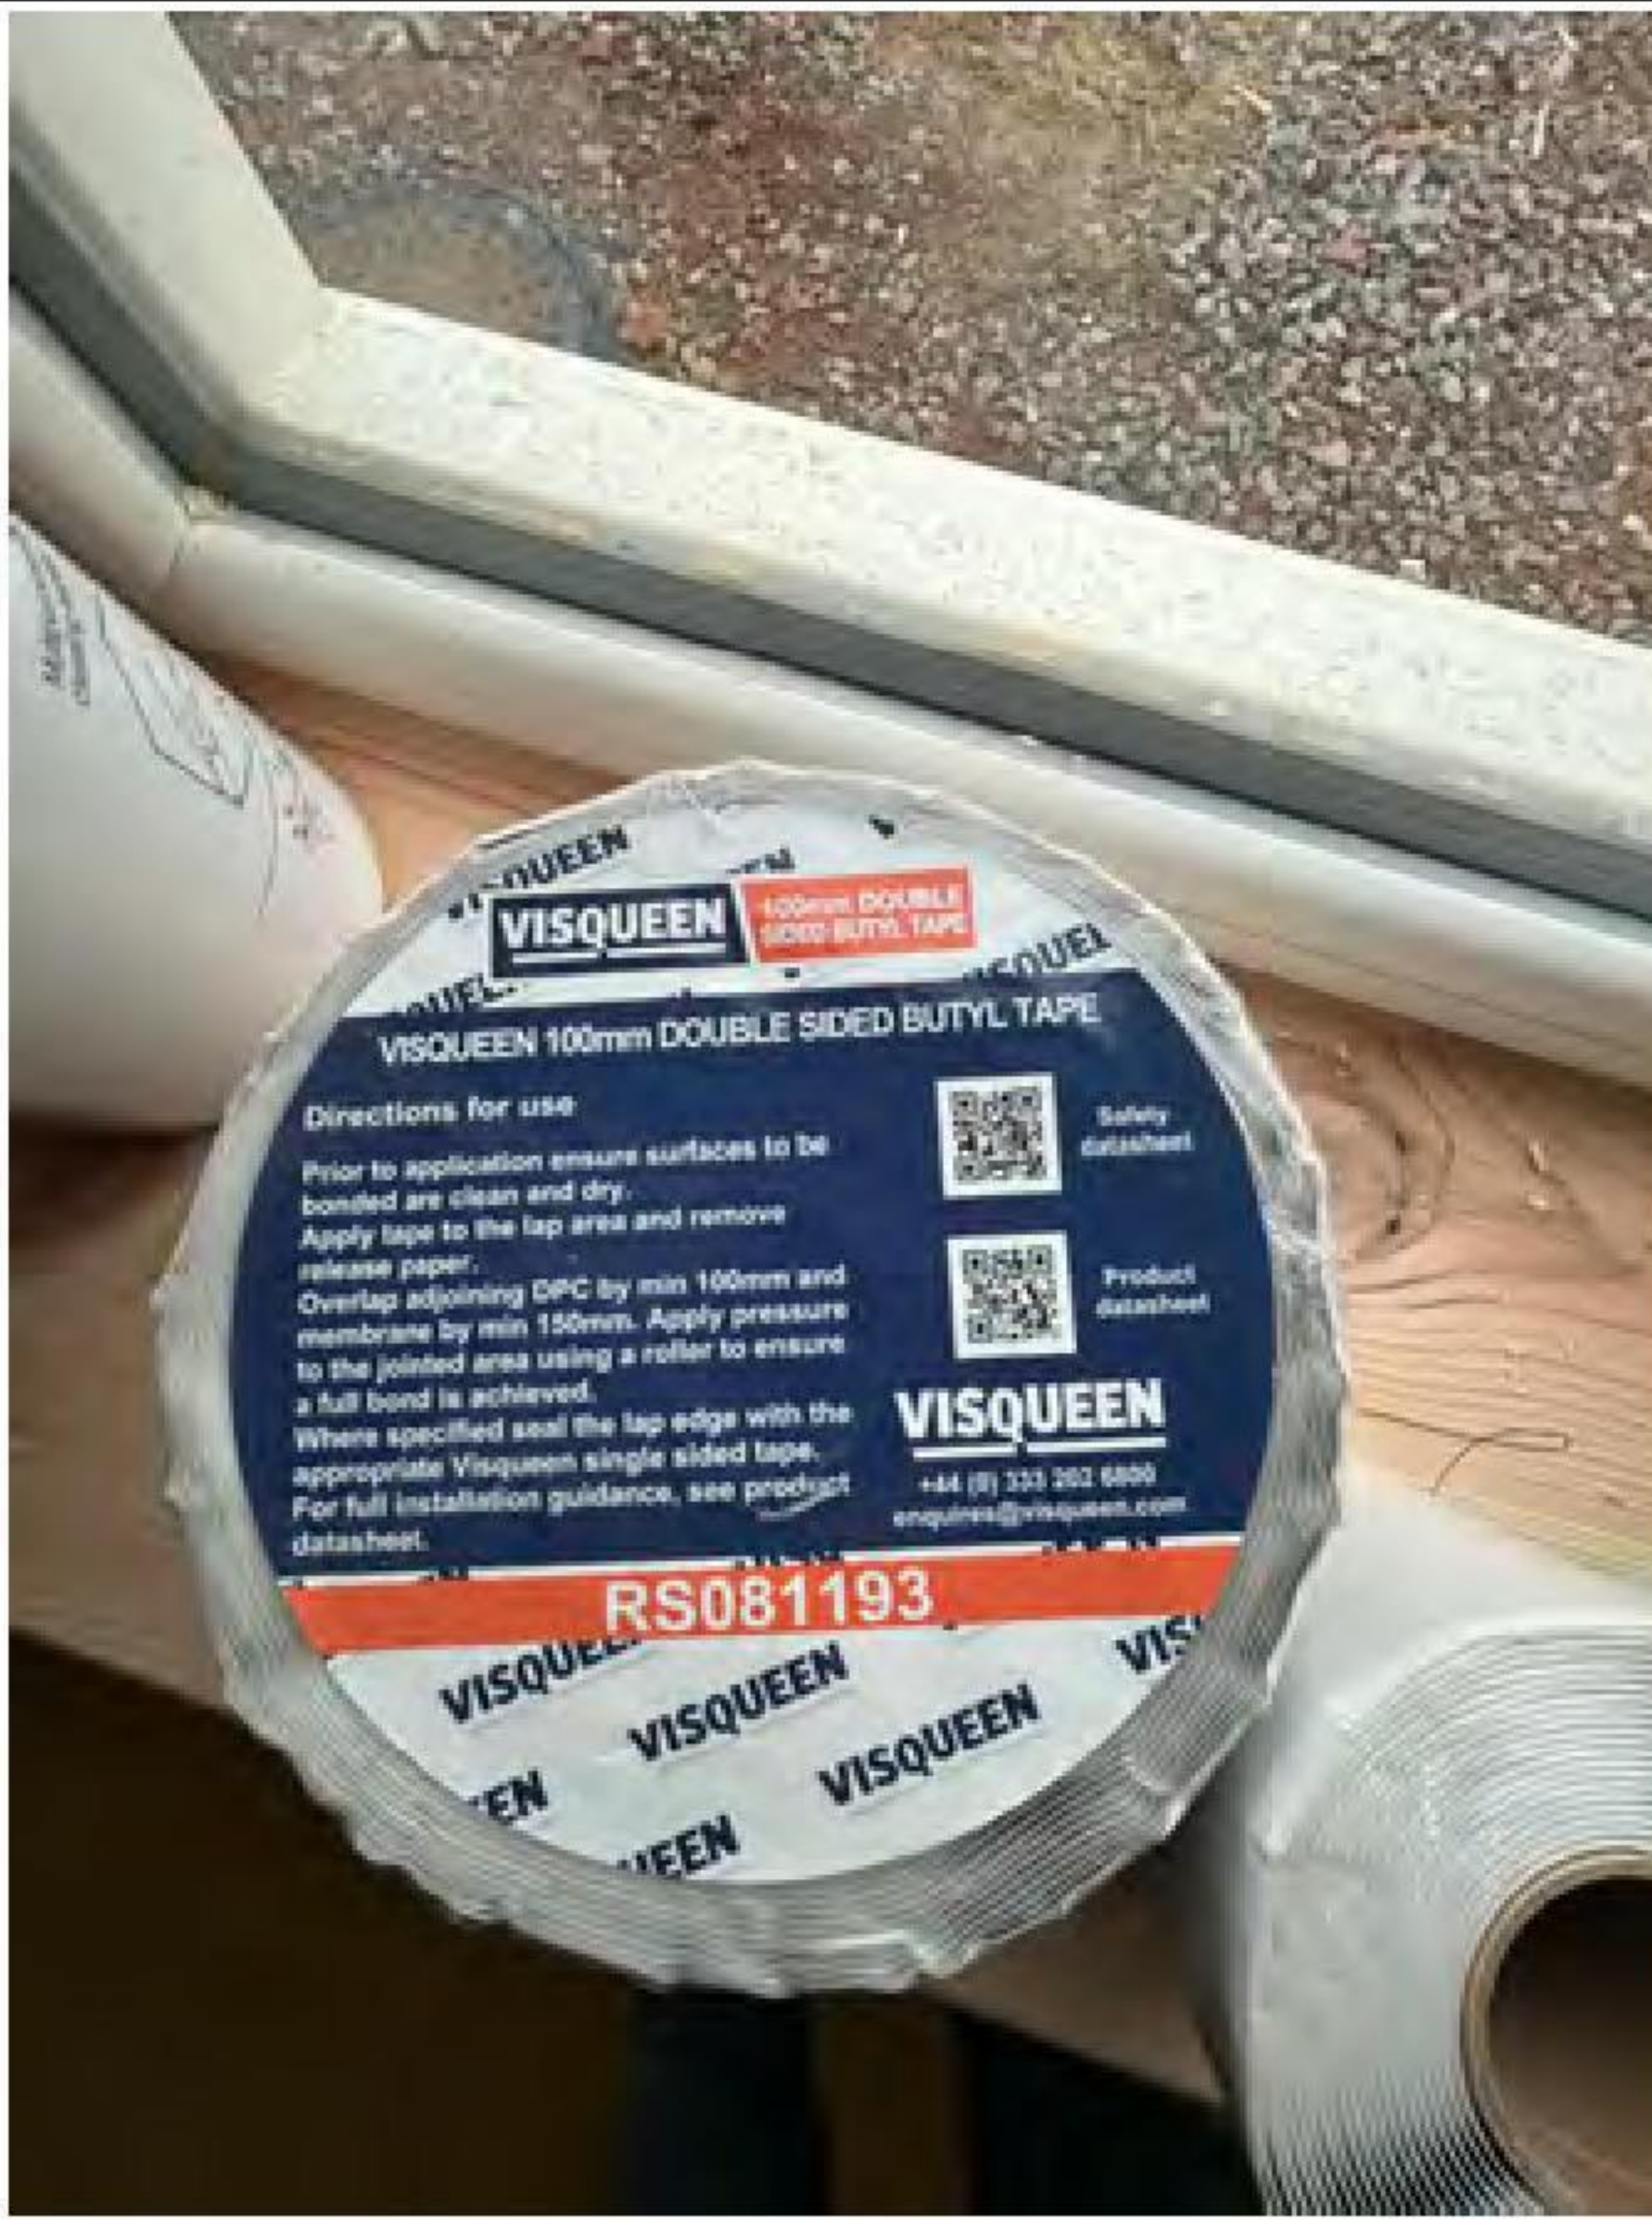
The Visqueen Double Sided Butyl Tape used throughout the installation.

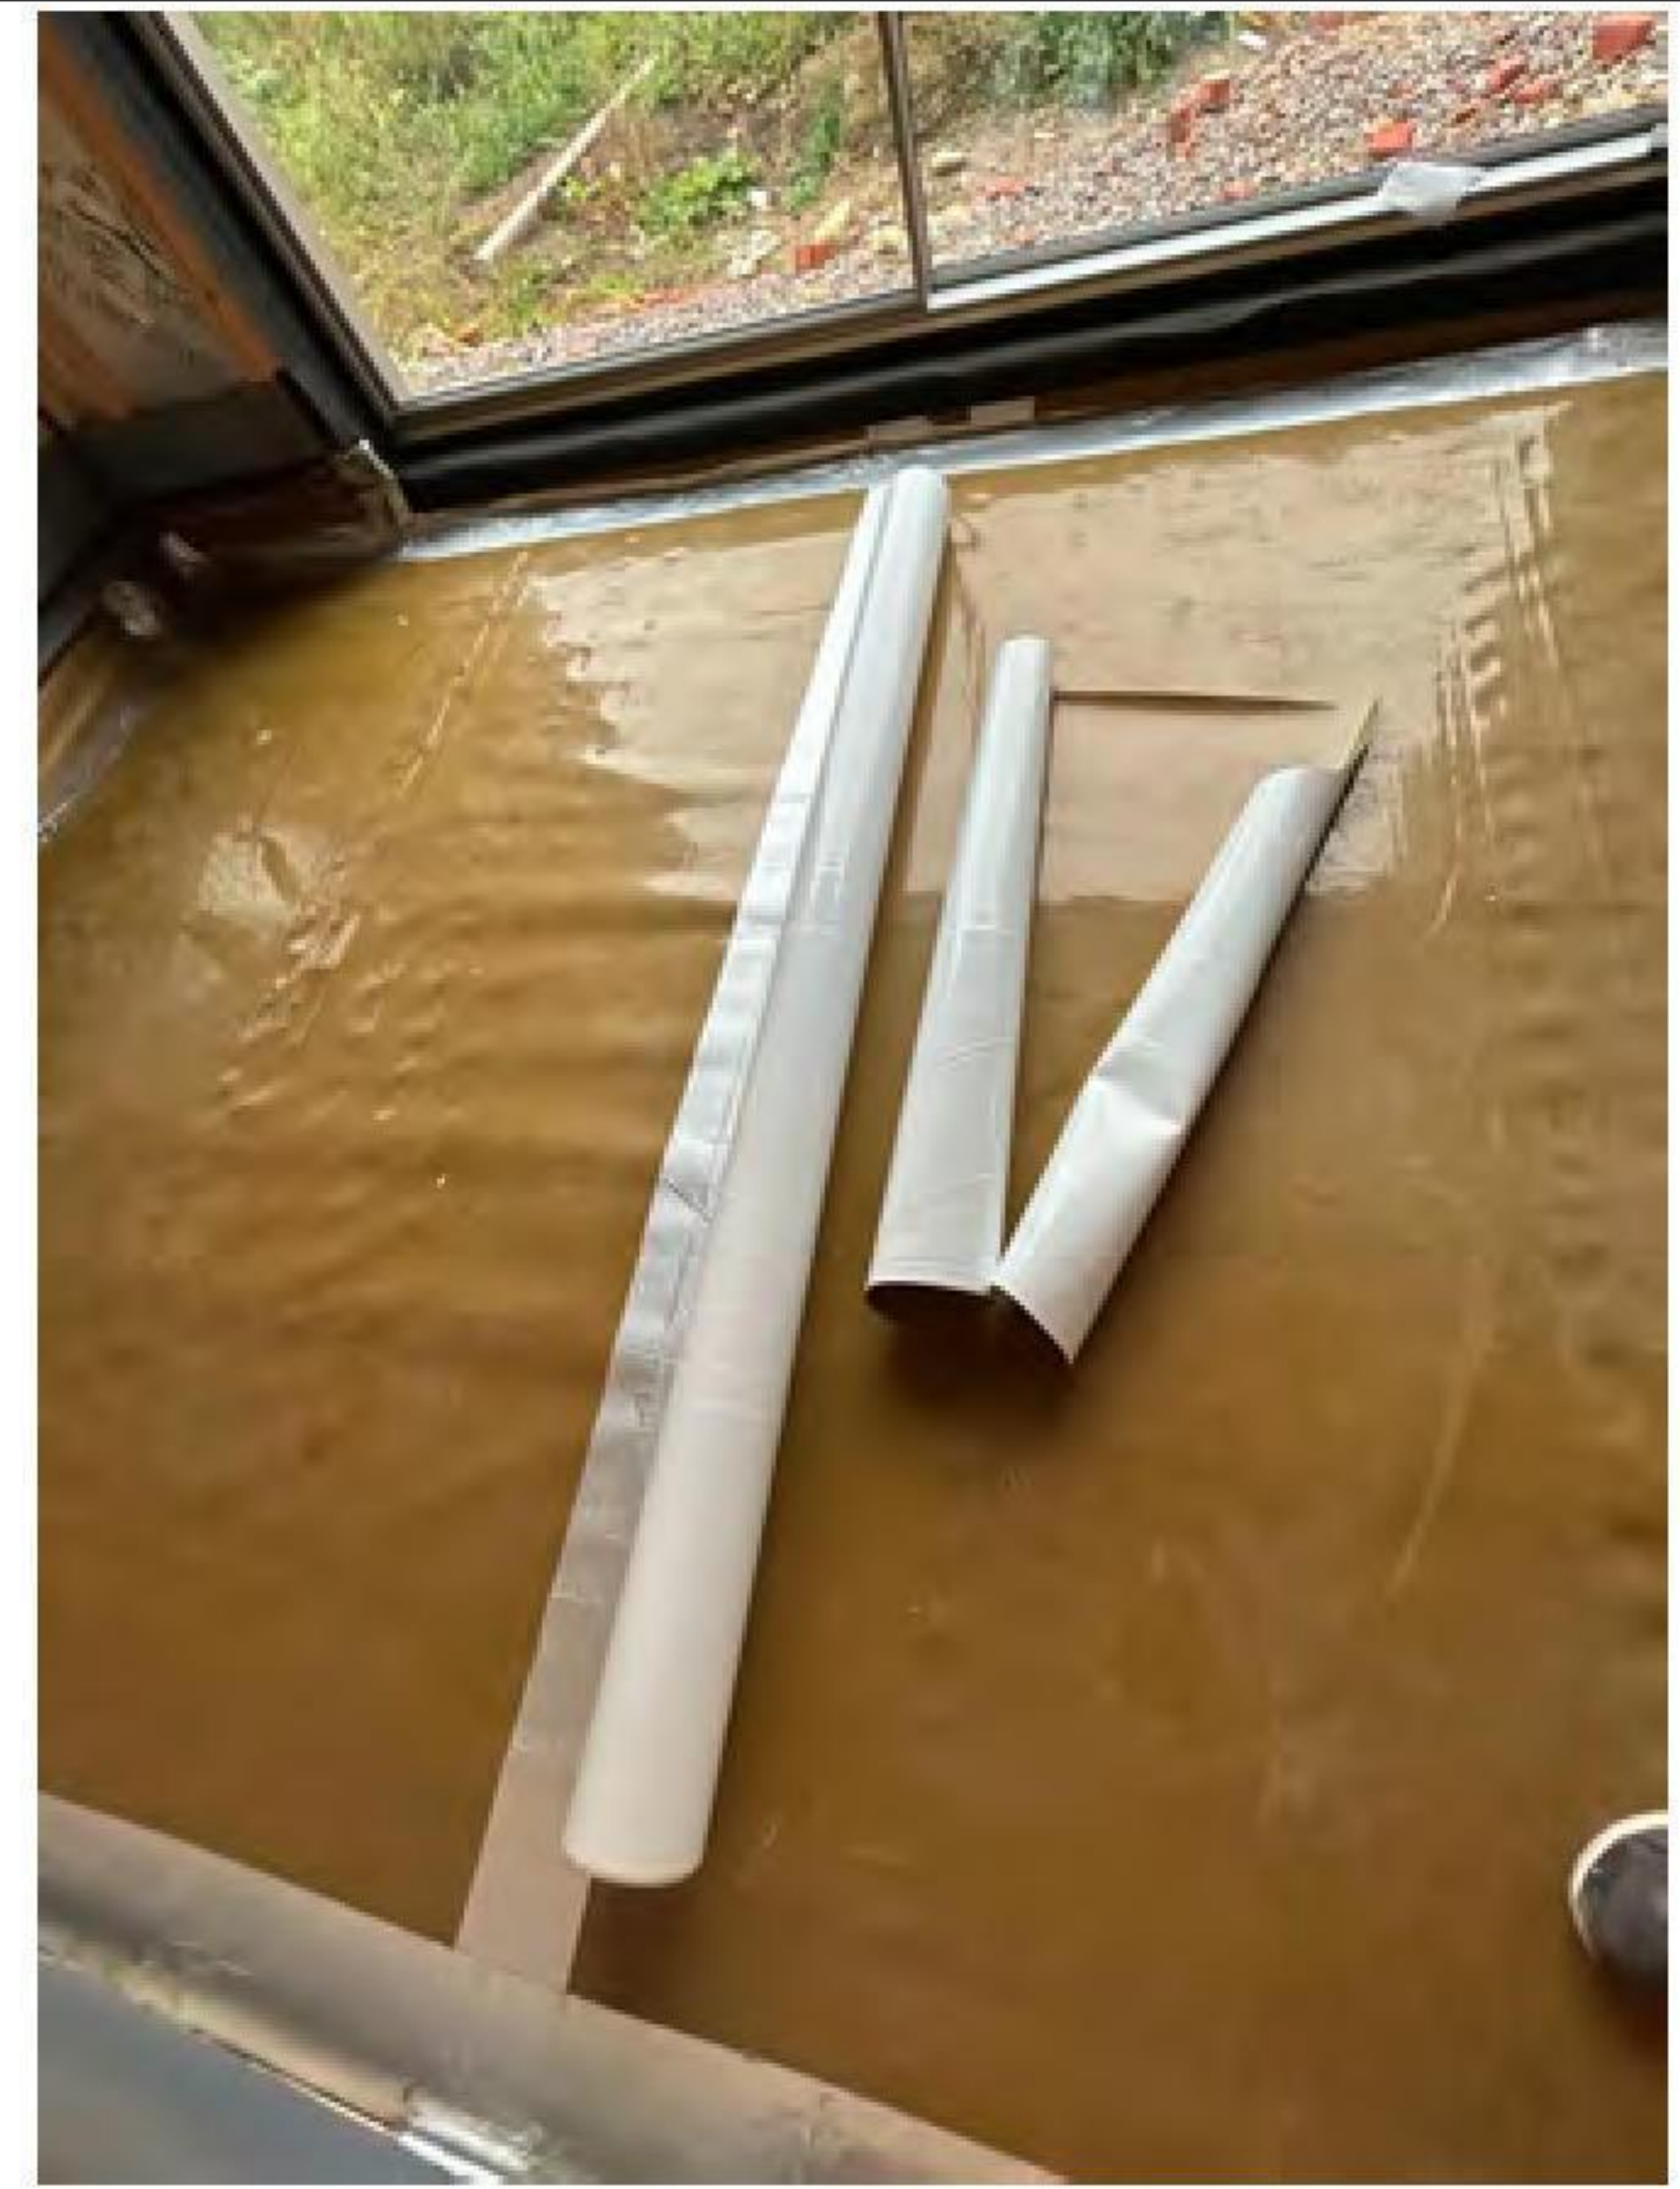
The membrane used.

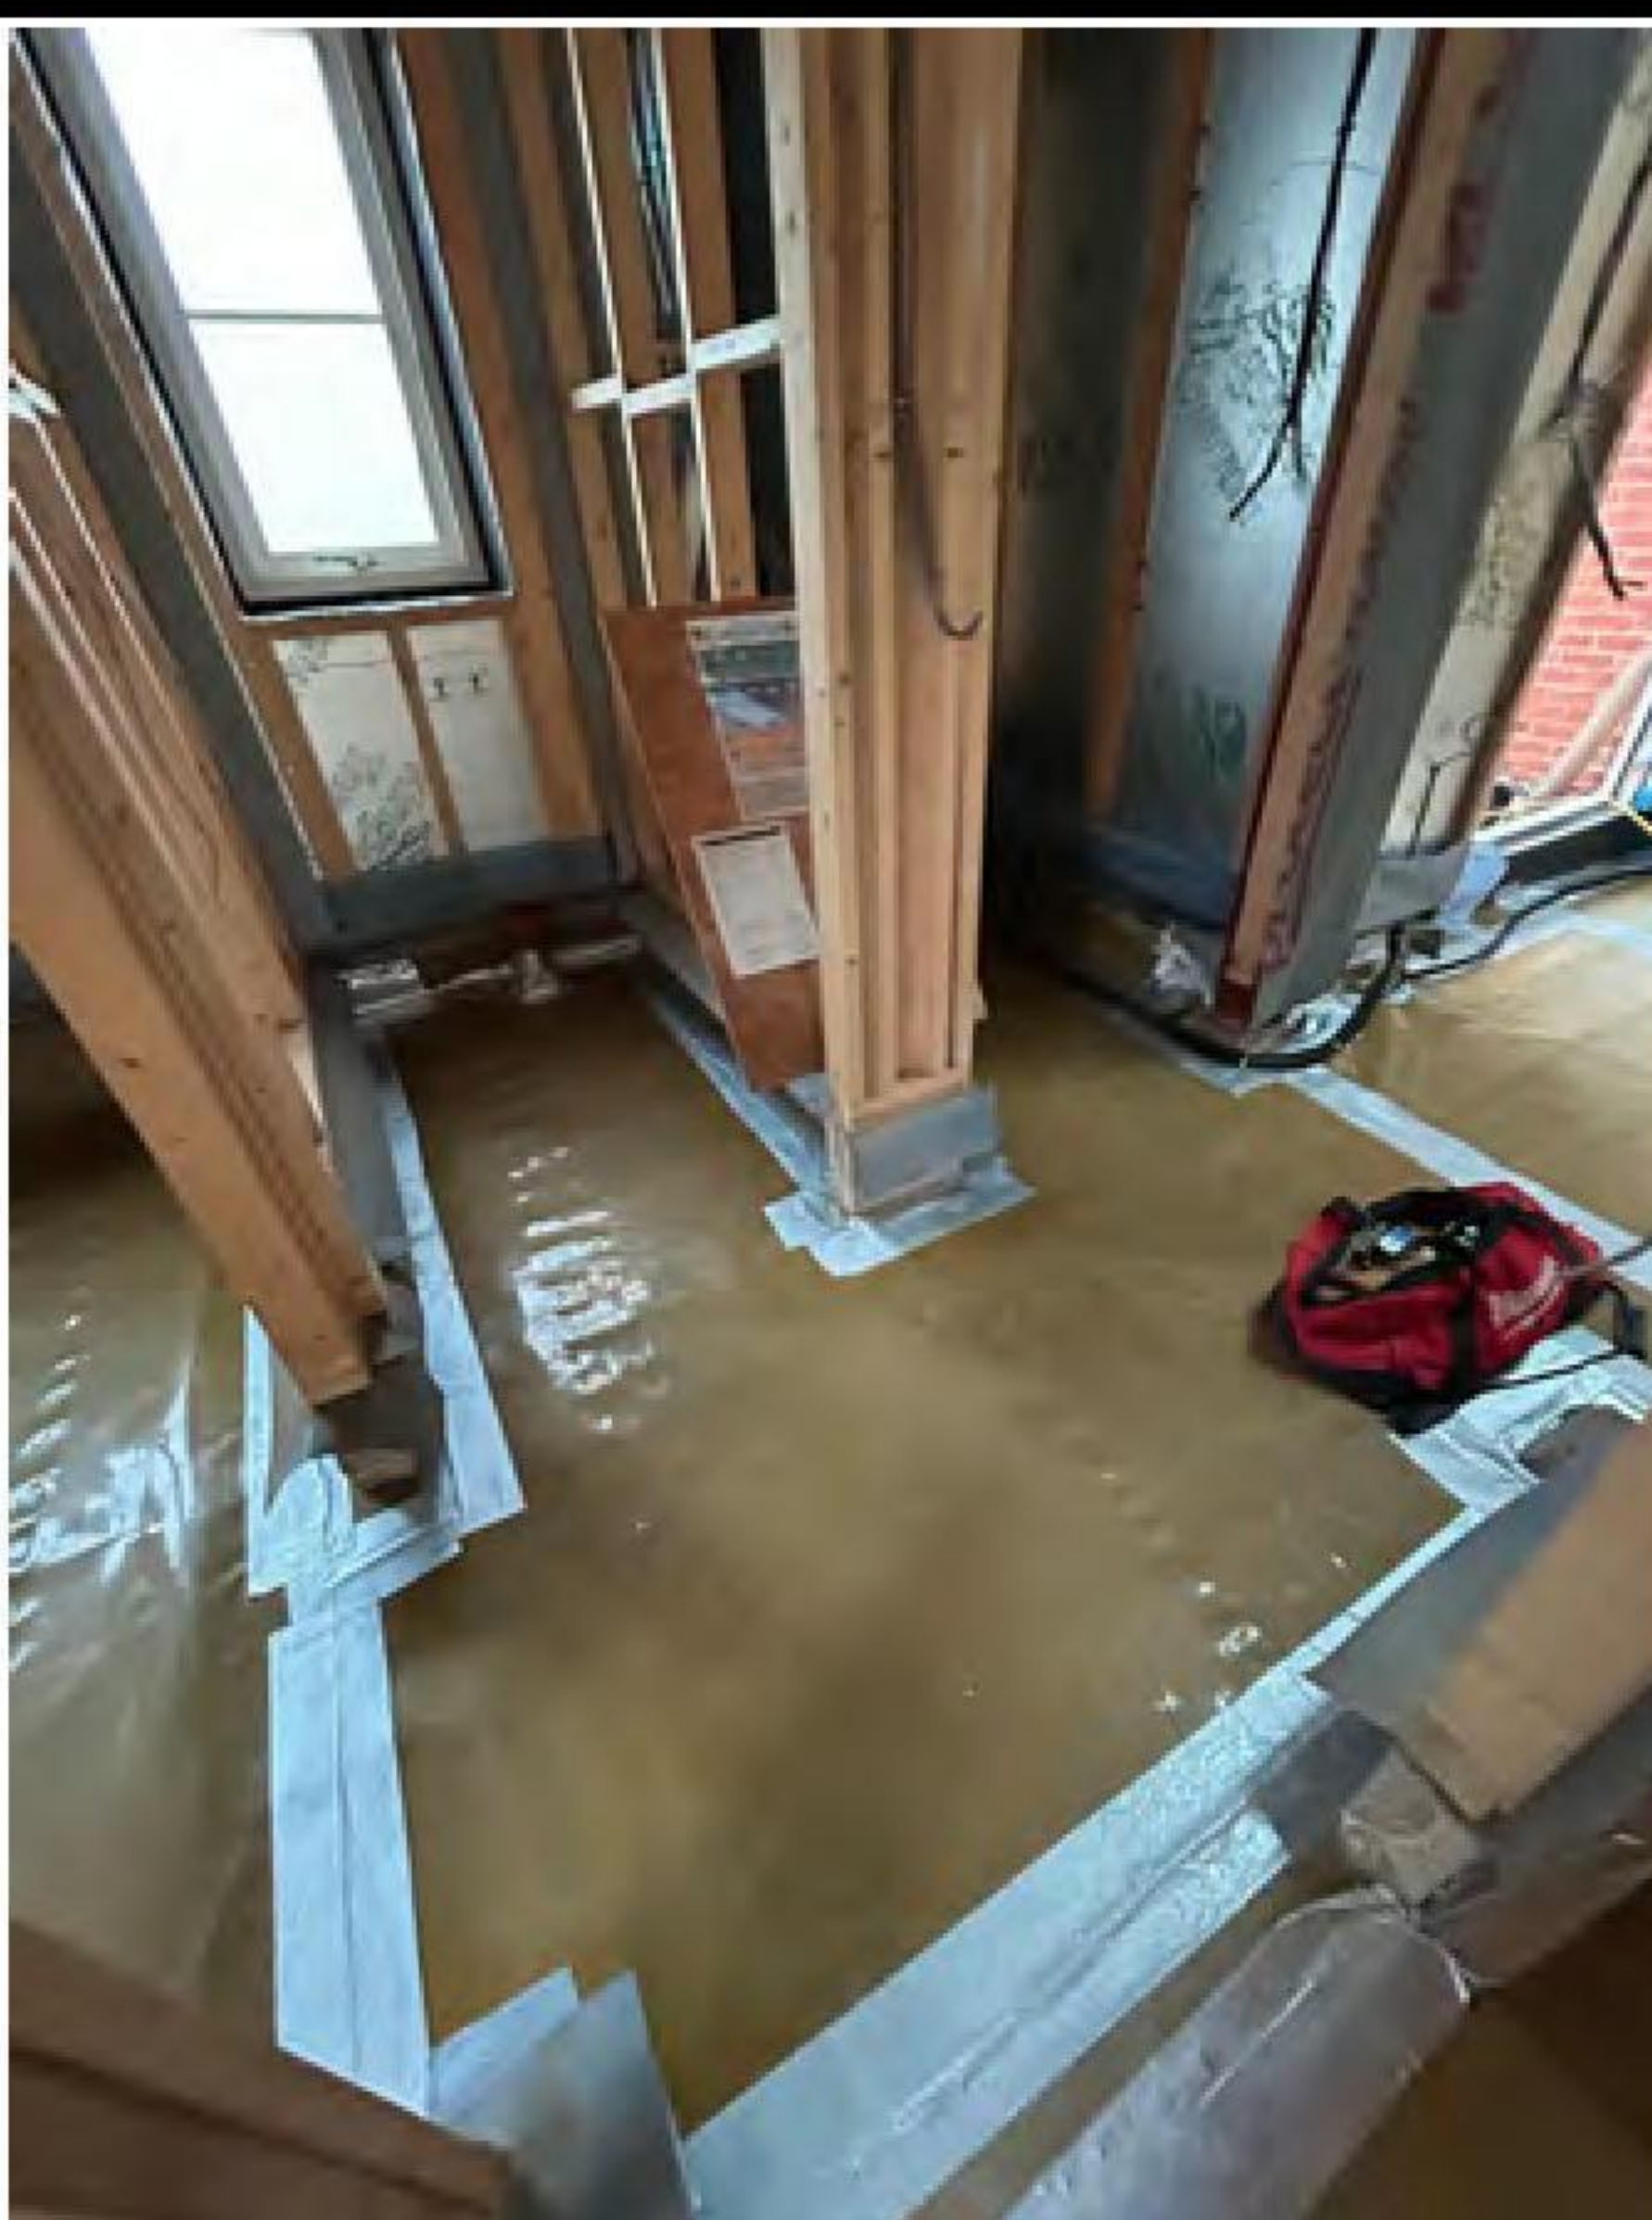
An overview of the infill installation to one of the rooms.
