# GeoShield Verification Report 1

GEO104739

Land to Rear of 67 Sunte Avenue,  
Lindfield,  
Haywards Heath,  
RH16 2AB

The Old Yard, Plot - Infills

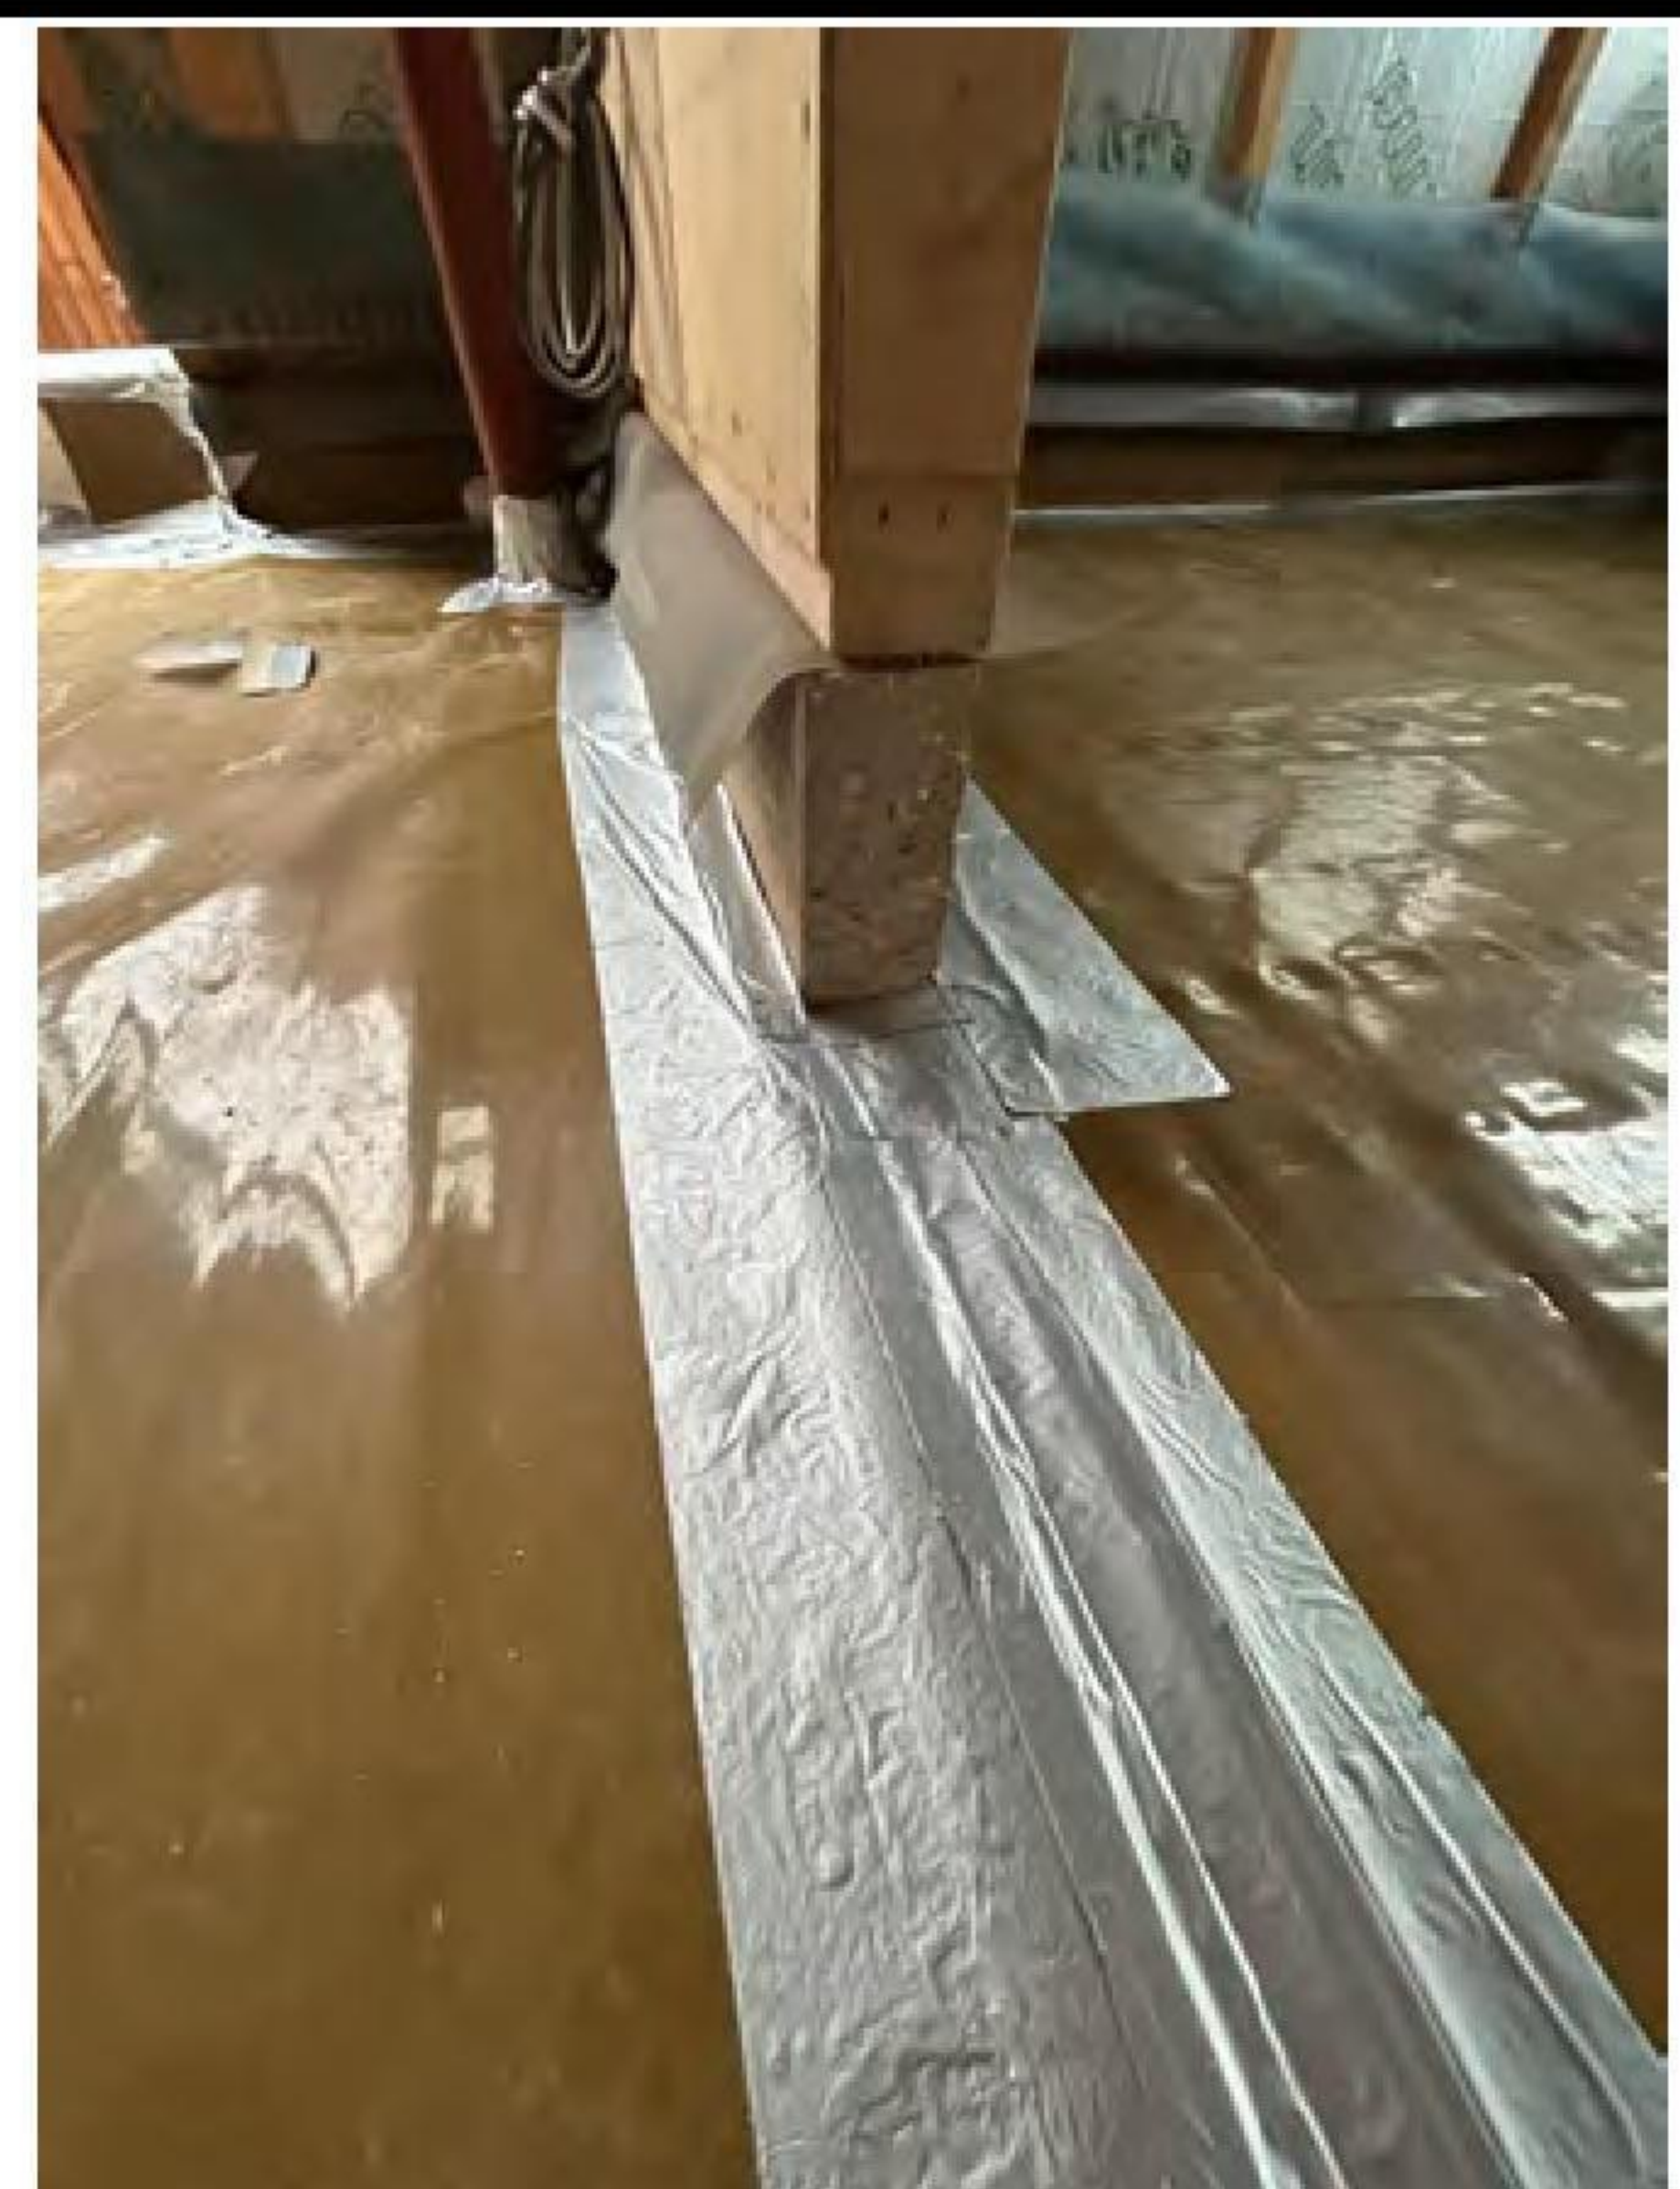
The membrane sealed upon the existing party wall.
