## CLARION CHARTERED SURVEYORS

**Condition Report and Roof covering Proposal**  
**On**  
**Original Roof Tiles and Proposed Roof Recovering**  
**At**  
**Wykehurst Place**  
**Bolney**  
**RH15 5QQ**

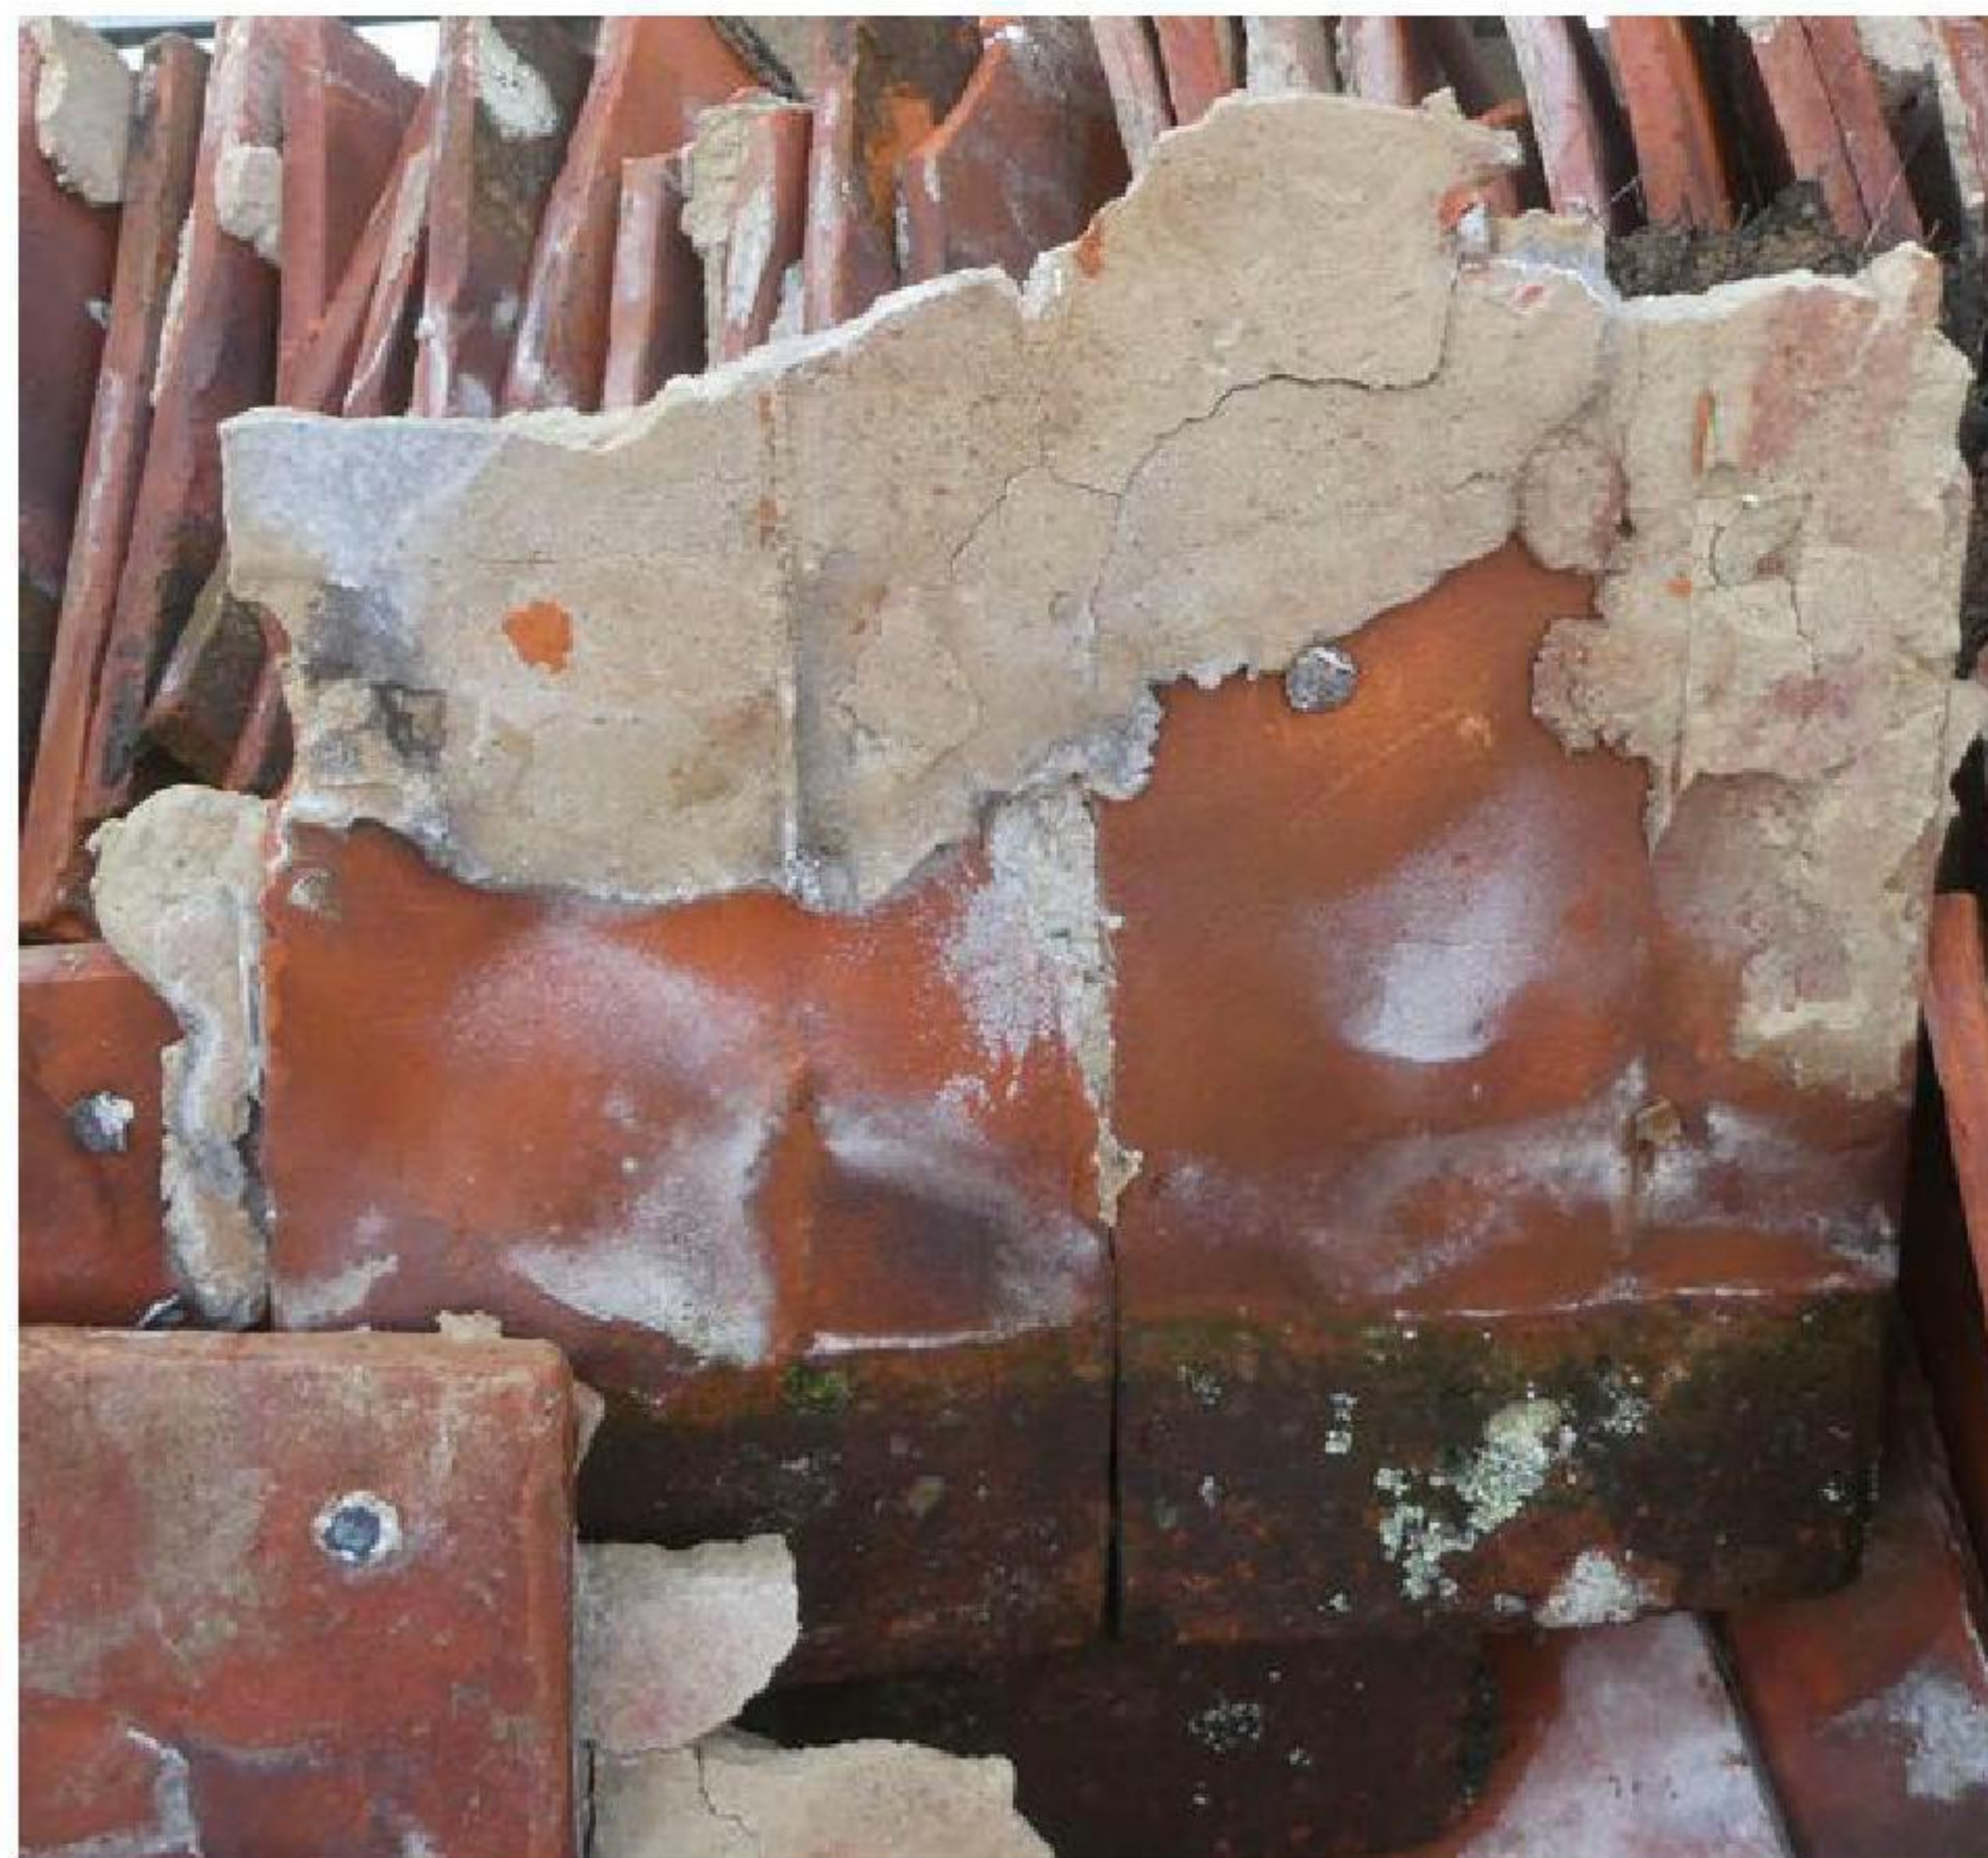
- 3.2 The location of the property below the Gatwick airport flightpath, subsequent pollution and the failure or former owners to carry out regular maintenance is likely to have accelerated the decay to the tiles
- 3.3 Large areas of tile have been lost leading to damage to the interior of the building and timber decay to sarking boards and rafters.
- 3.4 The use of Portland cement for bedding and laying has resulted in large areas of tile being bonded together and failing simultaneously. The Portland cement cannot be removed from the tile without breaking as the aged clay tile is much softer and weaker than the cement.

Original tiles with galvanised nails and Portland cement bonding tile together

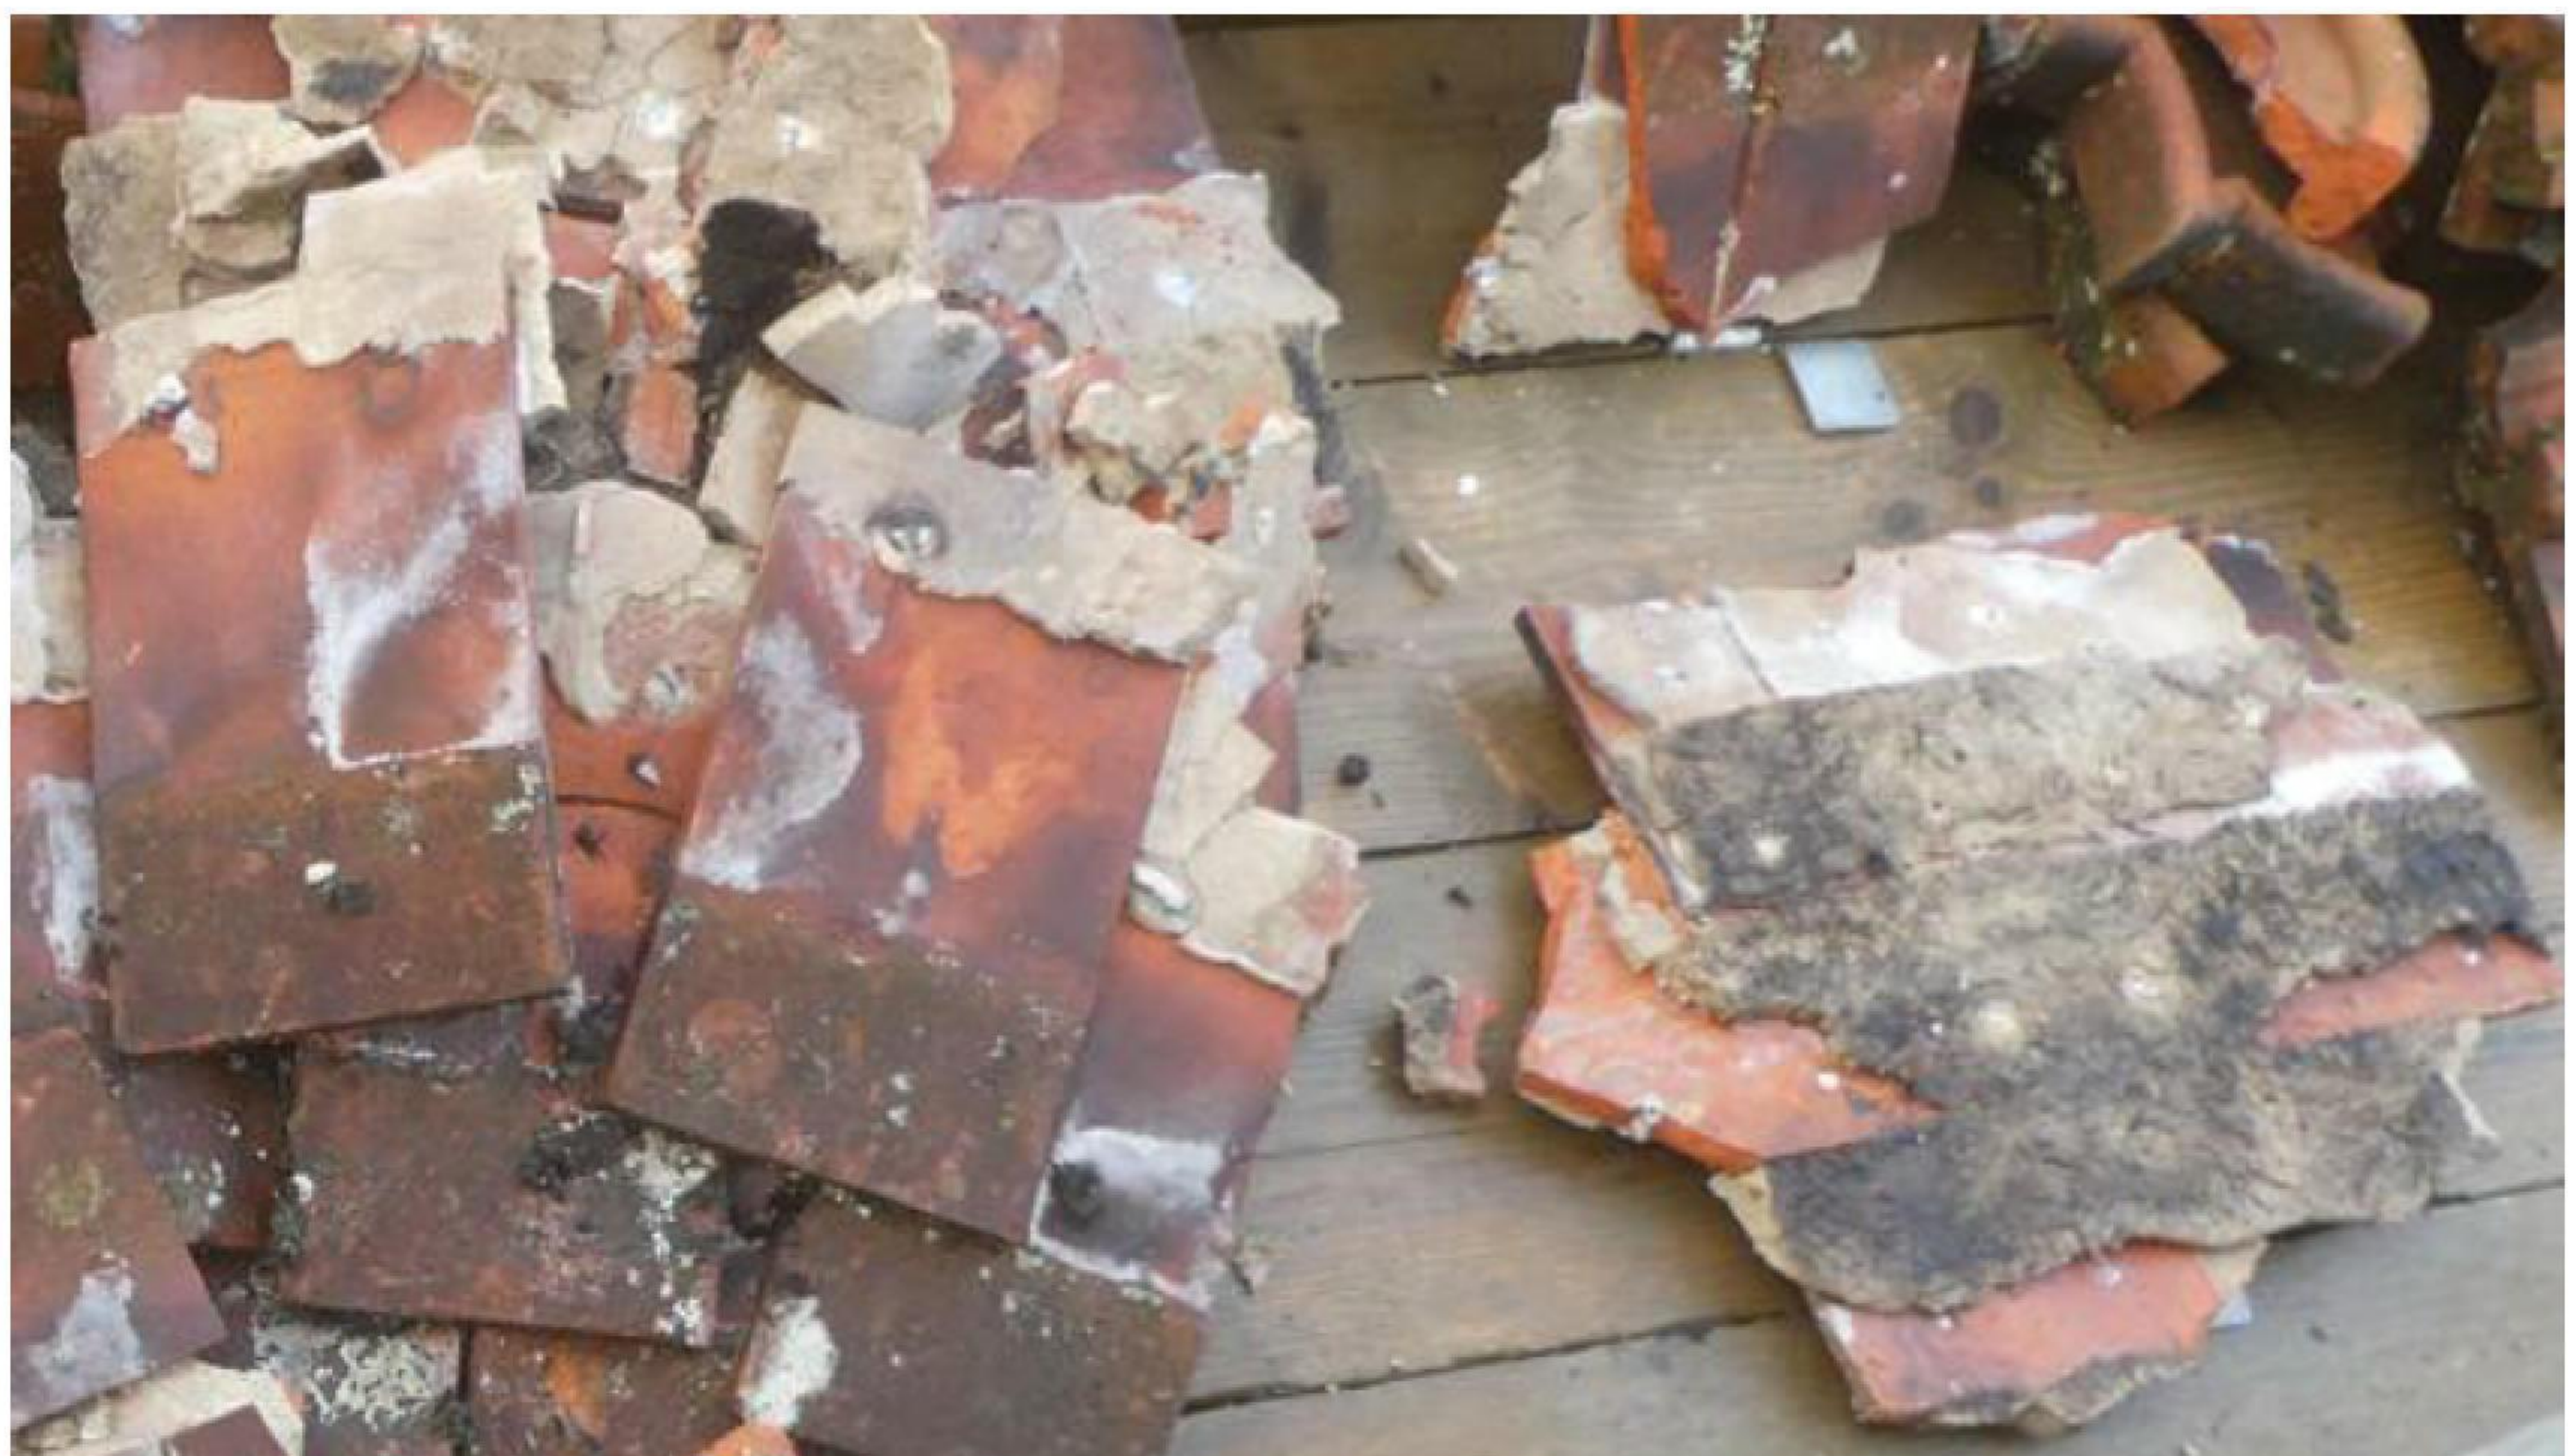
Original tiles cannot be saved due to cement mortar used for bedding

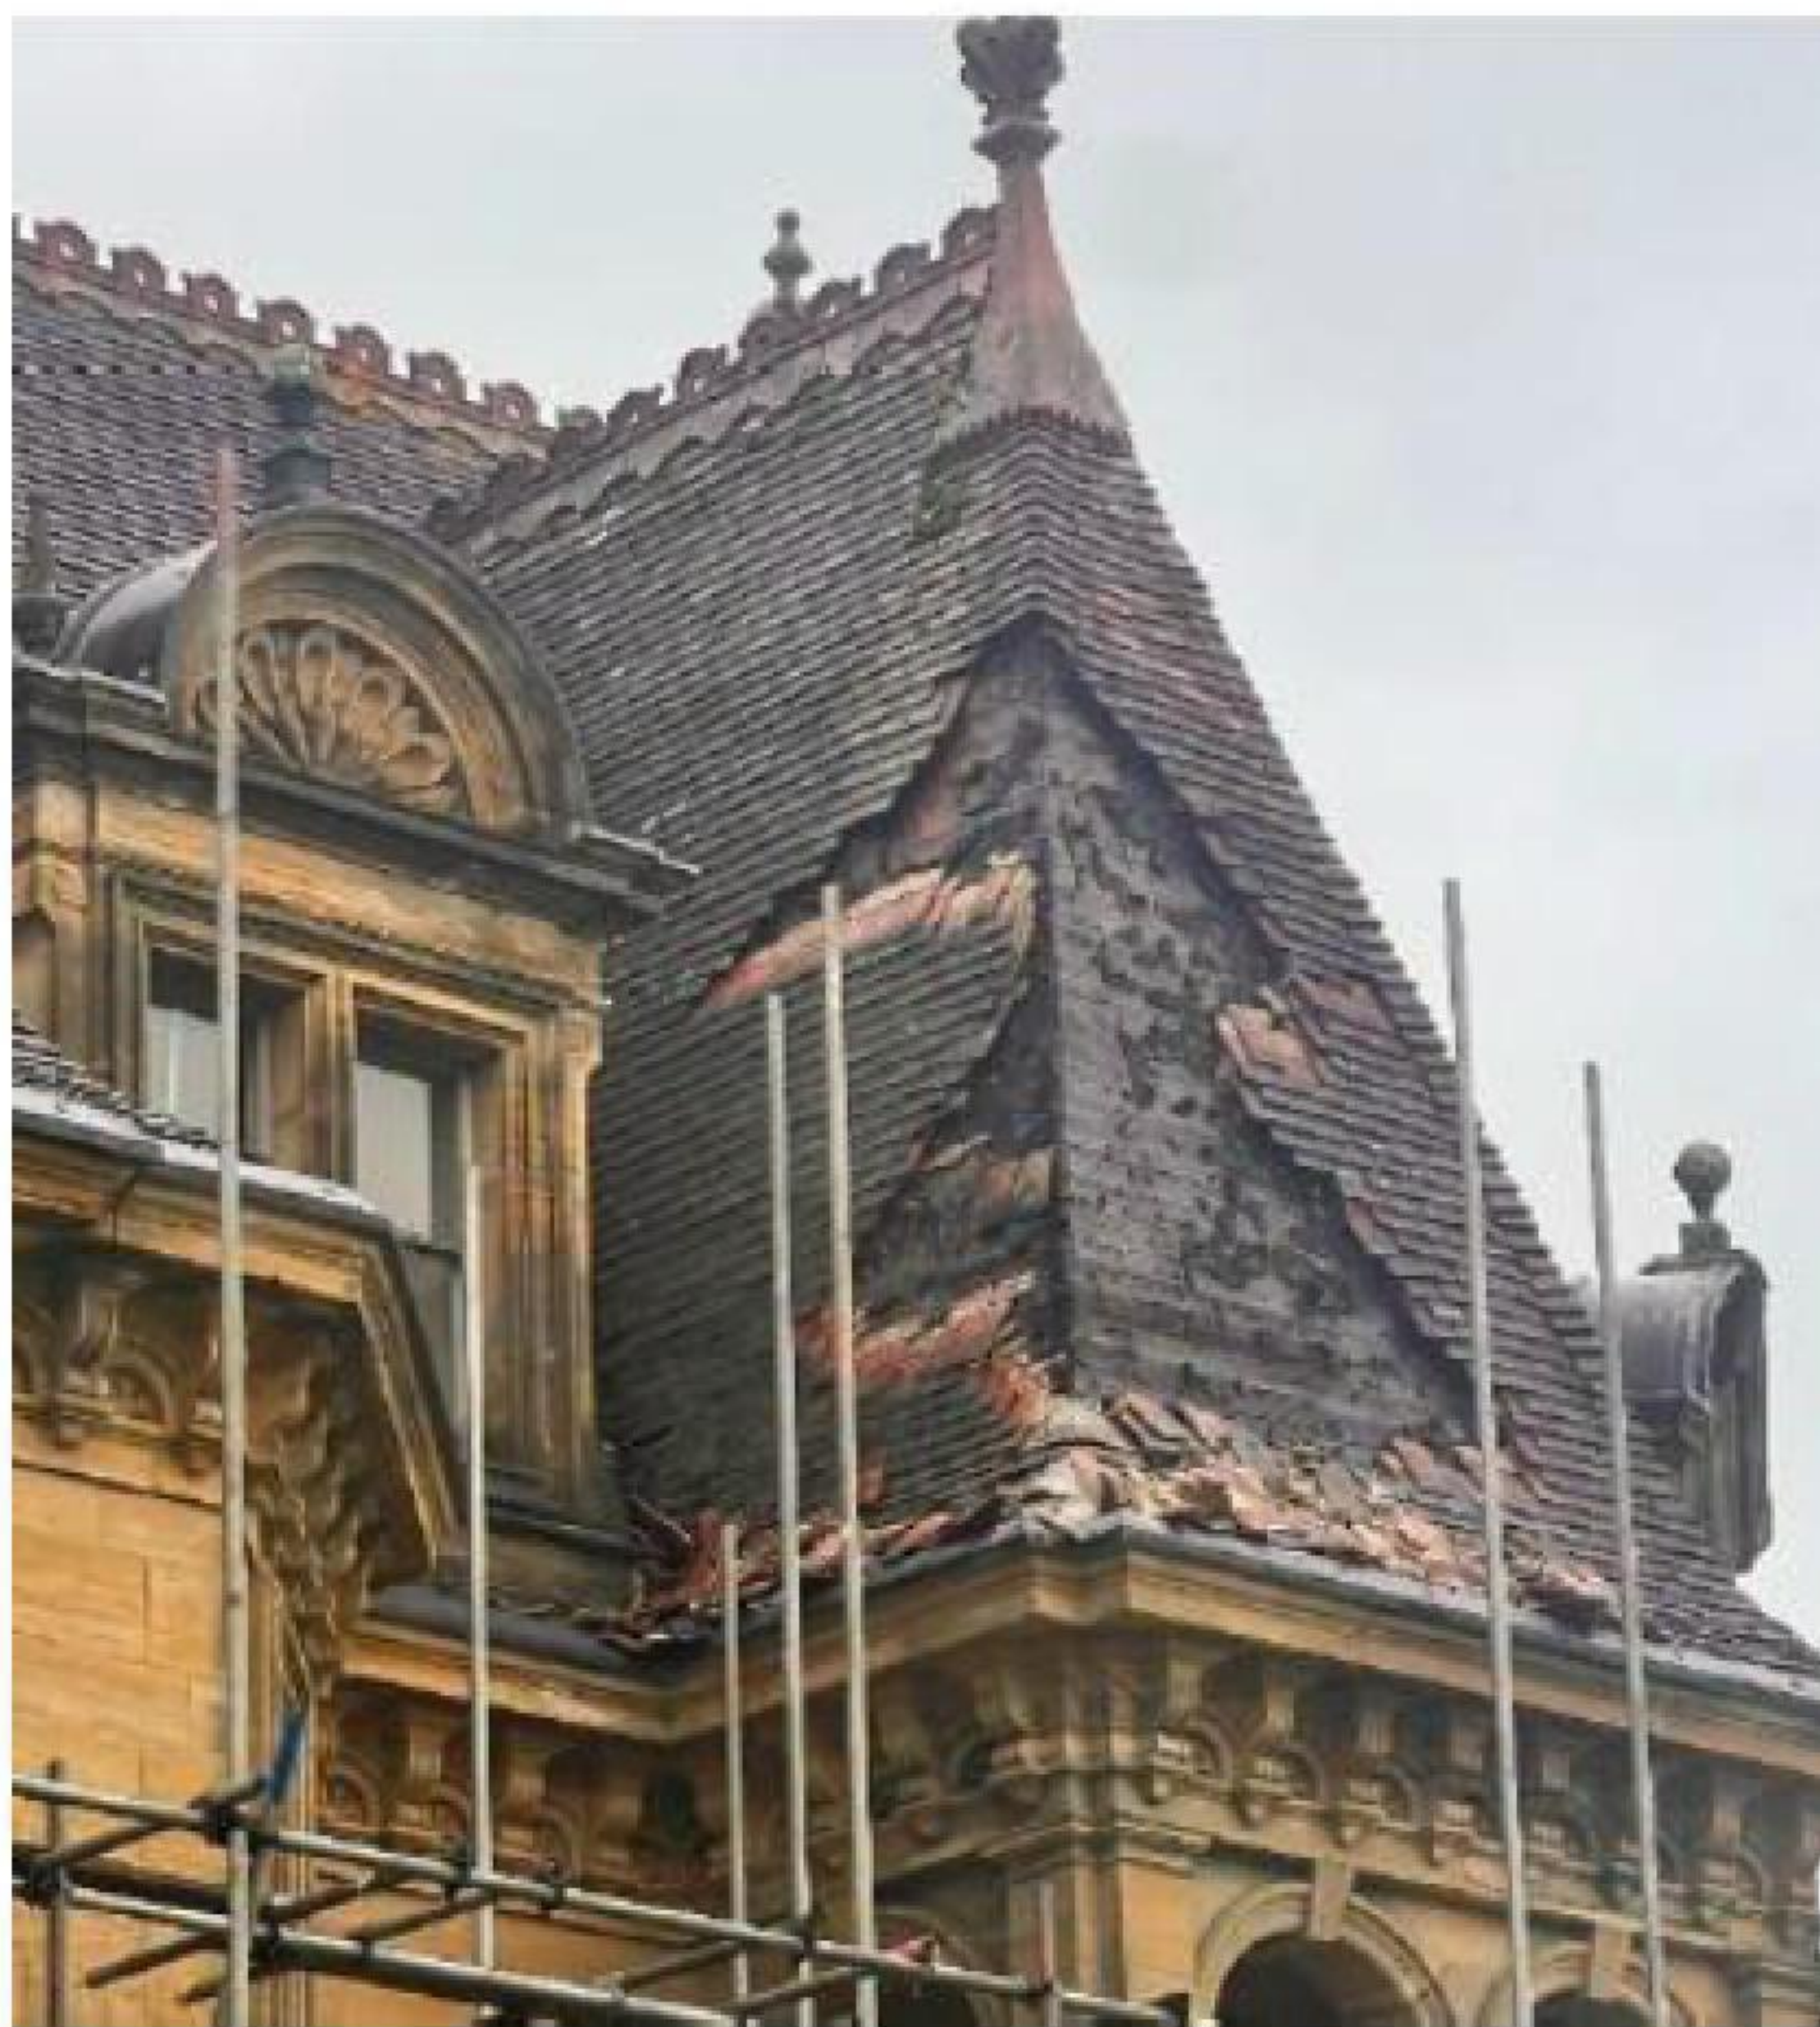
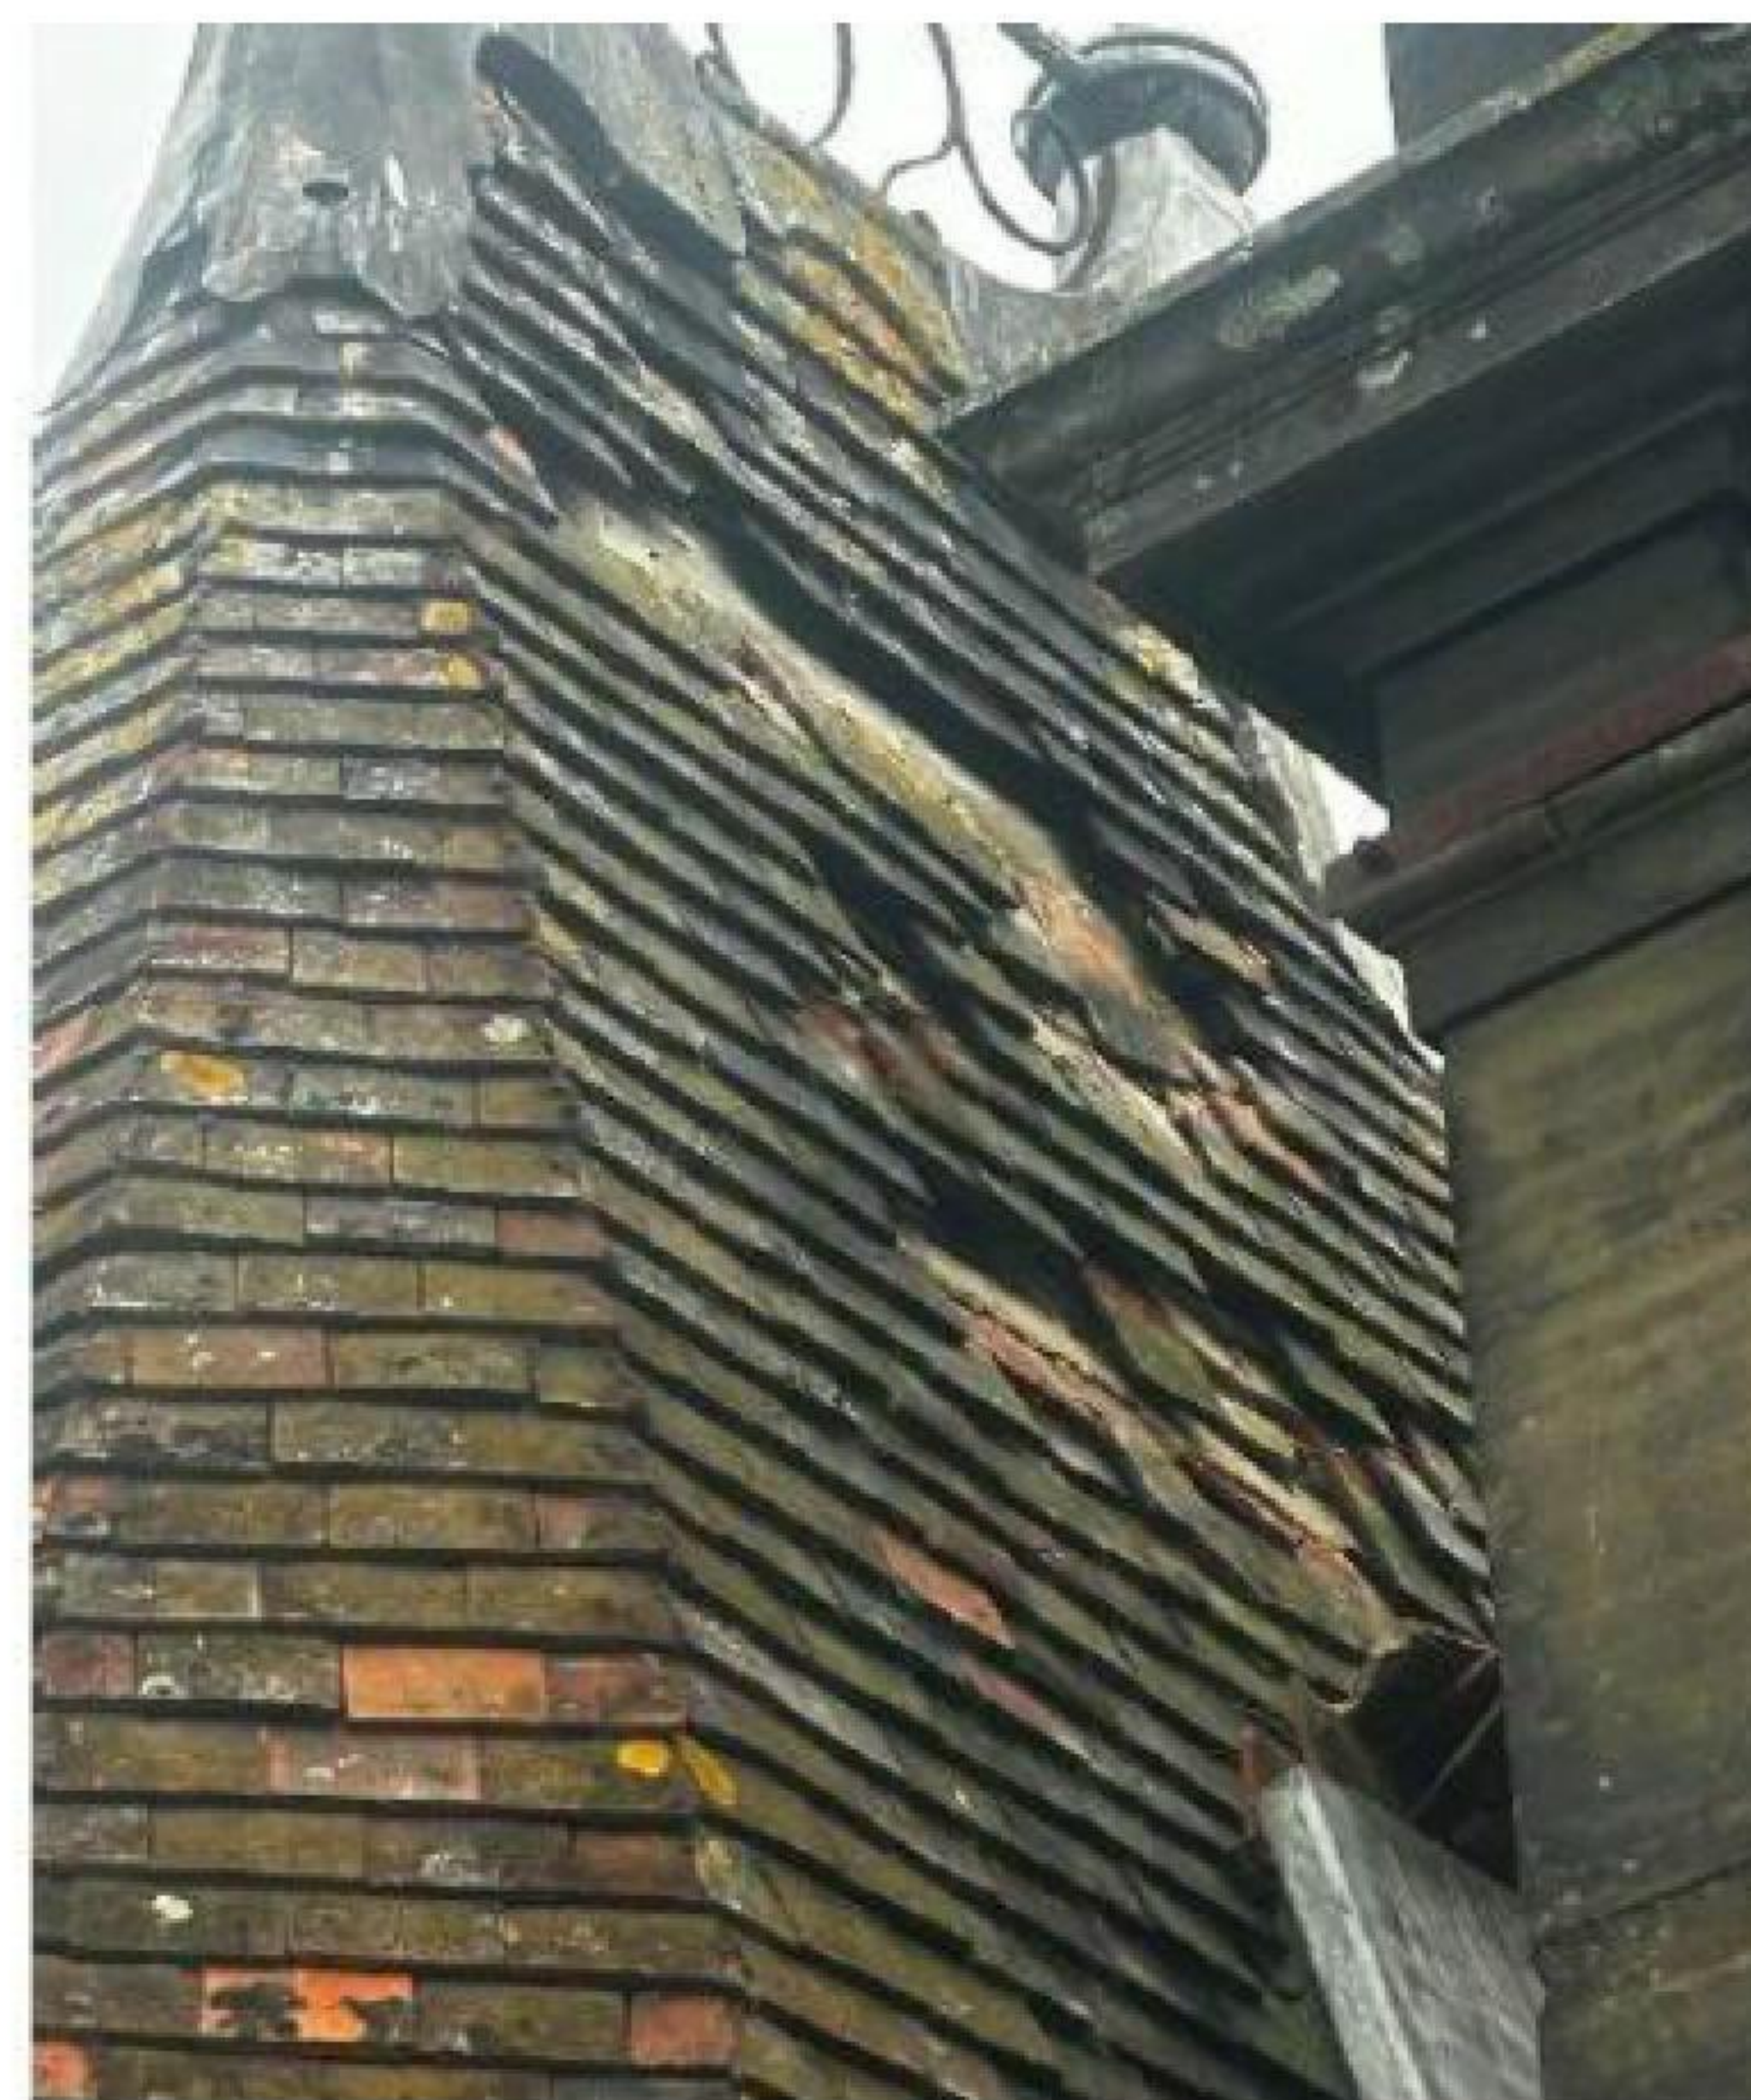
- 3.5 It would normally be expected to salvage over 50% of the tiles on a re-covered roof. However, due to the number of damaged tiles, their age and the use of Portland cement, none of the tiles have been found to be salvageable.
- 3.6 SPAB Recommends that a roof can generally be re-covered with new if more than 20% of the coverings have failed. This property has a much higher failure with almost complete failure of the roof covering.
4. Condition survey
- 4.1 The condition of the roof when purchased by the current owner was demonstrated in the listed building applications DM/25/2654 and 2655
- 4.2 The previous applications showed the total failure of large areas of roof coverings and tiles as detailed in the images below

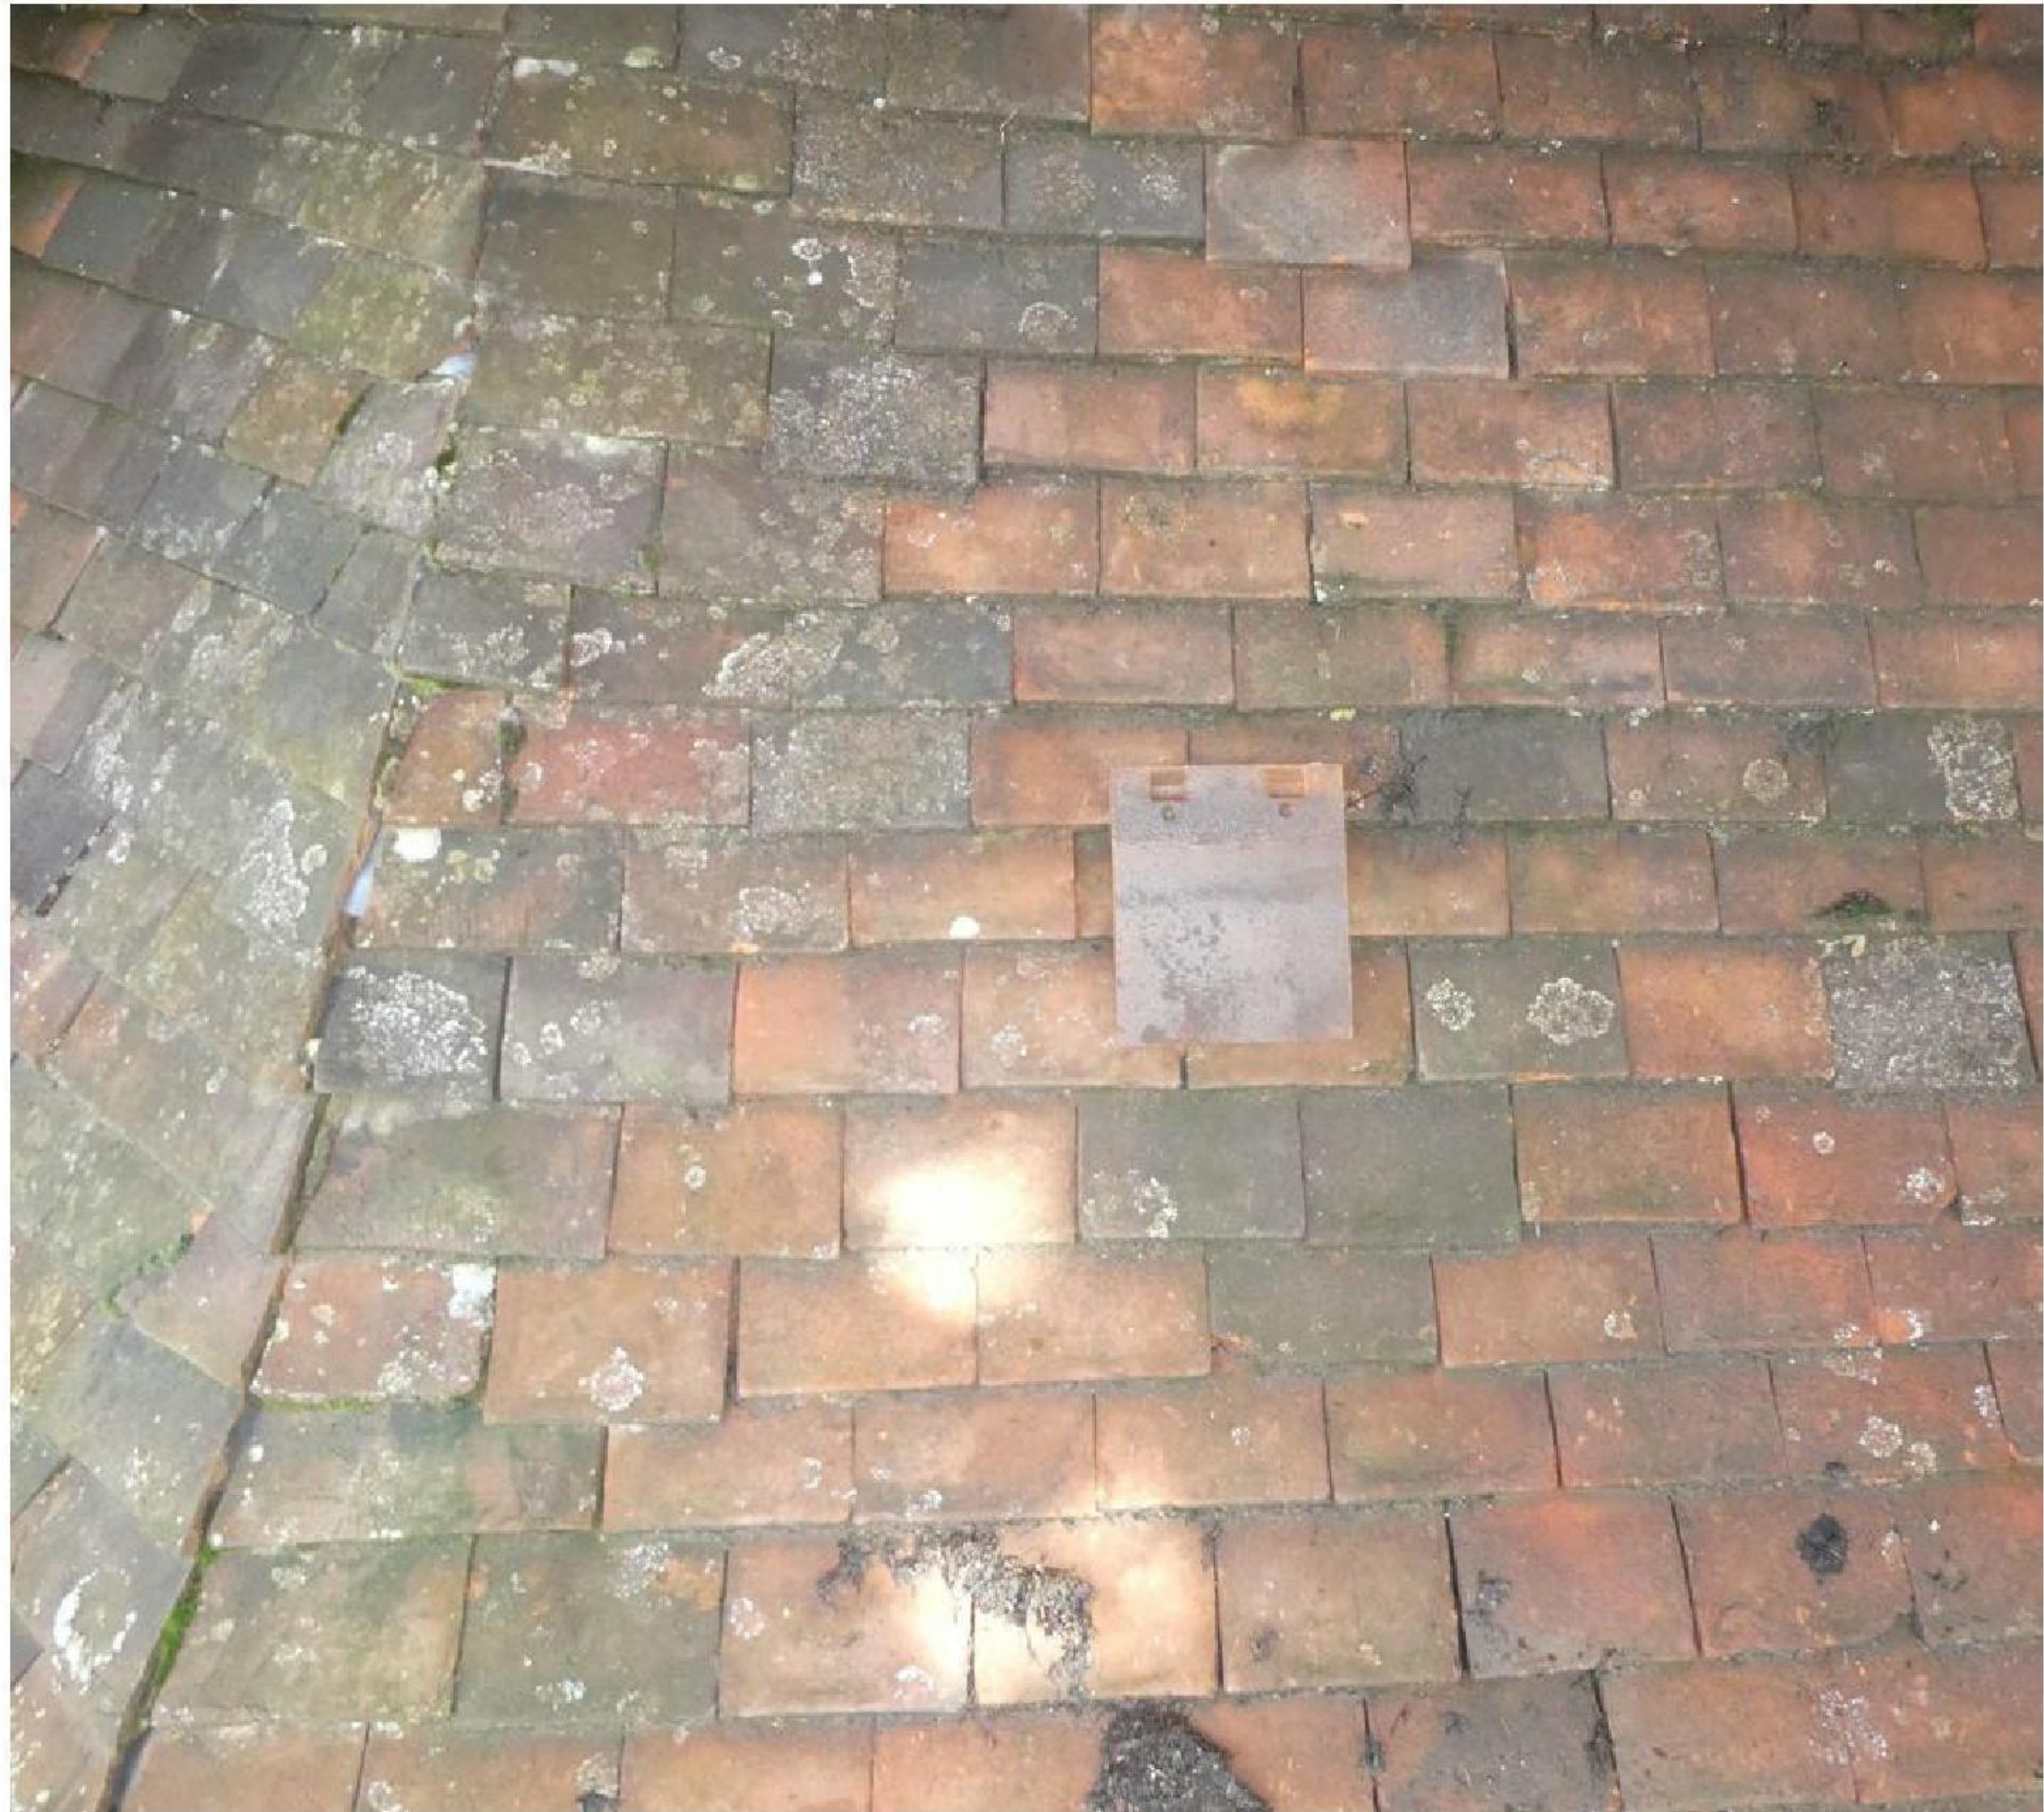
Edilans Phalempin Weathered Plain eves tile showing colour match  
Mitred tile to external corner

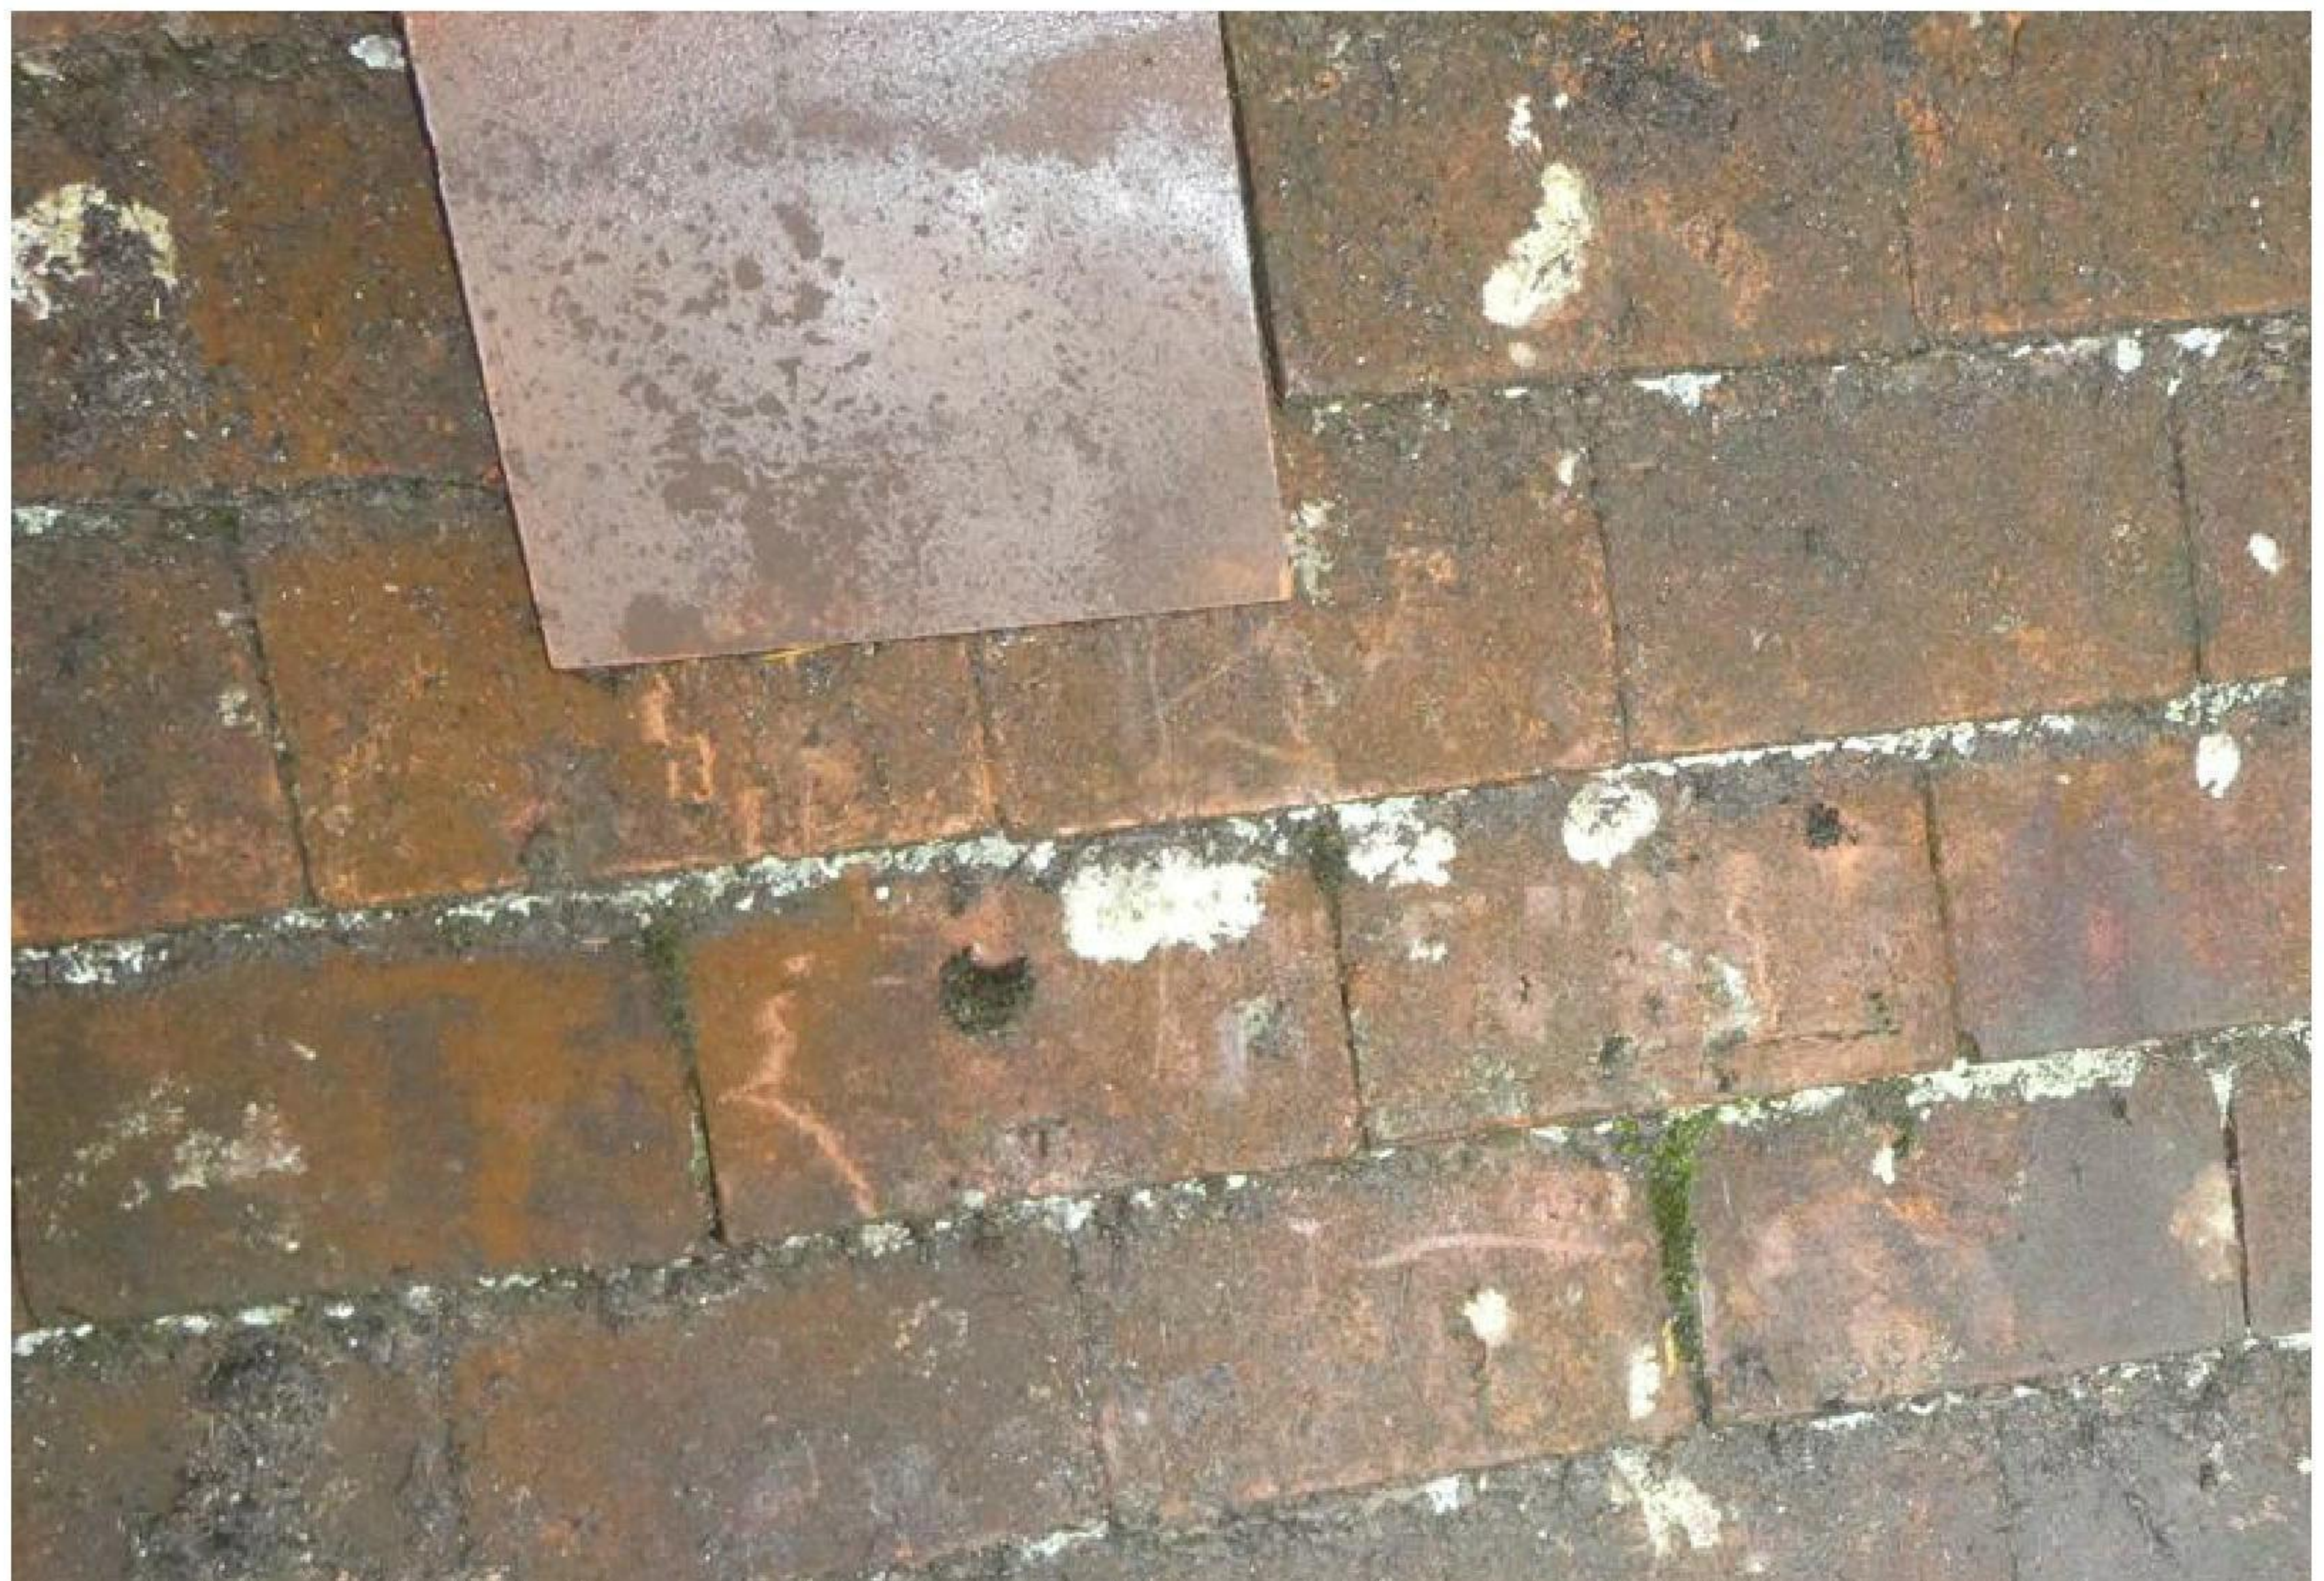
Edilans Phalempin Weathered Plain tile laid on existing  
The original tiles are a closer match when clean
