## CLARION CHARTERED SURVEYORS

**Condition Report and Roof covering Proposal**  
**On**  
**Original Roof Tiles and Proposed Roof Recovering**  
**At**  
**Wykehurst Place**  
**Bolney**  
**RH15 5QQ**

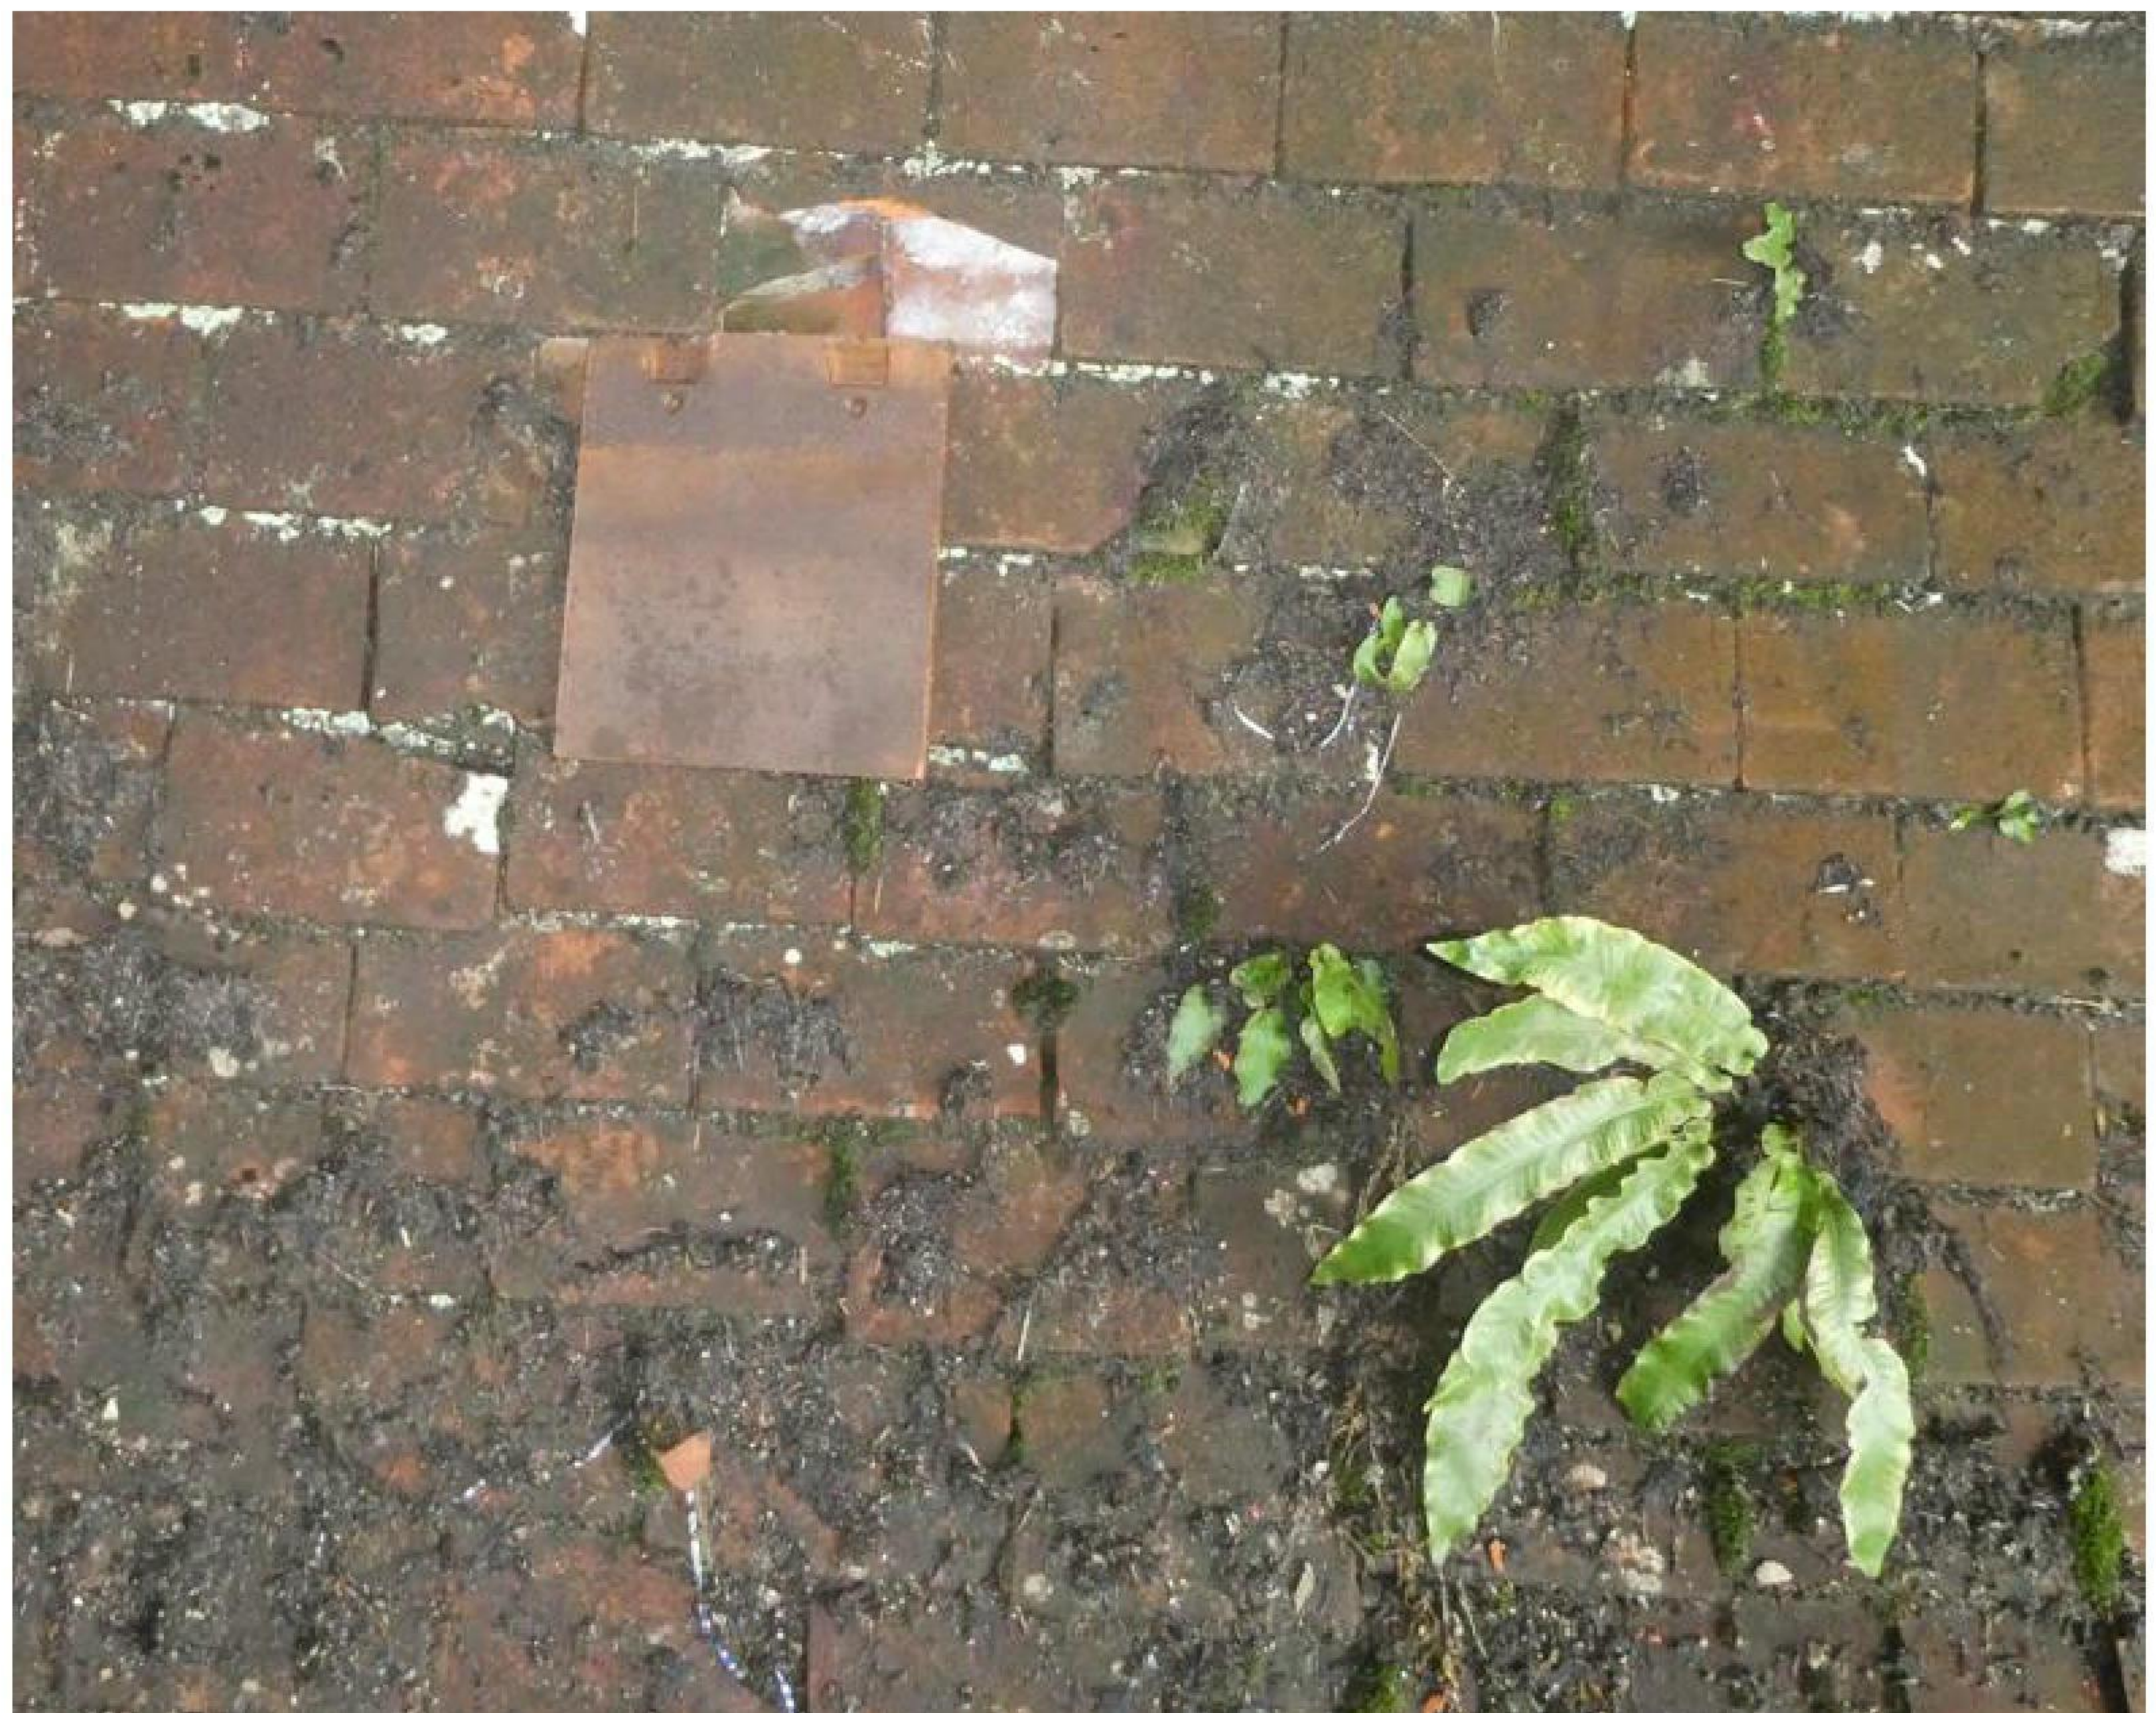
Edilans Phalempin Weathered Plain tile laid on low pitch section of roof

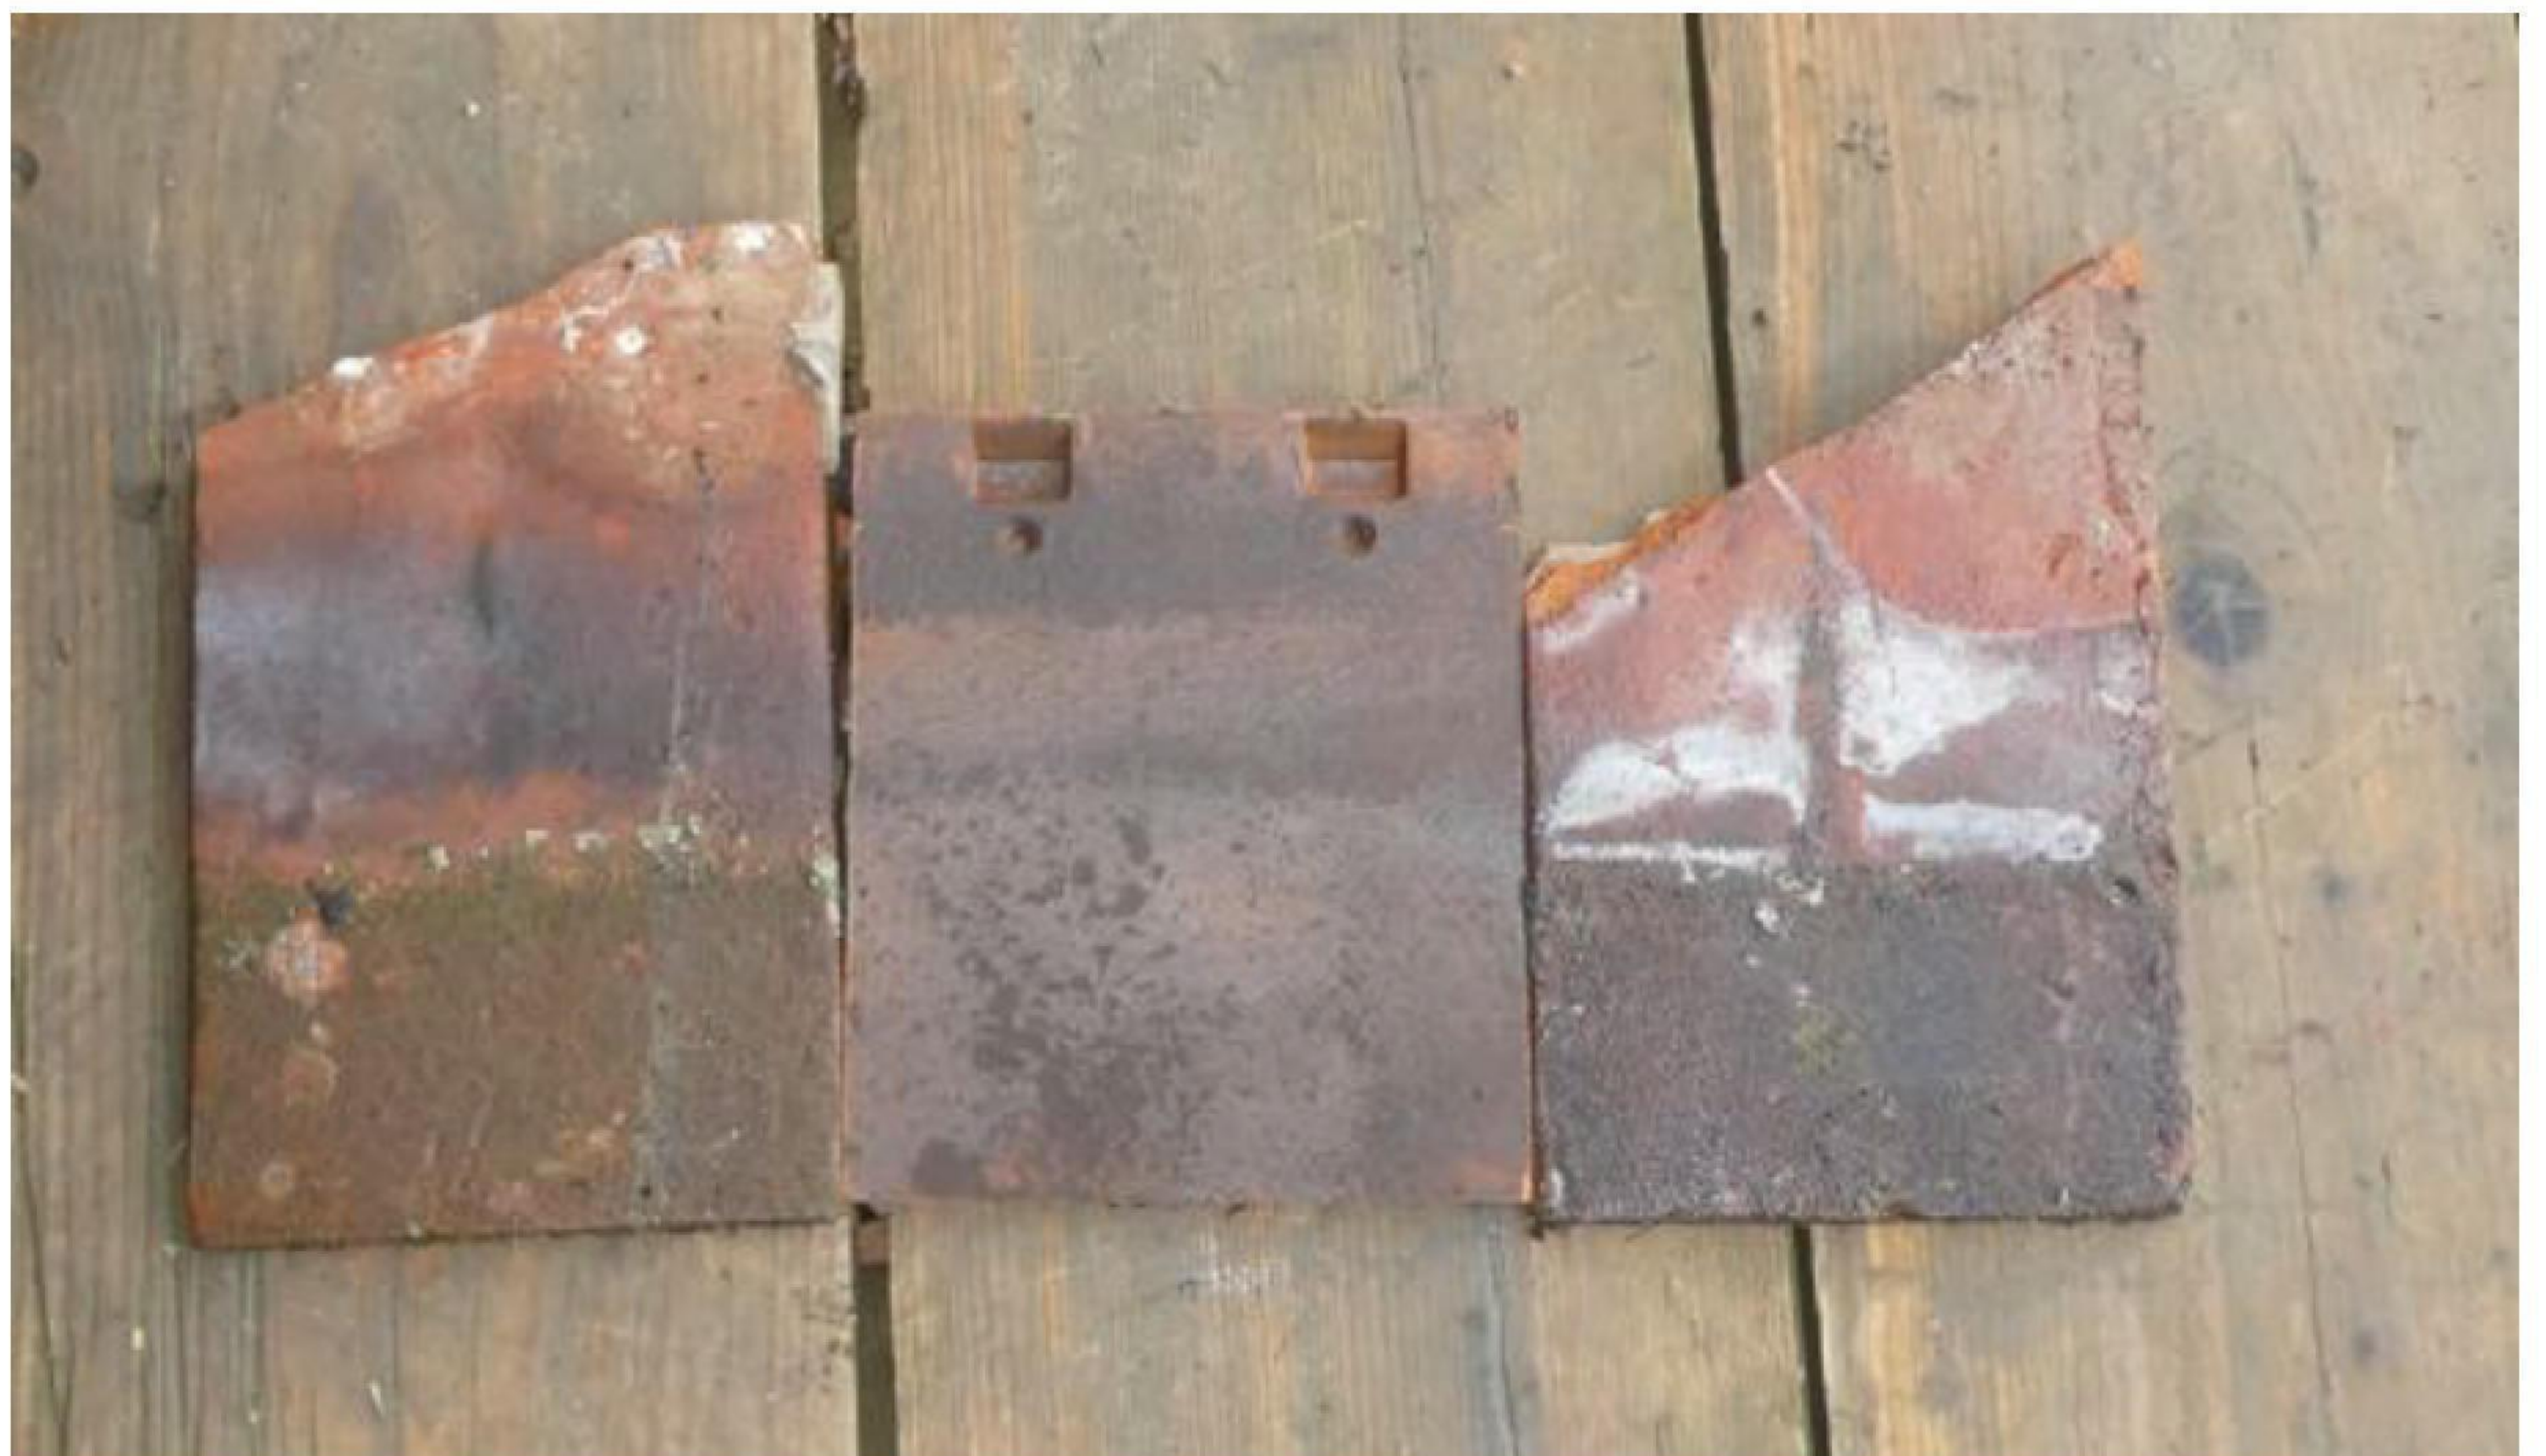
Edilans Phalempin Weathered Plain tile laid between two original removed tiles

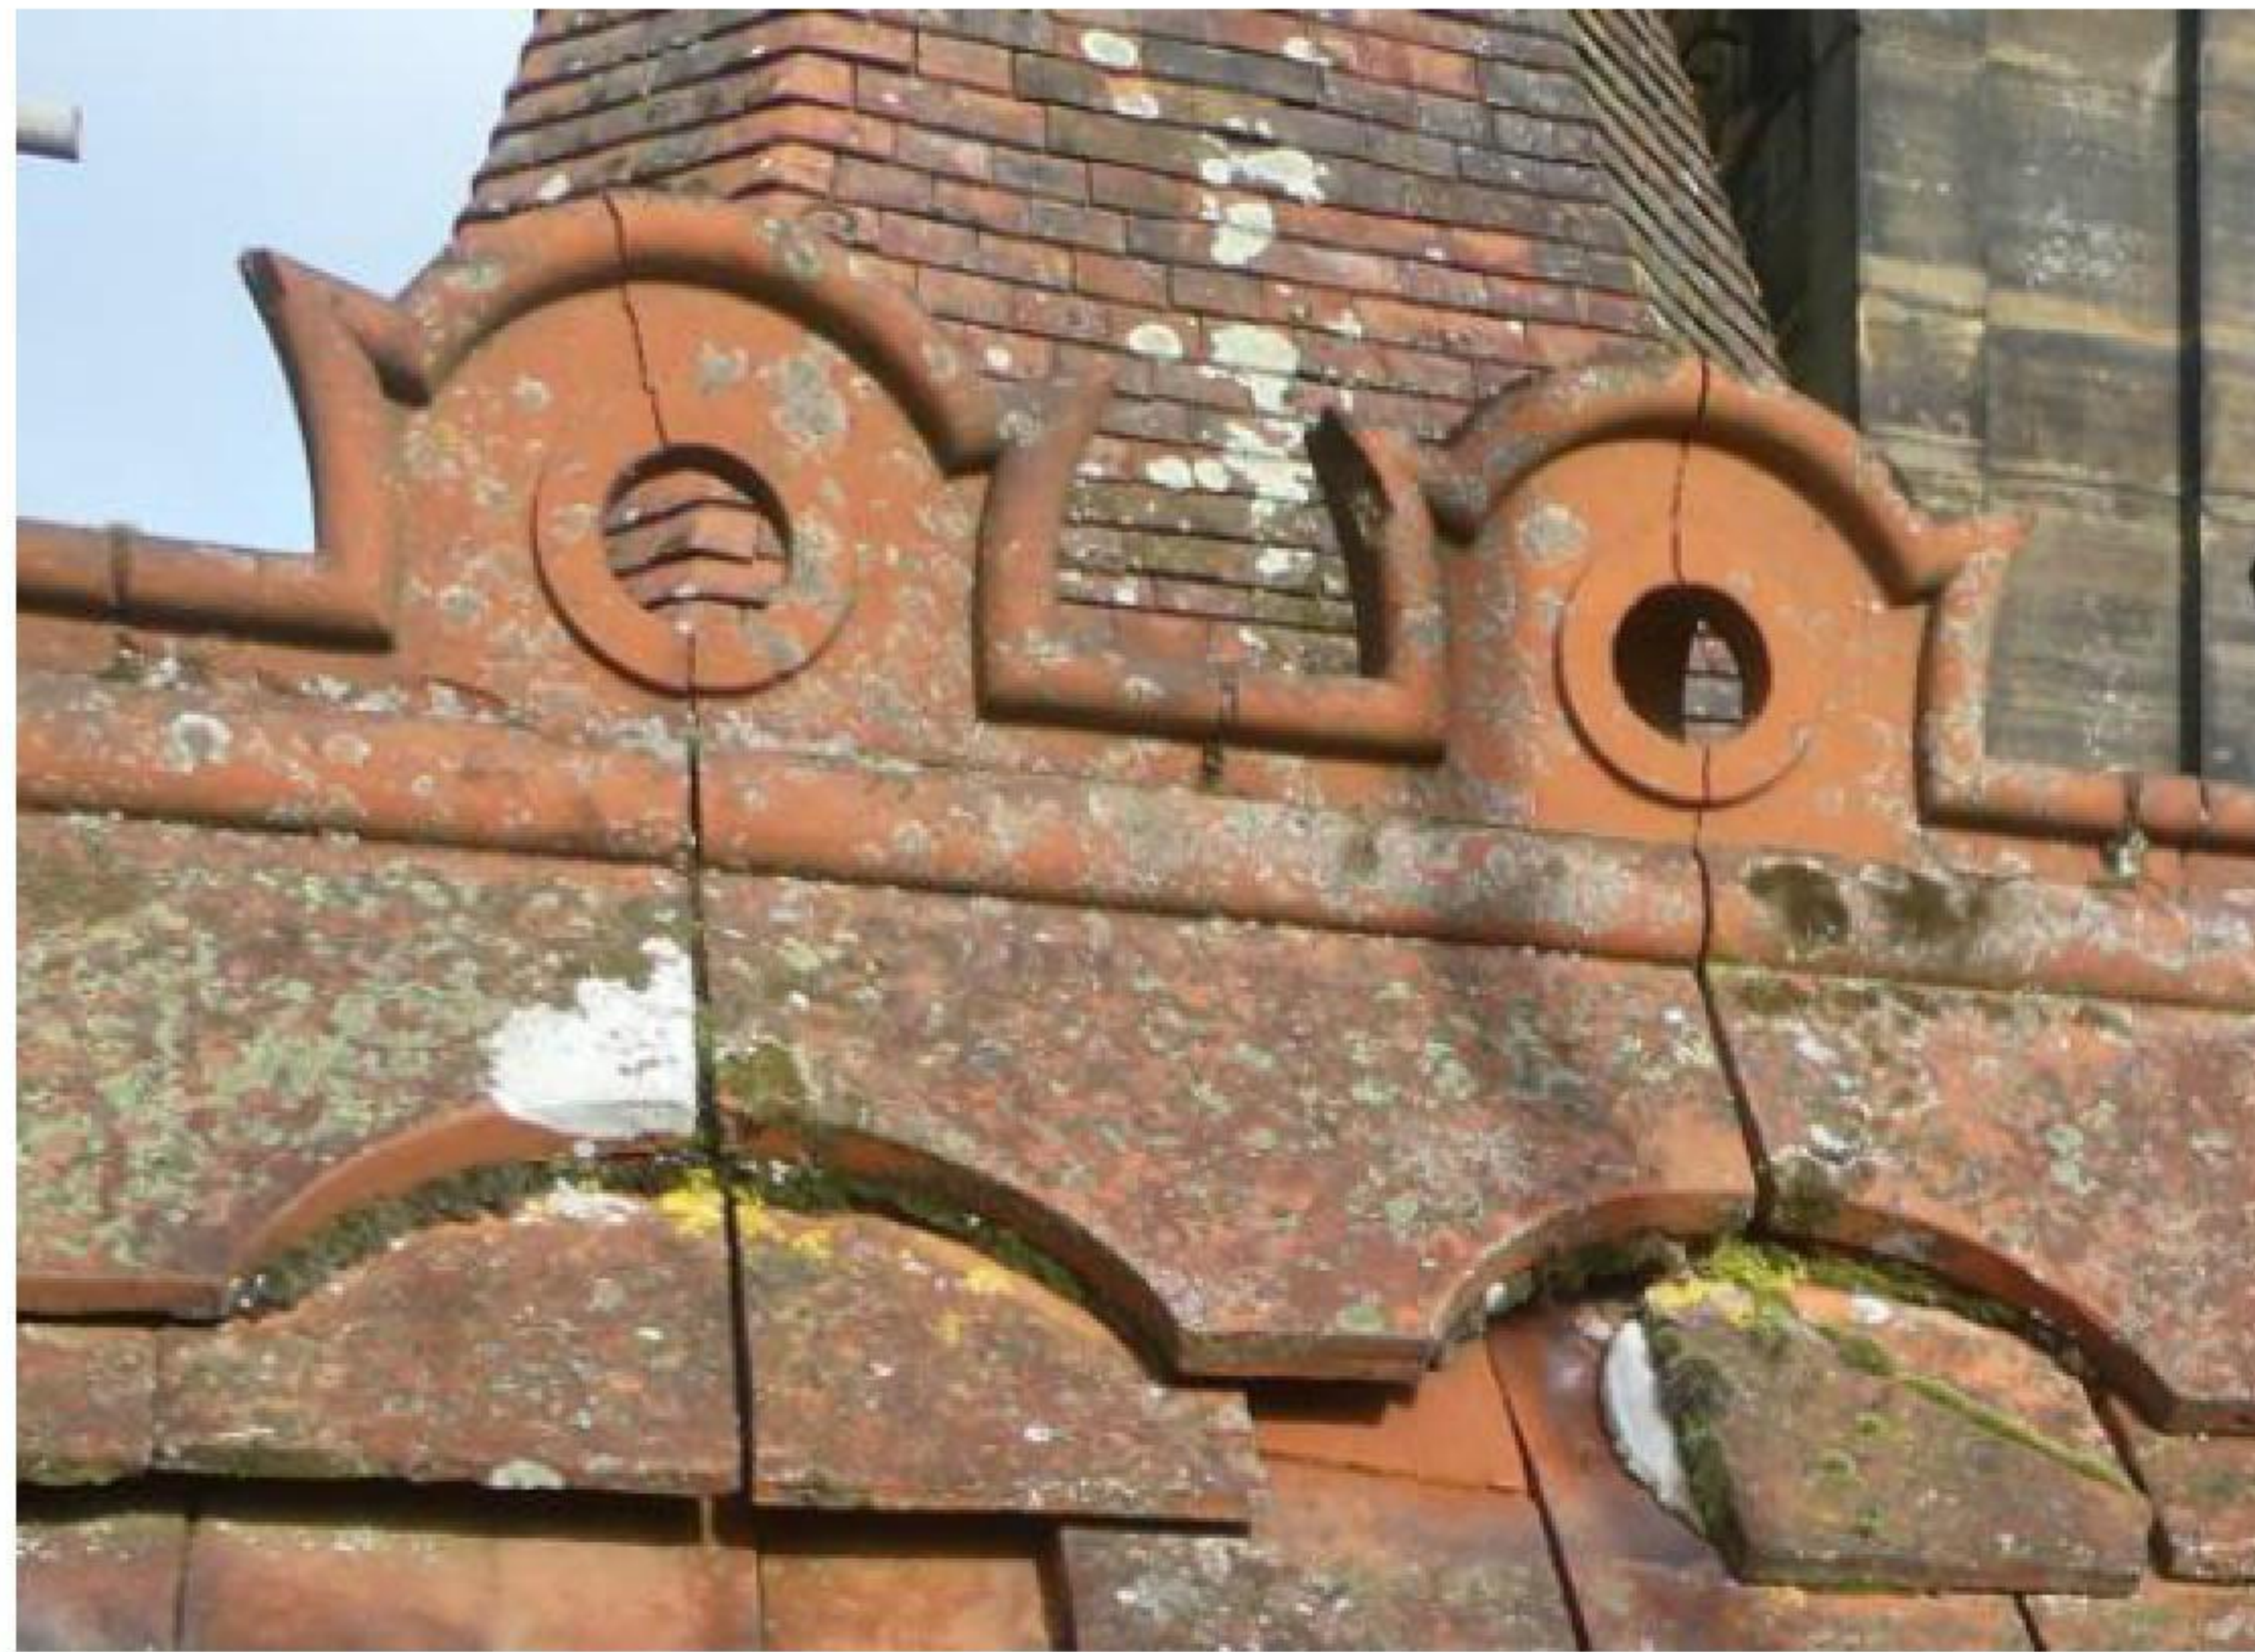
Damaged ridge tiles will be replaced where broken and cannot be saved

- 5.11 Finials and ridge tiles will be retained where possible and re-fixed. Many ridge tiles are decayed and cannot be retained. Where re-use is not possible new ridge tiles to match the existing will be manufactured by 'traditional Roof Tiles Ltd' and installed as existing.
