# **BS5837:2012 Tree Survey & Arboricultural Impact Assessment Report.**

## **Standen House and Garden – Extension to Visitor Reception Building.**

**Revision 2.**

**January 2026.**

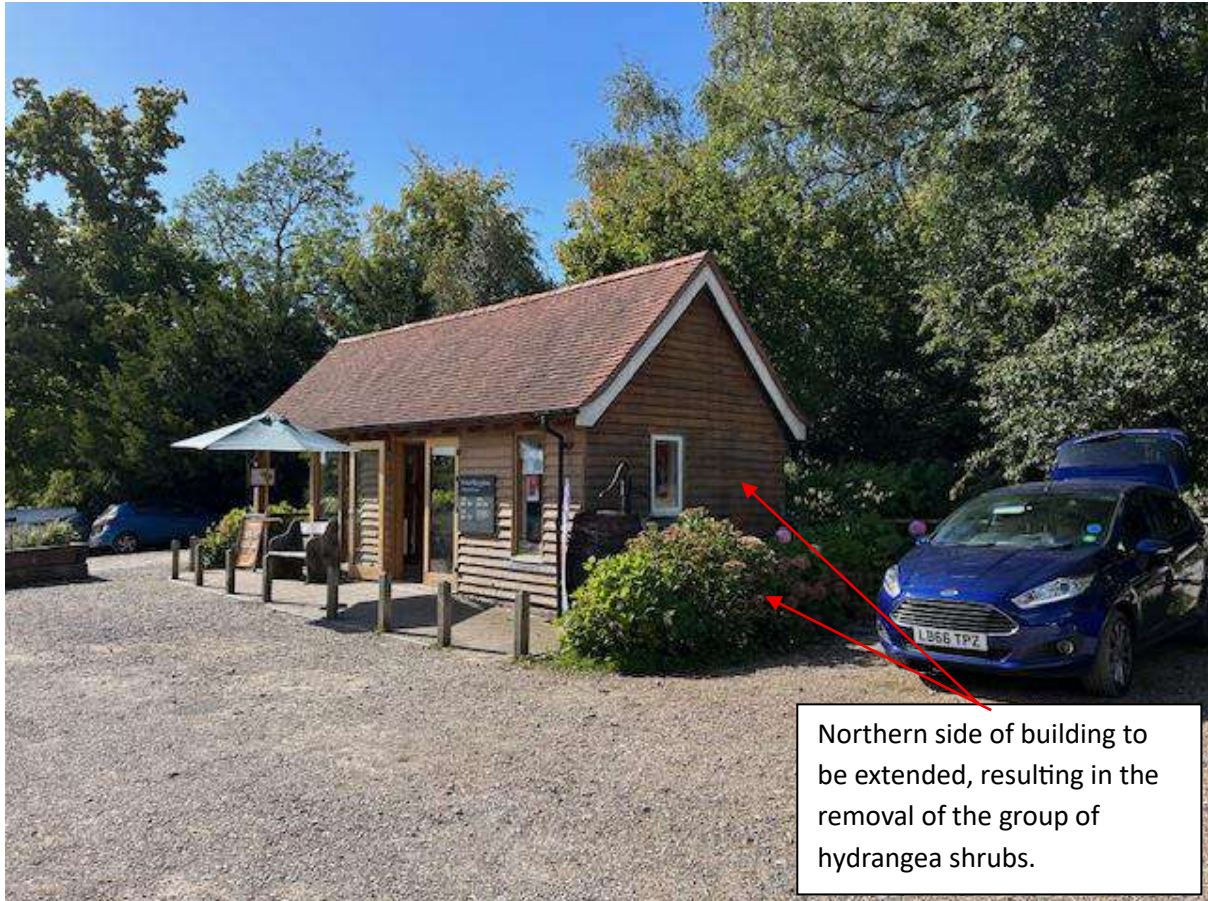
Photograph 1 – Visitor Reception Building.

Northern side of building to be extended, resulting in the removal of the group of hydrangea shrubs.

4.2.1 A group of hydrangea shrubs, located to the north of the visitor reception building, will need to be removed to enable the proposed extension to this building (Photograph 1, Appendix E). These shrubs could be transplanted to another suitable area of the property grounds.

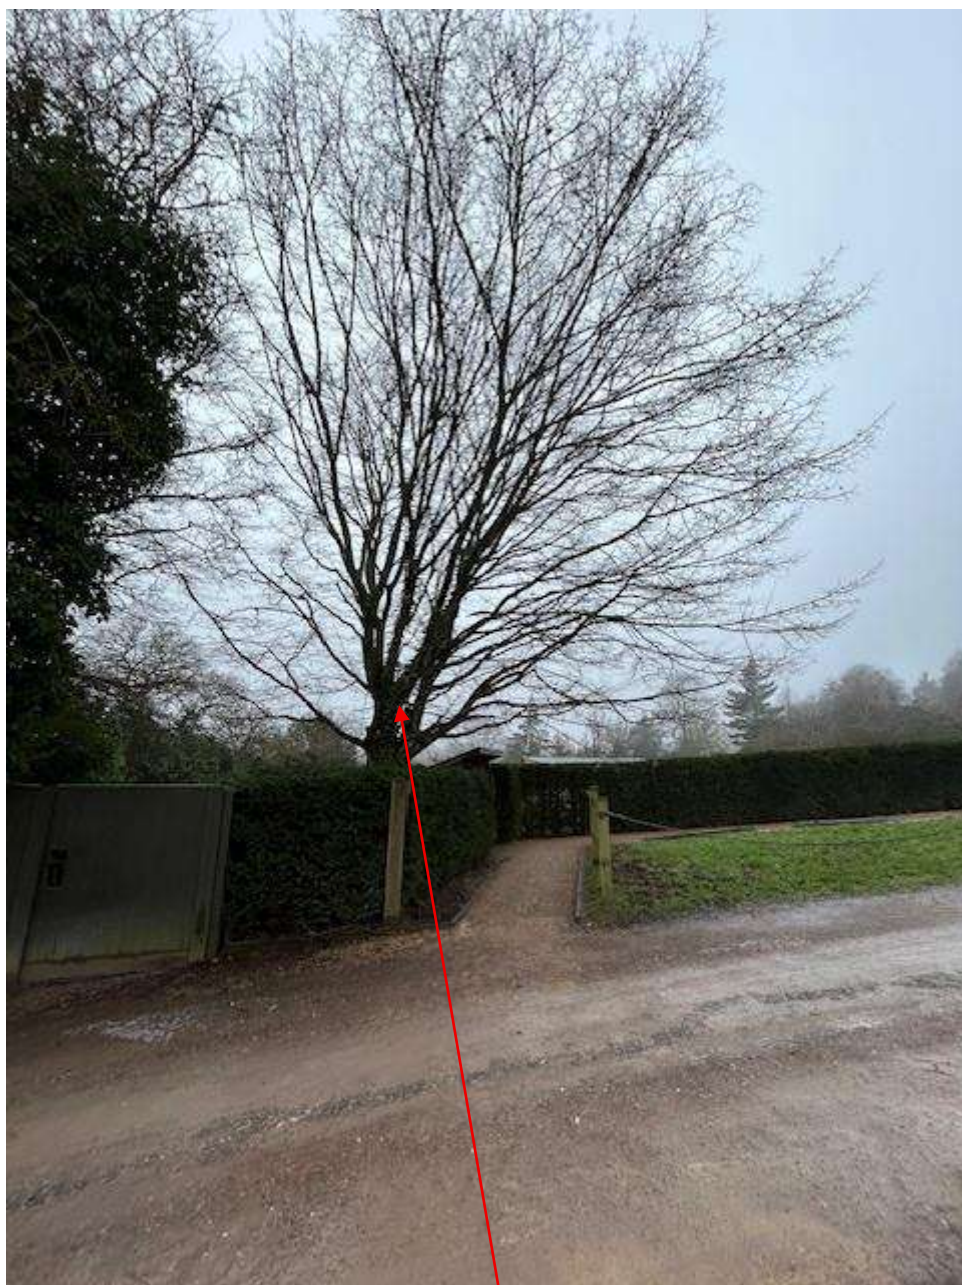
Photograph 11 – Common hornbeam (T6).

| Tree No. | Species | Category | Extent of Encroachment & Considerations<br>(S = Significant, I = Insignificant) |
|---|---|---|---|
| T6 | Common hornbeam | B.1.2. | North-western side of the RPA by 20m <sup>2</sup> /approximately 20% of the total RPA, within 2m from the main stem.<br>New services located within existing access drive and footpath. Root growth likely to be inhibited due to compacted ground in access drive, slightly less |

| | | | so in footpath. Excavations required close to main stem.<br>Extent of encroachment – significant (within the section of footpath). |

4.3.3 Sections of the water main services will significantly impact on trees T6 common hornbeam (Photograph 11) and T7 wild cherry (Photograph 12). Excavations within the RPAs of these 2 no. trees will need to be carried out by hand with the aid of a pneumatic breaker only (areas highlighted in green on the Tree Constraints Plan, Appendix B). Great care must be taken to preserve and work around roots greater than 25mm in diameter and clusters of smaller roots, avoiding damage to the bark. No roots over 25mm in diameter shall be severed without consultation with a competent arboriculturist. Where smaller roots need to be severed, they must be cut back using sharp secateurs or a sharp pruning saw.

4.3.4 Exposed roots must be wrapped or covered immediately with sacking to prevent desiccation and to protect them from rapid temperature changes. Any wrapping must be removed prior to backfilling. Prior to backfilling, and where possible, retained roots

must be surrounded with sharp sand (not builder's sand because of its high salt content), or other loose inert granular fill (e.g. pea gravel or horticultural grit).

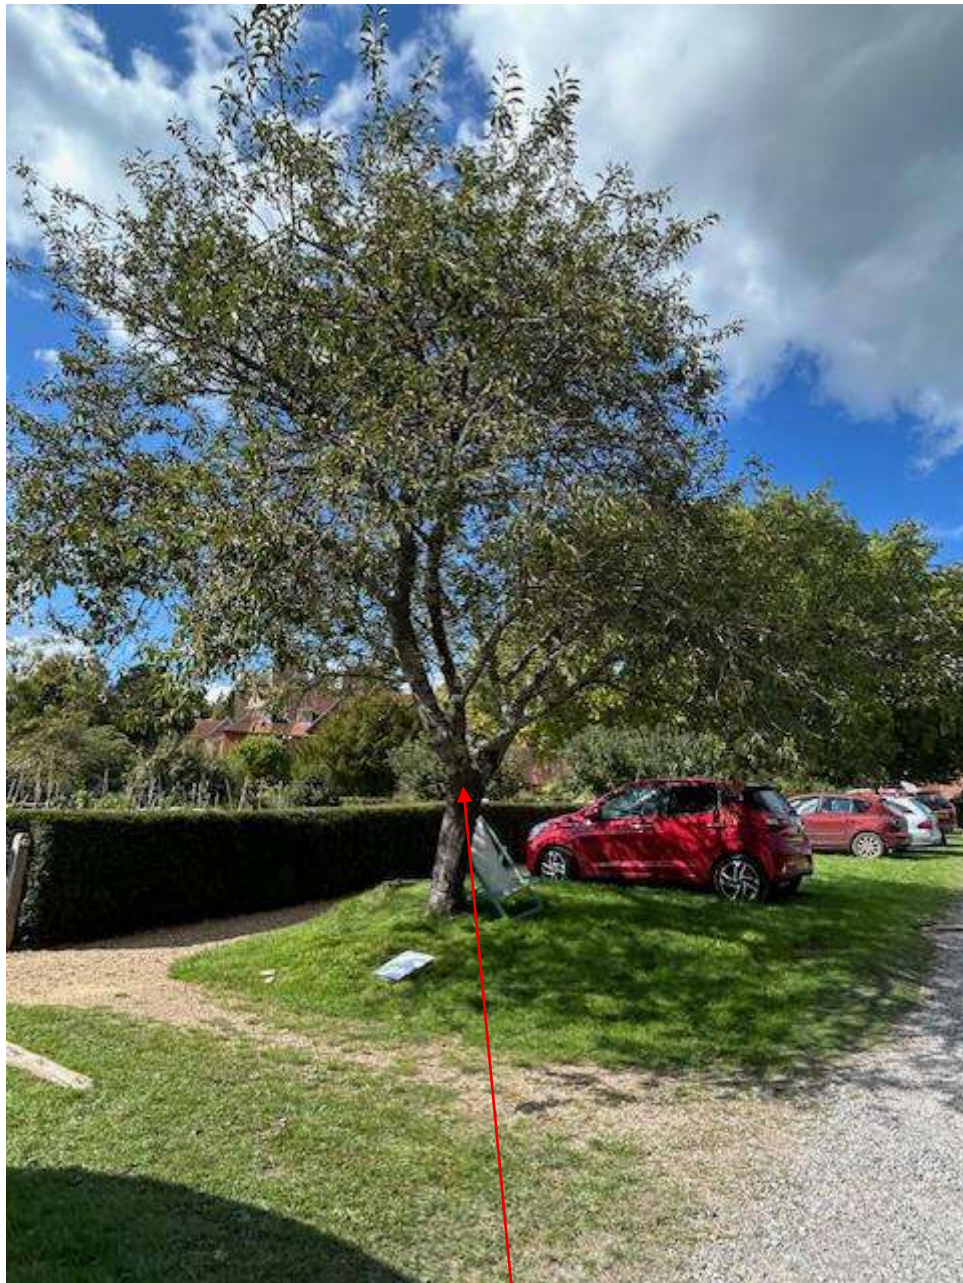
| T7 | Wild cherry | C.1.2. | South-western side of RPA by 10m <sup>2</sup> /approximately 14% of the total RPA, within 2m of main stem.<br>New services located within the existing footpath<br>Root growth likely to be partly inhibited due to compacted ground in footpath, but excavations will occur close to main stem.<br>Extent of encroachment – significant. |

Photograph 12 – Mature cherry tree (T7) in a grass verge with low branches over access road and footpath.

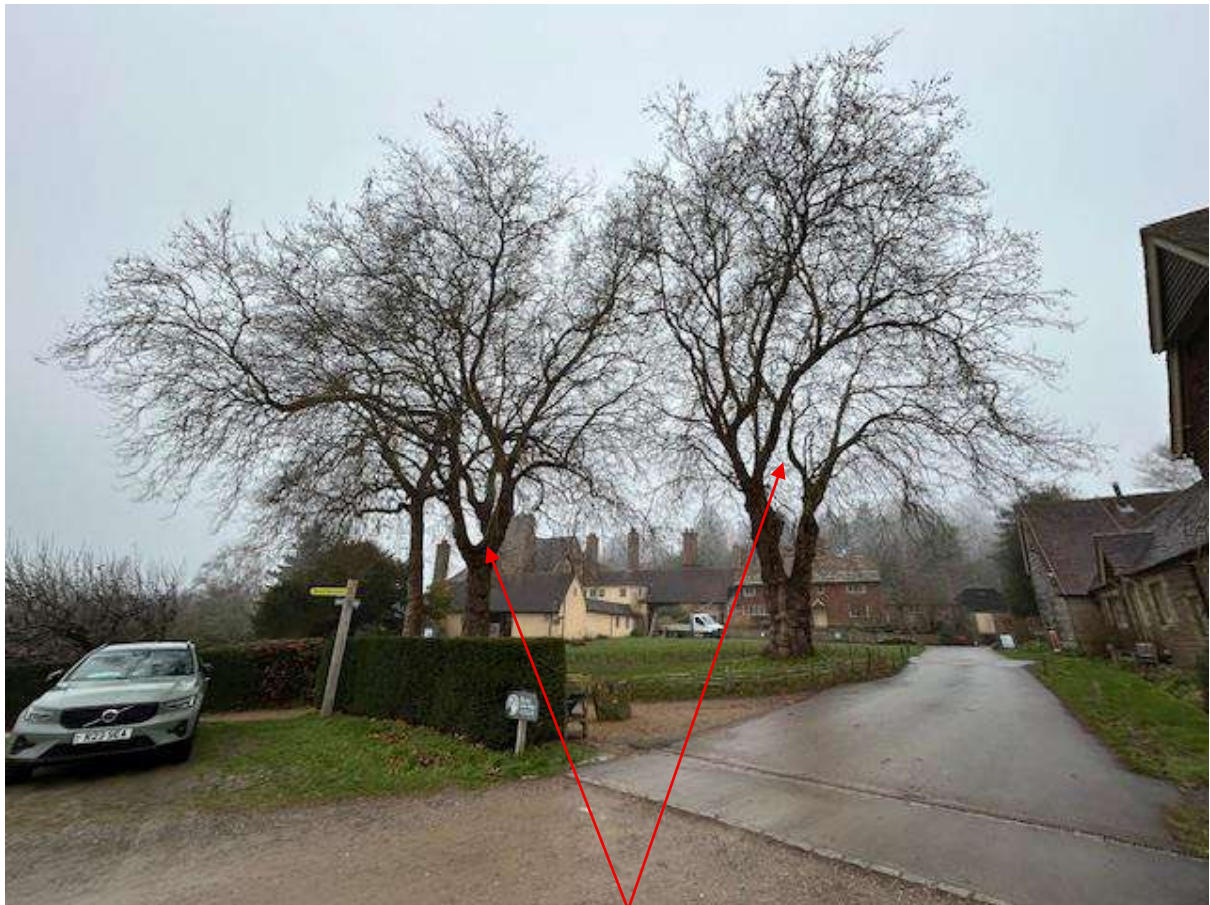
Photograph 13 – London plane (T8) & London plane (T9).

| T8 | London plane | A.1.2. | Eastern side of RPA by 30m <sup>2</sup> /less than 5% of the total RPA.<br>New services located within existing access drive where root growth likely to be inhibited due to compacted ground.<br>Extent of encroachment – not significant. |
| T9 | London plane | A.1.2. | Northern side of RPA by 126m <sup>2</sup> /approximately 18% of the total RPA.<br>New services located within existing access drive where root growth likely to be inhibited due to compacted ground.<br>Extent of encroachment – not significant. |

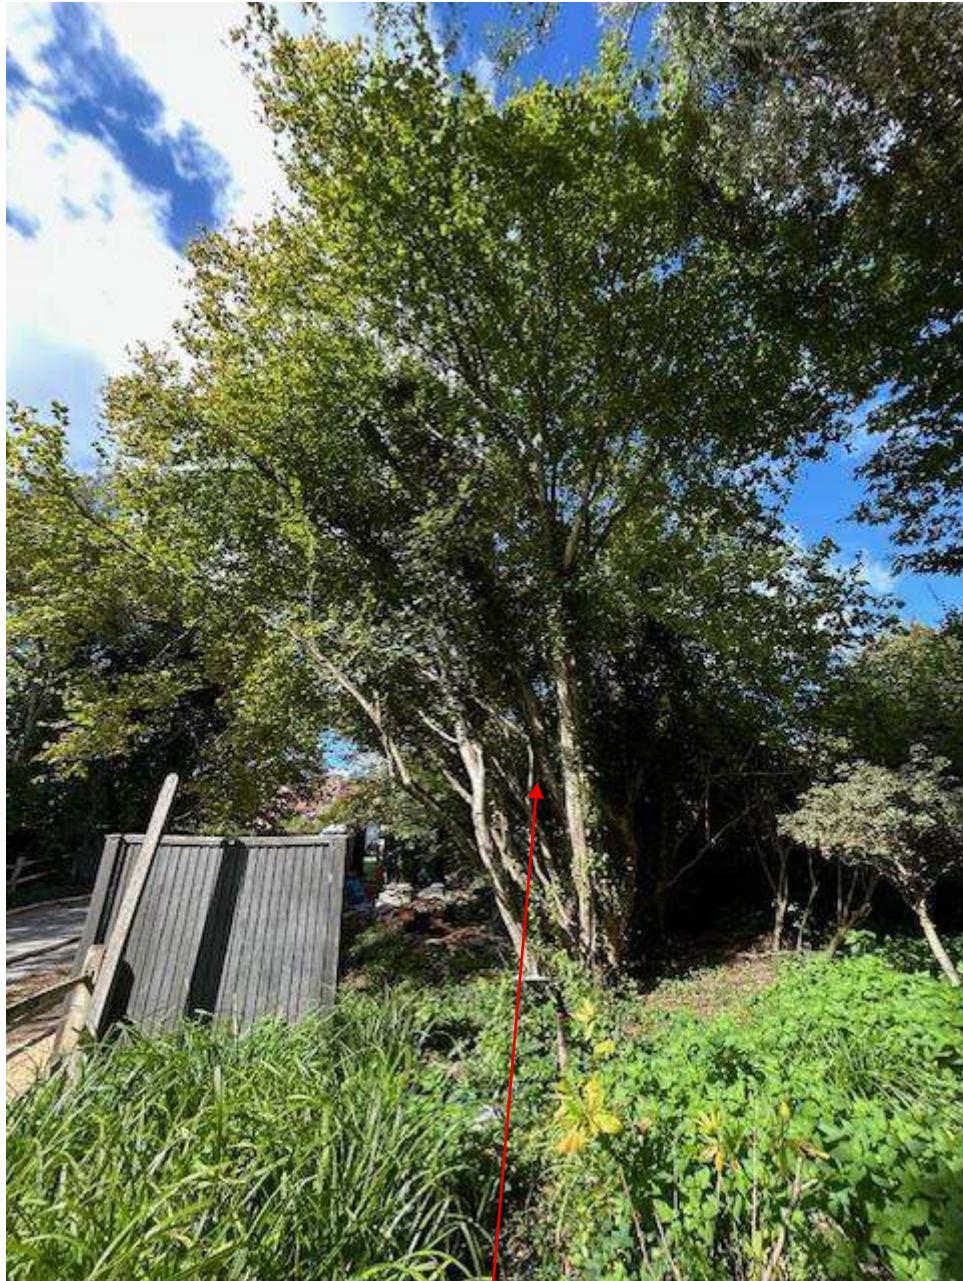
| G3 | 3 no. Common hazel | C.1.2. | South-western side of the RPA by 77m <sup>2</sup> /25% of the total RPA.<br>Extent of encroachment – significant. |

Photograph 15 – Group of 3 no. mature coppice hazel trees (G3) recommended for re-coppicing due to significant incursions within the RPA from the proposed new underground foul water mains.

- 4.3.5 A section of the proposed new underground foul water main services will significantly impact on G3. 3 no. common hazel (Photograph 15, Appendix E). It is recommended that these mature coppice trees are re-coppiced prior to the trenching operations, to ensure their safe, long-term retention.

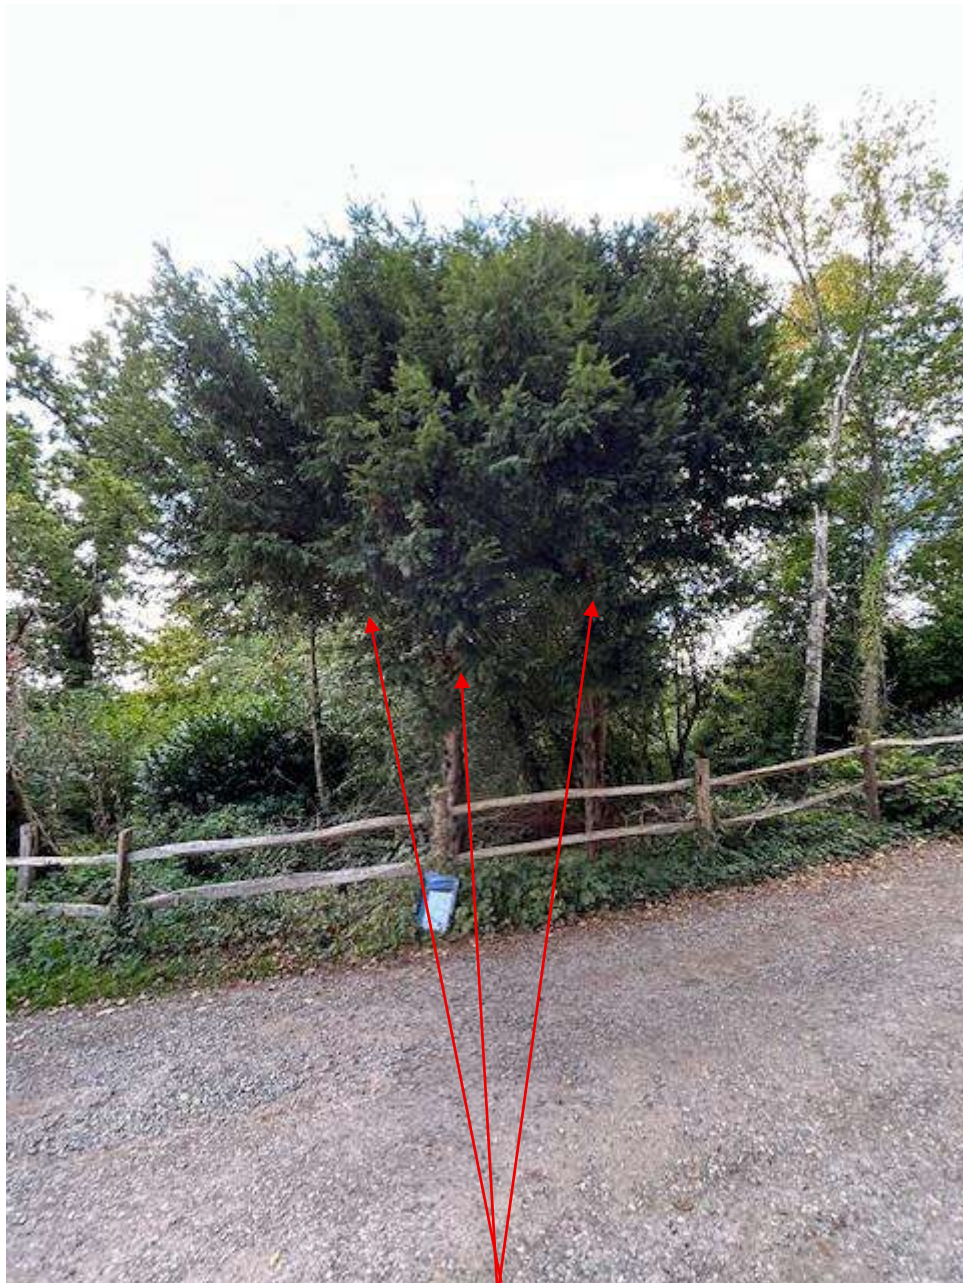
Photograph 16 – Group of 2 no. common yew trees (G4) with low branches over the access drive.

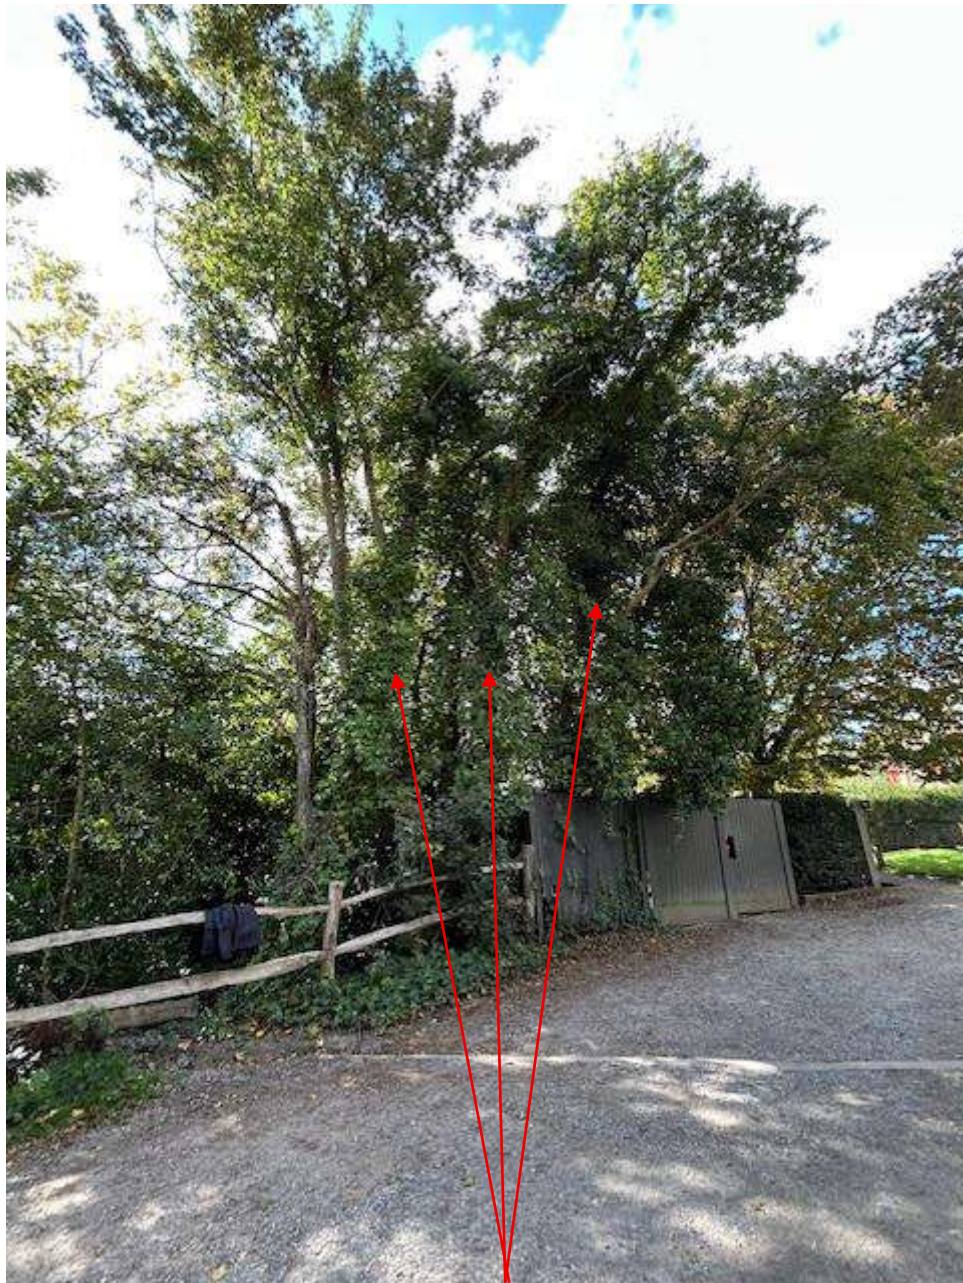
| Tree and Tag No<br>Species | Hght<br>(m) | Stems | | Crown | | Age | RP<br>A (m²)<br>R (m) | Phys<br>Condition | Structural<br>Condition | Preliminary Recommendations | | | Cat<br>ERC |
|---|---|---|---|---|---|---|---|---|---|---|---|--|---|
| | | | | E | 5 | 5 | | | | | A group of 1 no. single-stemmed, 1 no. twin-stemmed, and 1 no. triple-stemmed field maple trees overhanging main access road.<br>Dense ivy growth on main stems and in crowns hiding possible defects and adding weight to crowns.<br>Sever and remove a section of ivy from around the circumference of each stem base. | | 20 to 40 yrs |

Photograph 17 - Group of 3 no. field maple (G5) with dense ivy on main stems and in crowns hiding possible defects and adding weight to crowns.

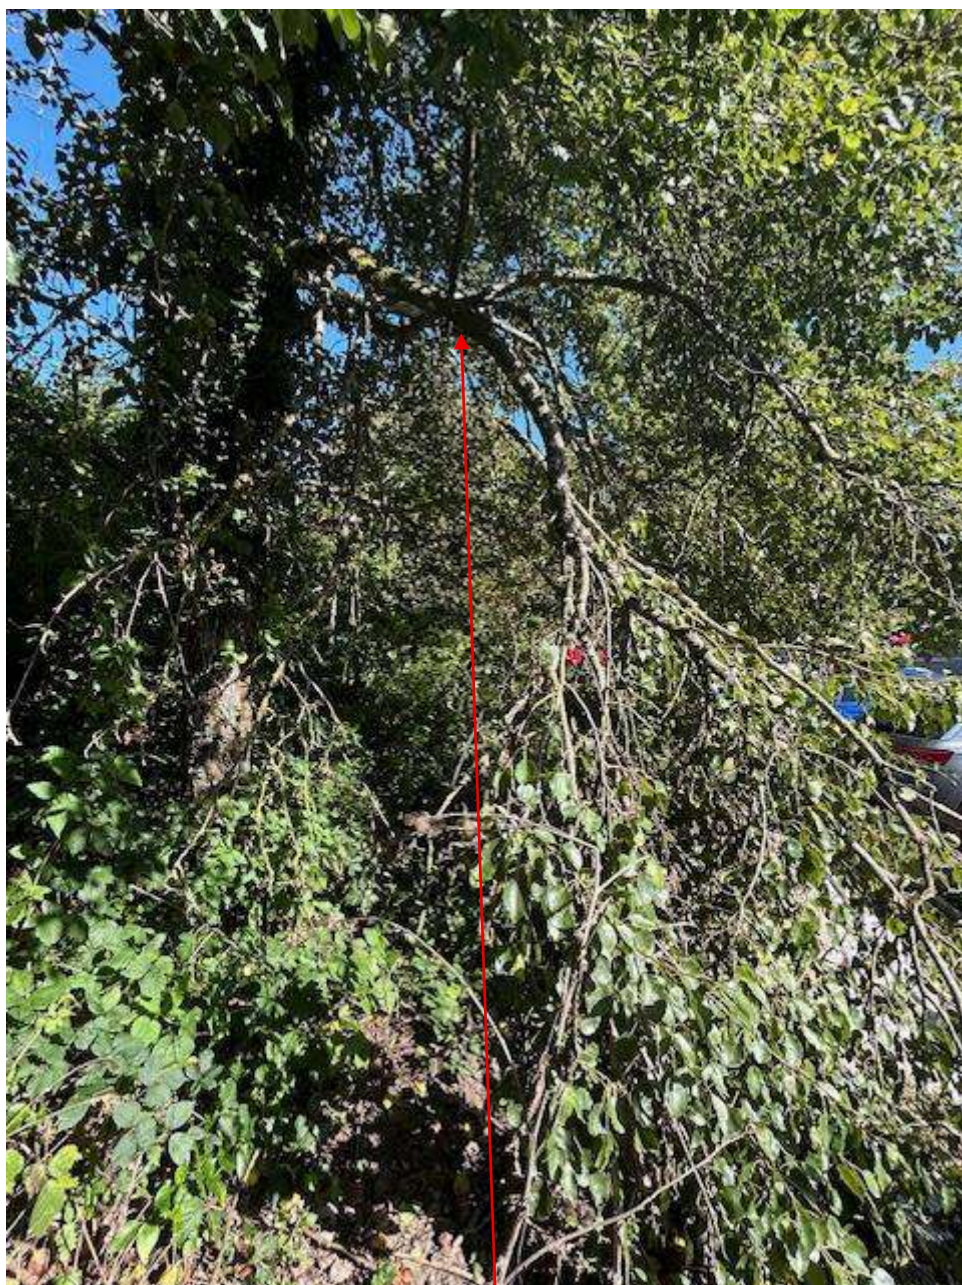
| Tree and Tag No<br>Species | Hght<br>(m) | Stems | | Crown | | Age | RP<br>A (m²)<br>R (m) | Phys<br>Condition | Structural<br>Condition | Preliminary Recommendations | | | Cat<br>ERC |
|---|---|---|---|---|---|---|---|---|---|---|---|--|---|
| | | | | S | 4 | 1 | | | | | Tree growing on raised bank.<br>1 no. partially broken, hanging branch on south-eastern side of crown at a height of approximately 2.5m. | | |

Photograph 18 – Common pear (T2) with 1 no. partially broken, hanging branch on south-eastern side of crown at a height of approximately 1.5m.

| Tree No. | Species. | Proposed Works. | Reason. |
|---|---|---|---|
| T2 | Common pear<br>(Photograph 18, Appendix E). | Remove 1 no. partially broken, hanging branch on south-eastern side of crown at a height of approximately 1.5m. | Safety works. |

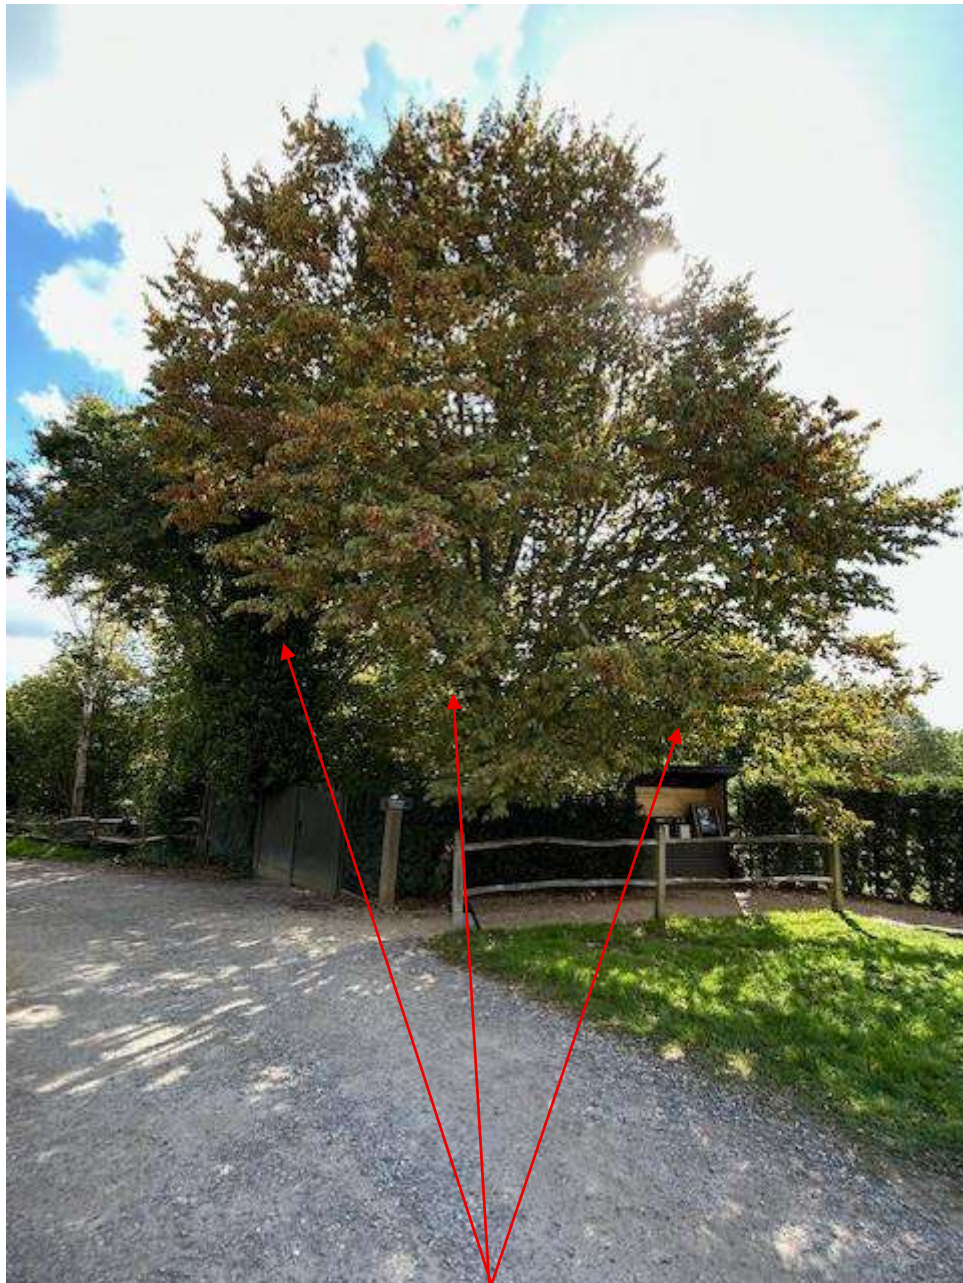
Photograph 19 – Common hornbeam (T6) with low branches overhanging access drive and footpath.

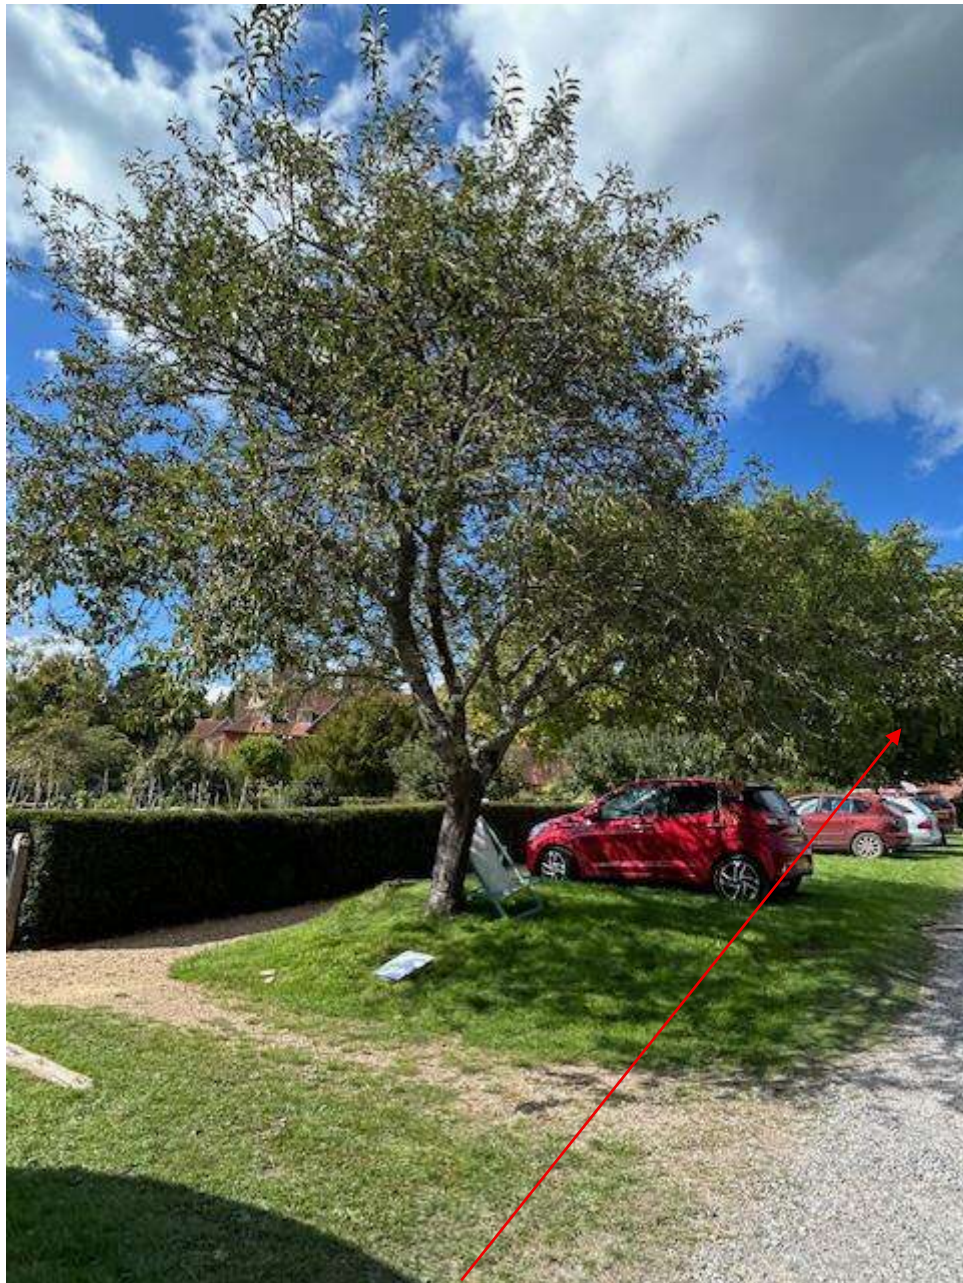
Photograph 20 – Wild cherry (T7) with low branches overhanging edge of access drive.

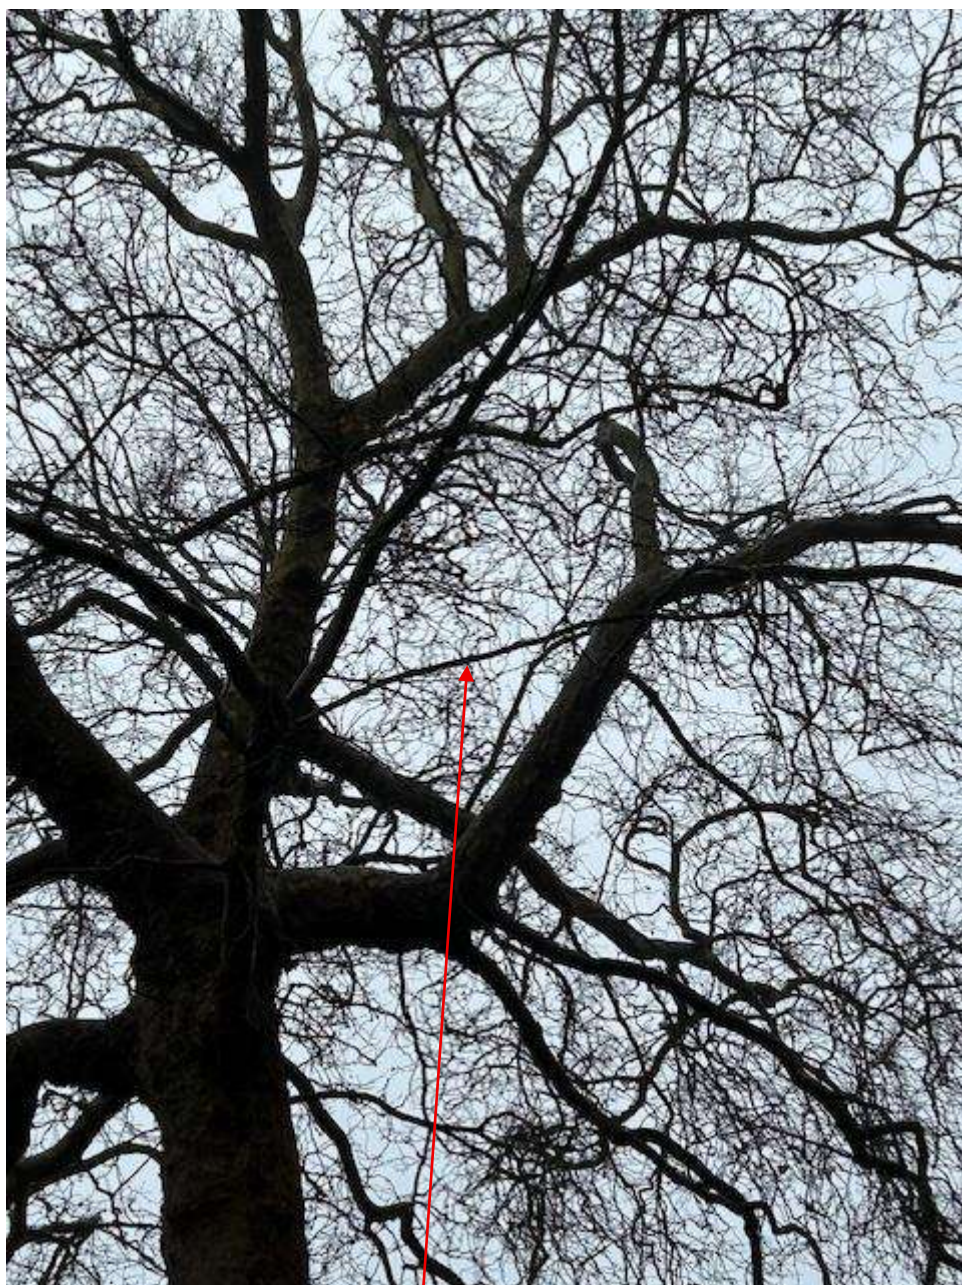
Photograph 21 – London plane (T10) with 1 no. broken, suspended branch in north-eastern side of crown at a height of approximately 10m.

| Tree No. | Species. | Proposed Works. | Reason. |
|---|---|---|---|
| T10 | London plane<br>(Photograph 21, Appendix E). | Remove 1 no. broken, suspended branch in north-eastern side of crown at a height of approximately 10m. | Safety works. |
