Title Listing Wall Assessment

Date 08-Jul-2023  
Doc Number 25632456  
Rev 01

Address 56 High St  
Lindfield  
West Sussex  
RH16 2HL

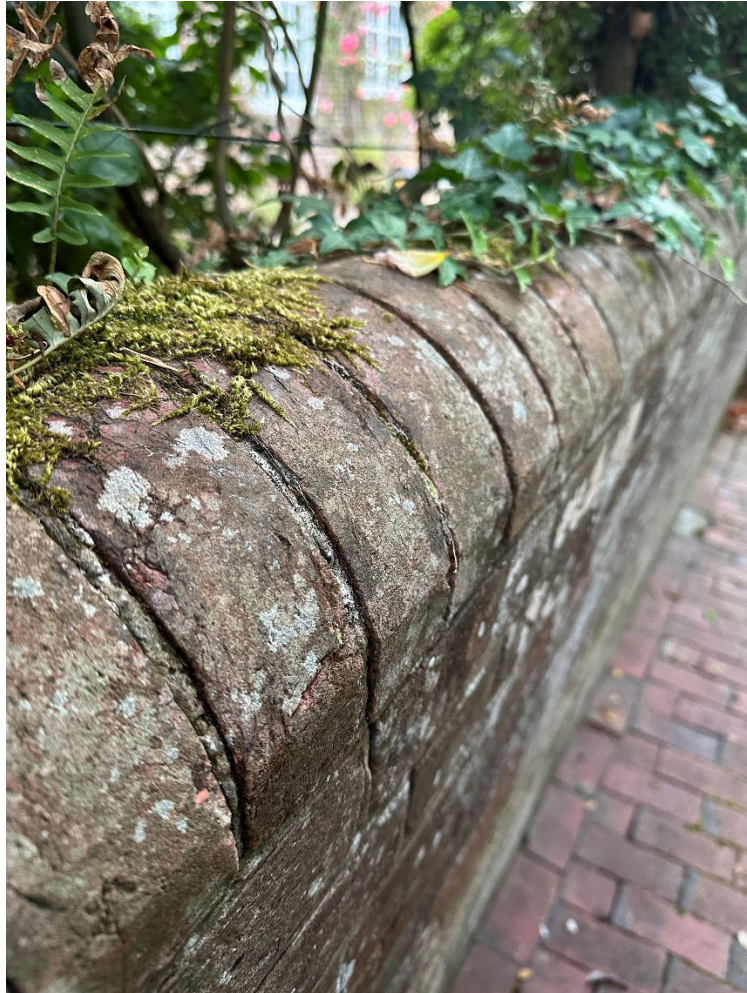
The main section of low-level wall is constructed from brick and mortar, with a half round curved coping brick capping the wall, as seen in the image below.

Constructed to a height of 1.35m, measured from the southern side of 56 High St and 15m in length, with a 1.4m return to the Eastern end.

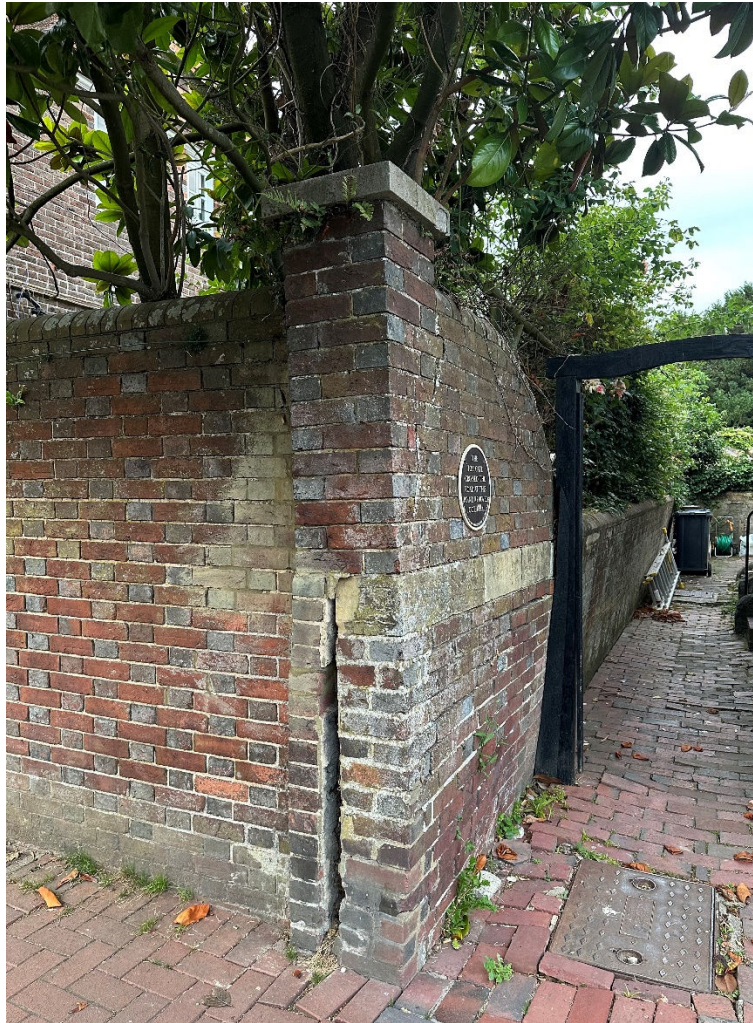
To the front of 58 High St, the wall has been constructed to a height of approximately 2.05m and can be seen to envelop the smaller original party wall, please see image below.

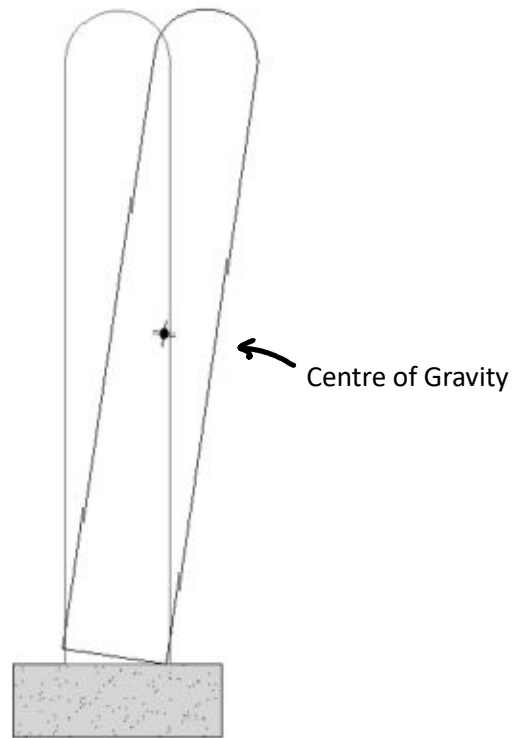
The wall is listing at an average angle of 8.7 degrees toward the South.

The 1.35m wall is listing to 8.7 degrees.

The wall is listing to a point where its centre of gravity is at the edge of its boundary and is at the edge of the mass of the wall.
