# The Peredur Centre, West Hoathly Road, East Grinstead, RH19 4NF

Tree Condition Report

28th May 2026

| Report reference: | DTE 26091 |

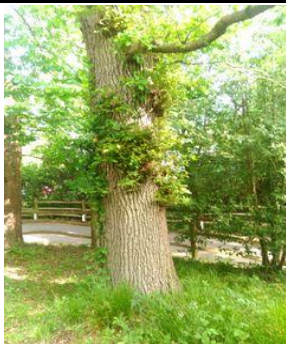
| Clickable link for Excel and PDF | Species | Measurements | Survey notes | Physiological Condition | Structural Condition | Risk Assessment | Risk Rating | Tree work recommendations | Photo | Ash Dieback Cat | What 3 Words |
|---|---|---|---|---|---|---|---|---|---|---|---|
| <a href="#">T0232</a> | Oak<br>( <i>Quercus sp.</i> ) | Height (m): 20<br>Life Stage: Mature | Tree adjoining entrance and roadway with significant dead wood | Normal | Critical | Likelihood of Failure: Imminent<br>Likelihood of Impact: Medium<br>Failure x Impact: Likely<br>Consequences: Minor<br>Risk Rating: Moderate | Moderate | Remove major deadwood only | | | ///glove.inp<br>ut.lovely |

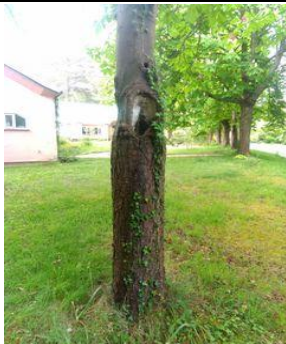
| Clickable link for Excel and PDF | Species | Measurements | Survey notes | Physiological Condition | Structural Condition | Risk Assessment | Risk Rating | Tree work recommendations | Photo | Ash Dieback Cat | What 3 Words |
|---|---|---|---|---|---|---|---|---|---|---|---|
| <a href="#">T0233</a> | Horse chestnut<br>( <i>Aesculus hippocastanum</i> ) | Height (m): 15<br>Life Stage: Early Mature | Significant decay at base overhanging entrance way | Below-average | Critical | Likelihood of Failure: Probable<br>Likelihood of Impact: High<br>Failure x Impact: Likely<br>Consequences: Significant<br>Risk Rating: High | High | Fell to as close to ground level as possible | | | ///meals.red<br>s.courier |

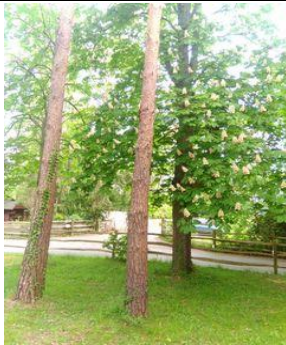
| Clickable link for Excel and PDF | Species | Measurements | Survey notes | Physiological Condition | Structural Condition | Risk Assessment | Risk Rating | Tree work recommendations | Photo | Ash Dieback Cat | What 3 Words |
|---|---|---|---|---|---|---|---|---|---|---|---|
| <a href="#">T0234</a> | Scots pine<br>( <i>Pinus sylvestris</i> ) | Height (m): 18<br>Life Stage: Mature | Standing dead tree within group of 7 Scots pine | Dead | Critical | Likelihood of Failure: Imminent<br>Likelihood of Impact: High<br>Failure x Impact: Very likely<br>Consequences: Significant<br>Risk Rating: High | High | Fell to as close to ground level as possible | | | ///driver.he<br>ars.mass |

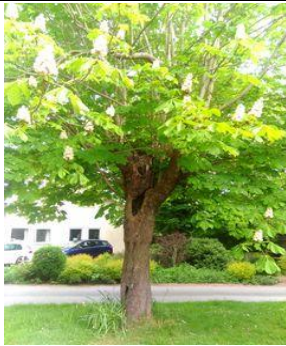
| Clickable link for Excel and PDF | Species | Measurements | Survey notes | Physiological Condition | Structural Condition | Risk Assessment | Risk Rating | Tree work recommendations | Photo | Ash Dieback Cat | What 3 Words |
|---|---|---|---|---|---|---|---|---|---|---|---|
| <a href="#">T0235</a> | Horse chestnut<br>( <i>Aesculus hippocastanum</i> ) | Height (m): 8<br>Life Stage: Mature | Pollarded tree with significant decay overhanging driveway | Normal | Critical | Likelihood of Failure: Probable<br>Likelihood of Impact: High<br>Failure x Impact: Likely<br>Consequences: Significant<br>Risk Rating: High | High | Fell to as close to ground level as possible<br><br>Note - standing dead stem adjacent could be removed at same time but currently poses no safety issues due to monolithed state | | | ///season.ch<br>ill.serve |

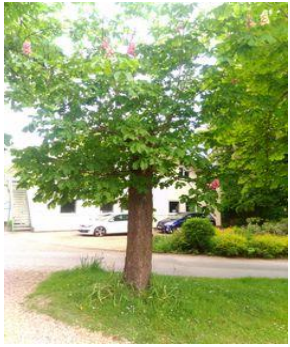
| <a href="#">T0236</a> | Horse chestnut<br>( <i>Aesculus hippocastanum</i> ) | Height (m): 6<br>Life Stage: Mature | Pollarded tree with decay from previous pruning | Normal | Manageable | Likelihood of Failure: Possible<br>Likelihood of Impact: High<br>Failure x Impact: Somewhat likely<br>Consequences: Significant<br>Risk Rating: Moderate | Moderate | Re pollard to previous points | | | ///gloves.sn<br>aps.barks |

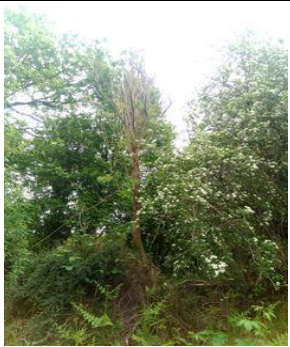
| <a href="#">T0237</a> | Ash<br>( <i>Fraxinus sp.</i> ) | Height (m): 6<br>Life Stage: Young | Almost dead tree adjoining roadway | Dying | Irremediable | Likelihood of Failure: Probable<br>Likelihood of Impact: High<br>Failure x Impact: Likely<br>Consequences: Severe<br>Risk Rating: High | High | Fell to ground level | | Ash Dieback Health<br>Class 4 - 25%-0%<br>remaining canopy | ///slang.tow<br>n.bless |

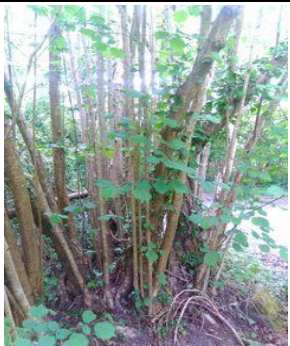
| <a href="#">T0238</a> | Hazel<br>( <i>Corylus avellana</i> ) | Height (m): 6<br>Stems: 20<br>Life Stage: Mature | Coppice tree fouling power lines | Normal | Manageable | Likelihood of Failure: Imminent<br>Likelihood of Impact: High<br>Failure x Impact: Very likely<br>Consequences: Significant<br>Risk Rating: High | High | Re Coppice to 0.5m above ground level to remove fouling of power line | | | ///assist.sca<br>rf.tolls |

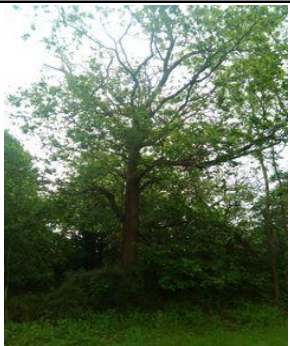
| <a href="#">T0239</a> | Oak<br>( <i>Quercus sp.</i> ) | Height (m): 16<br>Life Stage: Mature | Re trenching canopy overhanging roadway | Below-average | Manageable | Likelihood of Failure: Probable<br>Likelihood of Impact: High<br>Failure x Impact: Likely<br>Consequences: Minor<br>Risk Rating: Moderate | Moderate | Reduce by 4m to remove deadwood at top and over road and to reduce over grown stems on property side | | | ///loose.lea<br>ds.drops |

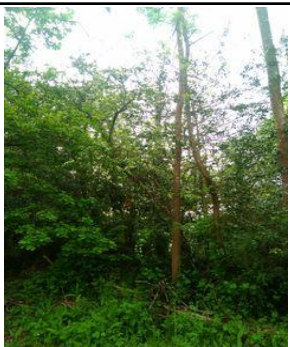
| <a href="#">T0240</a> | Common hawthorn<br>( <i>Crataegus monogyna</i> ) | Height (m): 6<br>Life Stage: Late Mature | Benched tree on power line overhanging road | Normal | Irremediable | Likelihood of Failure: Imminent<br>Likelihood of Impact: High<br>Failure x Impact: Very likely<br>Consequences: Significant<br>Risk Rating: High | High | Fell to as close to ground level as possible | | | ///vine.deep<br>ly.mess |

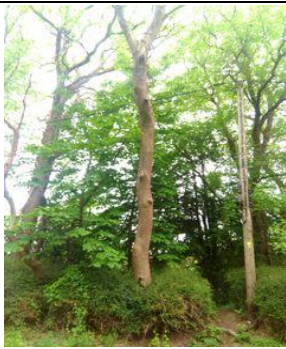
| <a href="#">T0241</a> | Ash<br>( <i>Fraxinus sp.</i> ) | Height (m): 18<br>Life Stage: Mature | Wound at base that is occluding well. One significant dead branch over roadway | Normal | Manageable | Likelihood of Failure: Imminent<br>Likelihood of Impact: High<br>Failure x Impact: Very likely<br>Consequences: Significant<br>Risk Rating: High | High | Remove major deadwood | | Ash Dieback Health Class 1 - 100%-75% remaining canopy | ///laws.zone<br>s.song |

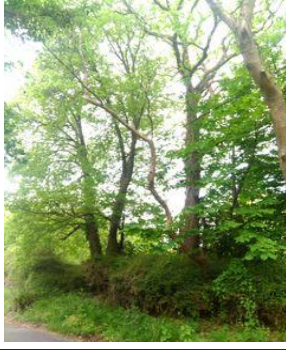
| <a href="#">T0242</a> | Ash<br>( <i>Fraxinus sp.</i> ) | Height (m): 8<br>Life Stage: Young | Standing dead tree over road | Dead | Critical | Likelihood of Failure: Imminent<br>Likelihood of Impact: High<br>Failure x Impact: Very likely<br>Consequences: Significant<br>Risk Rating: High | High | Fell to as close to ground level as possible | | Ash Dieback Health Class 4 - 25%-0% remaining canopy | ///priced.pa<br>rent.office |

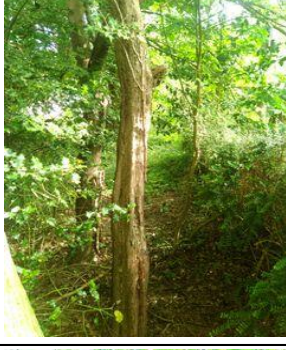
| <a href="#">T0243</a> | Common hawthorn<br>( <i>Crataegus monogyna</i> ) | Height (m): 7<br>Life Stage: Early Mature | Standing dead tree | Dead | Critical | Likelihood of Failure: Probable<br>Likelihood of Impact: High<br>Failure x Impact: Likely<br>Consequences: Significant<br>Risk Rating: High | High | Fell to as close to ground level as possible | | | ///radio.sca<br>n.payer |

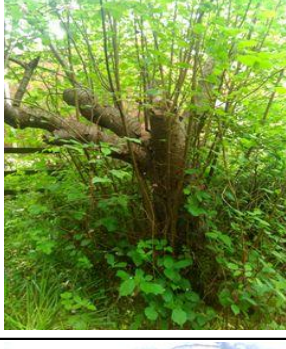
| <a href="#">T0244</a> | Cherry<br>( <i>Prunus sp.</i> 'Cherry') | Height (m): 3<br>Stems: 4<br>Life Stage: Mature | Severely decayed tree overhanging private residence | Below-average | Critical | Likelihood of Failure: Probable<br>Likelihood of Impact: High<br>Failure x Impact: Likely<br>Consequences: Minor<br>Risk Rating: Moderate | Moderate | Fell to. As close to ground level as possible | | | ///face.flap.<br>coach |

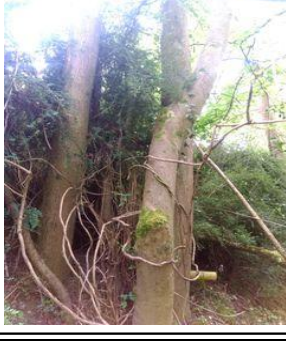
| <a href="#">T0245</a> | Ash<br>( <i>Fraxinus sp.</i> ) | Height (m): 18<br>Stems: 2<br>Life Stage: Mature | Two larger trees behind bungalow in woodland within falling distance of priority | Below-average | Manageable | Likelihood of Failure: Probable<br>Likelihood of Impact: Medium<br>Failure x Impact: Somewhat likely<br>Consequences: Significant<br>Risk Rating: Moderate | Moderate | Reduce to height if other adjacent previously reduce trees removing 6m of growth | | Ash Dieback Health Class 2 - 75%-50% remaining canopy | ///voices.tri<br>ps.dare |

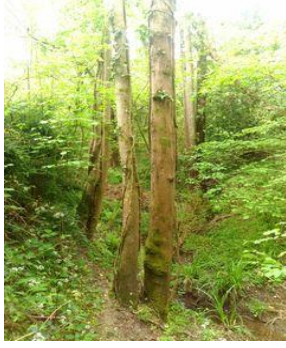
| <a href="#">T0246</a> | Ash<br>( <i>Fraxinus sp.</i> ) | Height (m): 18<br>Stems: 2<br>Life Stage: Mature | Two trees within falling distance of property | Low | Manageable | Likelihood of Failure: Probable<br>Likelihood of Impact: Medium<br>Failure x Impact: Somewhat likely<br>Consequences: Significant<br>Risk Rating: Moderate | Moderate | Reduce to height of previously reduce adjacent ash removing 6m | | Ash Dieback Health Class 3 - 50%-25% remaining canopy<br>Ash Dieback Health Class 4 - 25%-0% remaining canopy | ///habit.system.rock |

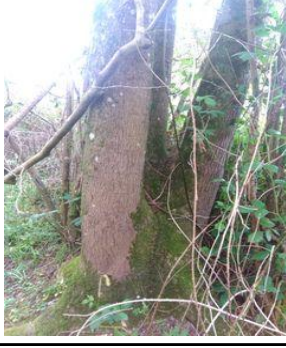
| <a href="#">T0247</a> | Ash<br>( <i>Fraxinus sp.</i> ) | Height (m): 18<br>Stems: 3<br>Life Stage: Late Mature | Dying tree on edge of woodland overhanging footpath | Dying | Irremediable | Likelihood of Failure: Probable<br>Likelihood of Impact: Medium<br>Failure x Impact: Somewhat likely<br>Consequences: Significant<br>Risk Rating: Moderate | Moderate | Monolith to 8m from ground level | | Ash Dieback Health Class 4 - 25%-0% remaining canopy | ///spark.labels.every |

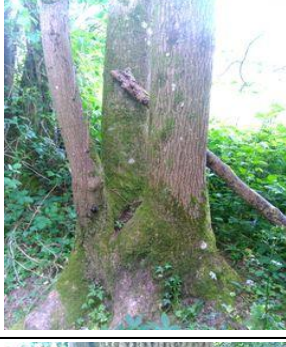
| <a href="#">T0248</a> | Ash<br>( <i>Fraxinus sp.</i> ) | Height (m): 18<br>Stems: 3<br>Life Stage: Mature | Standing dead tree | Dead | Critical | Likelihood of Failure: Probable<br>Likelihood of Impact: Medium<br>Failure x Impact: Somewhat likely<br>Consequences: Significant<br>Risk Rating: Moderate | Moderate | Fell to ground level due to dead nature | | Ash Dieback Health Class 4 - 25%-0% remaining canopy | ///grand.carbon.bump |

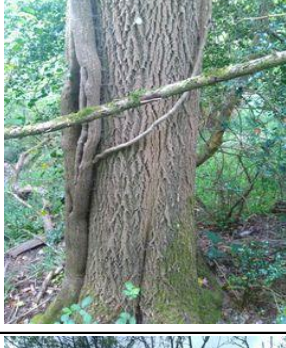
| <a href="#">T0249</a> | Ash<br>( <i>Fraxinus sp.</i> ) | Height (m): 20<br>Life Stage: Late Mature | Standing dead tree visible from walkway over broom | Dead | Critical | Likelihood of Failure: Probable<br>Likelihood of Impact: Medium<br>Failure x Impact: Somewhat likely<br>Consequences: Significant<br>Risk Rating: Moderate | Moderate | Fell to ground level given dead nature | | Ash Dieback Health Class 4 - 25%-0% remaining canopy | ///ropes.rats.margin |

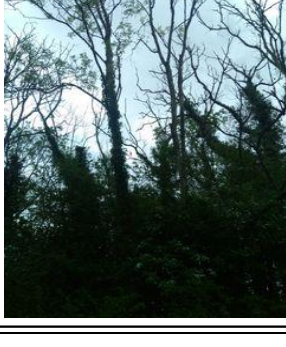
| <a href="#">T0250</a> | Ash<br>( <i>Fraxinus sp.</i> ) | Height (m): 16<br>Stems: 2<br>Life Stage: Mature | Declining tree overhanging footpath | Dying | Irremediable | Likelihood of Failure: Probable<br>Likelihood of Impact: Medium<br>Failure x Impact: Somewhat likely<br>Consequences: Significant<br>Risk Rating: Moderate | Moderate | Fell to ground level | | Ash Dieback Health Class 4 - 25%-0% remaining canopy | ///swift.splice.cats |

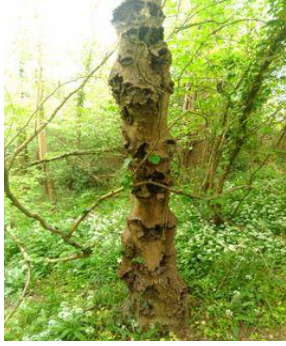
| <a href="#">T0251</a> | Ash<br>( <i>Fraxinus sp.</i> ) | Height (m): 15<br>Life Stage: Mature | Standing dead tree | Dead | Irremediable | Likelihood of Failure: Probable<br>Likelihood of Impact: Medium<br>Failure x Impact: Somewhat likely<br>Consequences: Significant<br>Risk Rating: Moderate | Moderate | Fell to ground level | | Ash Dieback Health<br>Class 4 - 25%-0%<br>remaining canopy | ///honey.pr<br>ess.policy |

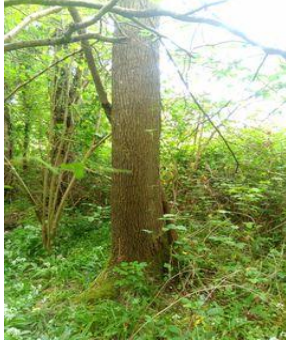
| <a href="#">T0253</a> | Ash<br>( <i>Fraxinus sp.</i> ) | Height (m): 20<br>Life Stage: Mature | Standing dead tree over<br>footpath | Dead | Critical | Likelihood of Failure: Probable<br>Likelihood of Impact: Medium<br>Failure x Impact: Somewhat likely<br>Consequences: Significant<br>Risk Rating: Moderate | Moderate | Fell to ground level | | Ash Dieback Health<br>Class 4 - 25%-0%<br>remaining canopy | ///object.tri<br>m.mining |

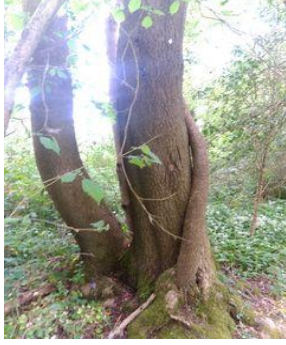
| <a href="#">T0257</a> | Ash<br>( <i>Fraxinus sp.</i> ) | Height (m): 20<br>Life Stage: Mature | Dying tree within minimal<br>canopy coverage<br>overhanging footpath | Dying | Irremediable | Likelihood of Failure: Probable<br>Likelihood of Impact: Medium<br>Failure x Impact: Somewhat likely<br>Consequences: Significant<br>Risk Rating: Moderate | Moderate | Fell to ground level | | Ash Dieback Health<br>Class 4 - 25%-0%<br>remaining canopy | ///eagle.for<br>got.salon |

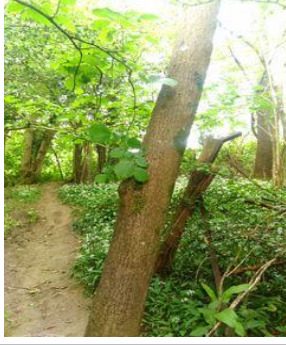
| <a href="#">T0258</a> | Ash<br>( <i>Fraxinus sp.</i> ) | Height (m): 13<br>Life Stage: Mature | Standing dead tree over<br>footpath | Dead | Irremediable | Likelihood of Failure: Probable<br>Likelihood of Impact: Medium<br>Failure x Impact: Somewhat likely<br>Consequences: Significant<br>Risk Rating: Moderate | Moderate | Fell to ground level | | Ash Dieback Health<br>Class 4 - 25%-0%<br>remaining canopy | ///washed.p<br>ens.pouch |

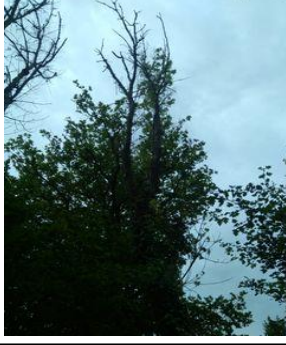
| <a href="#">T0259</a> | Ash<br>( <i>Fraxinus sp.</i> ) | Height (m): 16<br>Life Stage: Mature | Dying tree within falling<br>distance of house | Dying | Irremediable | Likelihood of Failure: Probable<br>Likelihood of Impact: High<br>Failure x Impact: Likely<br>Consequences: Severe<br>Risk Rating: High | High | Fell to ground level | | Ash Dieback Health<br>Class 4 - 25%-0%<br>remaining canopy | ///behave.n<br>otice.water |

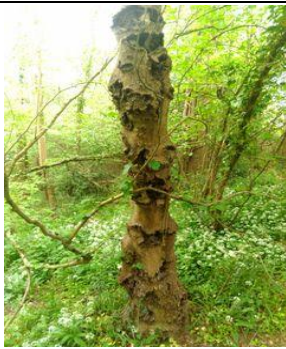
| <a href="#">T0251</a> | Ash<br>( <i>Fraxinus sp.</i> ) | Height (m): 15<br>Life Stage: Mature | Standing dead tree | Dead | Irremediable | Likelihood of Failure: Probable<br>Likelihood of Impact: Medium<br>Failure x Impact: Somewhat likely<br>Consequences: Significant<br>Risk Rating: Moderate | Moderate | Fell to ground level | | Ash Dieback Health<br>Class 4 - 25%-0%<br>remaining canopy | ///honey.pr<br>ess.policy |

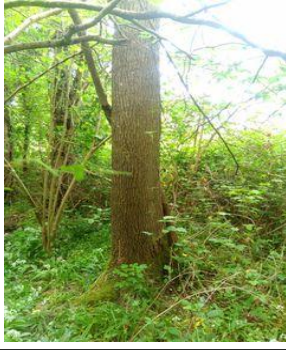
| <a href="#">T0253</a> | Ash<br>( <i>Fraxinus sp.</i> ) | Height (m): 20<br>Life Stage: Mature | Standing dead tree over<br>footpath | Dead | Critical | Likelihood of Failure: Probable<br>Likelihood of Impact: Medium<br>Failure x Impact: Somewhat likely<br>Consequences: Significant<br>Risk Rating: Moderate | Moderate | Fell to ground level | | Ash Dieback Health<br>Class 4 - 25%-0%<br>remaining canopy | ///object.tri<br>m.mining |

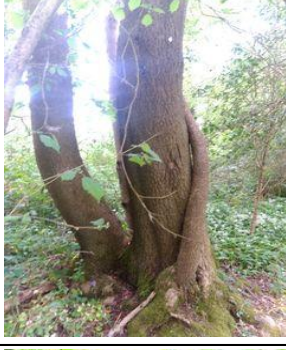
| <a href="#">T0257</a> | Ash<br>( <i>Fraxinus sp.</i> ) | Height (m): 20<br>Life Stage: Mature | Dying tree within minimal<br>canopy coverage<br>overhanging footpath | Dying | Irremediable | Likelihood of Failure: Probable<br>Likelihood of Impact: Medium<br>Failure x Impact: Somewhat likely<br>Consequences: Significant<br>Risk Rating: Moderate | Moderate | Fell to ground level | | Ash Dieback Health<br>Class 4 - 25%-0%<br>remaining canopy | ///eagle.for<br>got.salon |

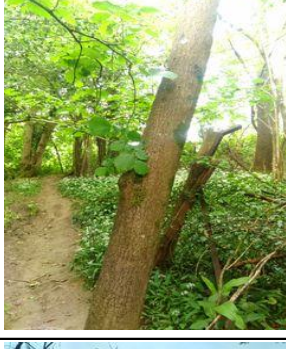
| <a href="#">T0258</a> | Ash<br>( <i>Fraxinus sp.</i> ) | Height (m): 13<br>Life Stage: Mature | Standing dead tree over<br>footpath | Dead | Irremediable | Likelihood of Failure: Probable<br>Likelihood of Impact: Medium<br>Failure x Impact: Somewhat likely<br>Consequences: Significant<br>Risk Rating: Moderate | Moderate | Fell to ground level | | Ash Dieback Health<br>Class 4 - 25%-0%<br>remaining canopy | ///washed.p<br>ens.pouch |

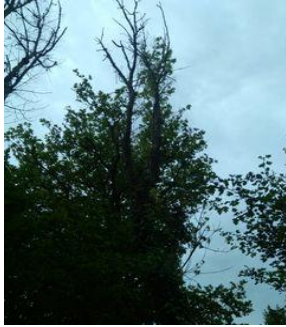
| <a href="#">T0259</a> | Ash<br>( <i>Fraxinus sp.</i> ) | Height (m): 16<br>Life Stage: Mature | Dying tree within falling<br>distance of house | Dying | Irremediable | Likelihood of Failure: Probable<br>Likelihood of Impact: High<br>Failure x Impact: Likely<br>Consequences: Severe<br>Risk Rating: High | High | Fell to ground level | | Ash Dieback Health<br>Class 4 - 25%-0%<br>remaining canopy | ///behave.n<br>otice.water |

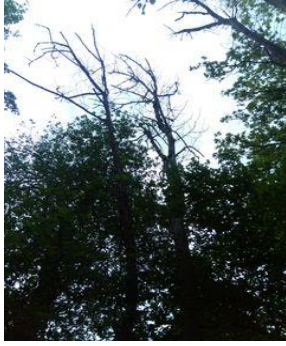
| <a href="#">T0262</a> | Ash<br>( <i>Fraxinus sp.</i> ) | Height (m): 14<br>Stems: 2<br>Life Stage: Mature | Standing dead tree | Dead | Critical | Likelihood of Failure: Probable<br>Likelihood of Impact: Medium<br>Failure x Impact: Somewhat likely<br>Consequences: Significant<br>Risk Rating: Moderate | Moderate | Fell to ground level | | Ash Dieback Health<br>Class 4 - 25%-0%<br>remaining canopy | ///give.wipe<br>s.crab |

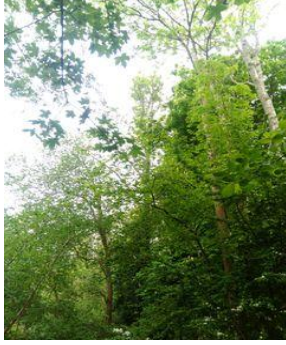
| <a href="#">T0263</a> | Ash<br>( <i>Fraxinus sp.</i> ) | Height (m): 18<br>Life Stage: Mature | Dying tree within falling<br>distance oh priperty | Dying | Irremediable | Likelihood of Failure: Probable<br>Likelihood of Impact: High<br>Failure x Impact: Likely<br>Consequences: Significant<br>Risk Rating: High | High | Fell to ground level | | Ash Dieback Health<br>Class 4 - 25%-0%<br>remaining canopy | ///admits.st<br>one.chefs |

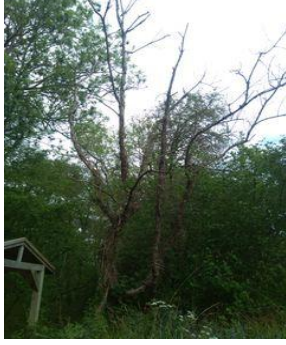
| <a href="#">T0264</a> | Ash<br>( <i>Fraxinus sp.</i> ) | Height (m): 10<br>Stems: 2<br>Life Stage: Mature | Standing dead tree<br>overhanging seating area<br>and carpark | Dead | Critical | Likelihood of Failure: Probable<br>Likelihood of Impact: High<br>Failure x Impact: Likely<br>Consequences: Significant<br>Risk Rating: High | High | Fell to ground level | | Ash Dieback Health<br>Class 4 - 25%-0%<br>remaining canopy | ///dared.coll<br>eague.strea<br>m |

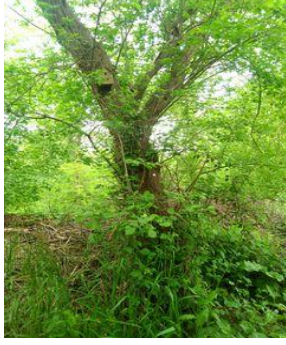
| <a href="#">T0265</a> | Goat willow<br>( <i>Salix caprea</i> ) | Height (m): 15<br>Life Stage: Mature | Decayed tree overhanging<br>seating area and pathway<br>into woodland | Normal | Manageable | Likelihood of Failure: Probable<br>Likelihood of Impact: Medium<br>Failure x Impact: Somewhat likely<br>Consequences: Significant<br>Risk Rating: Moderate | Moderate | Pollard to 4m in height | | | ///garage.fa<br>cing.boss |
