**Arboricultural Report – Southfields, Revision 1:  
Tree Survey,  
Arboricultural Impact Assessment,  
Arboricultural Method Statement  
& Tree Protection Plan**

Southfields, Keymer Road, Burgess Hill, RH15 0AW.

6<sup>th</sup> May 2026

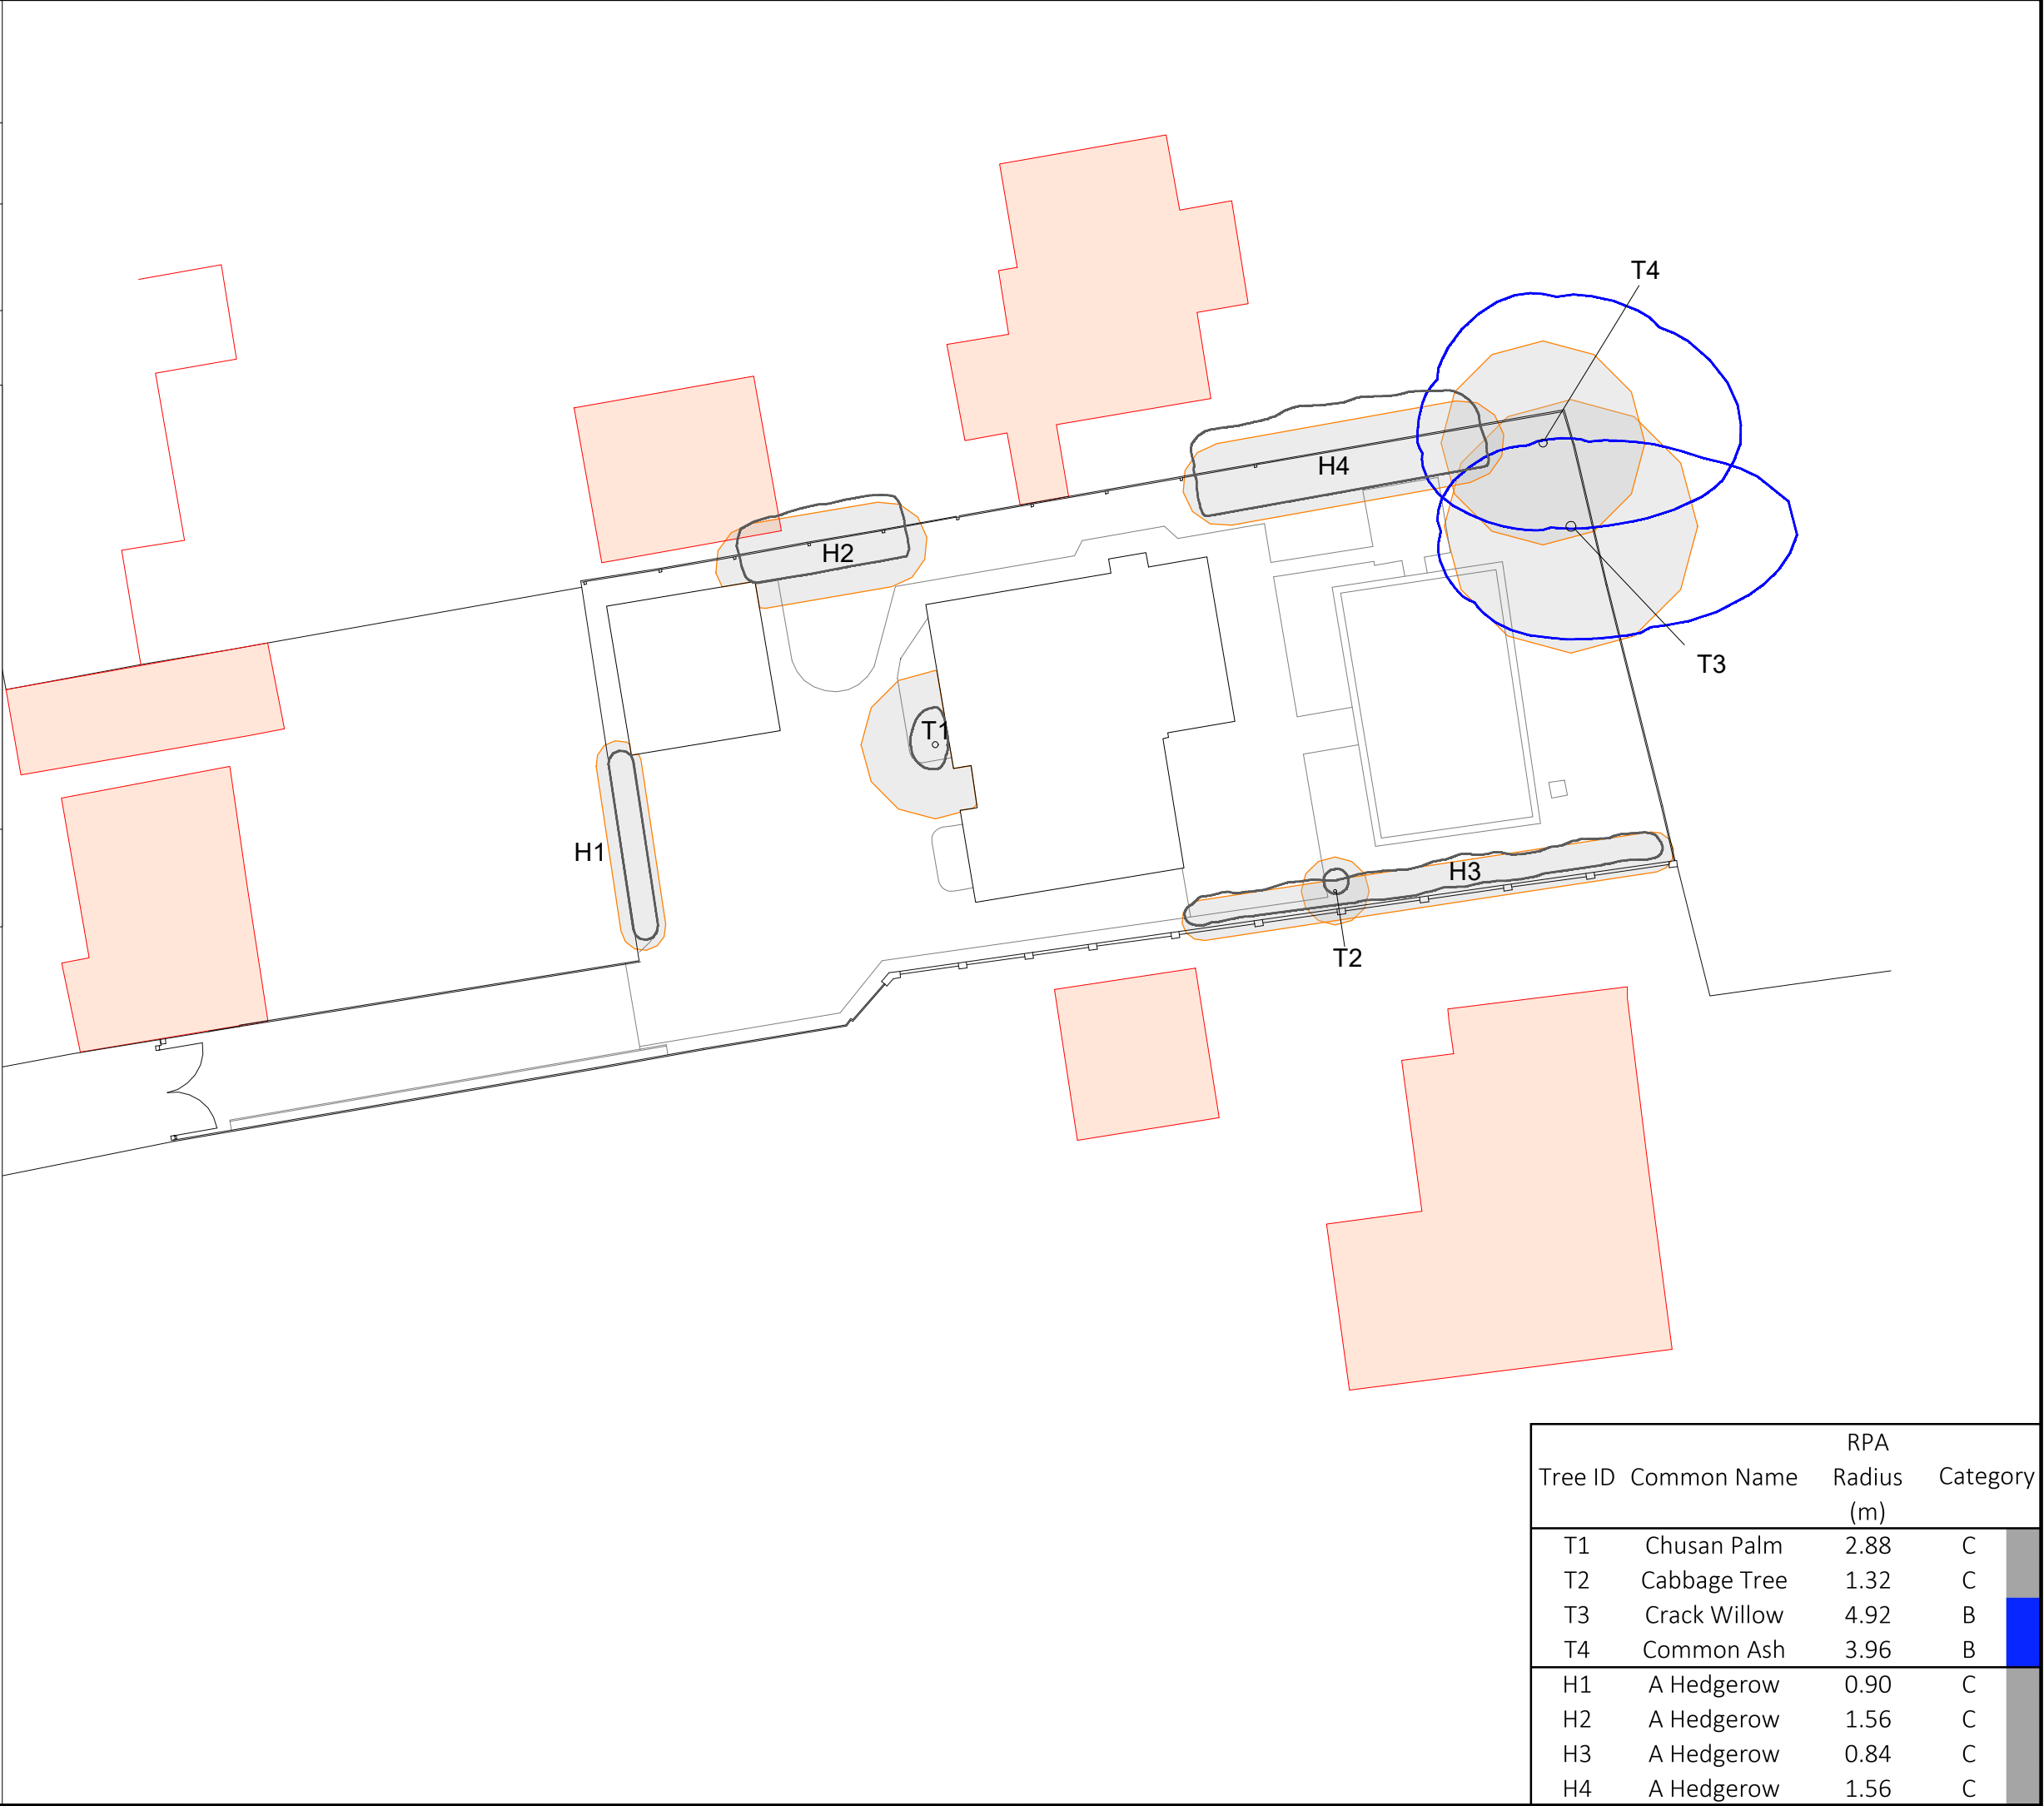
MAP FILENAME :  
Figure 1 - TCP Southfields 2026

5.6.1 The RPAs of the retained trees are calculated as recommended within BS 5837:2012. These areas are shown as shaded grey areas with a solid orange line on Figure 1 – TCP, and Figure 2 – TPP.

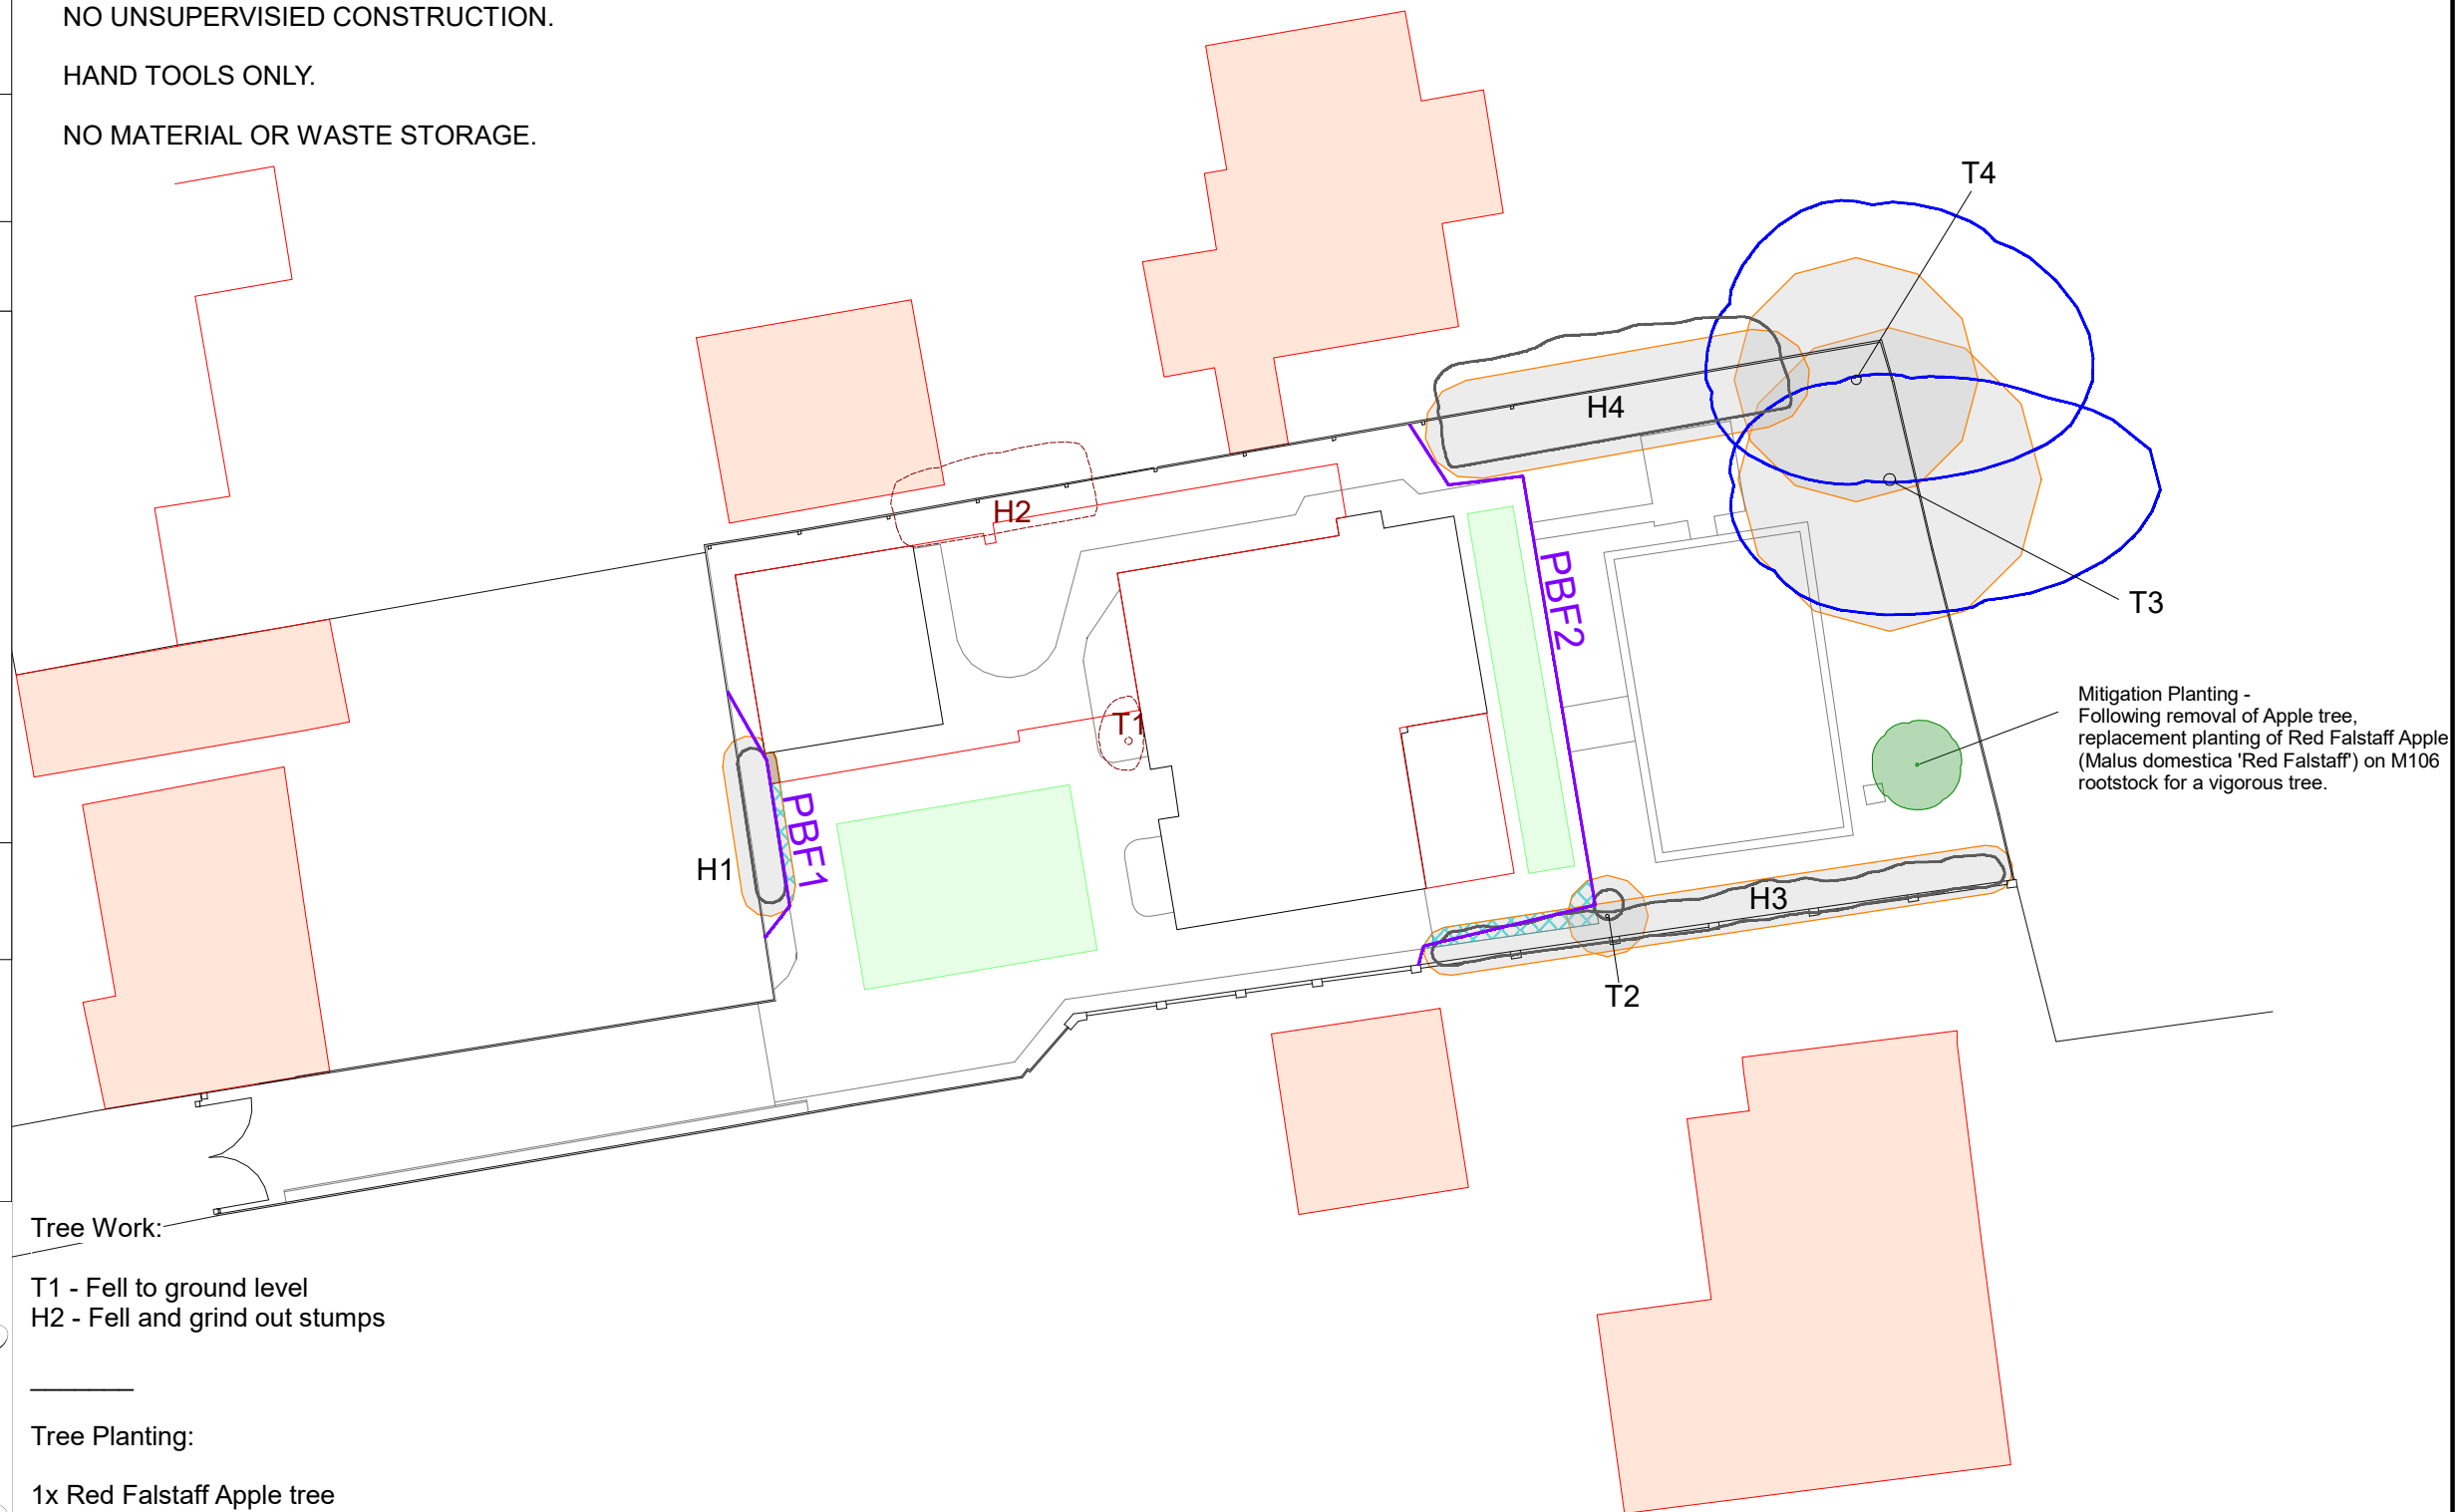
Removed Trees/hedges

6.8.4 Recommended planting placement has been plotted on the Tree Protection Plan - Figure 2. Locations have been selected based on the species requirements and with a view to maintain and improve the overall arboricultural value and visual amenity of the site.

Quarterly site visits.
