# LBM ECOLOGY

Preliminary Roost Assessment

Copthorne

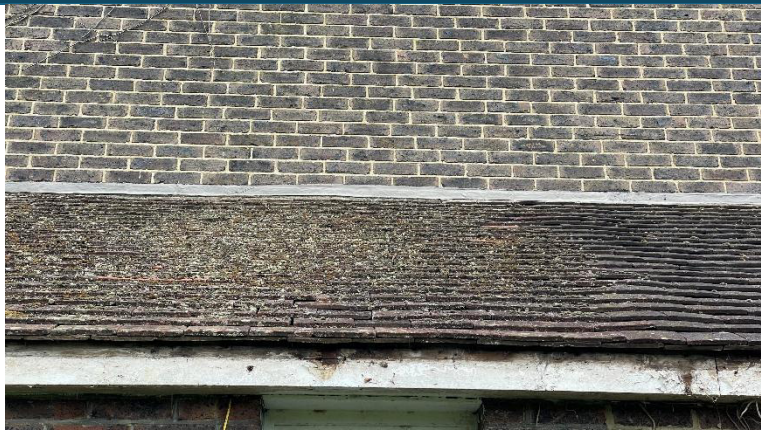
| Building No. | PRF Description | Photograph | Roosting Suitability |
|---|---|---|---|
| B1 | Lifted tile on the pitched eastern extension of B1, likely to be drafty. May lead to a small cavity between the tiles and base contained roof void. | | Moderate |

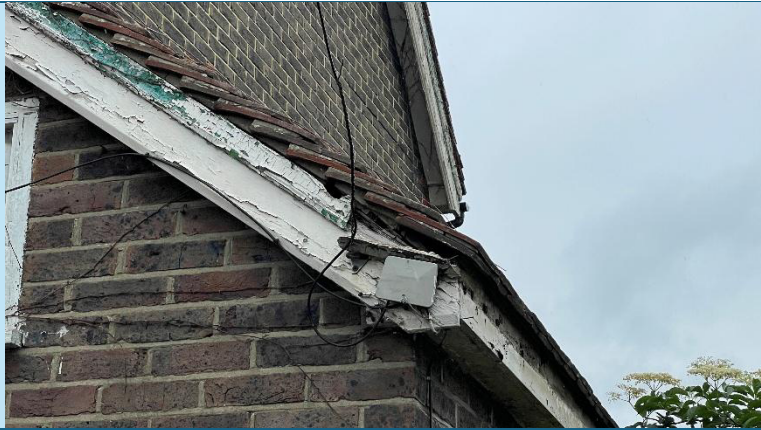
| Building No. | PRF Description | Photograph | Roosting Suitability |
|---|---|---|---|
| | Missing mortar under end tiles on the northern and southern aspects that leads to a small cavity between the base of the roof structure and tiles that extends the whole roof structure. It is approximately 4cm in height and 3cm wide. Is likely to be drafty due to the lifted tiles and missing mortar on both the southern and northern aspects. | | Moderate |

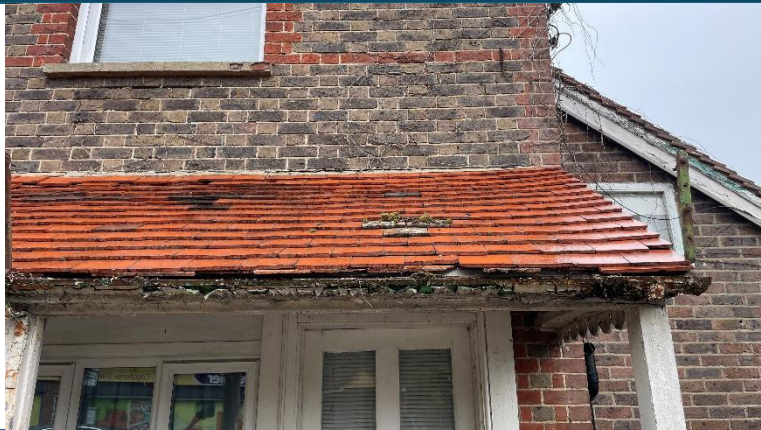
| Building No. | PRF Description | Photograph | Roosting Suitability |
|---|---|---|---|
| | Lifted tiles on the porch roof on the southern aspect of the building that leads to a small cavity between the base of porch roof and tiles. It is likely to be drafty due to the numerous lifted tiles and missing mortar on the western aspect. | | Moderate |

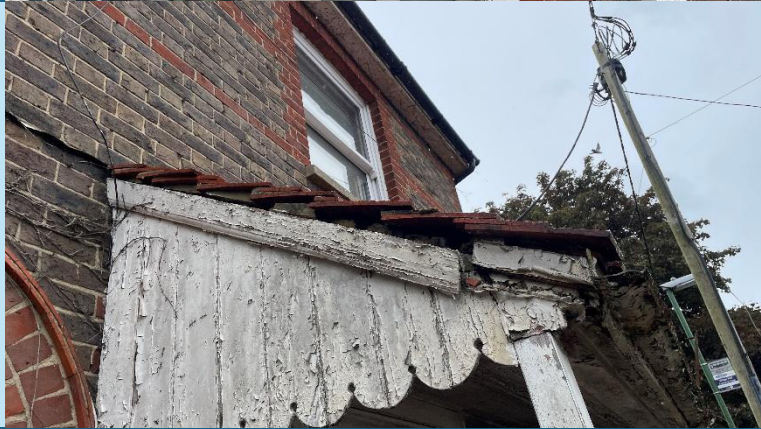
| Building No. | PRF Description | Photograph | Roosting Suitability |
|---|---|---|---|
| | Missing mortar on the western aspect of the porch roof that leads to a cavity between the base of the porch roof and tiles. It is likely to be drafty due to the numerous lifted tiles and missing mortar on the western aspect. | | Moderate |

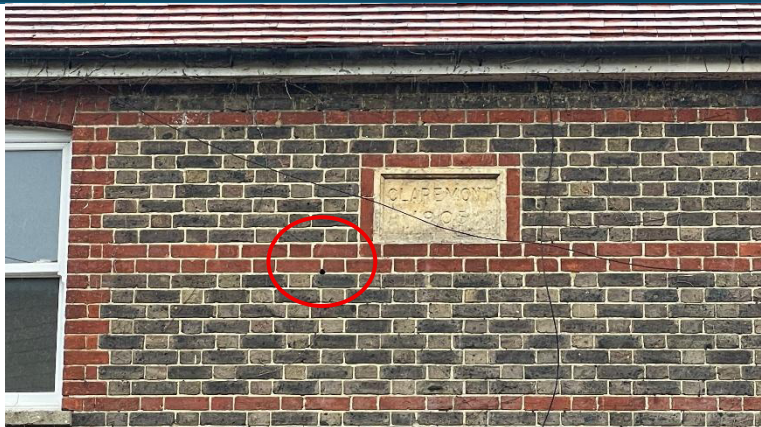
| Building No. | PRF Description | Photograph | Roosting Suitability |
|---|---|---|---|
| | A hole in the brickwork on the southern aspect of the building, potentially from removed pipework. It may lead to a cavity however, could not be inspected due to the feature being 4.5m from ground level. | | Moderate |

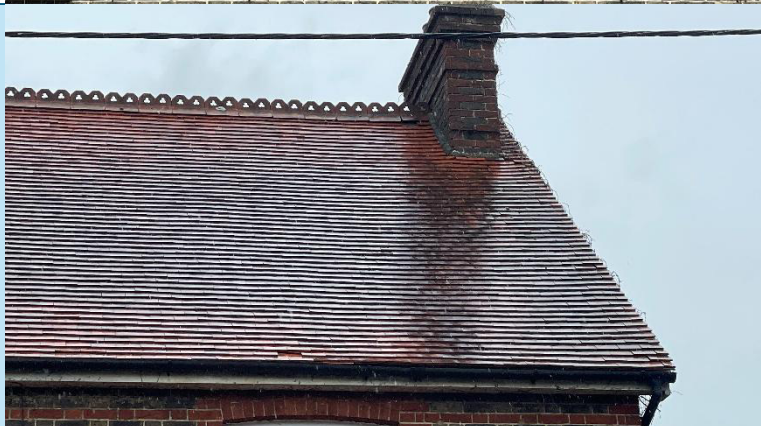
| Building No. | PRF Description | Photograph | Roosting Suitability |
|---|---|---|---|
| | Lifted ridge tiles on the pitched roof. Likely to be a superficial feature that is drafty and suitable for only small numbers of bats. | | Low |

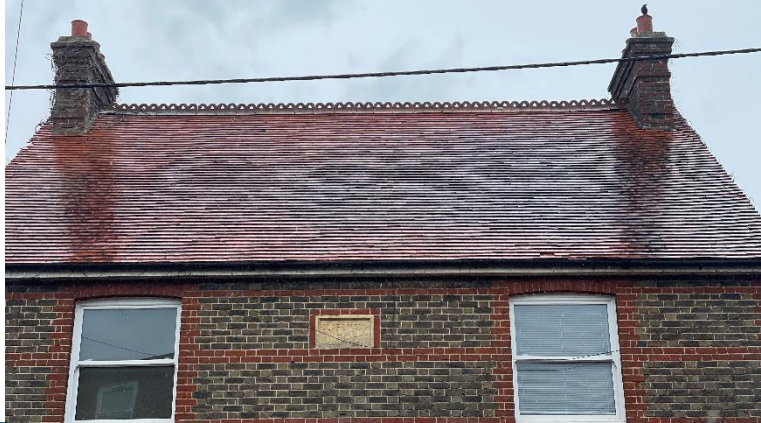
| Building No. | PRF Description | Photograph | Roosting Suitability |
|---|---|---|---|
| | Lifted tiles on the roof structure of the northern and southern aspects that is likely to be a small space where the tiles overlap. Likely to be superficial and drafty and large enough for low numbers of bats. | | Low |

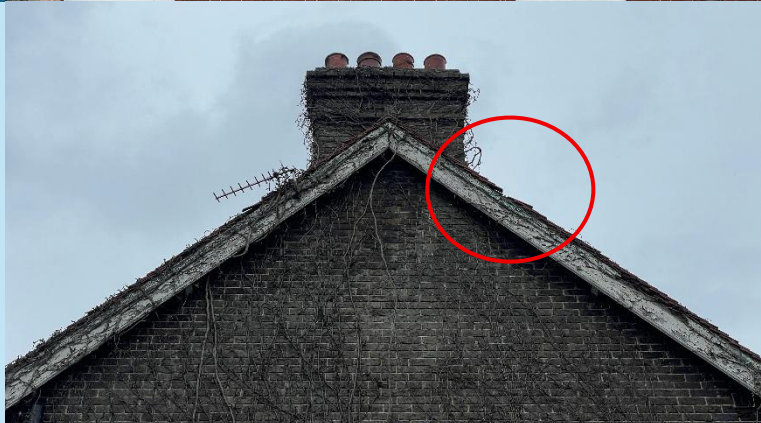
| Building No. | PRF Description | Photograph | Roosting Suitability |
|---|---|---|---|
| | Missing roof tiles on the western gable end of the southern pitched roof that may lead to a small cavity as a bird was seen entering the gap in missing tiles. Is likely to be fairly drafty, exposed to rain and fluctuate in temperatures so unlikely to provide suitable conditions for a maternity roost. | | Moderate |

| B1 | F013 | shop.this.master | missing tiles | 7.5m west | No | | | moderate | low | Missing tiles on gable end that may lead to a cavity in soffit. bird observed entering feature indicating presence of a cavity. No access into the loft space. on southern side of pitched roof |

As birds have been observed nesting within under the tiles on B1, the roofing works should be timed to occur outside of the nesting bird season (i.e. between September and mid-February inclusive). If this is not possible, it should be carried out following a nesting bird check by a suitably experienced ecologist to identify the presence of an active nest. If an active nest is discovered, a suitably sized buffer zone (3-5m, species dependent) should be enacted, whereby no works are permitted to occur until the young have fledged and/or the nest is no longer active.

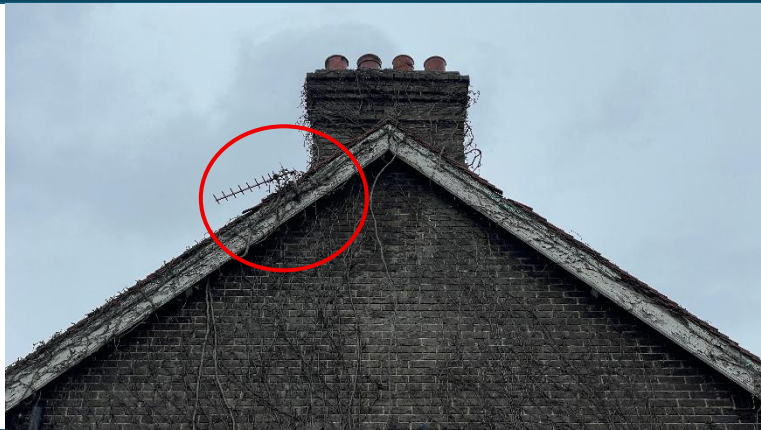
| Building No. | PRF Description | Photograph | Roosting Suitability |
|---|---|---|---|
| | A missing roof tile is present on the western gable end on the northern pitched roof that may lead to a small cavity that is likely to be drafty, exposed to rain and therefore unlikely to be suitable for a maternity roost. | | Moderate |

| B1 | F014 | badly.moss.foam | missing tile | 7.5m west | No | | | moderate | low | Missing tile intertwined with climbing plant roots. may provide access into a cavity as for F012, smaller access. on northern aide of pitched roof |

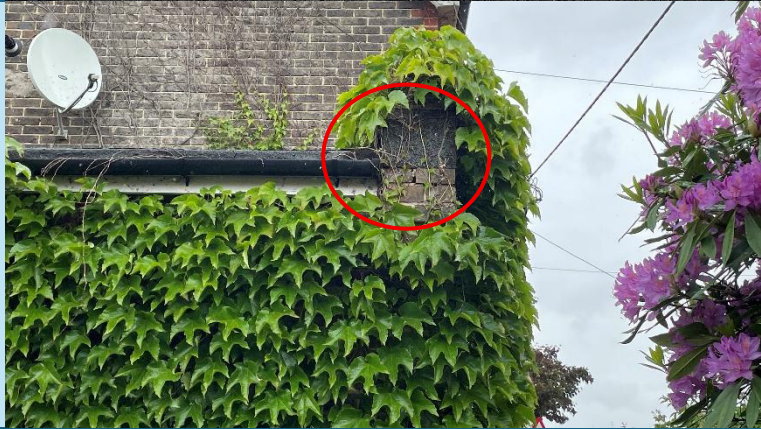
| Building No. | PRF Description | Photograph | Roosting Suitability |
|---|---|---|---|
| | Missing mortar in brickwork on the western flat roof extension with a western aspect, is very shallow, approximately 1.5cm in height,, 1cm wide and approx. 2cm in depth. | | Negligible |

| B1 | F017 | digit.learn.twigs | gap in mortar | 3.5m west | No | 2x1 | | low | | Missing mortar in brickwork on flat single storey extension on the western aspect in gap in Virginia creeper |

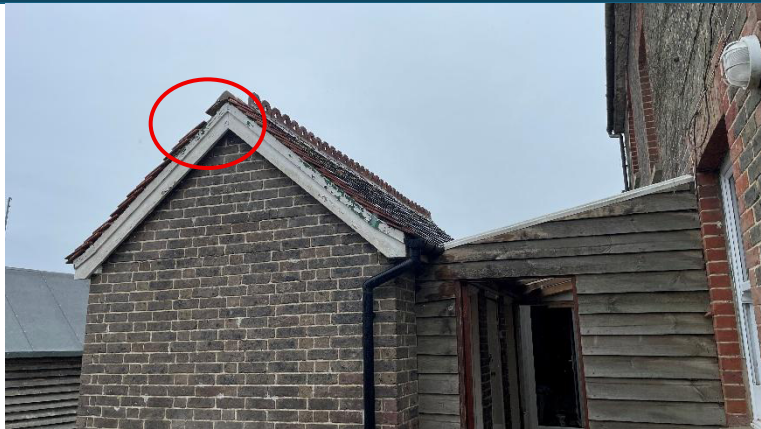
| Building No. | PRF Description | Photograph | Roosting Suitability |
|---|---|---|---|
| B2 | Missing tiles and mortar on the western aspect that leads to a very open and exposed cavity that is approx. 4cm in height, 5cm wide and 6cm in depth. It is too open and exposed to provide suitability for roosting bats. | | Negligible |

| B2 | F001 | home.moved.vibrates | missing tiles | 4m west | No | 3x5 | 4x5x6 | neg | | Missing Mortar under missing gable end tiles leads to a very open and exposed cavity. neg suitability |

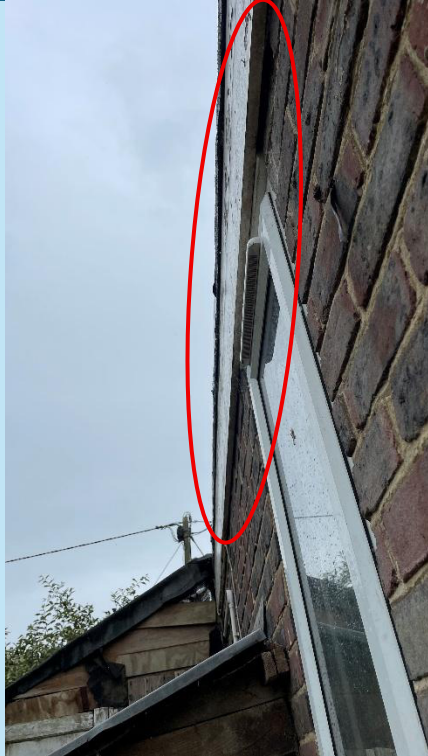
| Building No. | PRF Description | Photograph | Roosting Suitability |
|---|---|---|---|
| | Gap between the fascia board and wall that runs along the majority of the eastern aspect of the flat roof section of B2. It is approximately 10cm in height, 100cm in length and 1cm in depth. Is likely to be drafty and exposed. | | Low |

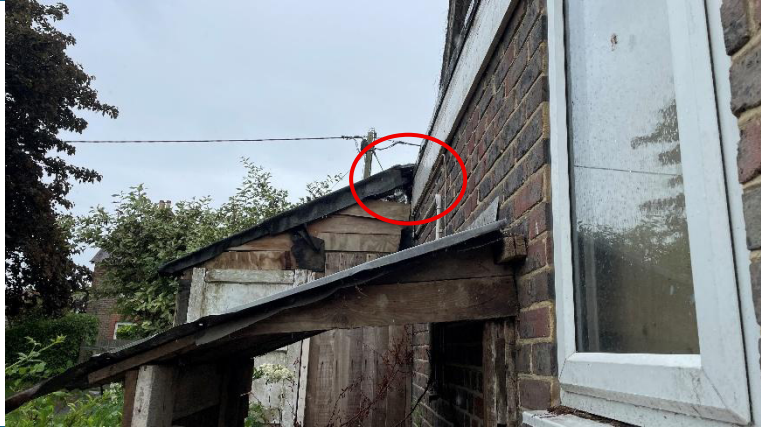
| Building No. | PRF Description | Photograph | Roosting Suitability |
|---|---|---|---|
| | Missing wooden cladding that provides access into a small space between the insulation of the pitched section of the wooden shed on the eastern section of B2. It is likely be drafty and exposed due to the large opening. It is a felt roof and wooden boarding so is unlikely to be thermally stable. | A photograph showing the exterior of a wooden shed. The shed has a pitched roof with dark wooden boarding. A red circle highlights a gap in the cladding where the roof meets the wall. To the right of the shed is a brick building with a white-framed window. The sky is overcast and there are some trees in the background. | Low |

| B2 | F005 | extra.splice.spun | missing wooden boarding | 3m north | No | 30x30 | | low | | Missing wooden cladding providing access into small cavity in pitched wooden shed. Gap between wooden rafter frame and felt roof. Likely drafty and exposed due to large opening |

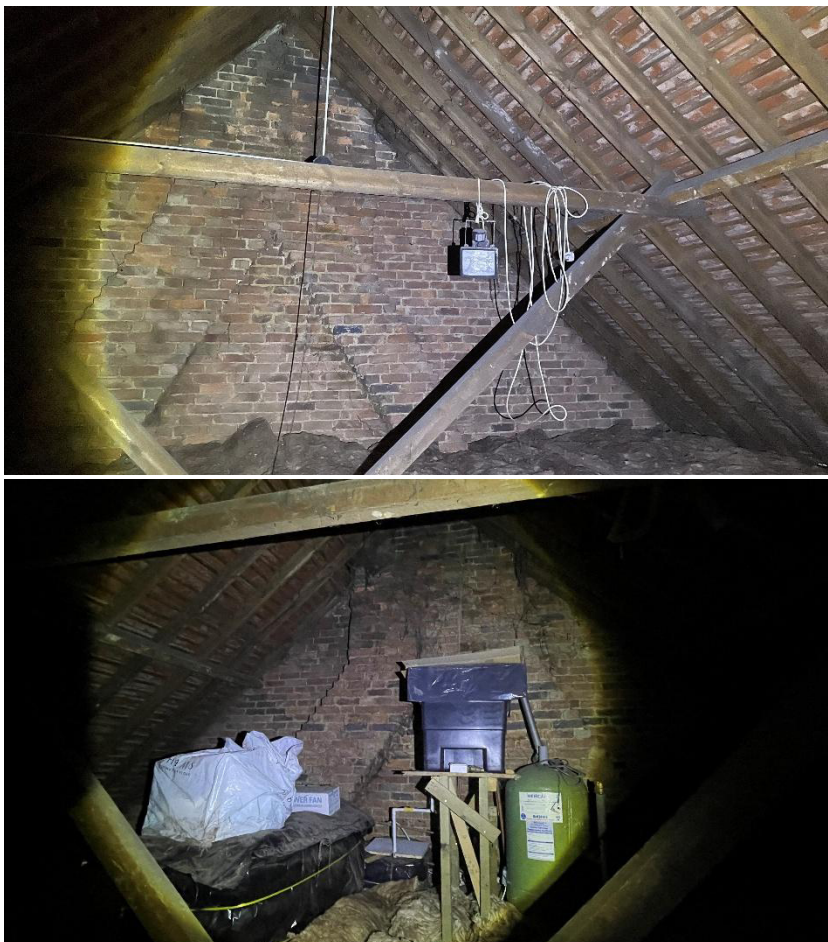
*Plate 5 Internal Loft void of B1*

The loft void of B1 is an open void with wooden rafter beams with fink arrangement. The clay tiles were pinned directly to the wooden rafter beams with no insulation lining the internal of the roof. Due to an absence of an internal lining, the loft void was very drafty. There is minor light ingress where the clay tiles overlap and around the gable end tiles, however no large openings were observed. No cracks or gaps in the brickwork were observed on the brickwork along the gable ends of the building on the western and eastern aspect. There is a water tank present in the loft space that is covered. The void had some items stored in the loft but was uncluttered and dusty indicating it had not been recently cleaned.

There were no boarded walkways, with the floor of the void lined with insulation. All of the loft space could be inspected from the loft hatch for bats or signs of bats. Rodent droppings were recorded, however no bats and no signs of bats were observed and no visible access/egress points were noted during the inspection. Due to the very drafty conditions, no visible access/egress points and no signs of bats observed in the form of droppings, the building was assessed with negligible suitability for a maternity roost.
