**Phase 1 Desk Study &  
Phase 2 Preliminary Site  
Investigation & Risk  
Assessment Report**

**Project Name:** Wealden House

**Location:** Lewes Road, East Grinstead, West Sussex RH19 3TB

**Project ID:** J16139

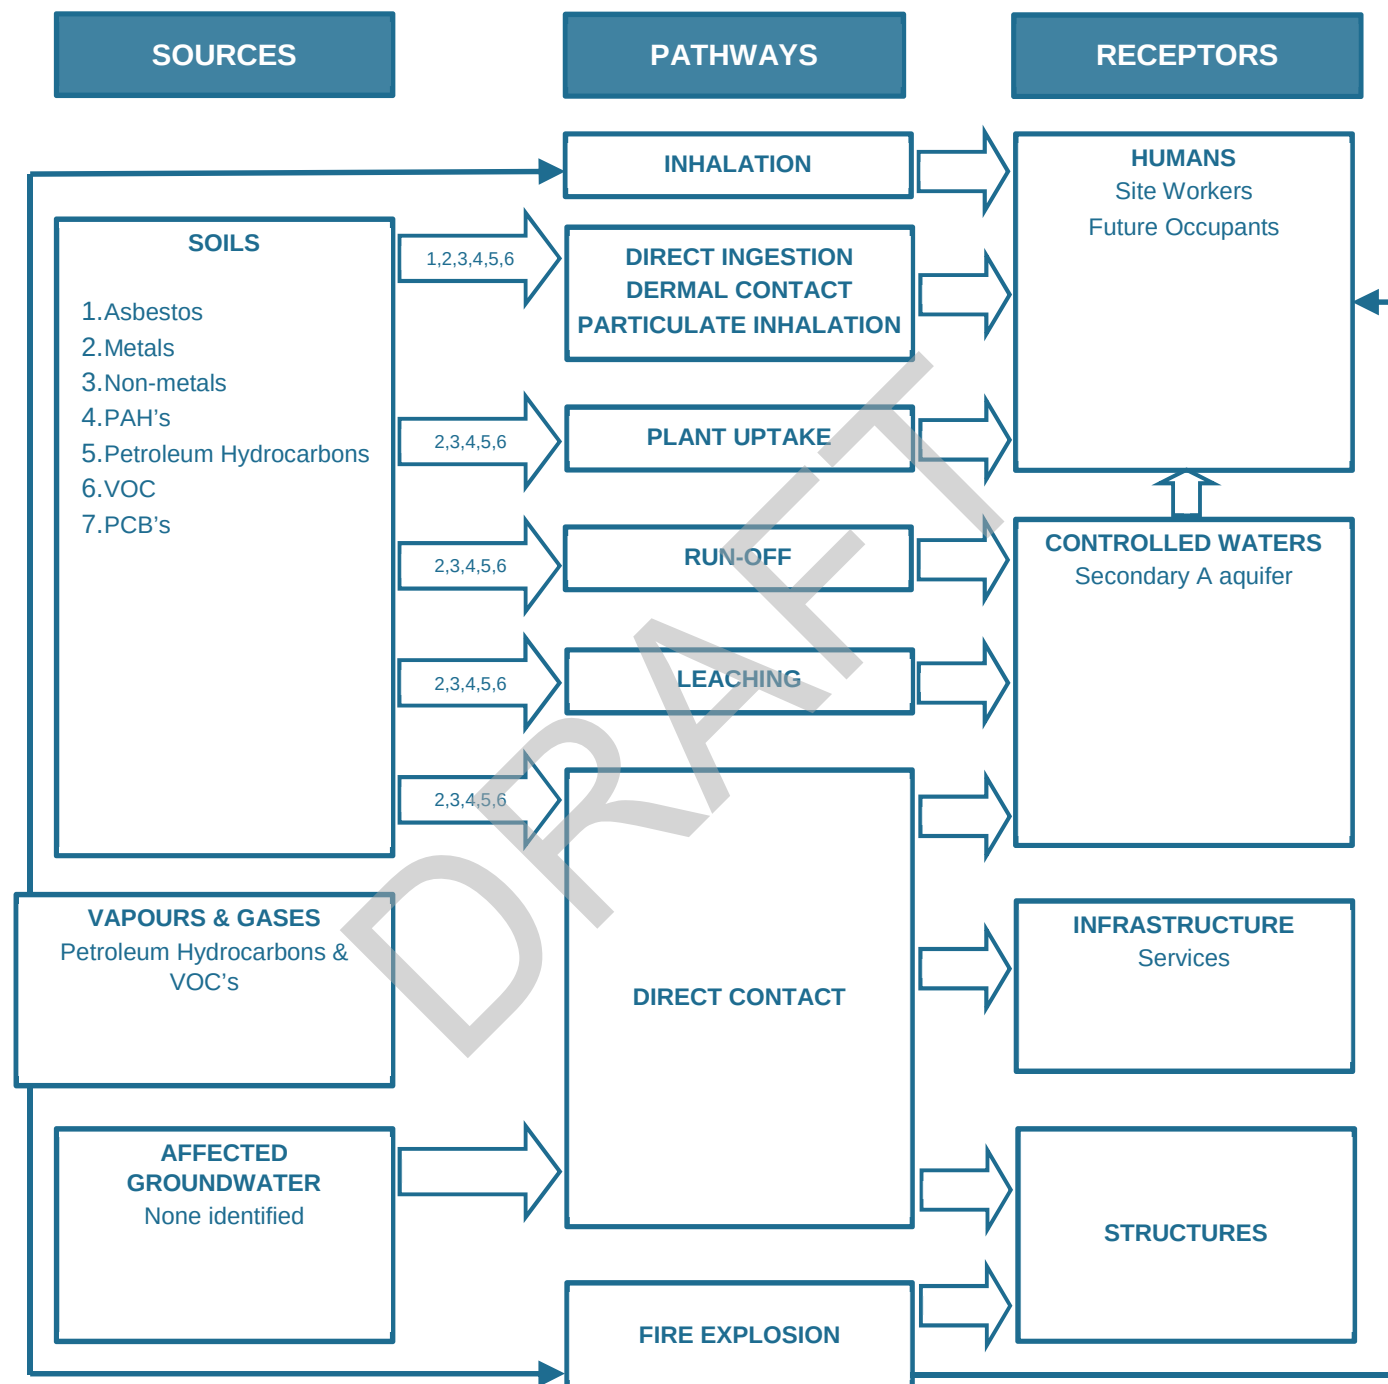
## 9.2 Pollutant Linkages and Conceptual Site Model Summary

The following diagram shows the potential pollutant linkages identified for the site and summarises the preliminary conceptual model:

// Denotes potential pollutant linkage not complete.
