Sunte House – Window Schedule (photographic record and brief description based on visual check from the interior)

| First Floor (1F) | |

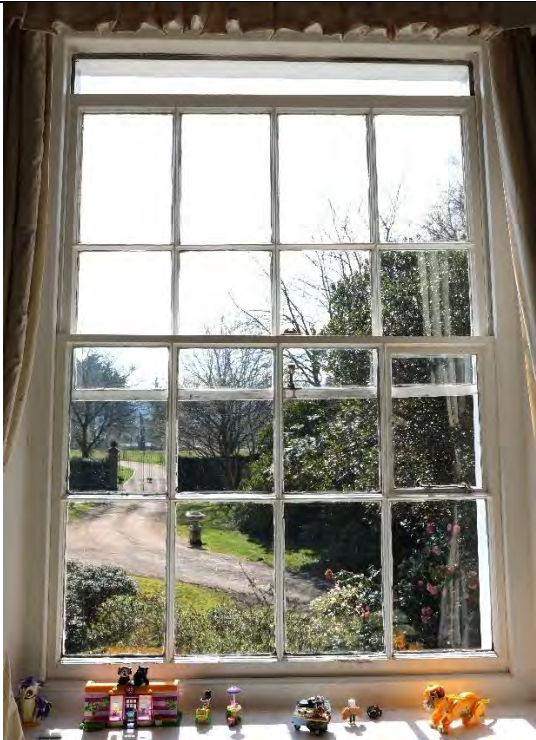
| | <p>1F – SW1 (1) (Bedroom)</p> <ul style="list-style-type: none"><li>- Timber-framed sash</li><li>- Single-glazed (8 over 8)</li><li>- Single pane crittal casement insert with metal fasteners</li><li>- Modern Brass Brighton fastener</li></ul> <p>Some (limited) cracking (mainly around the glazing bars and panes) and peeling of paint. Timber does not look soft or rotten. Overall appears to be in fair condition including the sash cord.</p> |

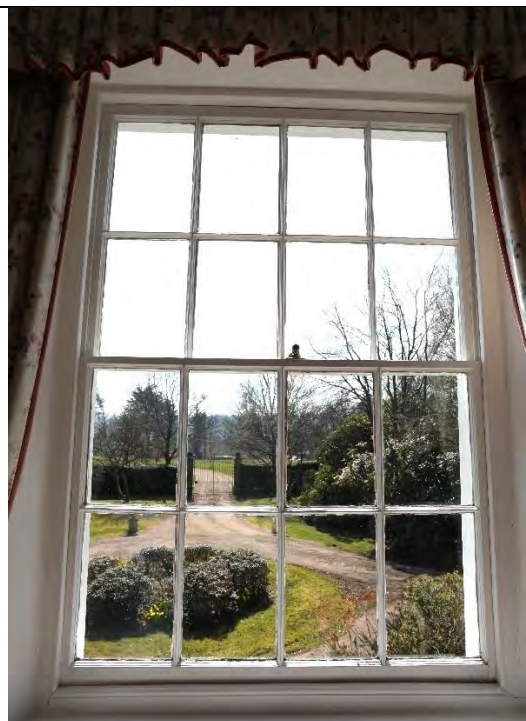
1F – SW2 (1) (Bedroom)

- Timber-framed sash
- Single-glazed (8 over 8)
- Modern Brass Brighton fastener

Some (limited) cracking (mainly around the glazing bars and panes) and peeling of paint. Timber does not look soft or rotten. Overall appears to be in fair condition including the sash cord.

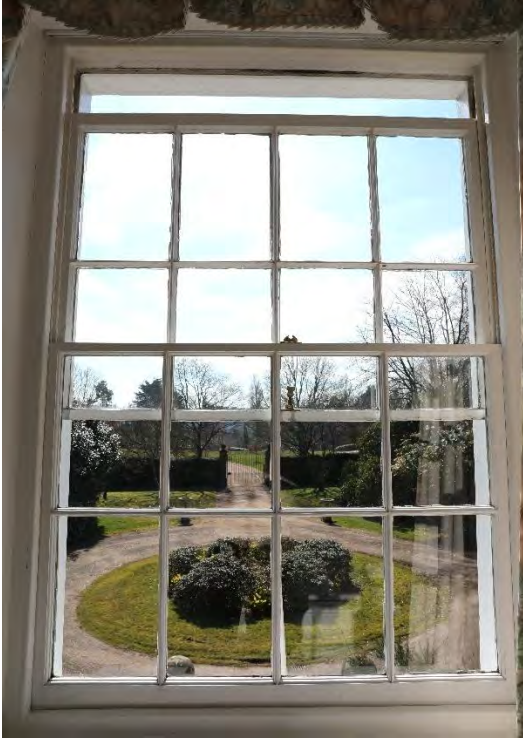
| South Elevation (S) | Middle (M) |
|---|---|
| | <p>1F – SM1 (1) (Bathroom)</p> <ul style="list-style-type: none"> <li>- Timber-framed sash</li> <li>- Single-glazed (8 over 8)</li> <li>- Modern Brass Brighton fastener</li> </ul> <p>Some (limited) cracking (mainly around the glazing bars and panes) and peeling of paint. Timber does not look soft or rotten. Overall appears to be in fair condition including the sash cord.</p> |

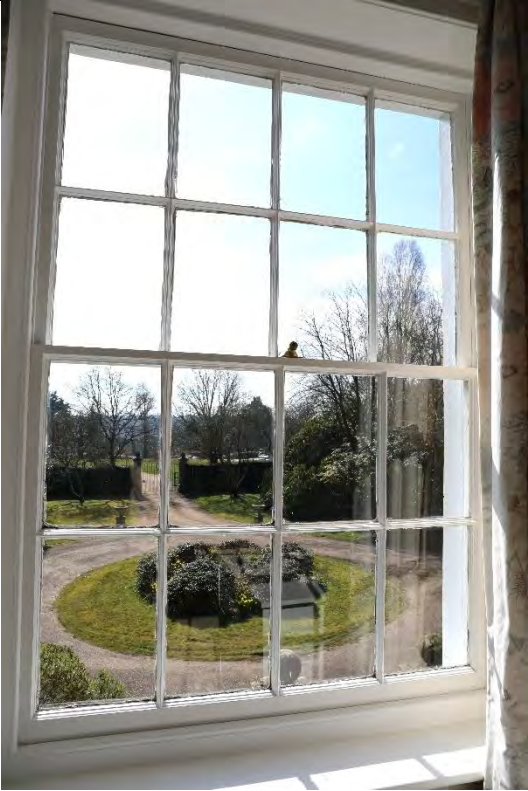
| <p><b>South Elevation (S)</b></p> | <p><b>East (E)</b></p> <p>1F – SE1 (1) (Master Bedroom)</p> <ul style="list-style-type: none"> <li>- Timber-framed sash</li> <li>- Single-glazed (8 over 8)</li> <li>- Modern Brass Brighton fastener</li> </ul> <p>Some (limited) cracking of paint (mainly around the glazing bars and panes). Timber does not look soft or rotten. Overall appears to be in fair condition including the sash cord.</p> |

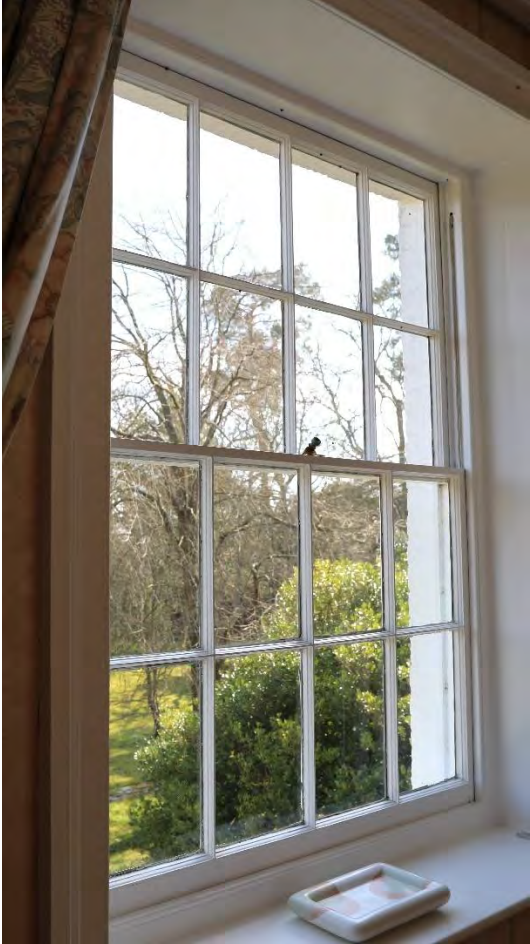
| East Elevation (E) | South (S) |
|---|---|
| | <p>1F – ES1 (1) (Master Bedroom)</p> <ul style="list-style-type: none"> <li>- Timber-framed sash</li> <li>- Single-glazed (8 over 8)</li> <li>- Modern Brass Brighton fastener</li> </ul> <p>Some (limited) cracking of paint (mainly around the glazing bars and panes). Timber doesn't look soft or rotten. Overall appears to be in fair condition including the sash cord.</p> |

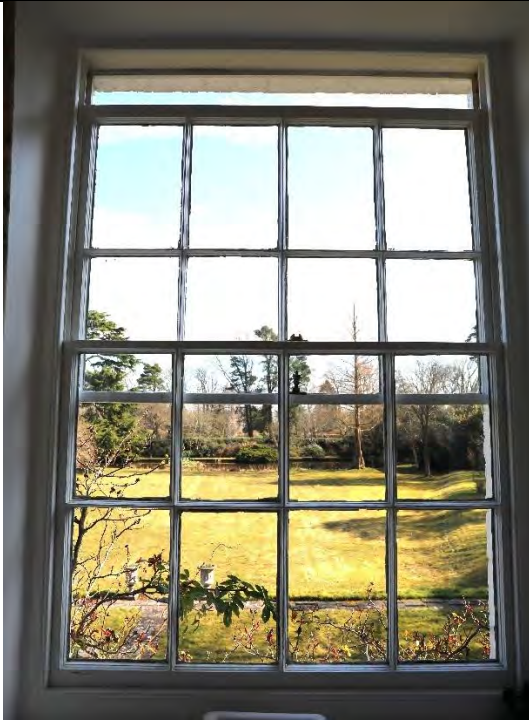
1F – ES2 (1) Master Bedroom

- Timber-framed sash
- Single-glazed (8 over 8)
- Modern Brass Brighton fastener

Some (limited) cracking of paint (mainly around the glazing bars and panes). Timber doesn't look soft or rotten. Overall appears to be in fair condition including the sash cord.

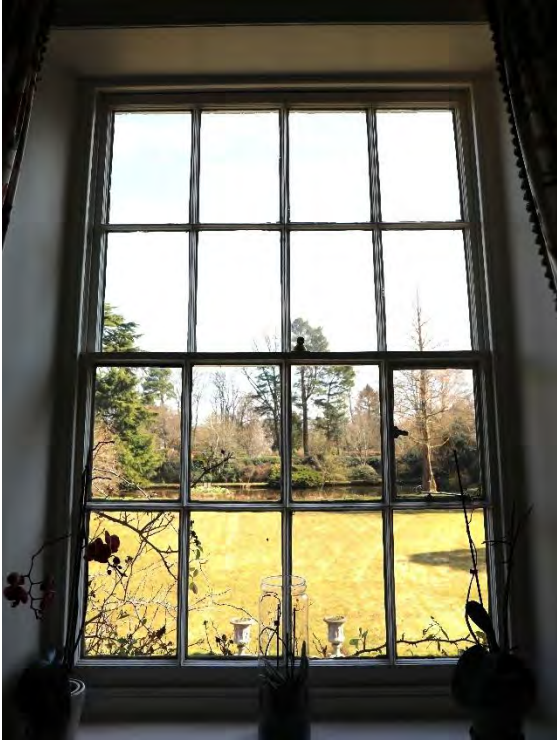
| East Elevation (E) | Middle (M) |
|---|---|
| | <p>1F – EM1 (1) Stairs Landing</p> <ul style="list-style-type: none"> <li>- Timber-framed sash</li> <li>- Single-glazed (8 over 8)</li> <li>- Single pane crittal casement insert with metal fasteners</li> <li>- Modern Brass Brighton fastener</li> </ul> <p>Some (limited) cracking of paint (mainly around the glazing bars and panes). Timber does not look soft or rotten. Overall appears to be in fair condition including the sash cord.</p> |

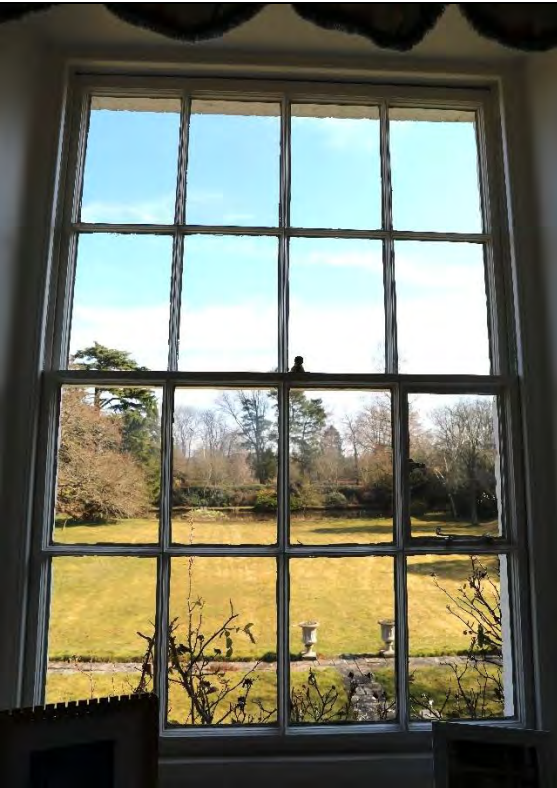
| East Elevation (E) | Middle (M) |
|---|---|
| | <p>1F – EN1 (1) Bedroom</p> <ul style="list-style-type: none"> <li>- Timber-framed sash</li> <li>- Single-glazed (8 over 8)</li> <li>- Single pane crittal casement insert with metal fasteners</li> <li>- Modern Brass Brighton fastener</li> </ul> <p>Some (limited) cracking of paint (mainly around the glazing bars and panes). Timber does not look soft or rotten. Overall appears to be in fair condition including the sash cord.</p> |

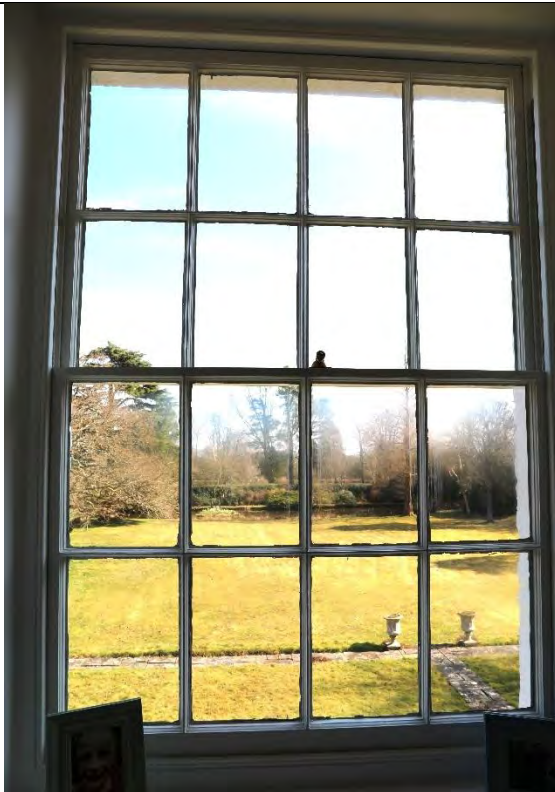
1F – EN2 (1) Bedroom

- Timber-framed sash
- Single-glazed (8 over 8)
- Modern Brass Brighton fastener

Some cracking of paint (mainly around the glazing bars and panes). Timber does not look soft or rotten. Overall appears to be in fair condition including the sash cord.

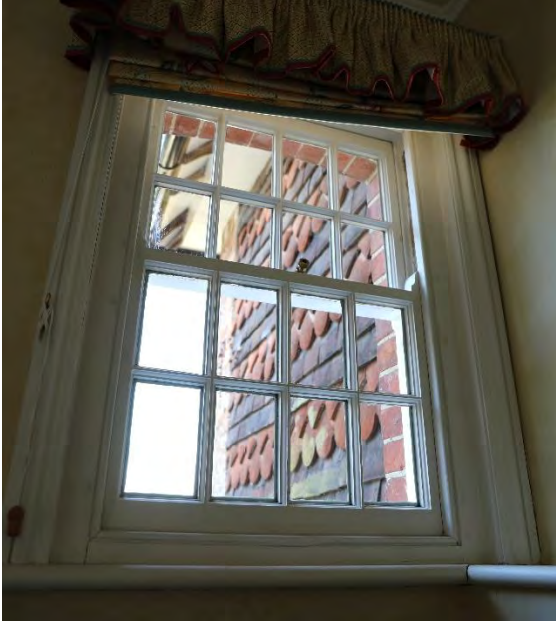
| North Elevation (N) | Middle (M) |
|---|---|
| | <p>1F – NM1 (1) (Study)</p> <ul style="list-style-type: none"> <li>- Timber-framed sash with simple curved horns</li> <li>- Single-glazed (8 over 8)</li> <li>- Modern Brass Brighton fastener</li> </ul> <p>Timber does not look soft or rotten. Overall appears to be in fair condition including the sash cord.</p> |

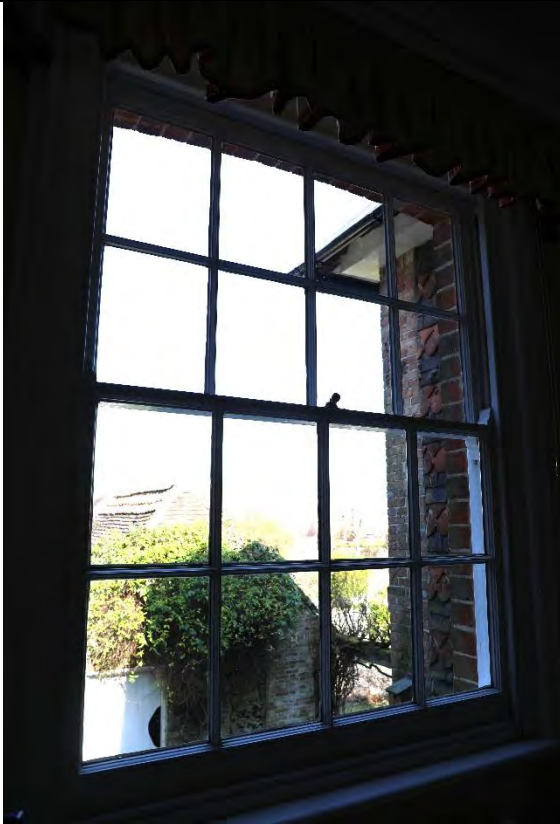
#### 1F – NM2 (Study)

- Timber-framed sash with simple curved horns
- Single-glazed (8 over 8)
- Modern Brass Brighton fastener

Timber does not look soft or rotten. Overall appears to be in fair condition including the sash cord.

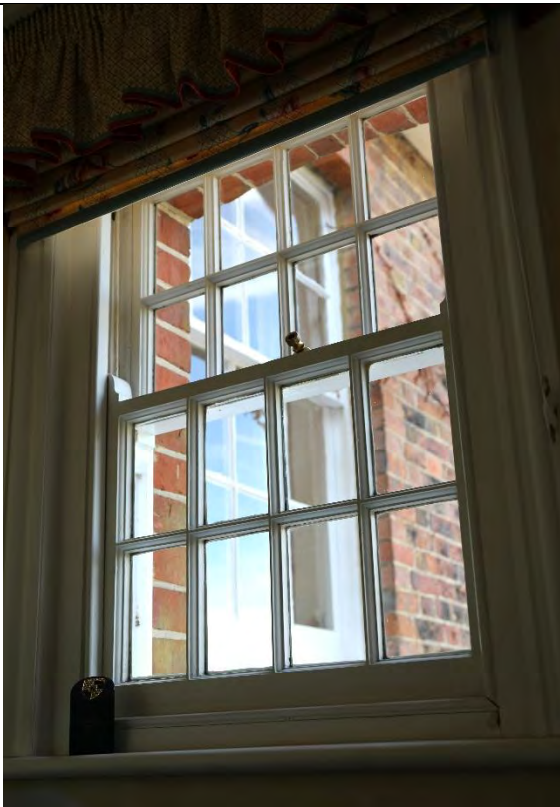
#### 1F – NM3 (Study)

- Timber-framed sash with simple curved horns
- Single-glazed (8 over 8)
- Modern Brass Brighton fastener

Timber does not look soft or rotten. Overall appears to be in fair condition including the sash cord.

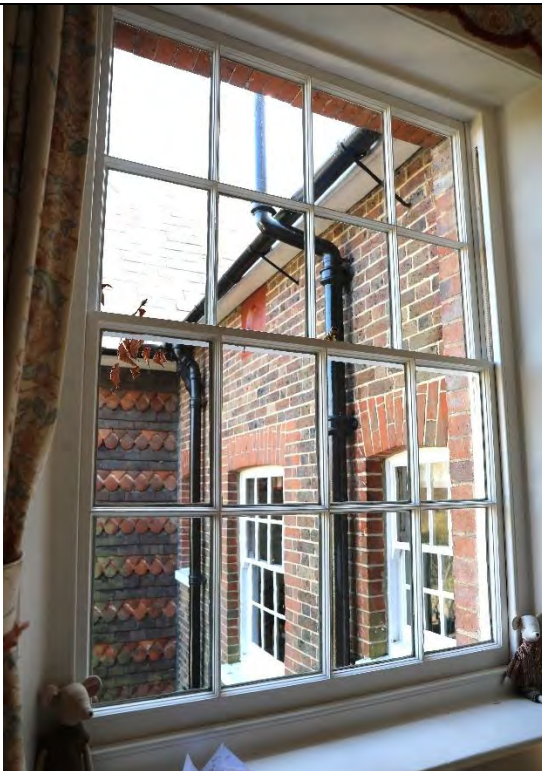
1F – NNW1 (1) Hallway

- Timber-framed sash
- Single-glazed (8 over 8) (in the Georgian style)
- Modern Brass Brighton fastener

Timber does not look soft or rotten. Overall appears to be in fair condition including the sash cord.

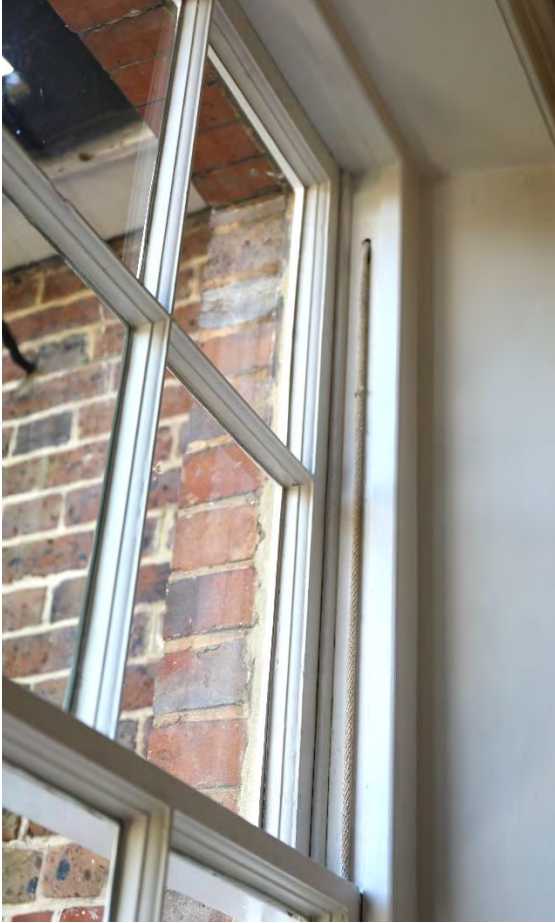
1F – NNW1 (2) Hallway

- Timber-framed sash
- Single-glazed (4 over 4)
- Brass Brighton fastener

Timber does not look soft or rotten. Overall appears to be in fair condition including the sash cord.

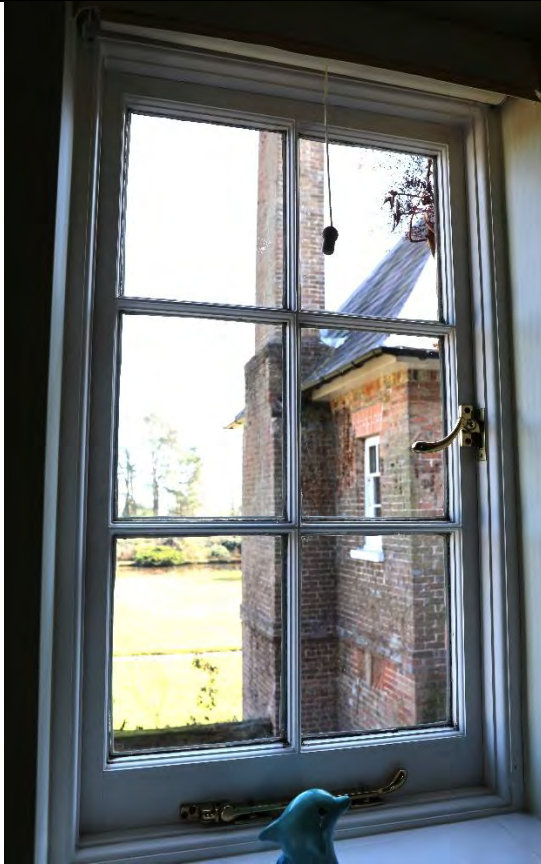
#### 1F – NNW2 (1) Bathroom

- Timber-framed casement (Twentieth Century based on physical evidence)
- Single-glazed (6 panes)
- Brass fasteners

Timber does not look soft or rotten. Overall appears to be in fair condition.

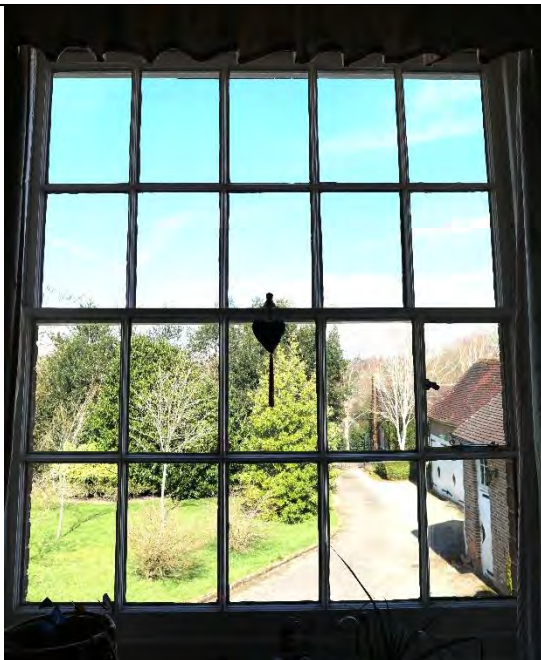
#### 1F – NW1 (1) (Bedroom)

- Timber-framed sash (in the Georgian style)
- Single-glazed (10 over 10)
- Single pane crittal casement insert with metal fasteners
- Modern Brass Brighton fastener

Some (limited) cracking of paint (mainly around the glazing bars and panes). Timber does not look soft or rotten. Overall appears to be in fair condition including the sash cord.

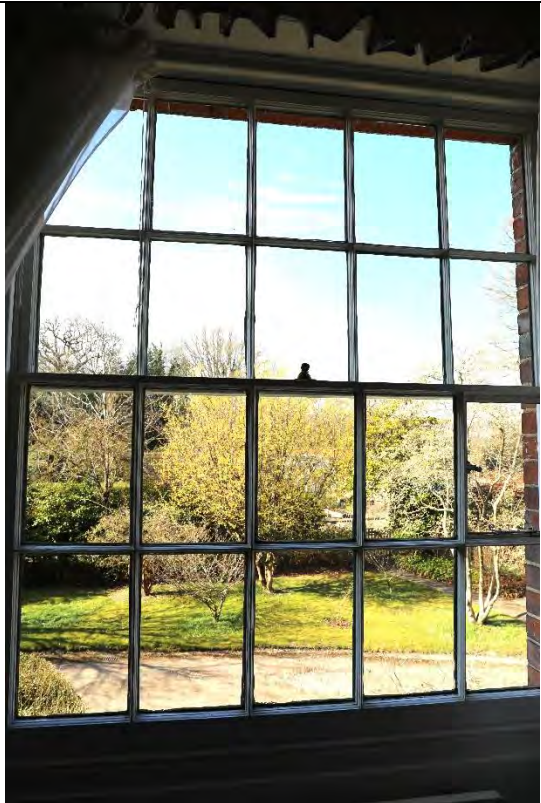
| <p><b>West Elevation (W)</b></p> | <p><b>North (N)</b></p> <p>1F – WN1 (1) Bedroom)</p> <ul style="list-style-type: none"> <li>- Timber-framed sash (in the Georgian style)</li> <li>- Single-glazed (10 over 10)</li> <li>- Single pane crittal casement insert with metal fasteners</li> <li>- Modern Brass Brighton fastener</li> </ul> <p>Some (limited) cracking of paint (mainly around the glazing bars and panes). Timber does not look soft or rotten. Overall appears to be in fair condition including the sash cord.</p> |

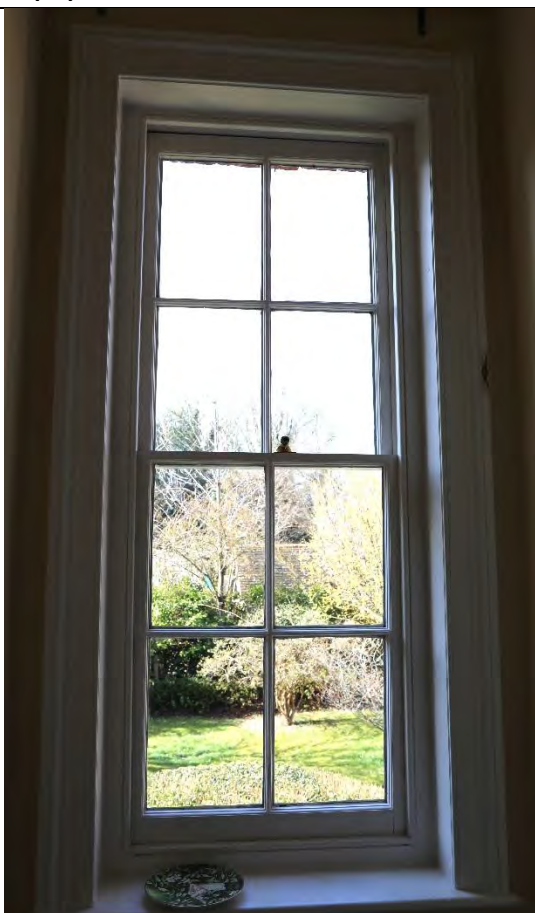
1F – WM1 (1) (Ensuite Bathroom)

- Timber-framed sash (Twentieth Century based on physical evidence)
- Single-glazed (4 over 4)
- Modern Brass Brighton fastener

Some (limited) cracking of paint (mainly around the glazing bars and panes). Timber does not look soft or rotten. Overall appears to be in fair condition including the sash cord.

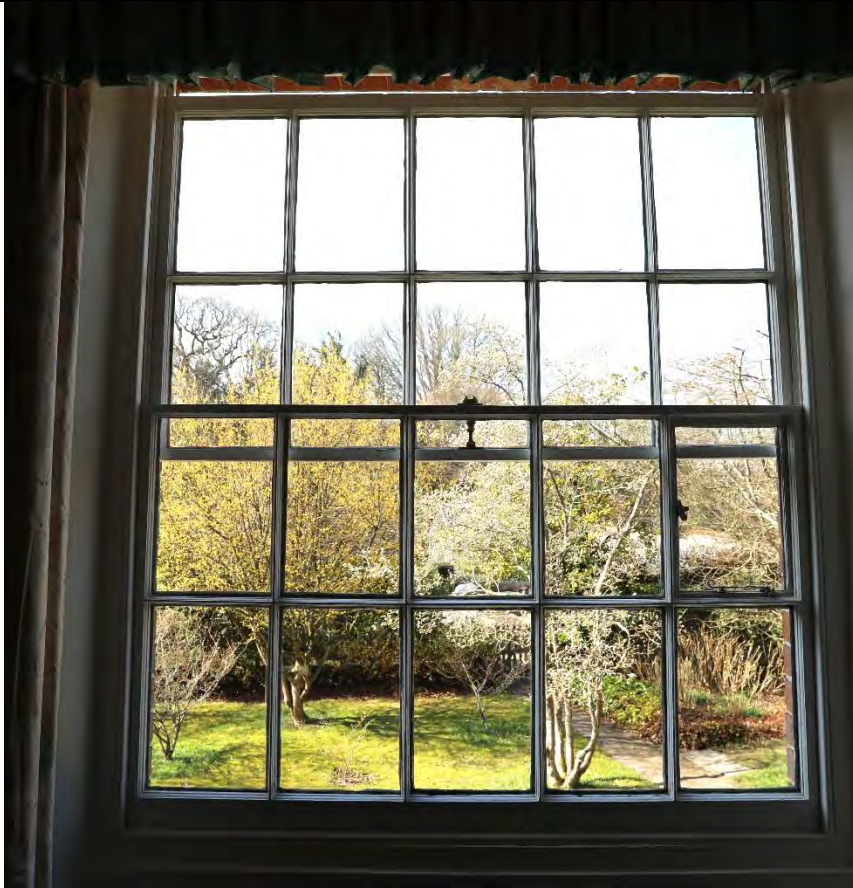
1F – WM2 (1) (Bathroom)

- Timber-framed sash (in the Georgian style)
- Single-glazed (10 over 10)
- Single pane critical casement insert with metal fasteners
- Modern Brass Brighton fastener

Some (limited) cracking of paint (mainly around the glazing bars and panes). Timber does not look soft or rotten. Overall appears to be in fair condition including the sash cord.

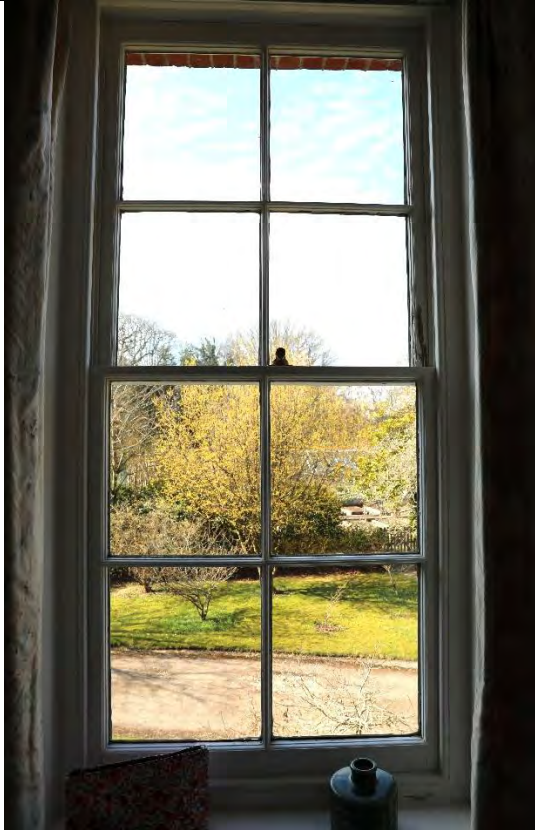
1F – WS1 (1) (Hallway)

- Timber-framed sash
- Single-glazed (4 over 4)
- Modern Brass Brighton fastener

Some cracking of paint (mainly around and on the glazing bars and panes) and peeling of paint. Timber does not look soft or rotten. Overall appears to be in fair condition including the sash cord.
