**Sunte House – Window Schedule** (photographic record and brief description based on visual check from the interior)

| <b>Second Floor (2F)</b> | |

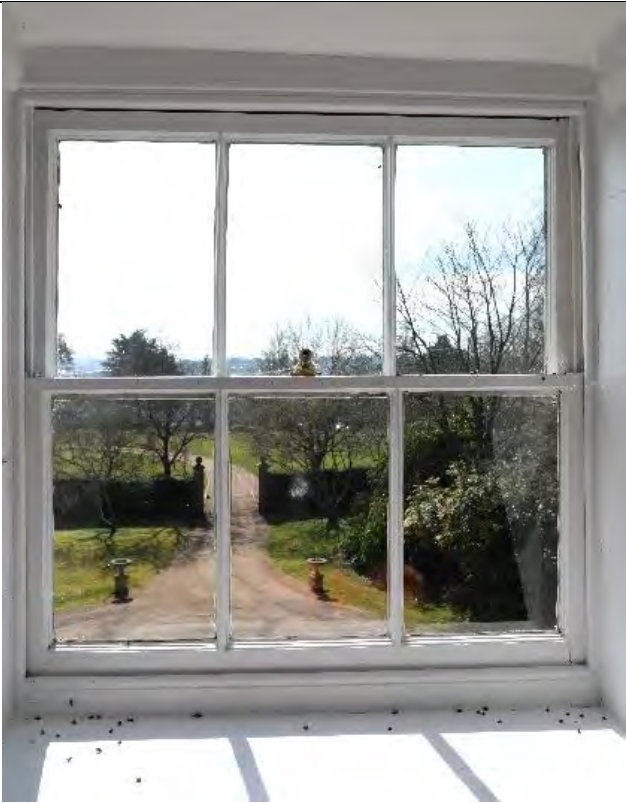
| | <ul style="list-style-type: none"><li>- Timber-framed sash</li><li>- Single-glazed (3 over 3)</li><li>- Modern Brass Brighton fastener</li></ul> <p>Some cracking and peeling of paint. Small gap between the sash bars and the bottom rail. Gap between the top rail and the head. Timber doesn't look soft or rotten. Overall appears to be in fair condition including the sash cord.</p> |

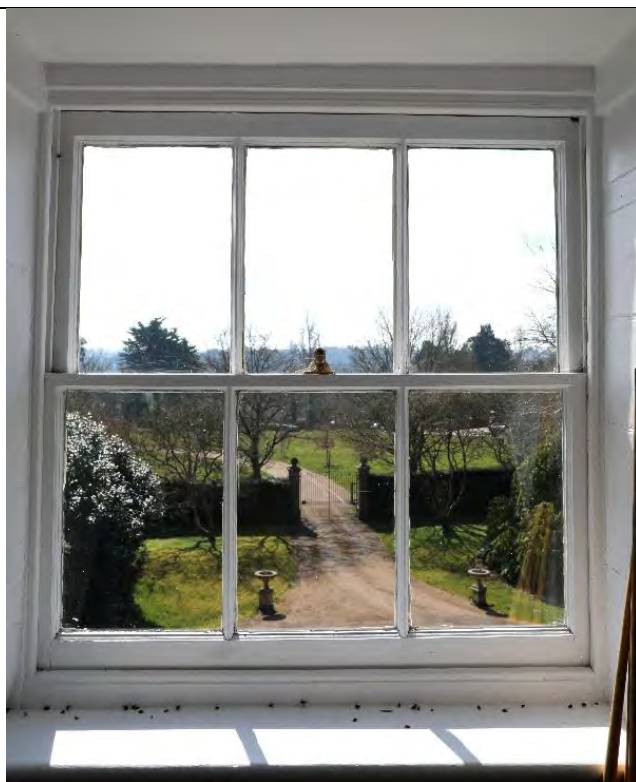
2F – SED1 (1)

Some cracking and peeling of paint. Small gap between the sash bars and the bottom rail. Small gap between the top rail and the head. Timber doesn't look soft or rotten. Overall appears to be in fair condition including the sash cord.

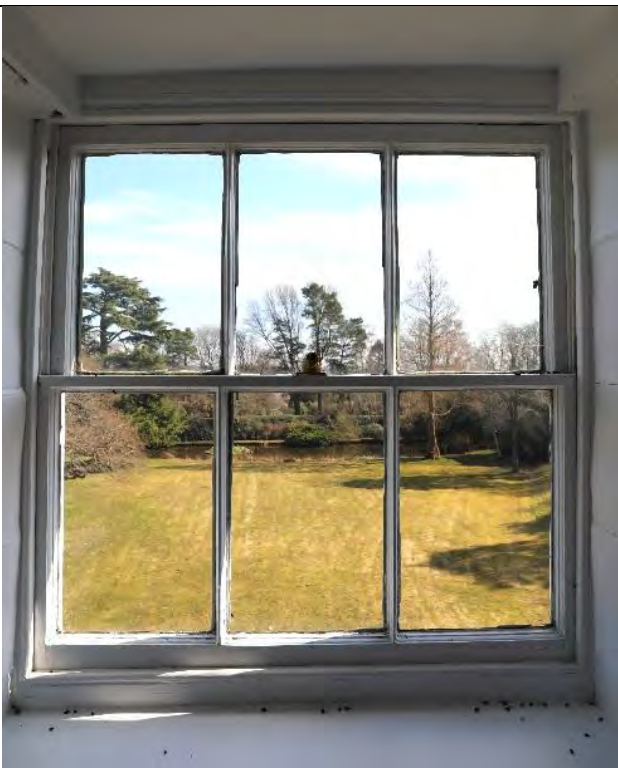
2F – ED1 (1)

Some cracking and peeling of paint. Gap between the top rail and the head. Timber doesn't look soft or rotten. Overall appears to be in fair condition including the sash cord.

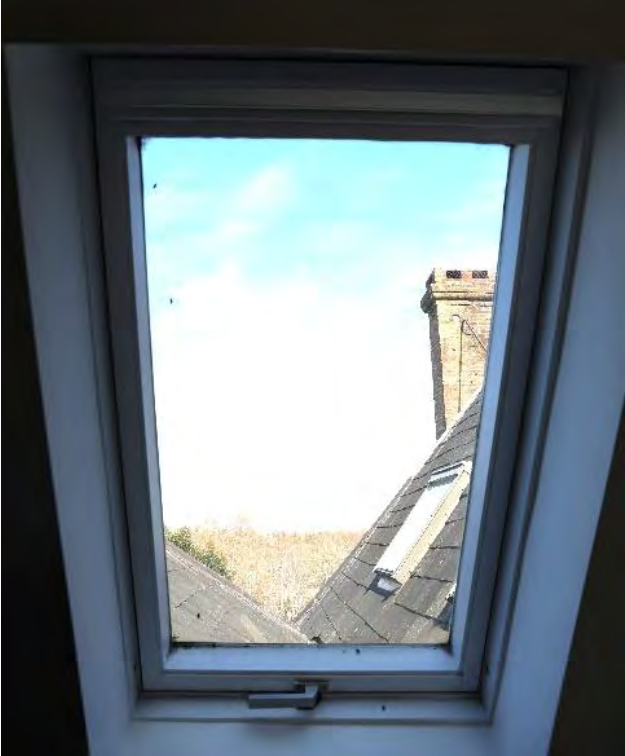
| North Roof Slope (NRS) | East Side (E) |
|---|---|
| | <p>2F – NRSE1</p> <ul style="list-style-type: none"> <li>- Timber-framed</li> <li>- Double-glazed (rectangular single pane)</li> <li>- Metal window lock</li> </ul> <p>Fair - Good condition.</p> |

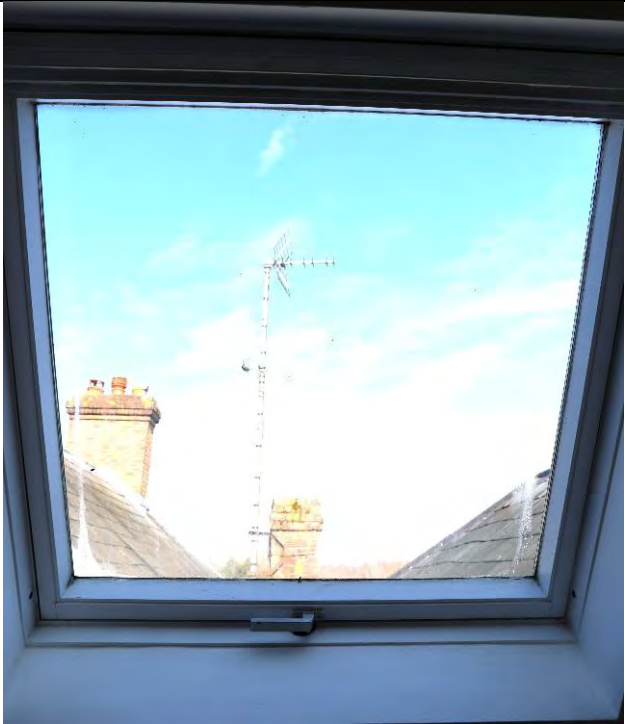
| North Roof Slope (NRS) | East Side (E) |
|---|---|
| | <p>2F – NRSW1</p> <ul style="list-style-type: none"> <li>- Timber-framed</li> <li>- Double-glazed (square single pane)</li> <li>- Metal window lock</li> </ul> <p>Some condensation in the glass indicating that the seal may have failed.</p> |

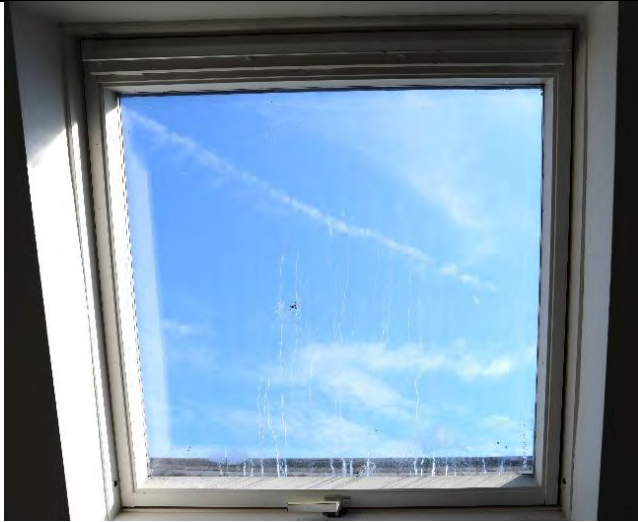
2F – WRS1 (1)

Fair - Good condition.

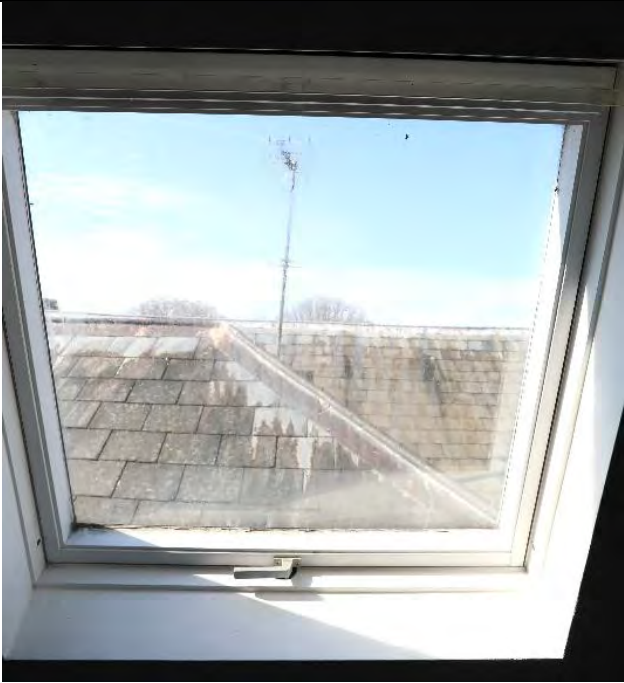
| East Roof Slope (ERS) | North Side (N) |
|---|---|
| | <p>2F – ERSN1 (1)</p> <ul style="list-style-type: none"> <li>- Timber-framed</li> <li>- Double-glazed (square single pane)</li> <li>- Metal window lock</li> </ul> <p>Some condensation in the glass indicating that the seal may have failed. Some cracking and peeling of paint.</p> |

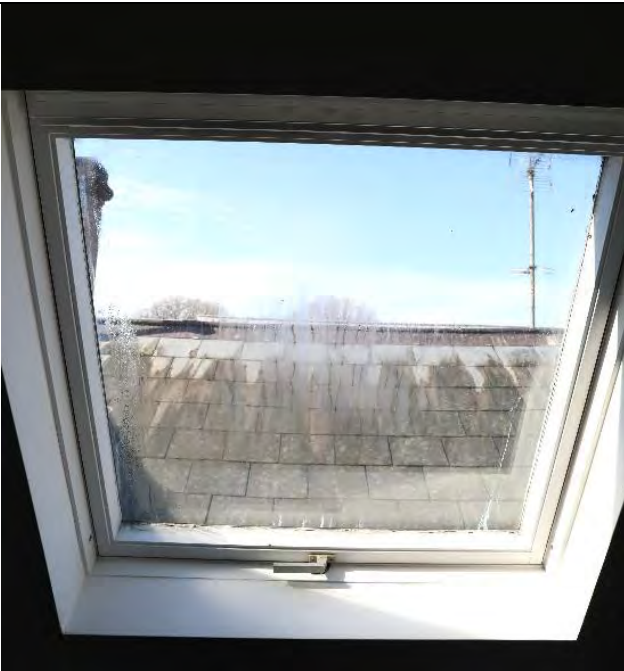
| East Roof Slope (ERS) | North Side (N) |
|---|---|
| | <p>2F – ERSS1 (1)</p> <ul style="list-style-type: none"> <li>- Timber-framed</li> <li>- Double-glazed (square single pane)</li> <li>- Metal window lock</li> </ul> <p>Some condensation in the glass indicating that the seal may have failed.</p> |
