**Tree condition survey of trees**  
**at**  
**Manor Drive, Cuckfield, RH17 5BT**

*Report date*  
27<sup>th</sup> November 2024

*Client*  
Mr R Barry  
19 Manor Drive  
Cuckfield  
RH17 5BT

*Report reference*  
J1301\_05

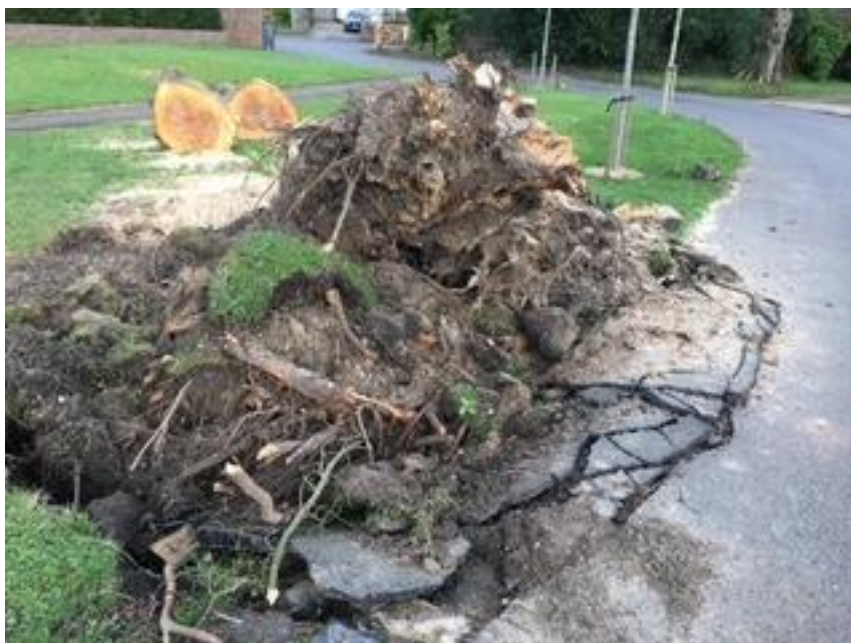
- 6.1 The prior failure of a tree, approximately February 2020, on the north side of the access road prompted a survey of the trees. This survey is a continuation of the management of the trees. This survey has identified a number of features requiring remedial works. To aid consideration of the features identified I have provided below additional information on the features in order of the first occasion of their occurrence as well as additional notes.

SAL2 Prior tree failure opposite no.19.

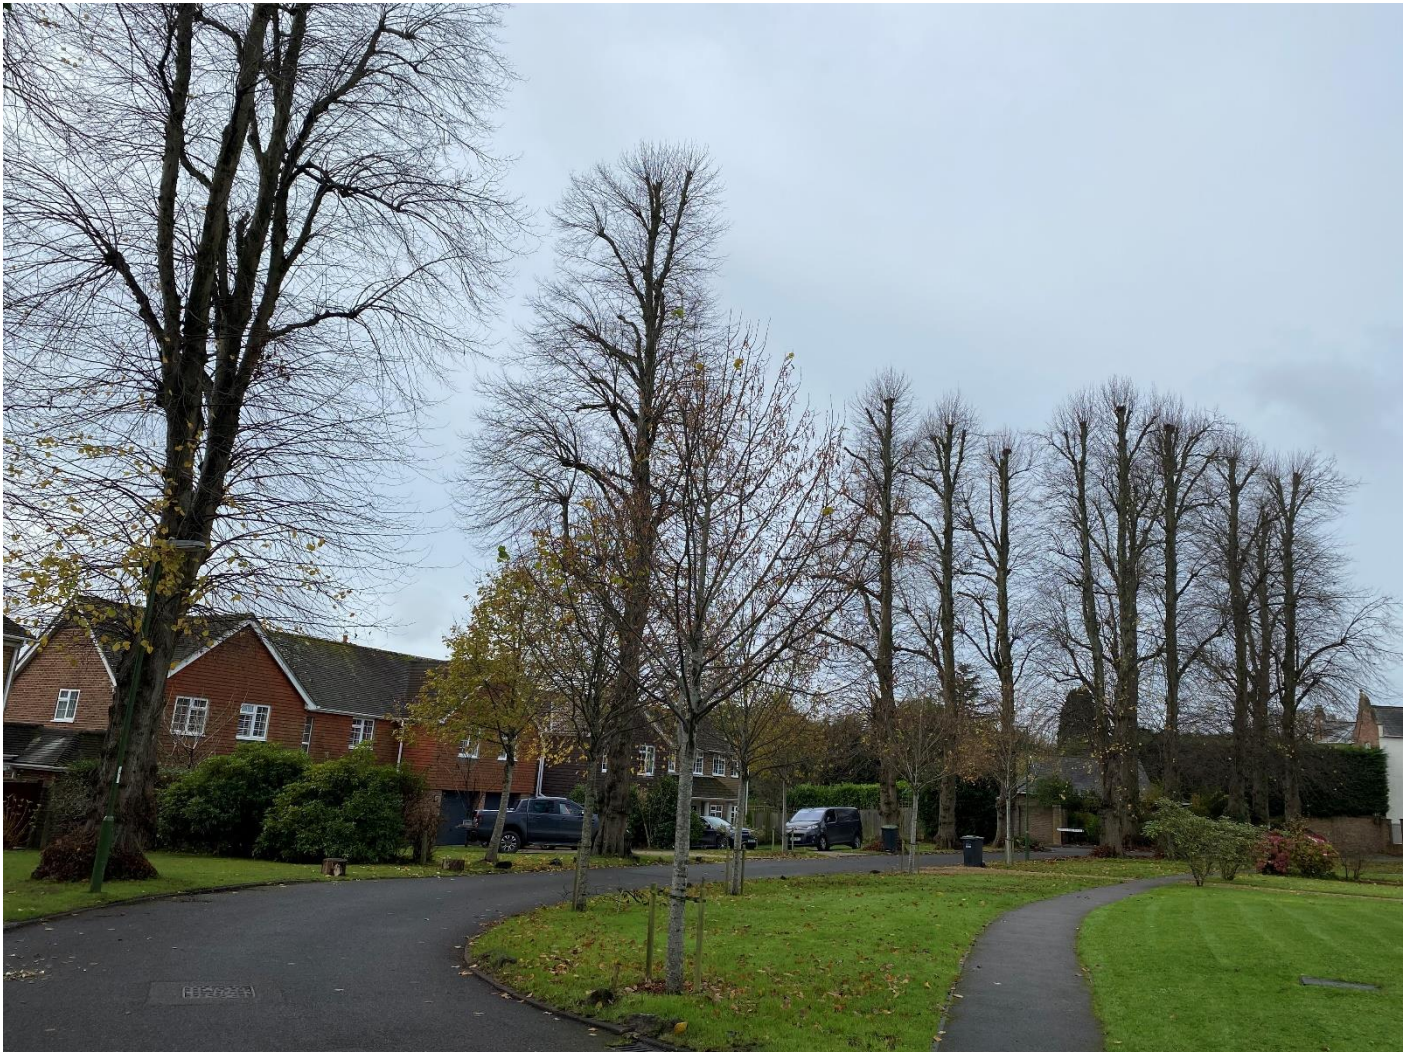
SAL3 Lime of mature lime trees with new trees establishing to maintain the long term visual amenity to the site and local area.

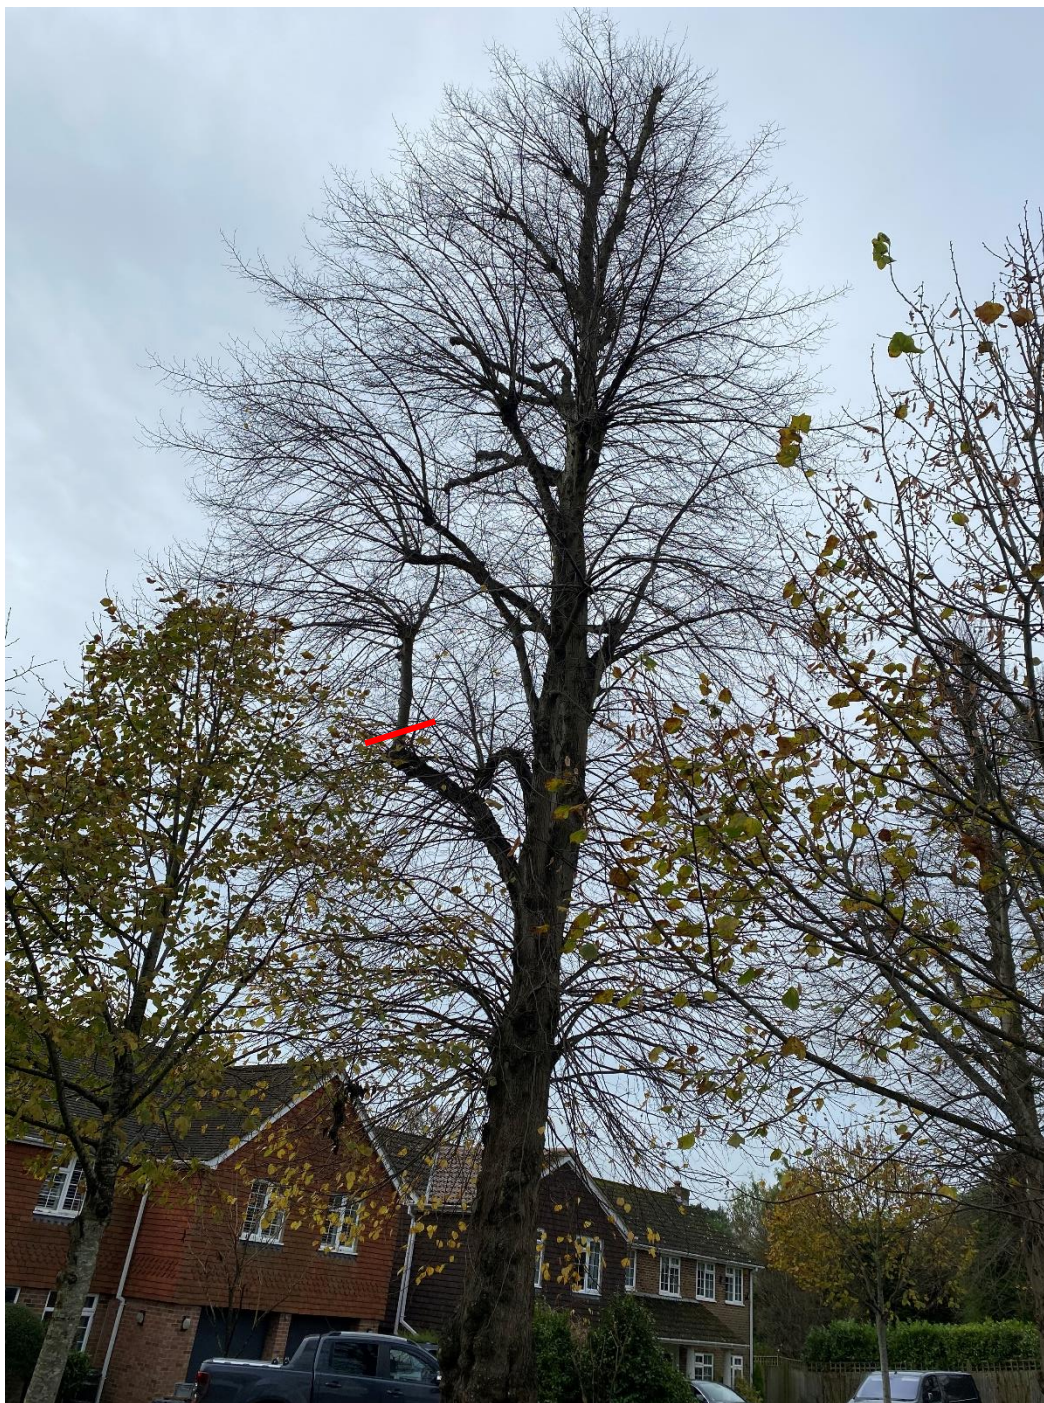
- 6.4 Where regrowth has redeveloped maturing upright growth on branches, this creates a loading on the branch potentially increasing the risk of torsional branch failure through the wind loading twisting the branch. Whilst the risk is low, if other works are being implemented, it is appropriate to manage these uprights.

SAL4 Typical upright growth to be pruned out of the tree shown by position of red line (indicating anticipated pruning point).
