# Tree Condition Survey Report (VTA)

**Site:** Haywards Heath Police Station, 1b Bolnore Rd, Haywards  
Heath RH16 4BA

**Client:** Sussex Police

| <i>GC Document Reference</i> | J240862 | | | |

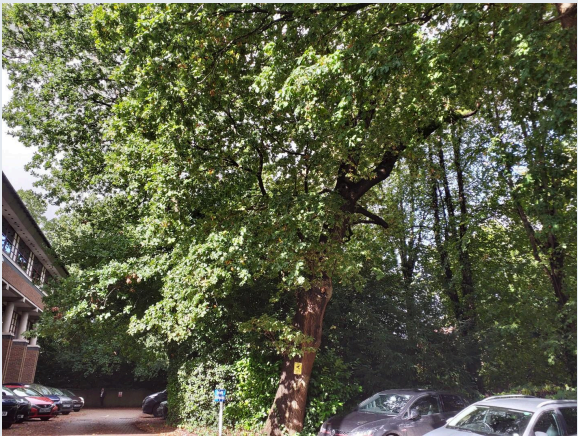
| Pedunculate oak Tree ID #2 | |

| Tree Survey Schedule | | | | | | | | | | | | | | | | | |
|---|---|---|---|---|---|---|---|---|---|---|---|---|---|---|---|---|---|
| 2 | 992 | Pedunculate oak | Quercus robur | 20+m | 650 | Mature | Fair | Fair | Tree leaning towards public highway, cavity in main stem at approximately 3m from ground level, major deadwood present and overhanging carpark area | No Visible Issues or Defects | Cavity in Stem, Leaning Stem - Major | Major Dead Wood Over 50mm Diameter | None Observed | Building, Car park, Footpath | High | Good | Client |

| Tree / Group ID | Common Name | Work Task | Work Priority | Description | Tag No |
|---|---|---|---|---|---|
| 2 | Pedunculate oak | Remove Dead Wood | Within 1 - 3 Months | | 992 |
| 2 | Pedunculate oak | Reduce Crown in Height (by 2m) and Shape (Specify final height and width) | Within 1 - 3 Months | | 992 |
| 2 | Pedunculate oak | Crown Lift Over Car Park/ Footpath to 2.5m | Within 1 - 3 Months | | 992 |

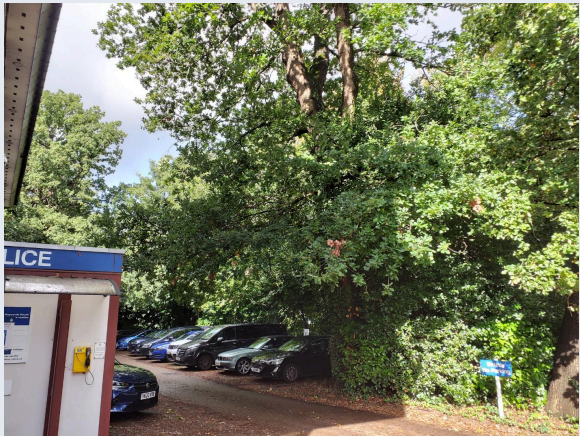
| Pedunculate oak Tree ID #3 | |

| Tree Survey Schedule | | | | | | | | | | | | | | | | | |
|---|---|---|---|---|---|---|---|---|---|---|---|---|---|---|---|---|---|
| 3 | | Pedunculate oak | Quercus robur | 20+m | 800 | Mature | Fair | Fair | Low branches overhanging access road and parking spaces | No Visible Issues or Defects | Bottle Butt, Ivy - Insignificant | Low Branches, Minor Dead Wood Under 50mm Diameter | None Observed | Building, Car park, Footpath | High | Good | Client |

| Tree / Group ID | Common Name | Work Task | Work Priority | Description | Tag No |
|---|---|---|---|---|---|
| 3 | Pedunculate oak | Crown Lift to Specified Amount | Within 1 - 3 Months | Lift Crown to 3m from ground level | |

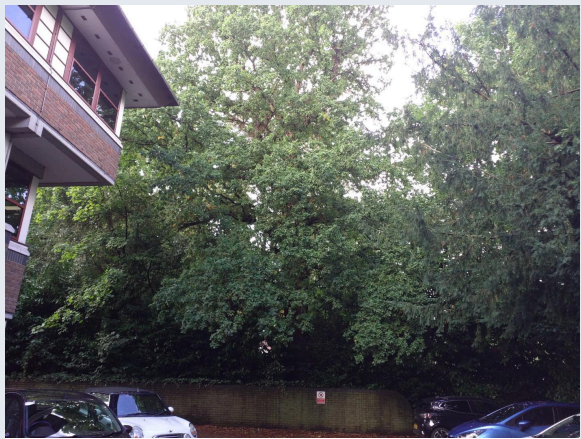
Pedunculate oak Tree ID #7

| Tree Survey Schedule | | | | | | | | | | | | | | | | | |
|---|---|---|---|---|---|---|---|---|---|---|---|---|---|---|---|---|---|
| 7 | | Pedunculate oak | Quercus robur | 20+m | 800 | Mature | Fair | Fair | Low branches overhanging access road | No Visible Issues or Defects | Bottle Butt, Ivy - Insignificant | Low Branches, Minor Dead Wood Under 50mm Diameter | None Observed | Building, Car park, Footpath | High | Good | Client |

| Tree / Group ID | Common Name | Work Task | Work Priority | Description | Tag No |
|---|---|---|---|---|---|
| 7 | Pedunculate oak | Crown Lift to Specified Amount | Within 1 - 3 Months | Lift Crown to 3m from ground level | |

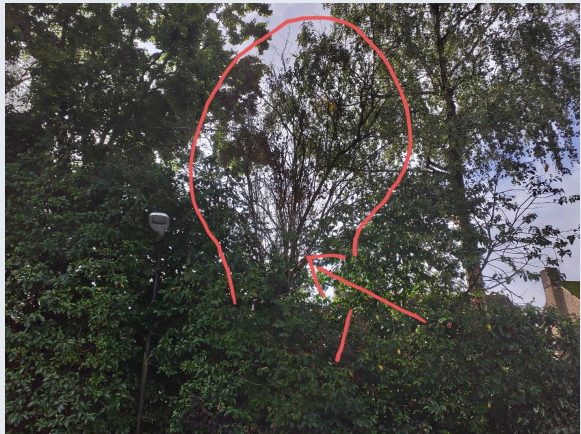
| Cherry plum Tree ID #11 | |

| Tree Survey Schedule | | | | | | | | | | | | | | | | | |
|---|---|---|---|---|---|---|---|---|---|---|---|---|---|---|---|---|---|
| 11 | No tag - Restricted access | Cherry plum | Prunus cerasifera | 5-10m | 300 | Early-mature | Poor | Poor | | No Visible Issues or Defects | Multi-Stem | Crown Dieback, Major Dead Wood Over 50mm Diameter, Poor Vitality | None Observed | Car park | High | No access - crown health only assessed | Client |

| Comments: | Restricted access due to dense vegetation |

| Tree / Group ID | Common Name | Work Task | Work Priority | Description | Tag No |
|---|---|---|---|---|---|
| 11 | Cherry plum | Dismantle to ground level | Within 1 - 3 Months | | No tag - Restricted access |

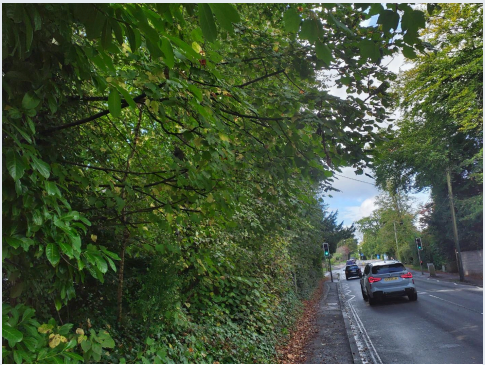
Group ID #1

| Tree Group Survey Schedule | | | | | | | | | | | | | | | | | | |
|---|---|---|---|---|---|---|---|---|---|---|---|---|---|---|---|---|---|---|
| 1 | | Lime species | Tilia sp. | 9 | 16-20m | 450-600mm | Mature | Fair | Fair | Epicormic growth is now starting to encroach on public highway and footpath | None Significant | Prolific Epicormic/Basal Growth | Low Branches, Lapsed Pollard, Minor Dead Wood Under 50mm Diameter | None Observed | Car park, Footpath, Road | High | No access to base/stem | Client |

| Group Details | |
|---|---|
| Comments: | Restricted access and visibility to basil area and upper canopy due to prolific basal/epicormic growth |

| Tree / Group ID | Common Name | Work Task | Work Priority | Description | Tag No |
|---|---|---|---|---|---|
| Group 1 | Lime species | Re-Pollard | Within 3 - 6 Months | Re-pollard all trees in group.<br>Due to the scale of work, Traffic management and parking restrictions to be considered, price should be given on application once all aspects of the above are considered | |
