PAY/EM/63830

**RE: Clear Water Barn, Fox Hill, Haywards Heath**

As requested, I visited the above site on Thursday, June 12<sup>th</sup> to inspect the structural condition of the Barn. The purpose of the inspection was to provide a report upon the suitability of the structure to conversion for domestic or commercial usage.

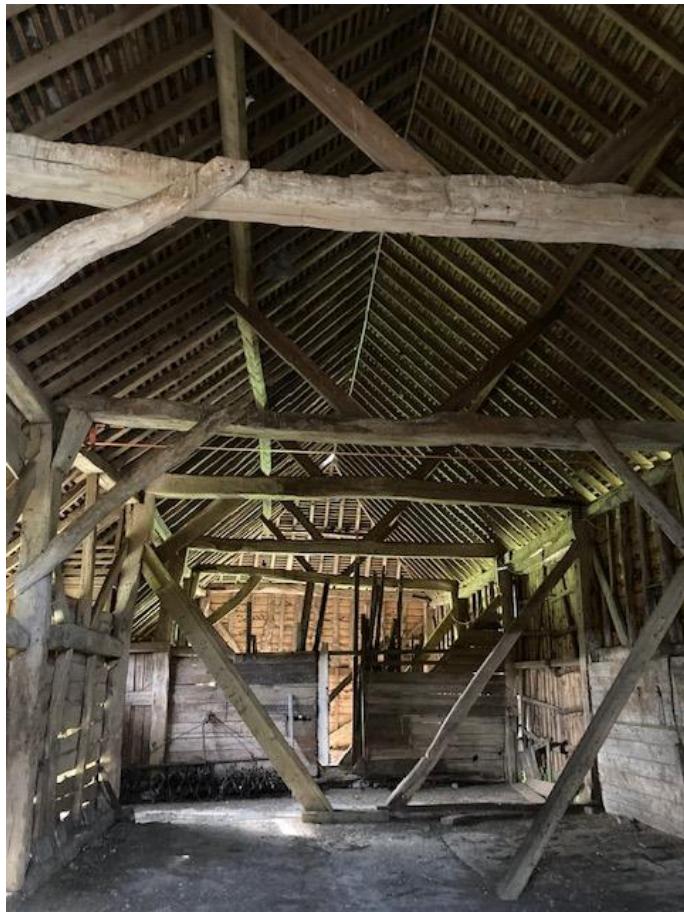
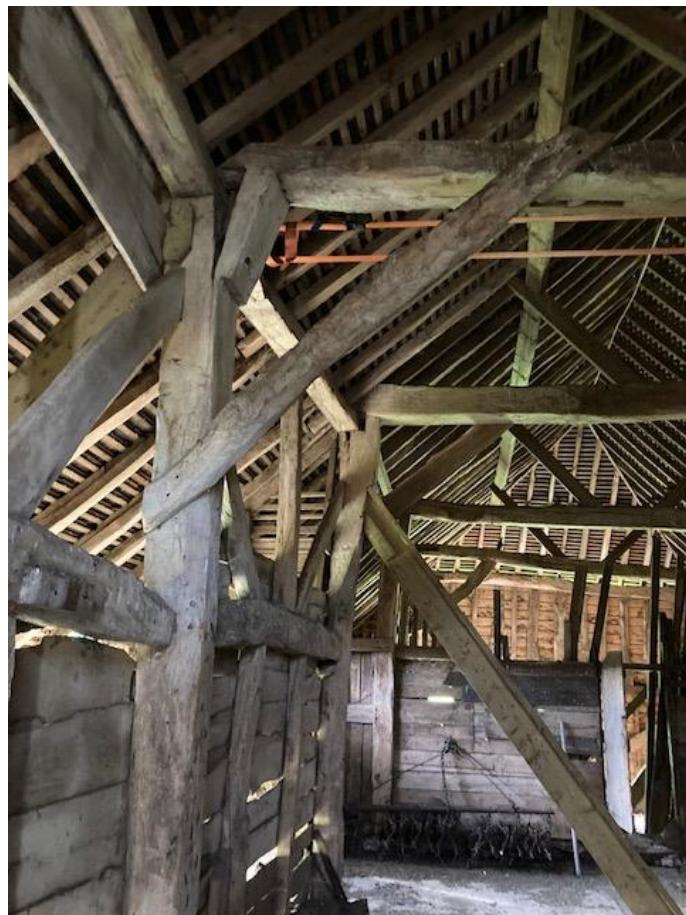
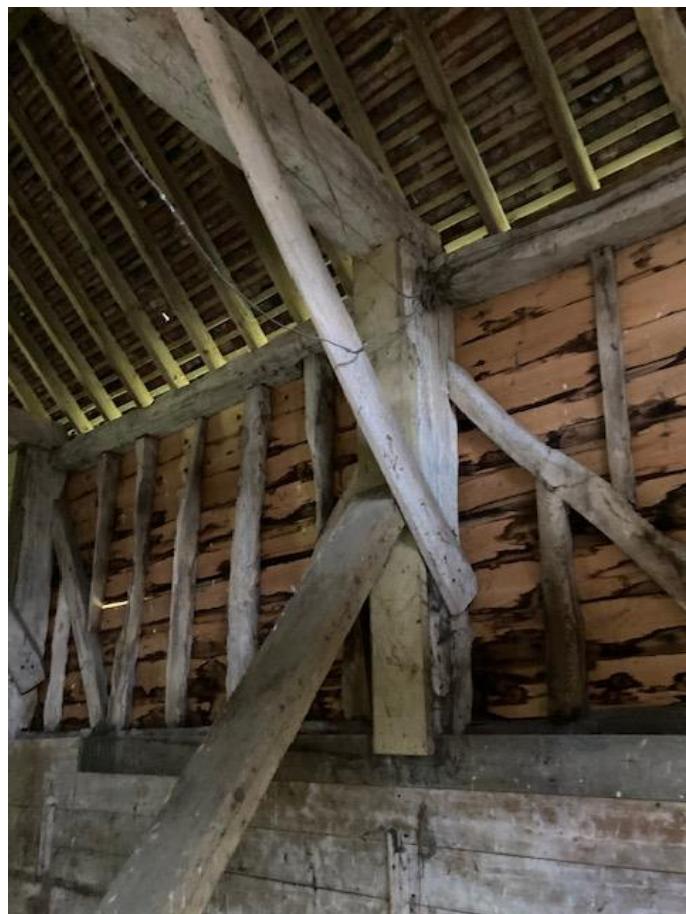
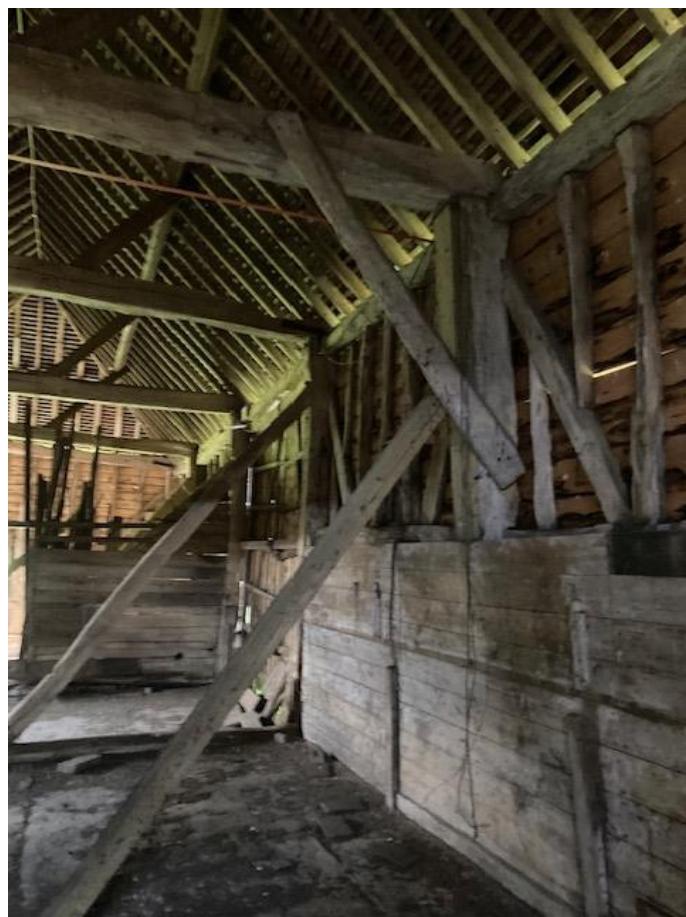
Some of the other frames have had high-level braces spiked to one side of each frame and elsewhere softwood raking struts have been introduced - see photographs 2 to 6.

The general condition of the timber frame is such that I consider it will be suitable for conversion for domestic or commercial usage. Some remedial works will of course be necessary. A permanent repair to the second cross frame will be necessary and there will also be a need to rationalise and improve the stability bracing to the other cross frames.

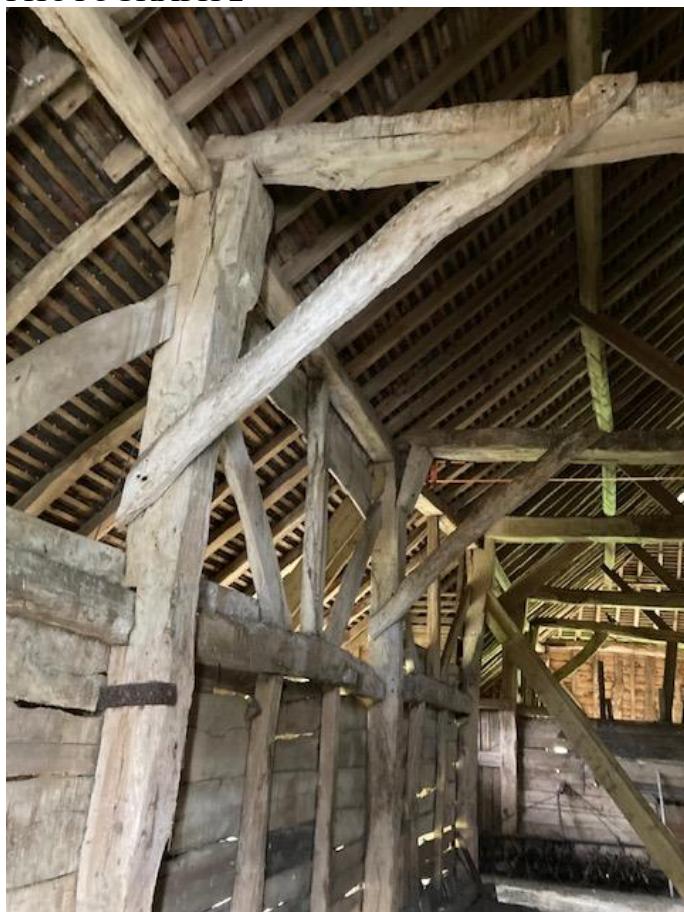
PHOTOGRAPH 3

There was however one frame, frame number 2 where the post-stock has split - see photograph 3. Some tension strapping has been introduced to tie the two opposing wall plates.

The second frame shows a large split between the tie beam and the poststock. This has presumably necessitated the strapping repair and the introduction of additional bracing in the lean-to.

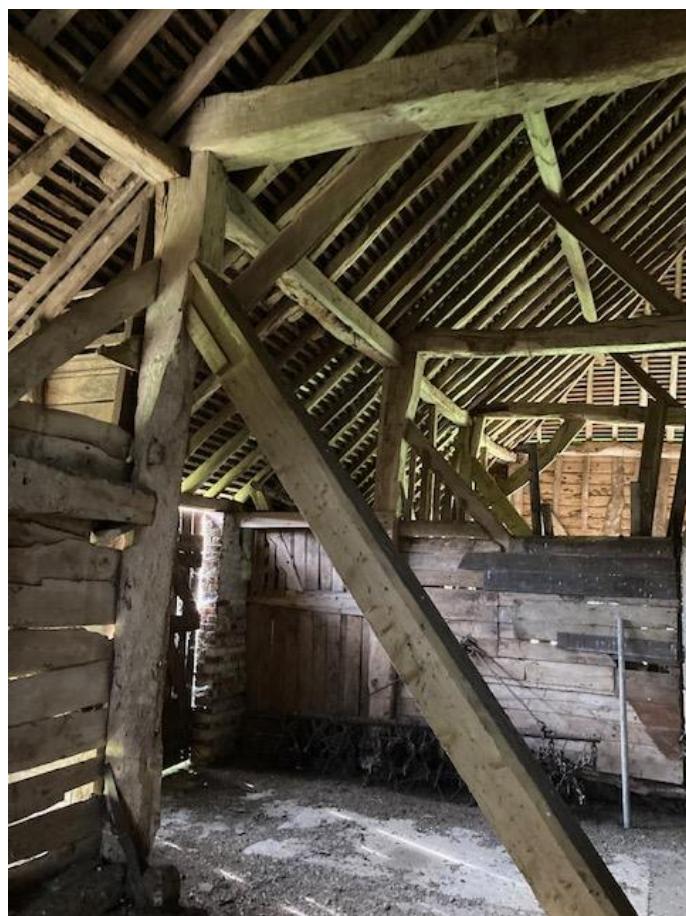
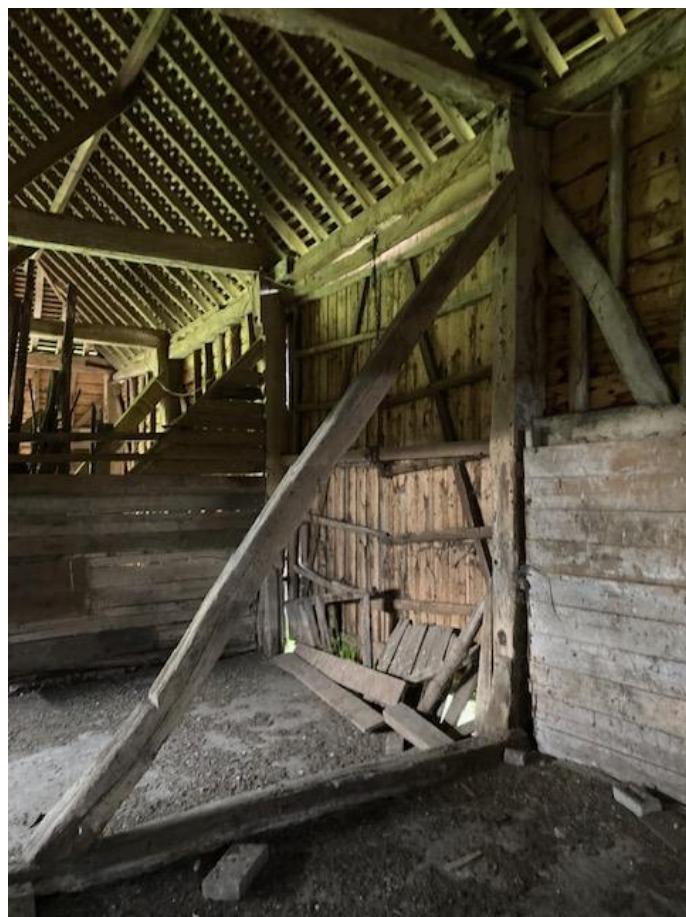
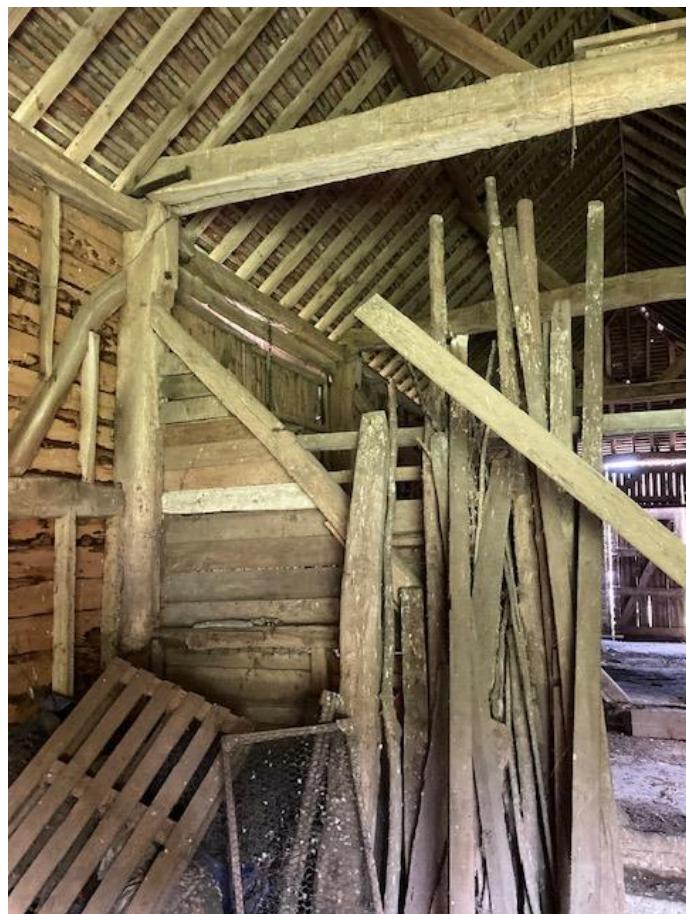
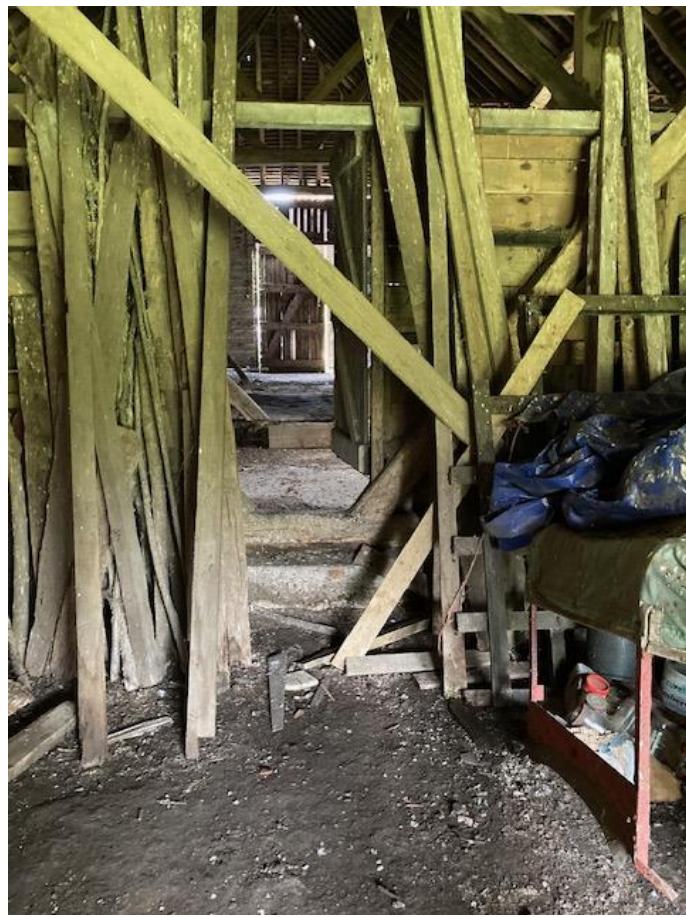
Frame number 4 is of the raking strut type and frame number 3 is thought to have also been of the raking strut type - see photographs numbered 7 to 10.

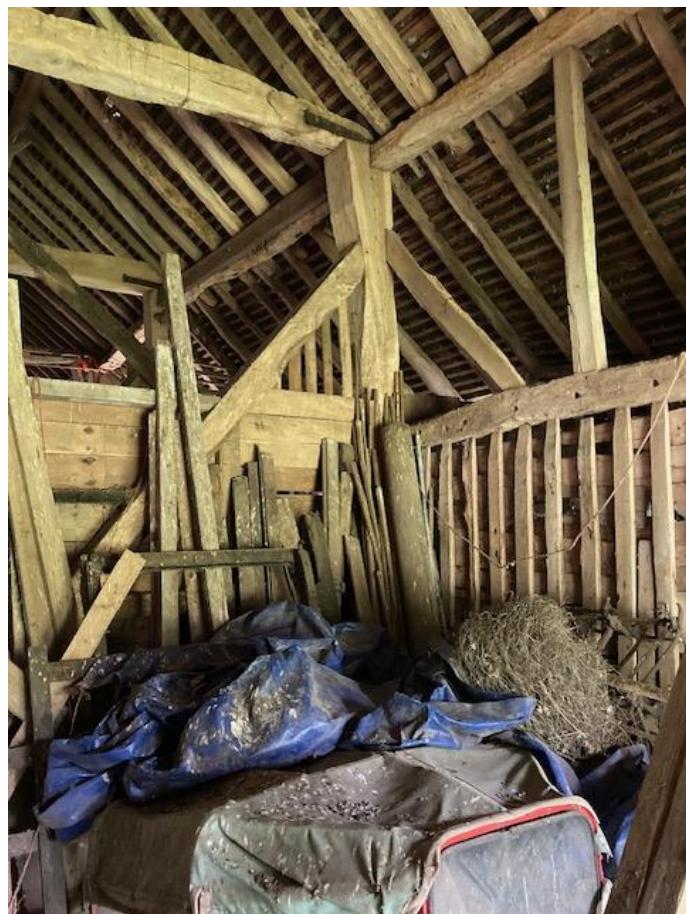
PHOTOGRAPH 11

The timber framing to the east frame (between the main barn and the lean-to areas) had similar main framing but was more open with fewer secondary studs – see photograph 11.

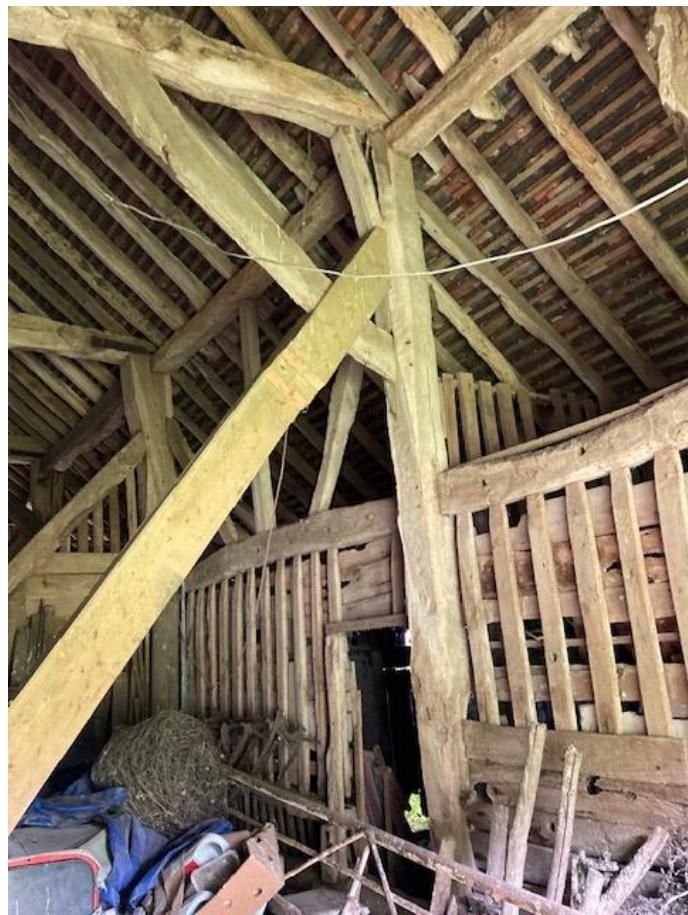
PHOTOGRAPH 12

The timber framing to the main front elevation (west) was fairly traditional with immediate posts, mid-height rails, and infill timber studding. Most bays were adequately braced. It was noted that some local concrete underpinning had been carried out at the south end. The older timber framing had been supported off new softwood plates off some shuttered concrete underpinning – see photograph 12.

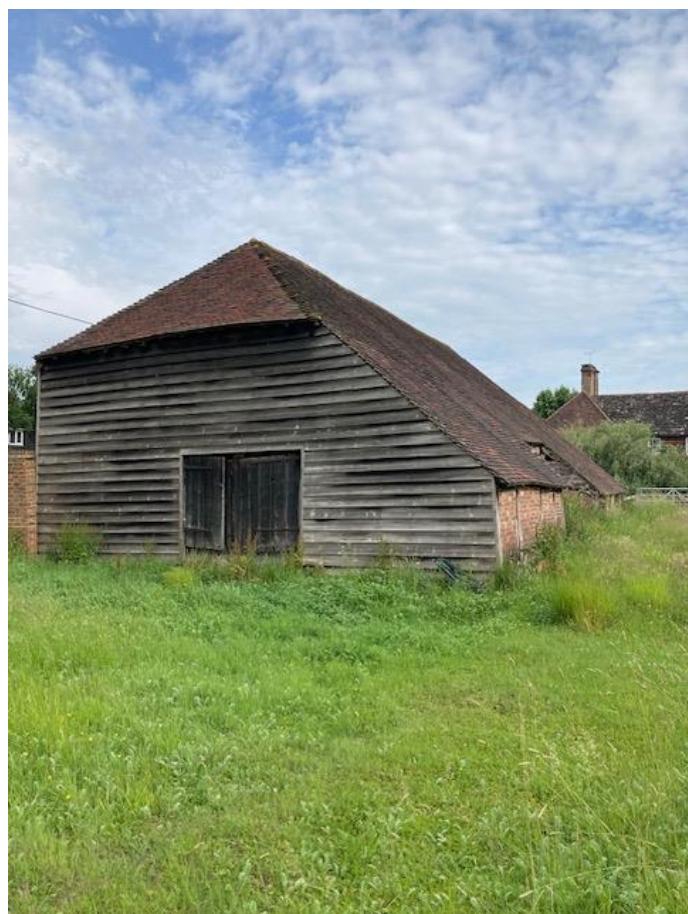
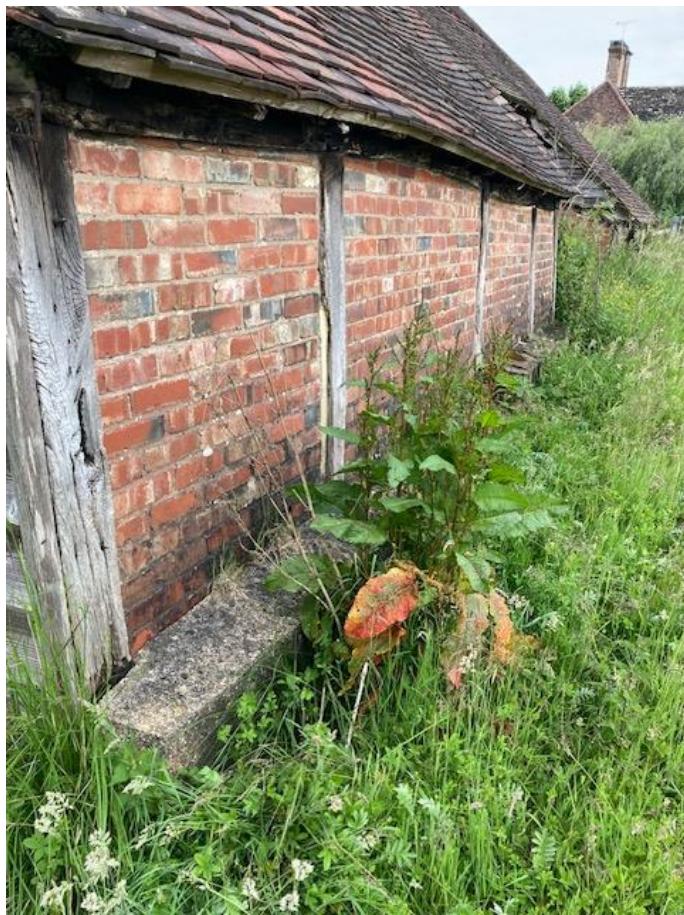
The rear walls to the lean-to areas are of timber frame construction but with brick infilling. Brick panels vary between half-brick and full-brick thickness. There has been some displacement of the rear wall to the south lean-to. The base of the wall has moved outwards and there has been some remedial concrete underpinning – see photographs numbers 15 & 16.

There is evidence of some past movement to some of the walls to the lean-to areas. Some local concrete underpinning has been carried out. The foundations and ground conditions are not known but according to the Geological map of the area the site is underlain by soils of the upper Tunbridge Wells sand series. Given the neglected state of the building, it is difficult to judge whether there is any real evidence of any ongoing movement to the lean-to walls.

The suitability of the foundations to be the lean-to areas will need to be assessed and monitored. Subject to the final proposals for the building some local mass concrete underpinning may be required.

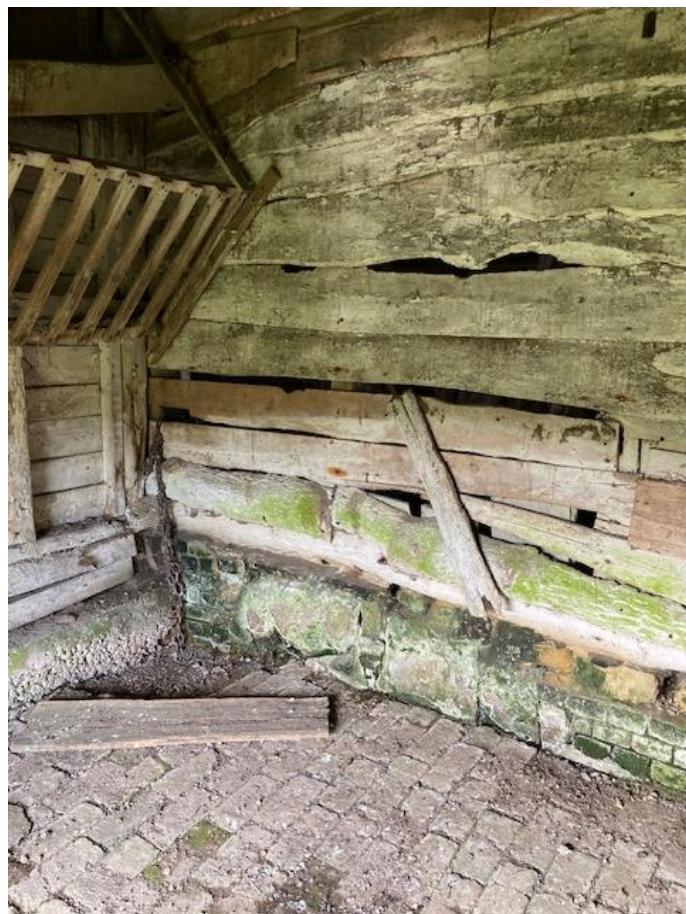
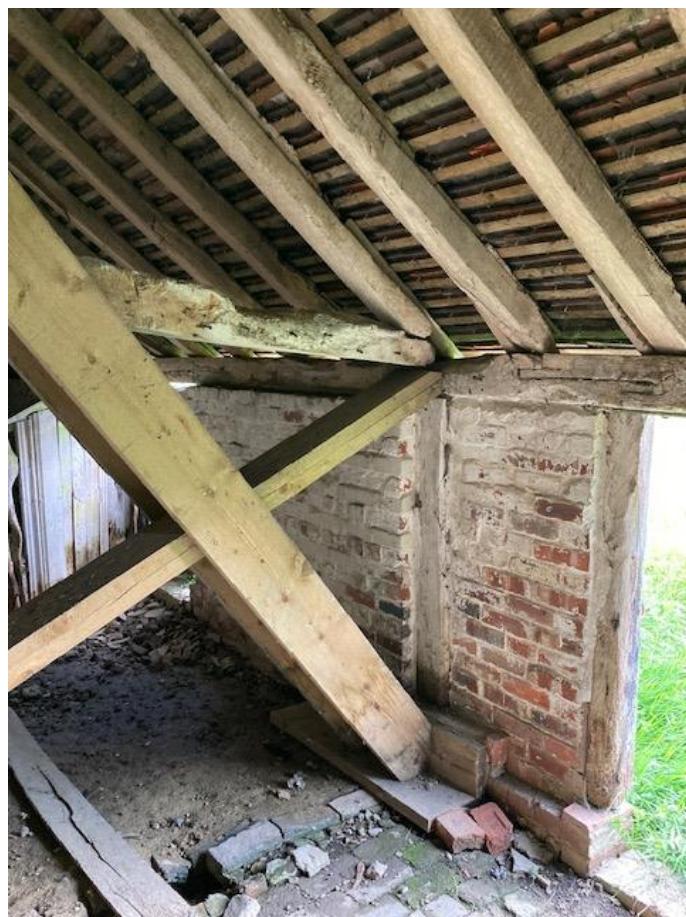
The north lean-to area had a brick paved floor laid to fall towards the rear. The timber rafters were of more random sizes and rough cut. Some sizeable timber cross-bracing has been introduced at the main second frame position – see photographs 21 and 22.

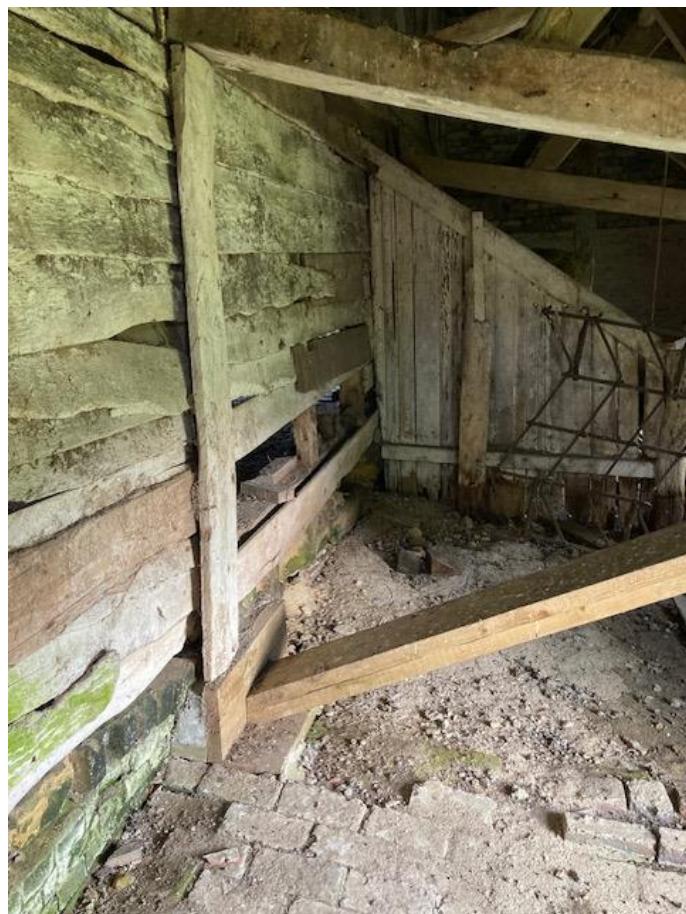
PHOTOGRAPH 23

The lean-to floor was at a lower depth than the main barn. The sub-structure wall to the east frame was exposed in places and could be seen to be built using sandstone blocks – see photograph 23.
