MS05636

Barn to south east of  
Pickhams House,  
Cuckfield Road,  
Hurstpierpoint BN6 9LL

| JOB TITLE<br>Barn at Pickhams House, Hurstpierpoint. | | DATE<br>May 2021 |

Barn to south east of Pickhams House, Cuckfield Road, Hurstpierpoint BN6 9LL.

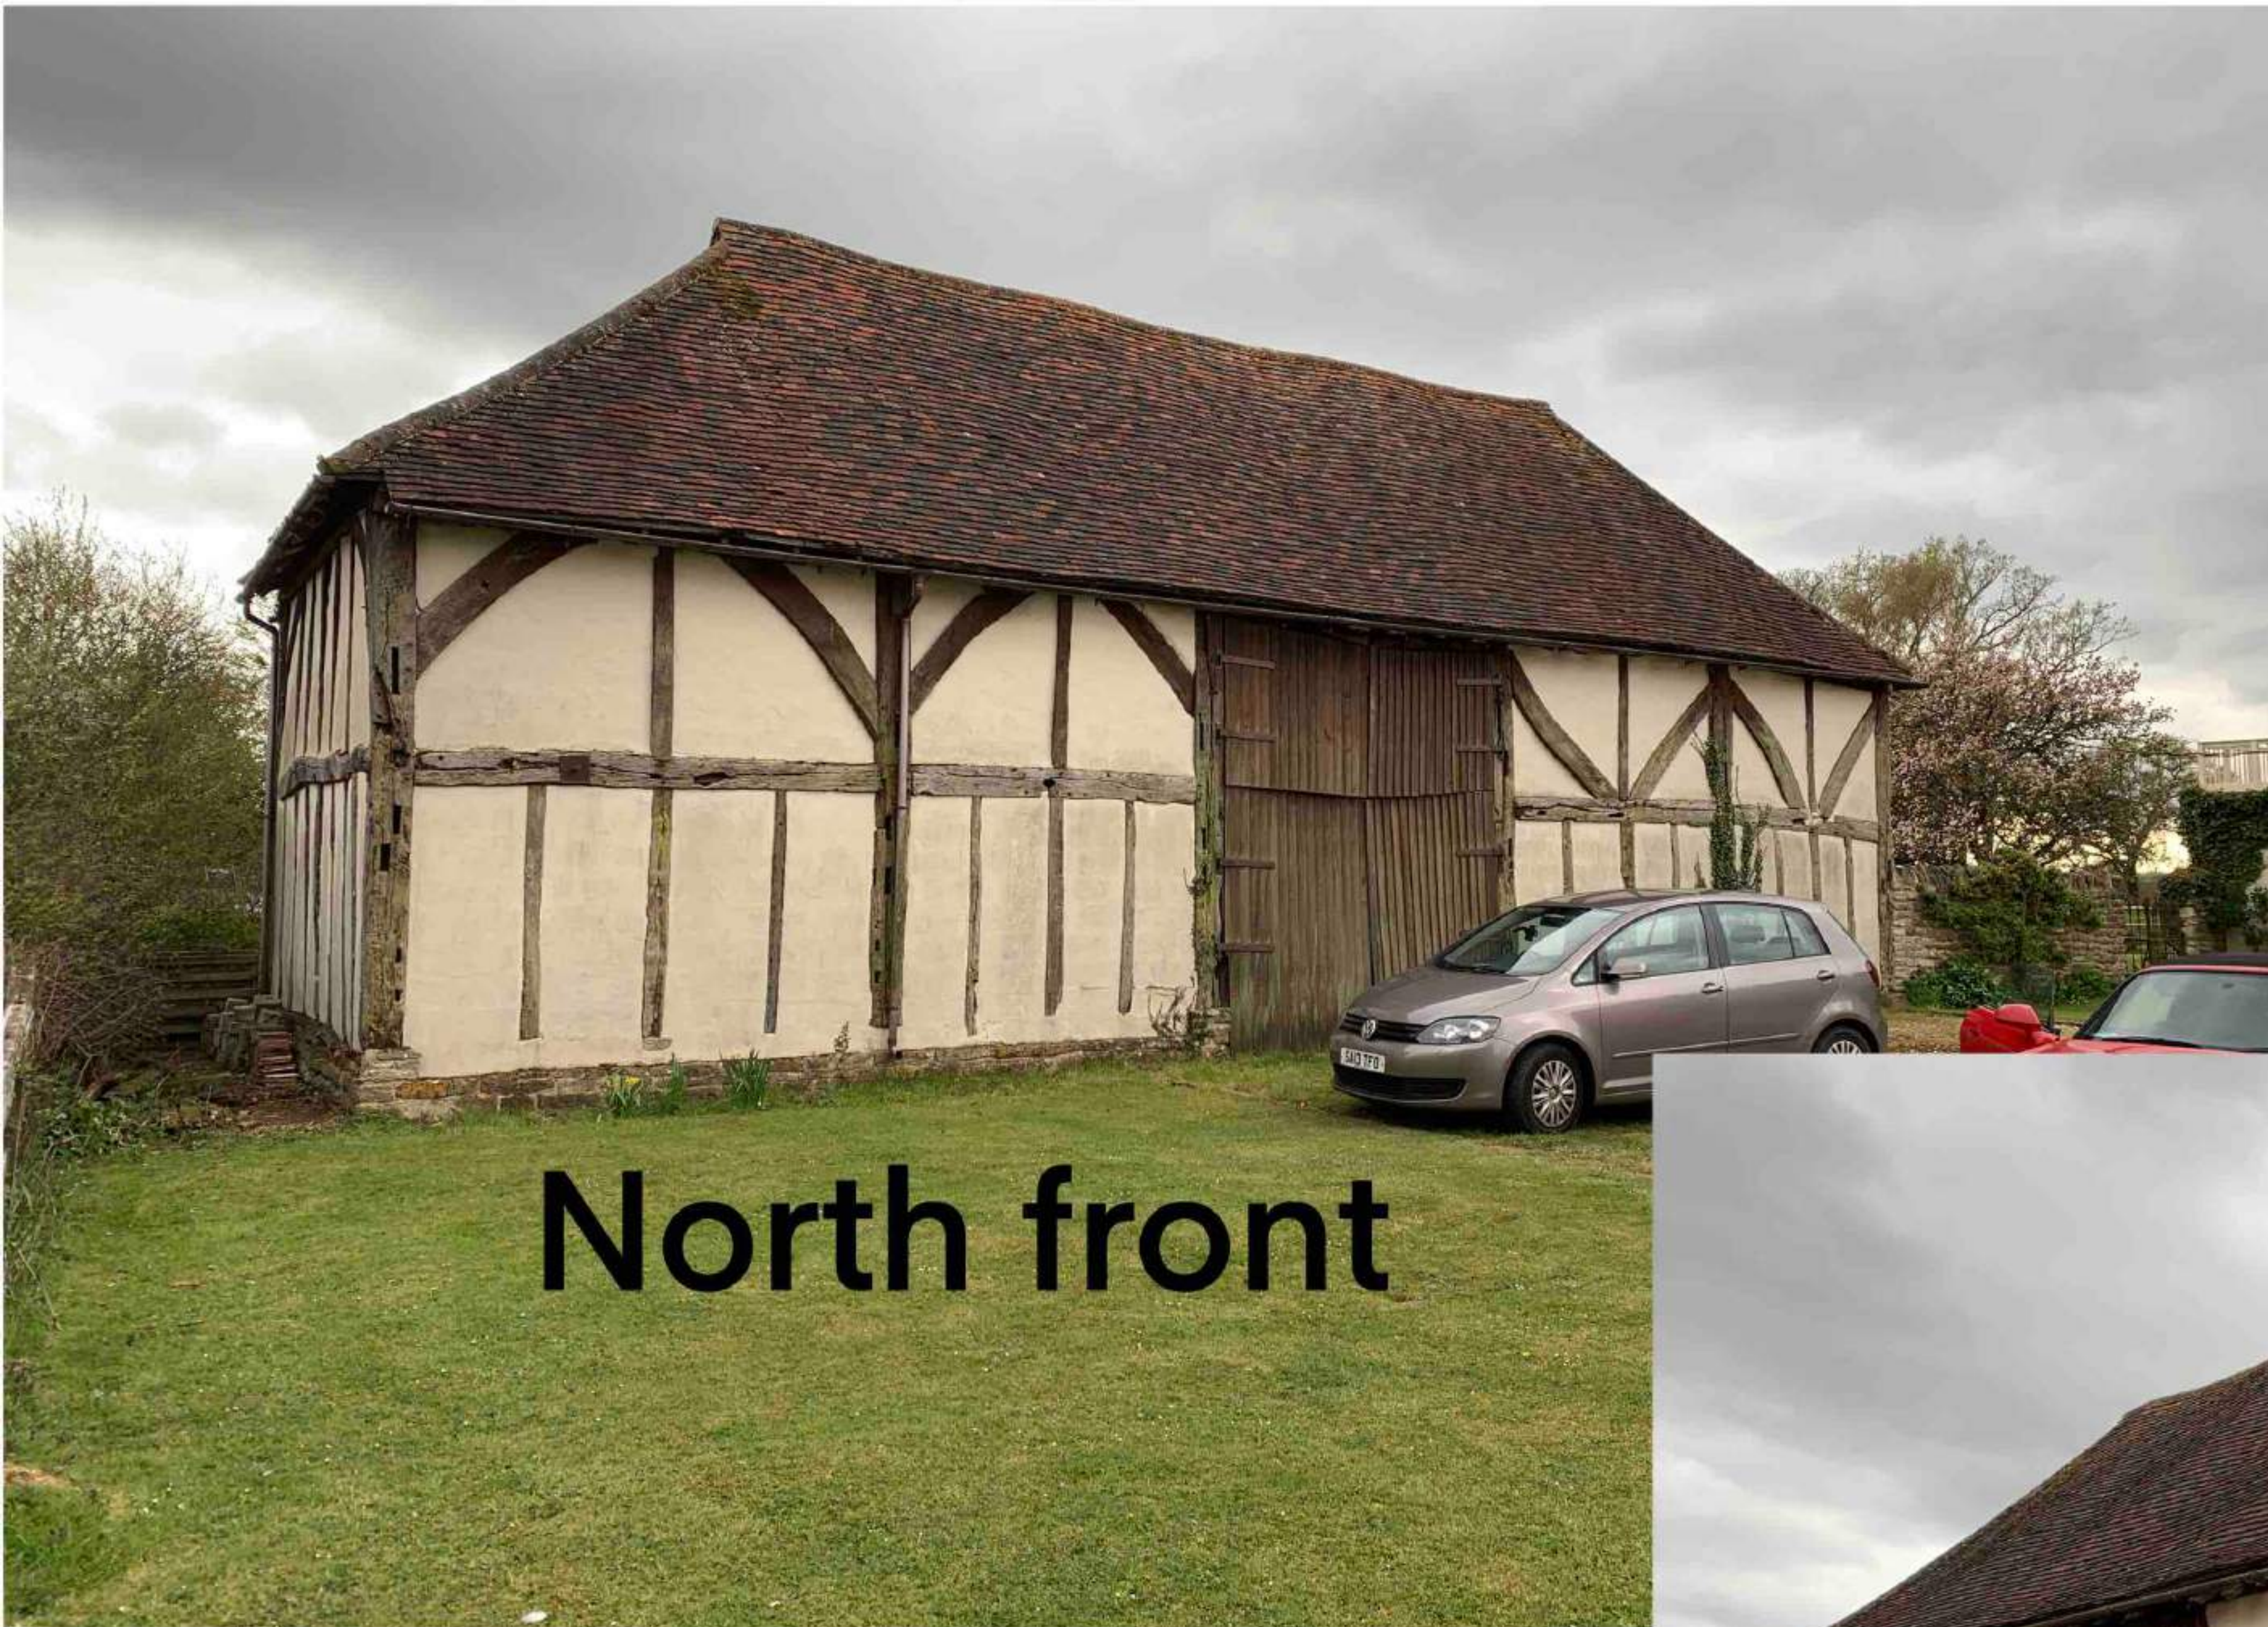
**North front**

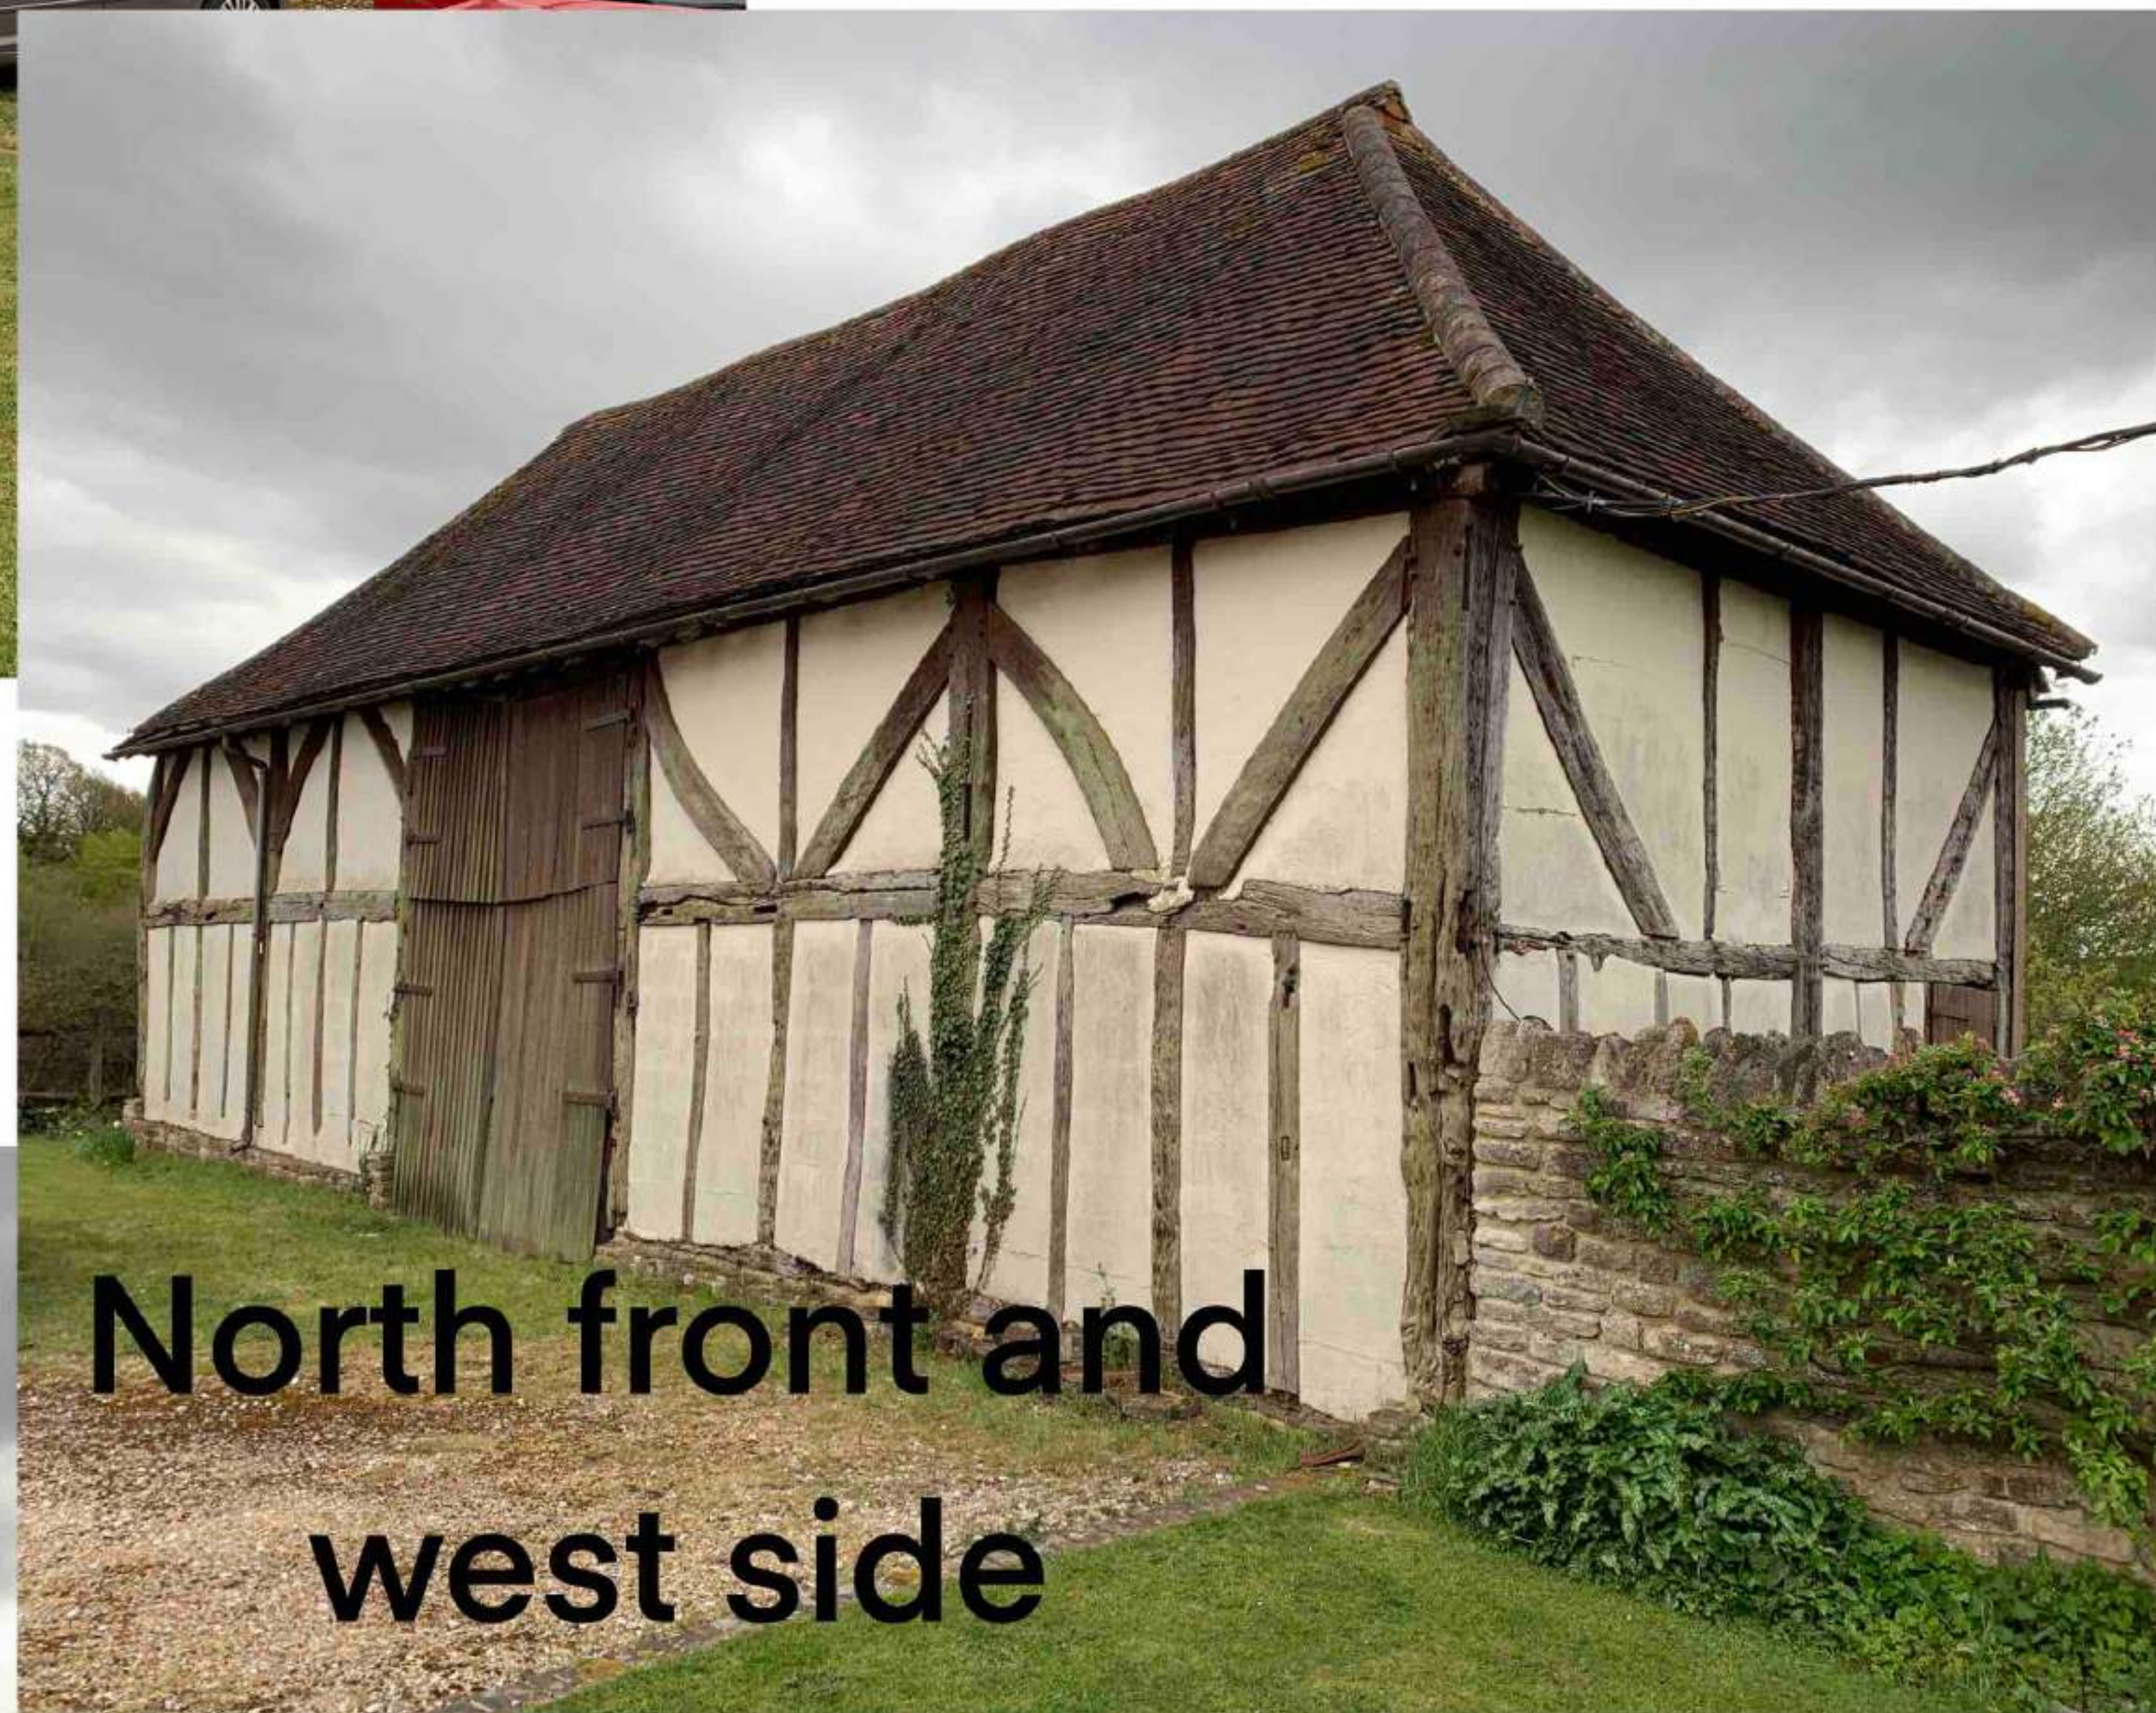
**North front and  
west side**

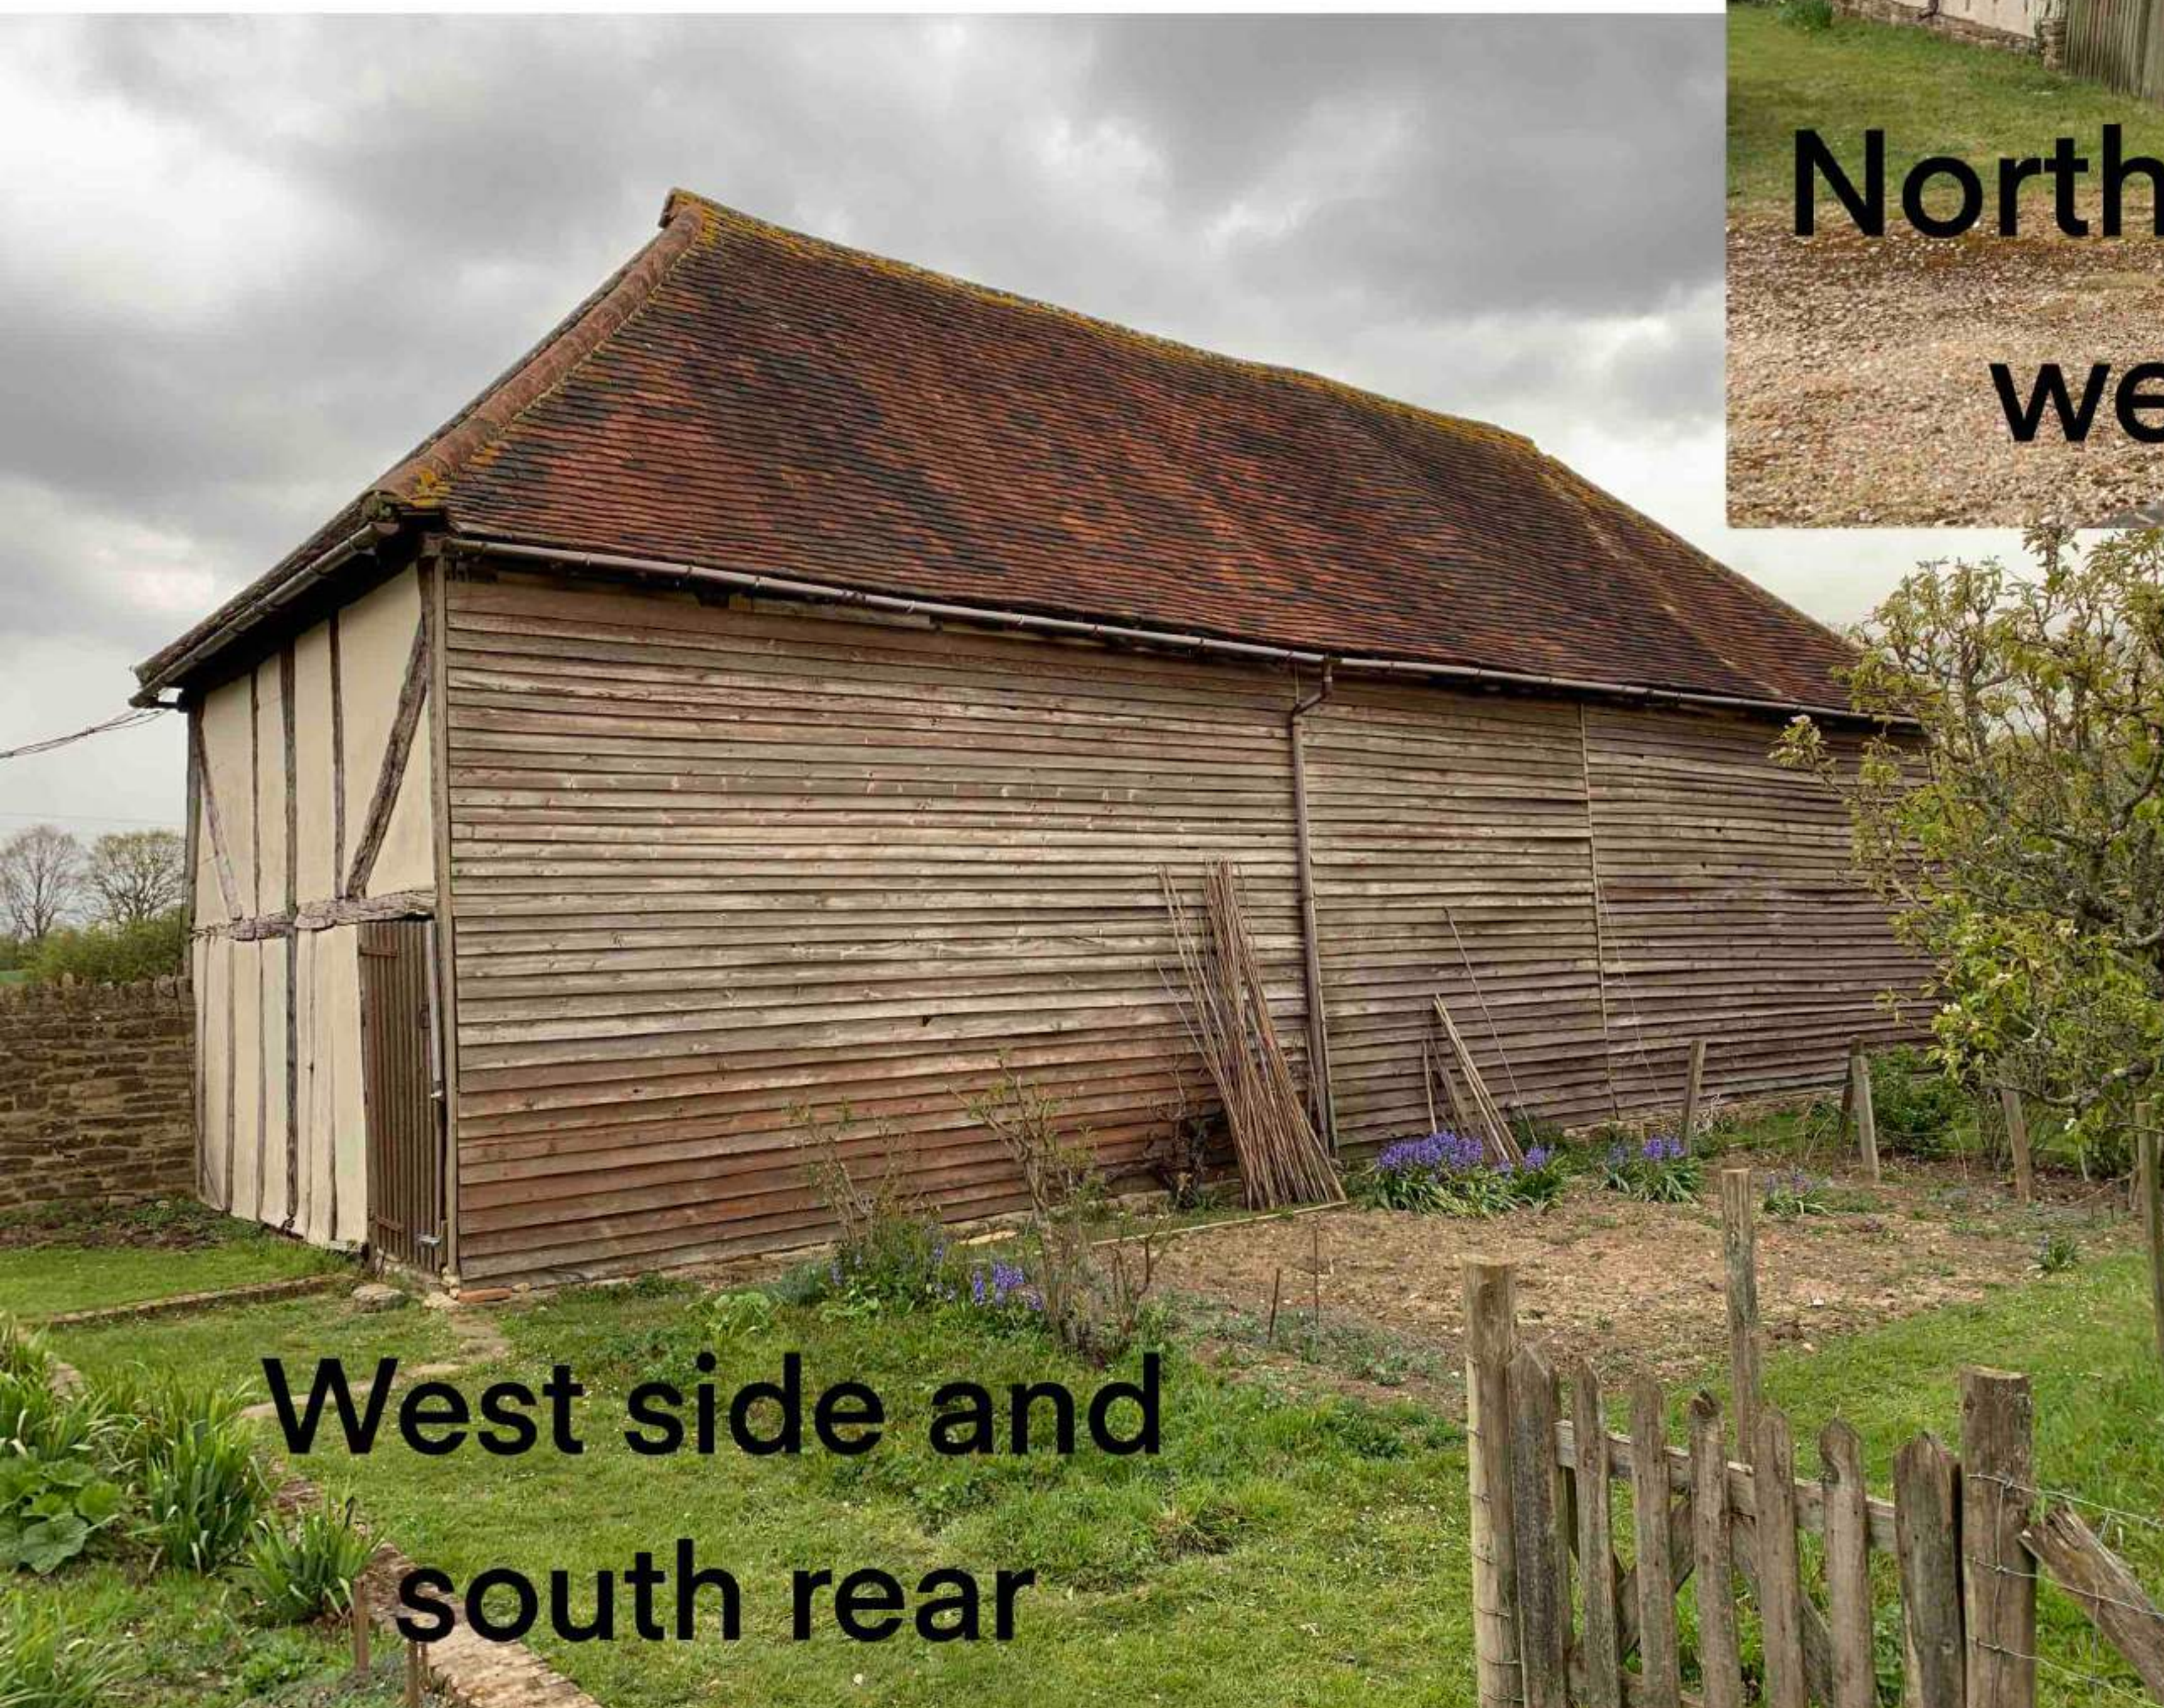
**West side and  
south rear**

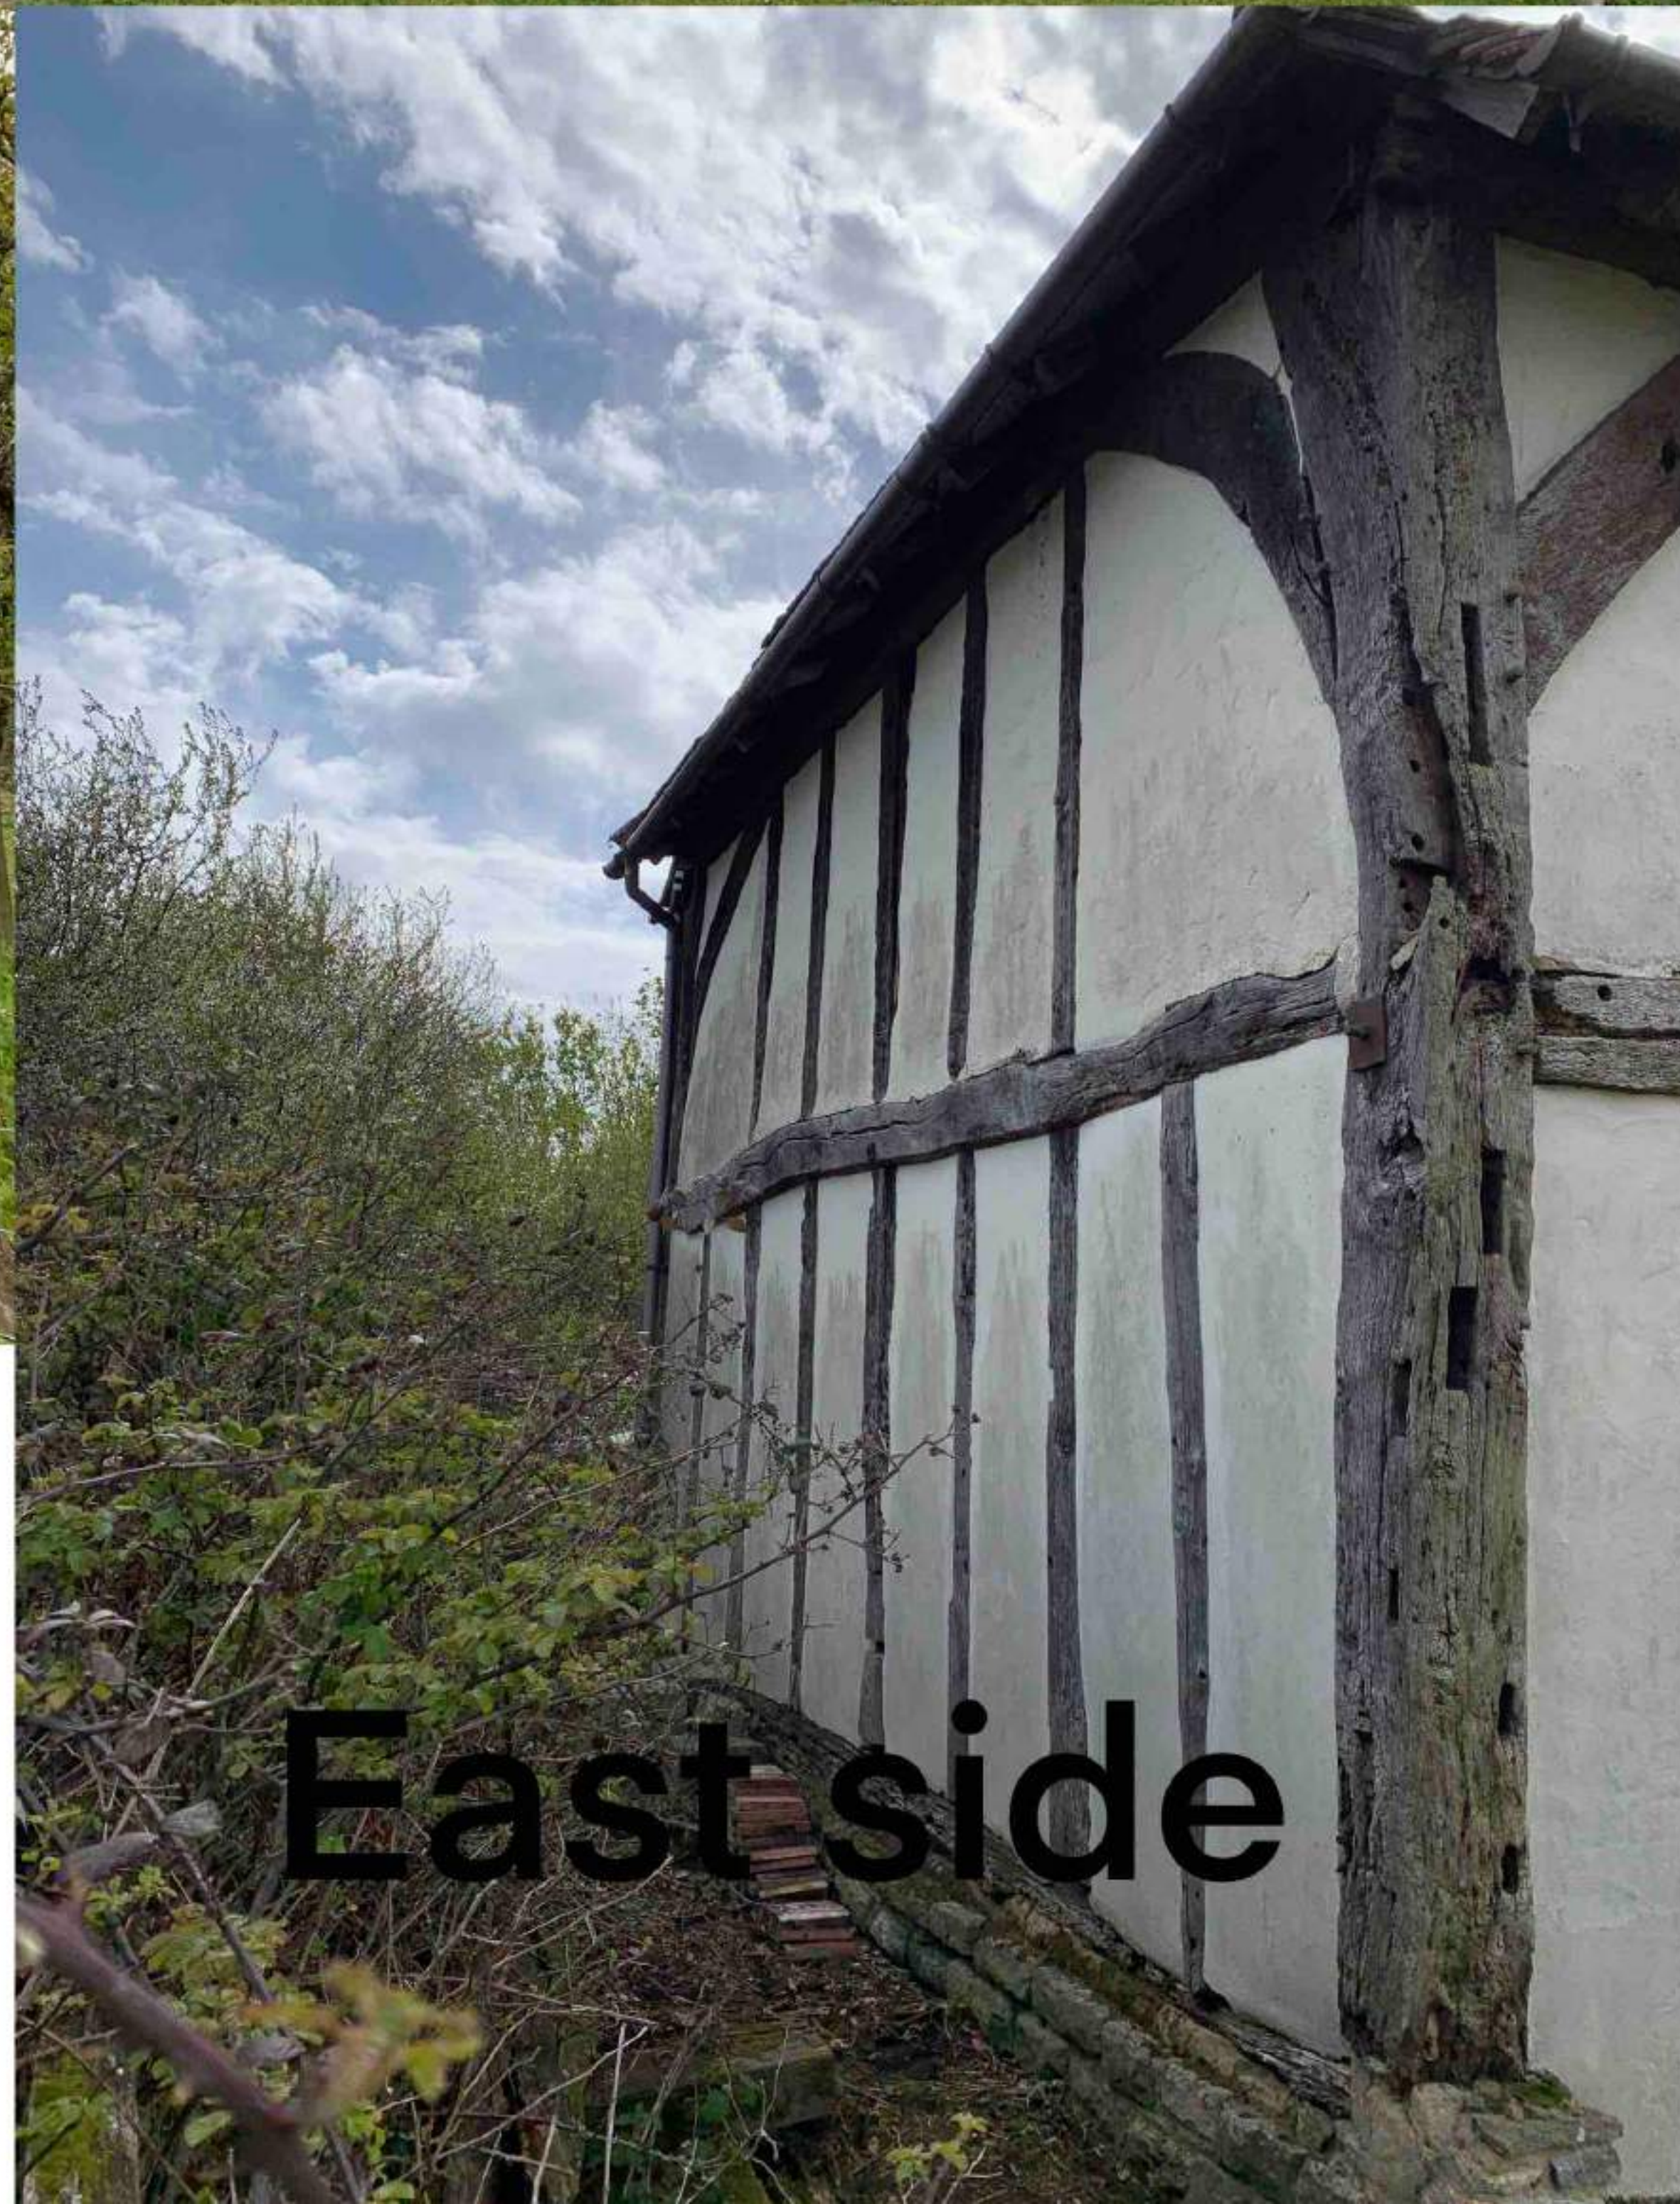
**East side**

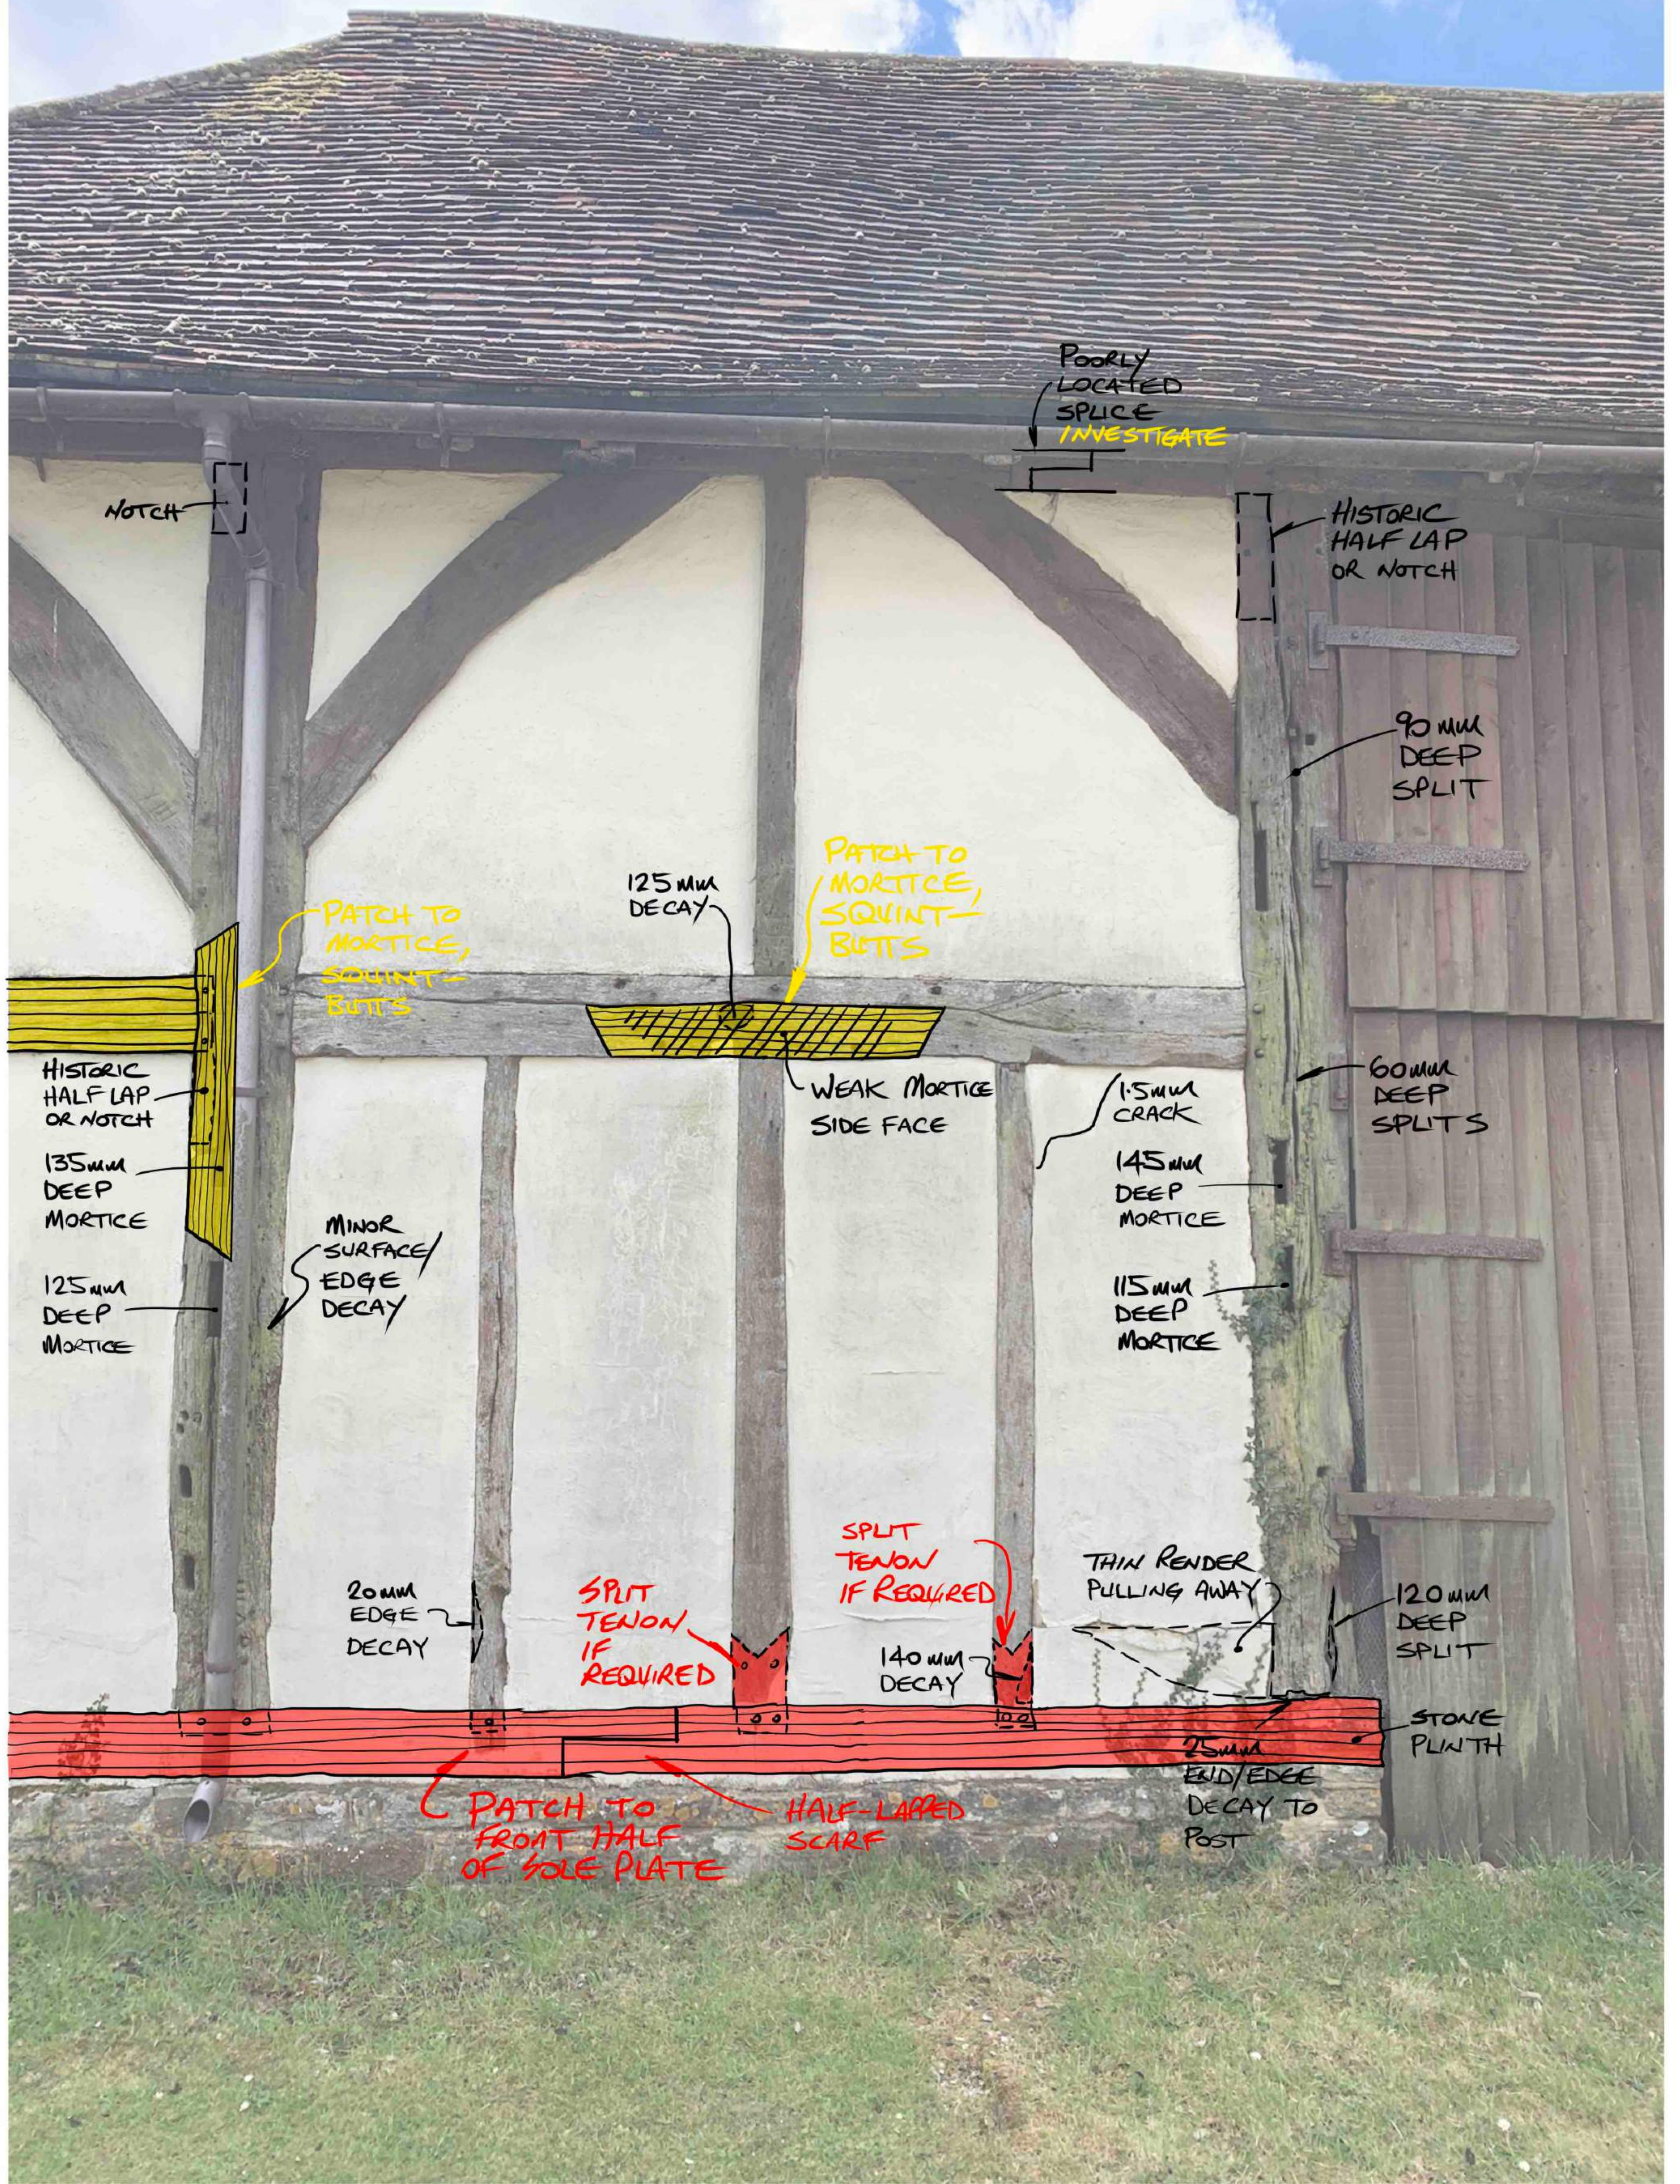
POORLY  
LOCATED  
SPLICE  
INVESTIGATE

90mm  
DEEP  
SPLIT

125mm  
DECAY

WEAK MORTICE  
SIDE FACE

1.5mm  
CRACK

60mm  
DEEP  
SPLITS

MINOR  
SURFACE/  
EDGE  
DECAY

20mm  
EDGE  
DECAY

140mm  
DECAY

THIN RENDER  
PULLING AWAY

120mm  
DEEP  
SPLIT

25mm  
END/EDGE  
DECAY TO  
POST

PATCH TO  
MORTICE,  
SQUINT-  
BUTTS

SPLIT  
TENON  
IF  
REQUIRED

PATCH TO  
FRONT HALF  
OF SOLE PLATE

HALF-LAPPED  
SCARF

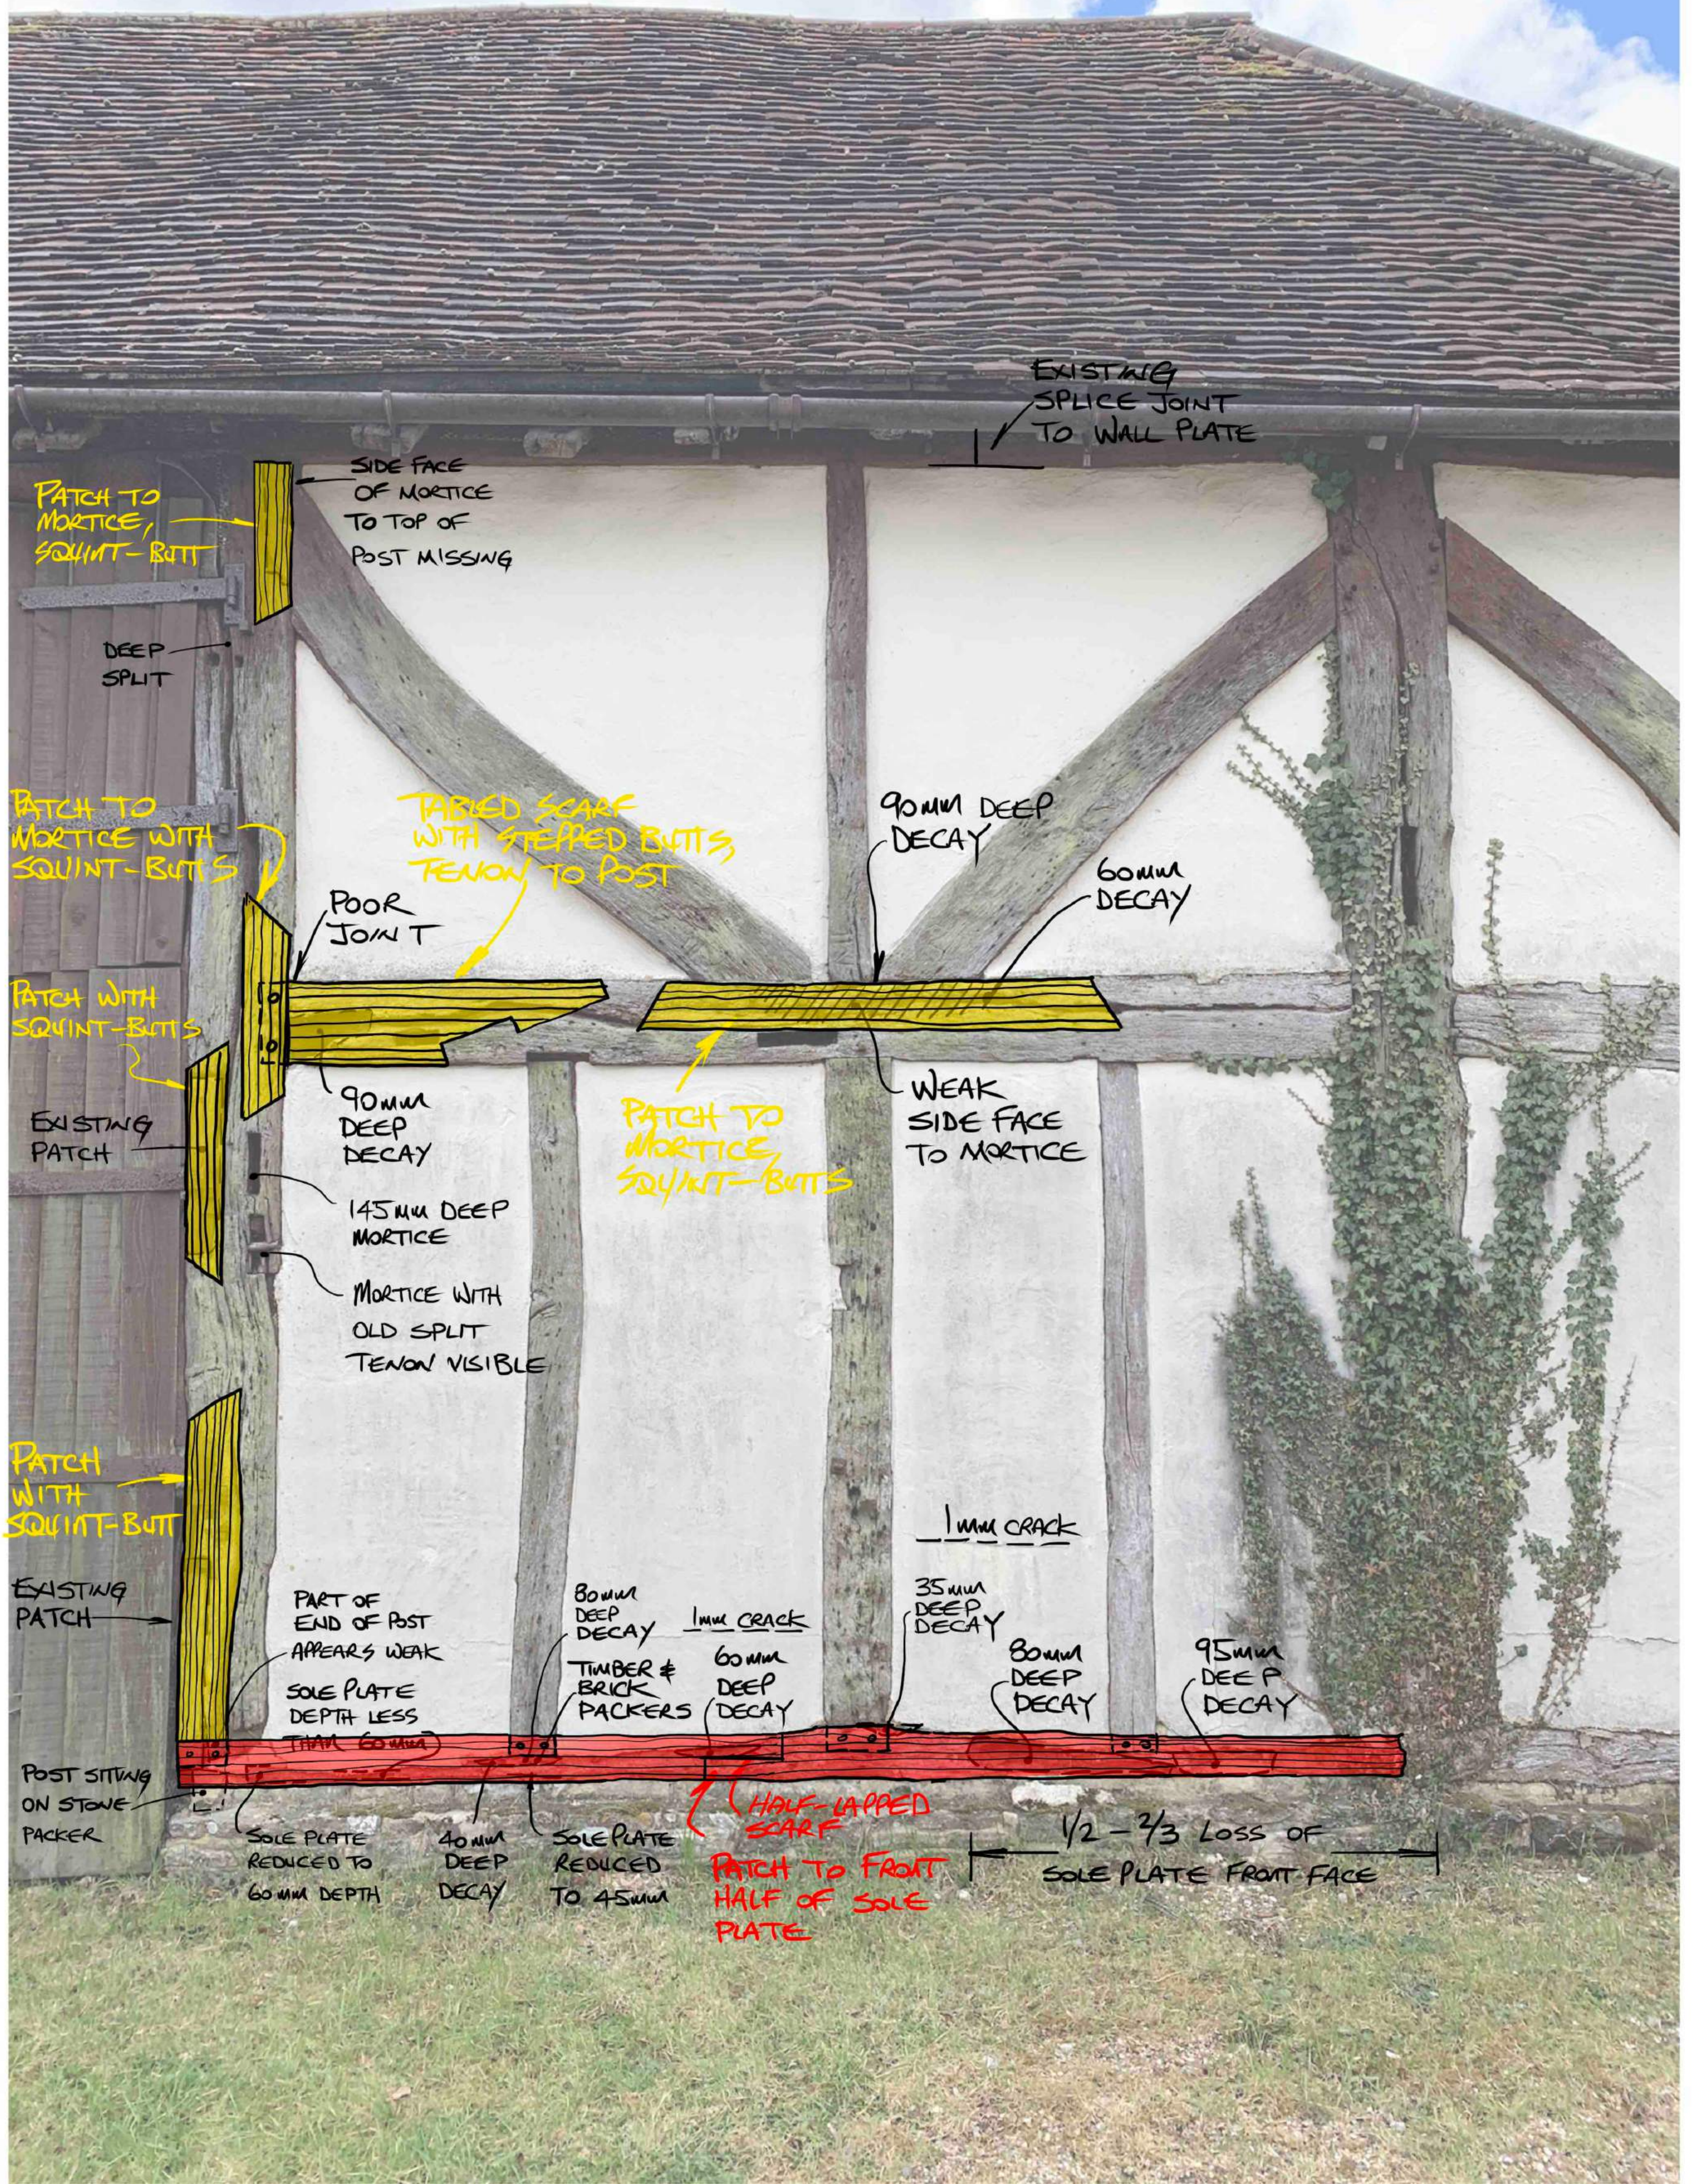
SIDE FACE  
OF MORTICE  
TO TOP OF  
POST MISSING

DEEP  
SPLIT

90MM DEEP  
DECAY

60MM  
DECAY

POOR  
JOINT

90MM  
DEEP  
DECAY

WEAK  
SIDE FACE  
TO MORTICE

PART OF  
END OF POST  
APPEARS WEAK

SOLE PLATE  
DEPTH LESS  
THAN 60MM

80MM  
DEEP  
DECAY

1mm CRACK  
60MM  
DEEP  
DECAY

35MM  
DEEP  
DECAY

95MM  
DEEP  
DECAY

SOLE PLATE  
REDUCED TO  
60MM DEPTH

40MM  
DEEP  
DECAY

SOLE PLATE  
REDUCED  
TO 45MM

1/2 - 2/3 LOSS OF  
SOLE PLATE FRONT FACE

PATCH TO  
MORTICE,  
SQUINT-BUTT

PATCH TO  
MORTICE WITH  
SQUINT-BUTTS

PATCH WITH  
SQUINT-BUTTS

PATCH TO  
MORTICE  
SQUINT-BUTTS

PATCH  
WITH  
SQUINT-BUTT

HALF-LAPPED  
SCARF  
PATCH TO FRONT  
HALF OF SOLE  
PLATE
