MS05636

Barn to south east of  
Pickhams House,  
Cuckfield Road,  
Hurstpierpoint BN6 9LL

| JOB TITLE<br>Barn at Pickhams House, Hurstpierpoint. | | DATE<br>May 2021 |

Barn to south east of Pickhams House, Cuckfield Road, Hurstpierpoint BN6 9LL.

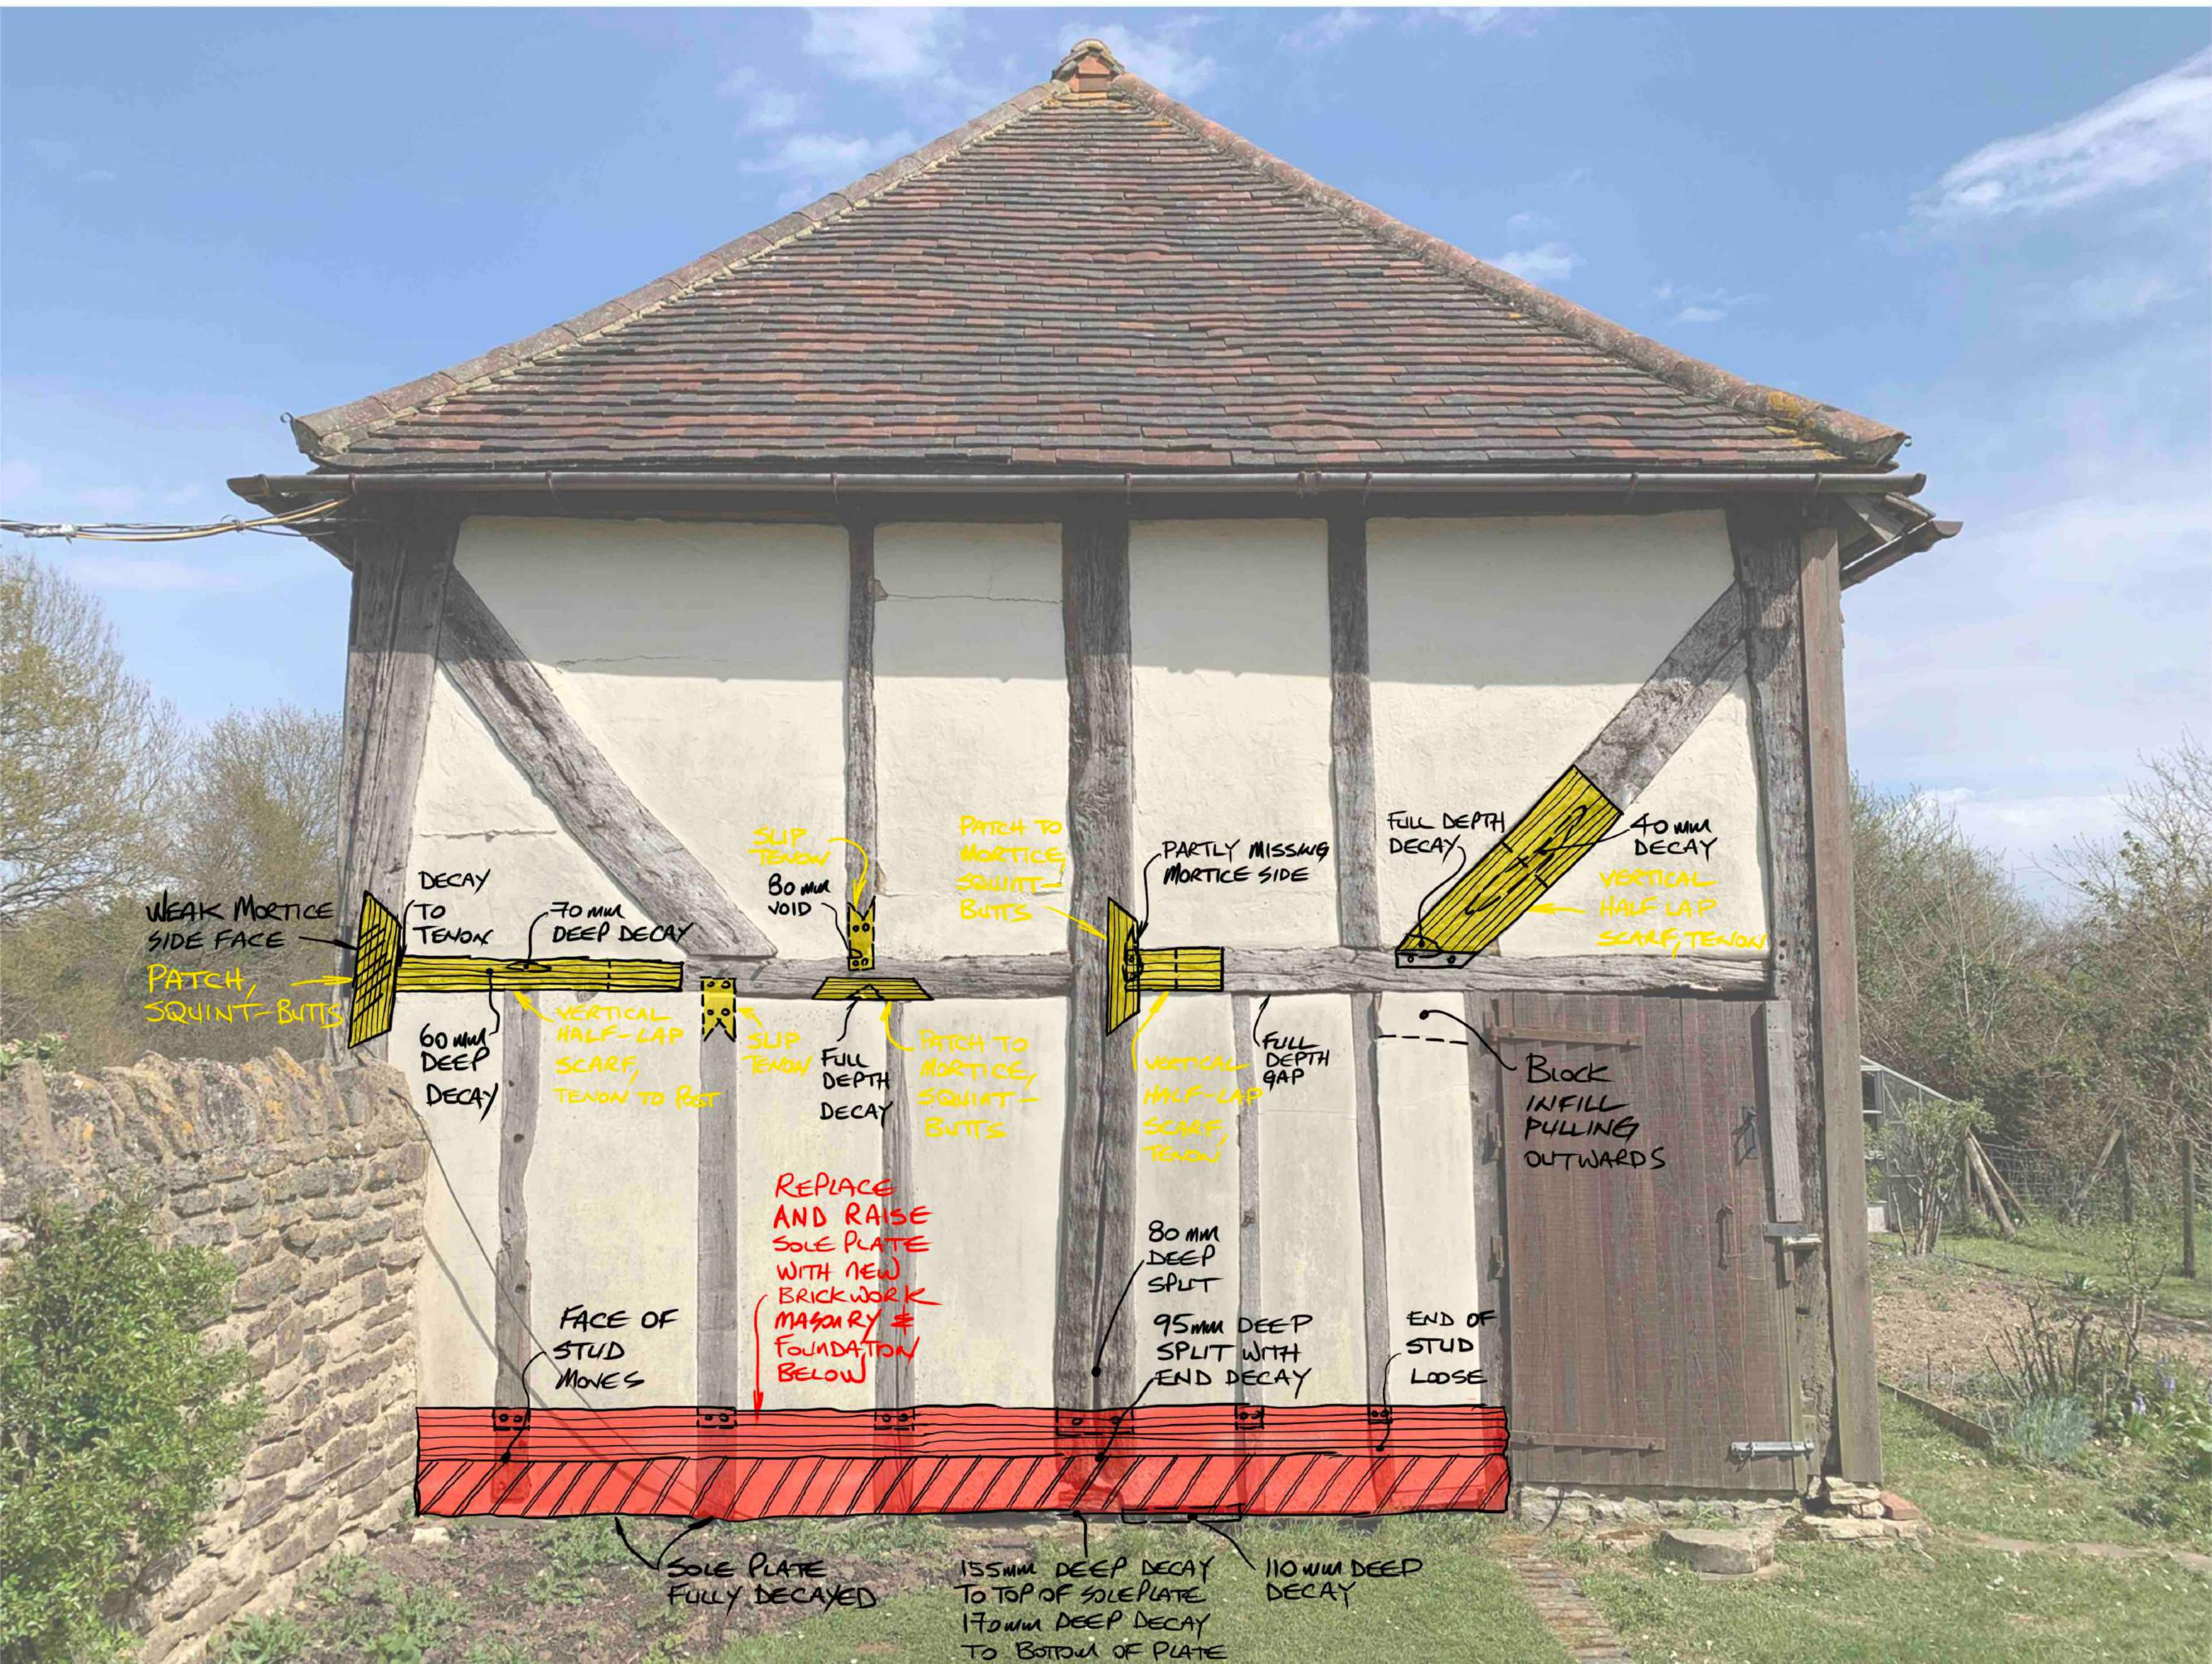
DECAY  
TO  
TENON

70mm  
DEEP DECAY

60mm  
DEEP  
DECAY

FULL  
DEPTH  
DECAY

PARTLY MISSING  
MORTICE SIDE

FULL  
DEPTH  
GAP

FULL DEPTH  
DECAY

40mm  
DECAY

BLOCK  
INFILL  
PULLING  
OUTWARDS

FACE OF  
STUD  
MOVES

80mm  
DEEP  
SPLIT

95mm DEEP  
SPLIT WITH  
END DECAY

END OF  
STUD  
LOOSE

SOLE PLATE  
FULLY DECAYED

155mm DEEP DECAY  
TO TOP OF SOLE PLATE  
170mm DEEP DECAY  
TO BOTTOM OF PLATE

110mm DEEP  
DECAY

WEAK MORTICE  
SIDE FACE  
PATCH,  
SQUINT-BUTTS

VERTICAL  
HALF-LAP  
SCARF,  
TENON TO POST

PATCH TO  
MORTICE,  
SQUINT-  
BUTTS

VERTICAL  
HALF-LAP  
SCARF,  
TENON

VERTICAL  
HALF LAP  
SCARF, TENON

REPLACE  
AND RAISE  
SOLE PLATE  
WITH NEW  
BRICKWORK  
MASSORY &  
FOUNDATION  
BELOW

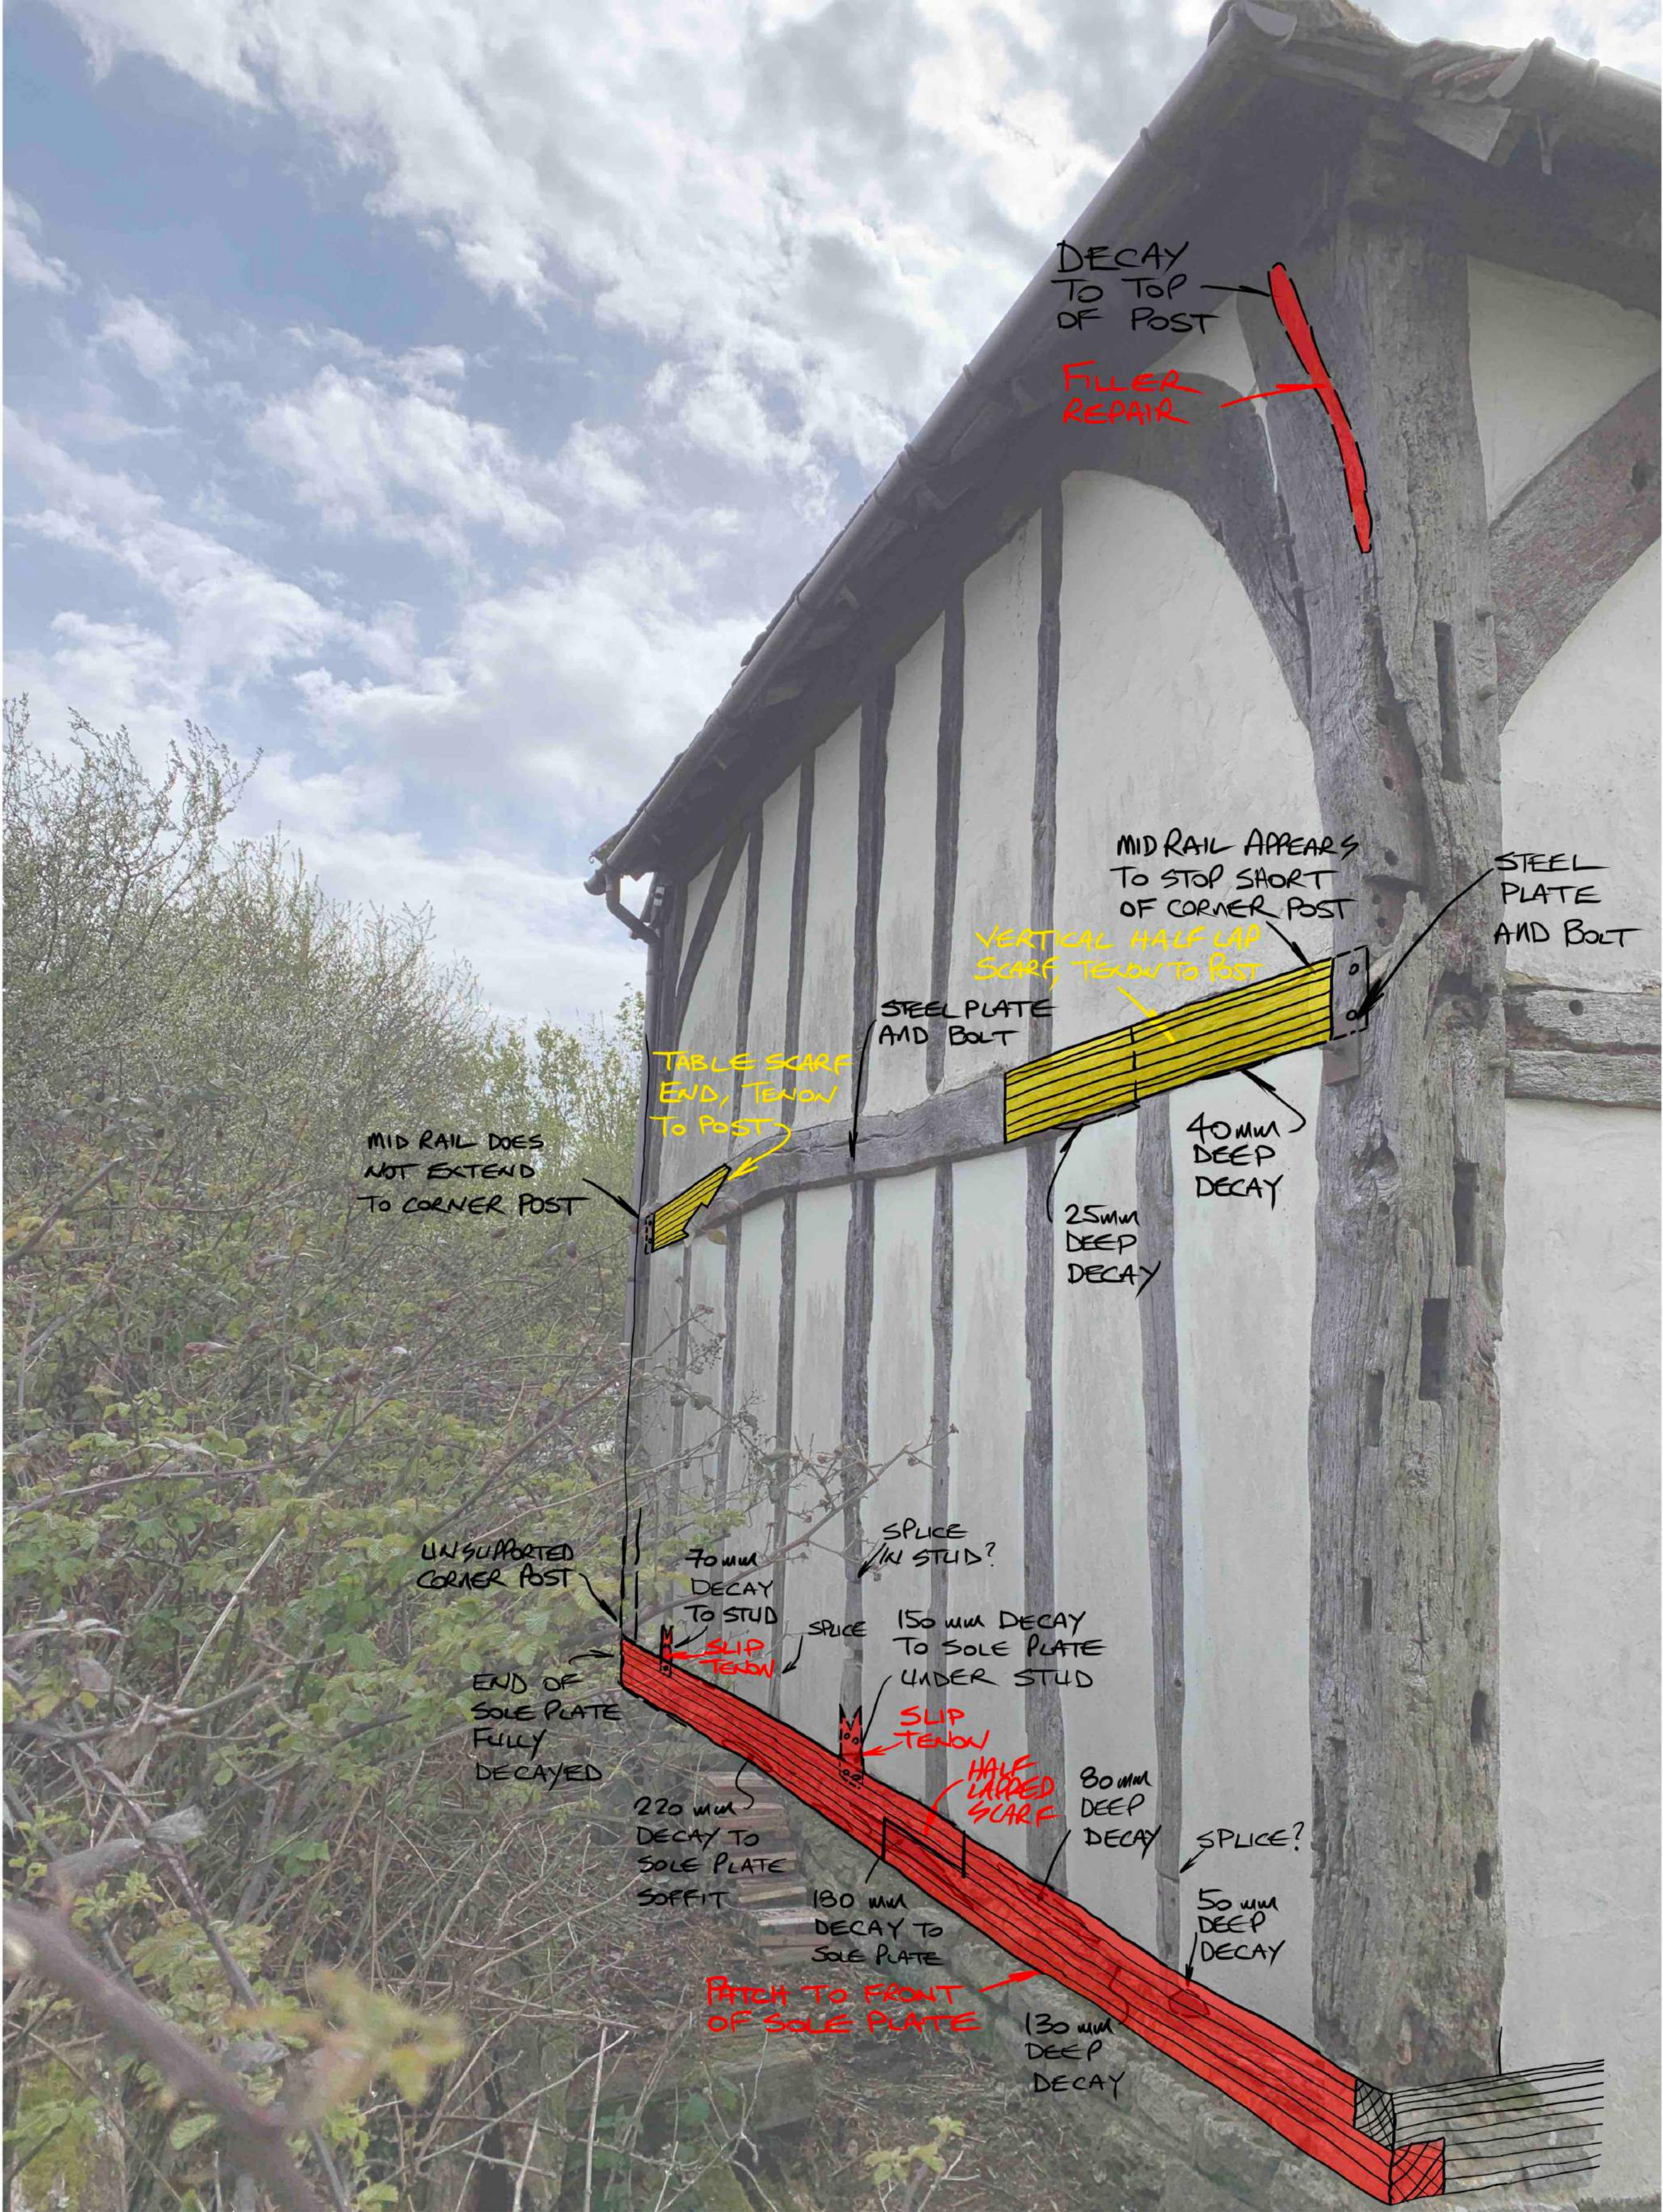
DECAY TO TOP OF POST

MID RAIL APPEARS TO STOP SHORT OF CORNER POST

MID RAIL DOES NOT EXTEND TO CORNER POST

40mm DEEP DECAY

25mm DEEP DECAY

UNSUPPORTED CORNER POST

70mm DECAY TO STUD

150mm DECAY TO SOLE PLATE UNDER STUD

END OF SOLE PLATE FULLY DECAYED

80mm DEEP DECAY

220mm DECAY TO SOLE PLATE SOFFIT

180mm DECAY TO SOLE PLATE

50mm DEEP DECAY

130mm DEEP DECAY

VERTICAL HALF LAP SCARF, TENON TO POST

TABLE SCARF END, TENON TO POST

PATCH TO FRONT OF SOLE PLATE

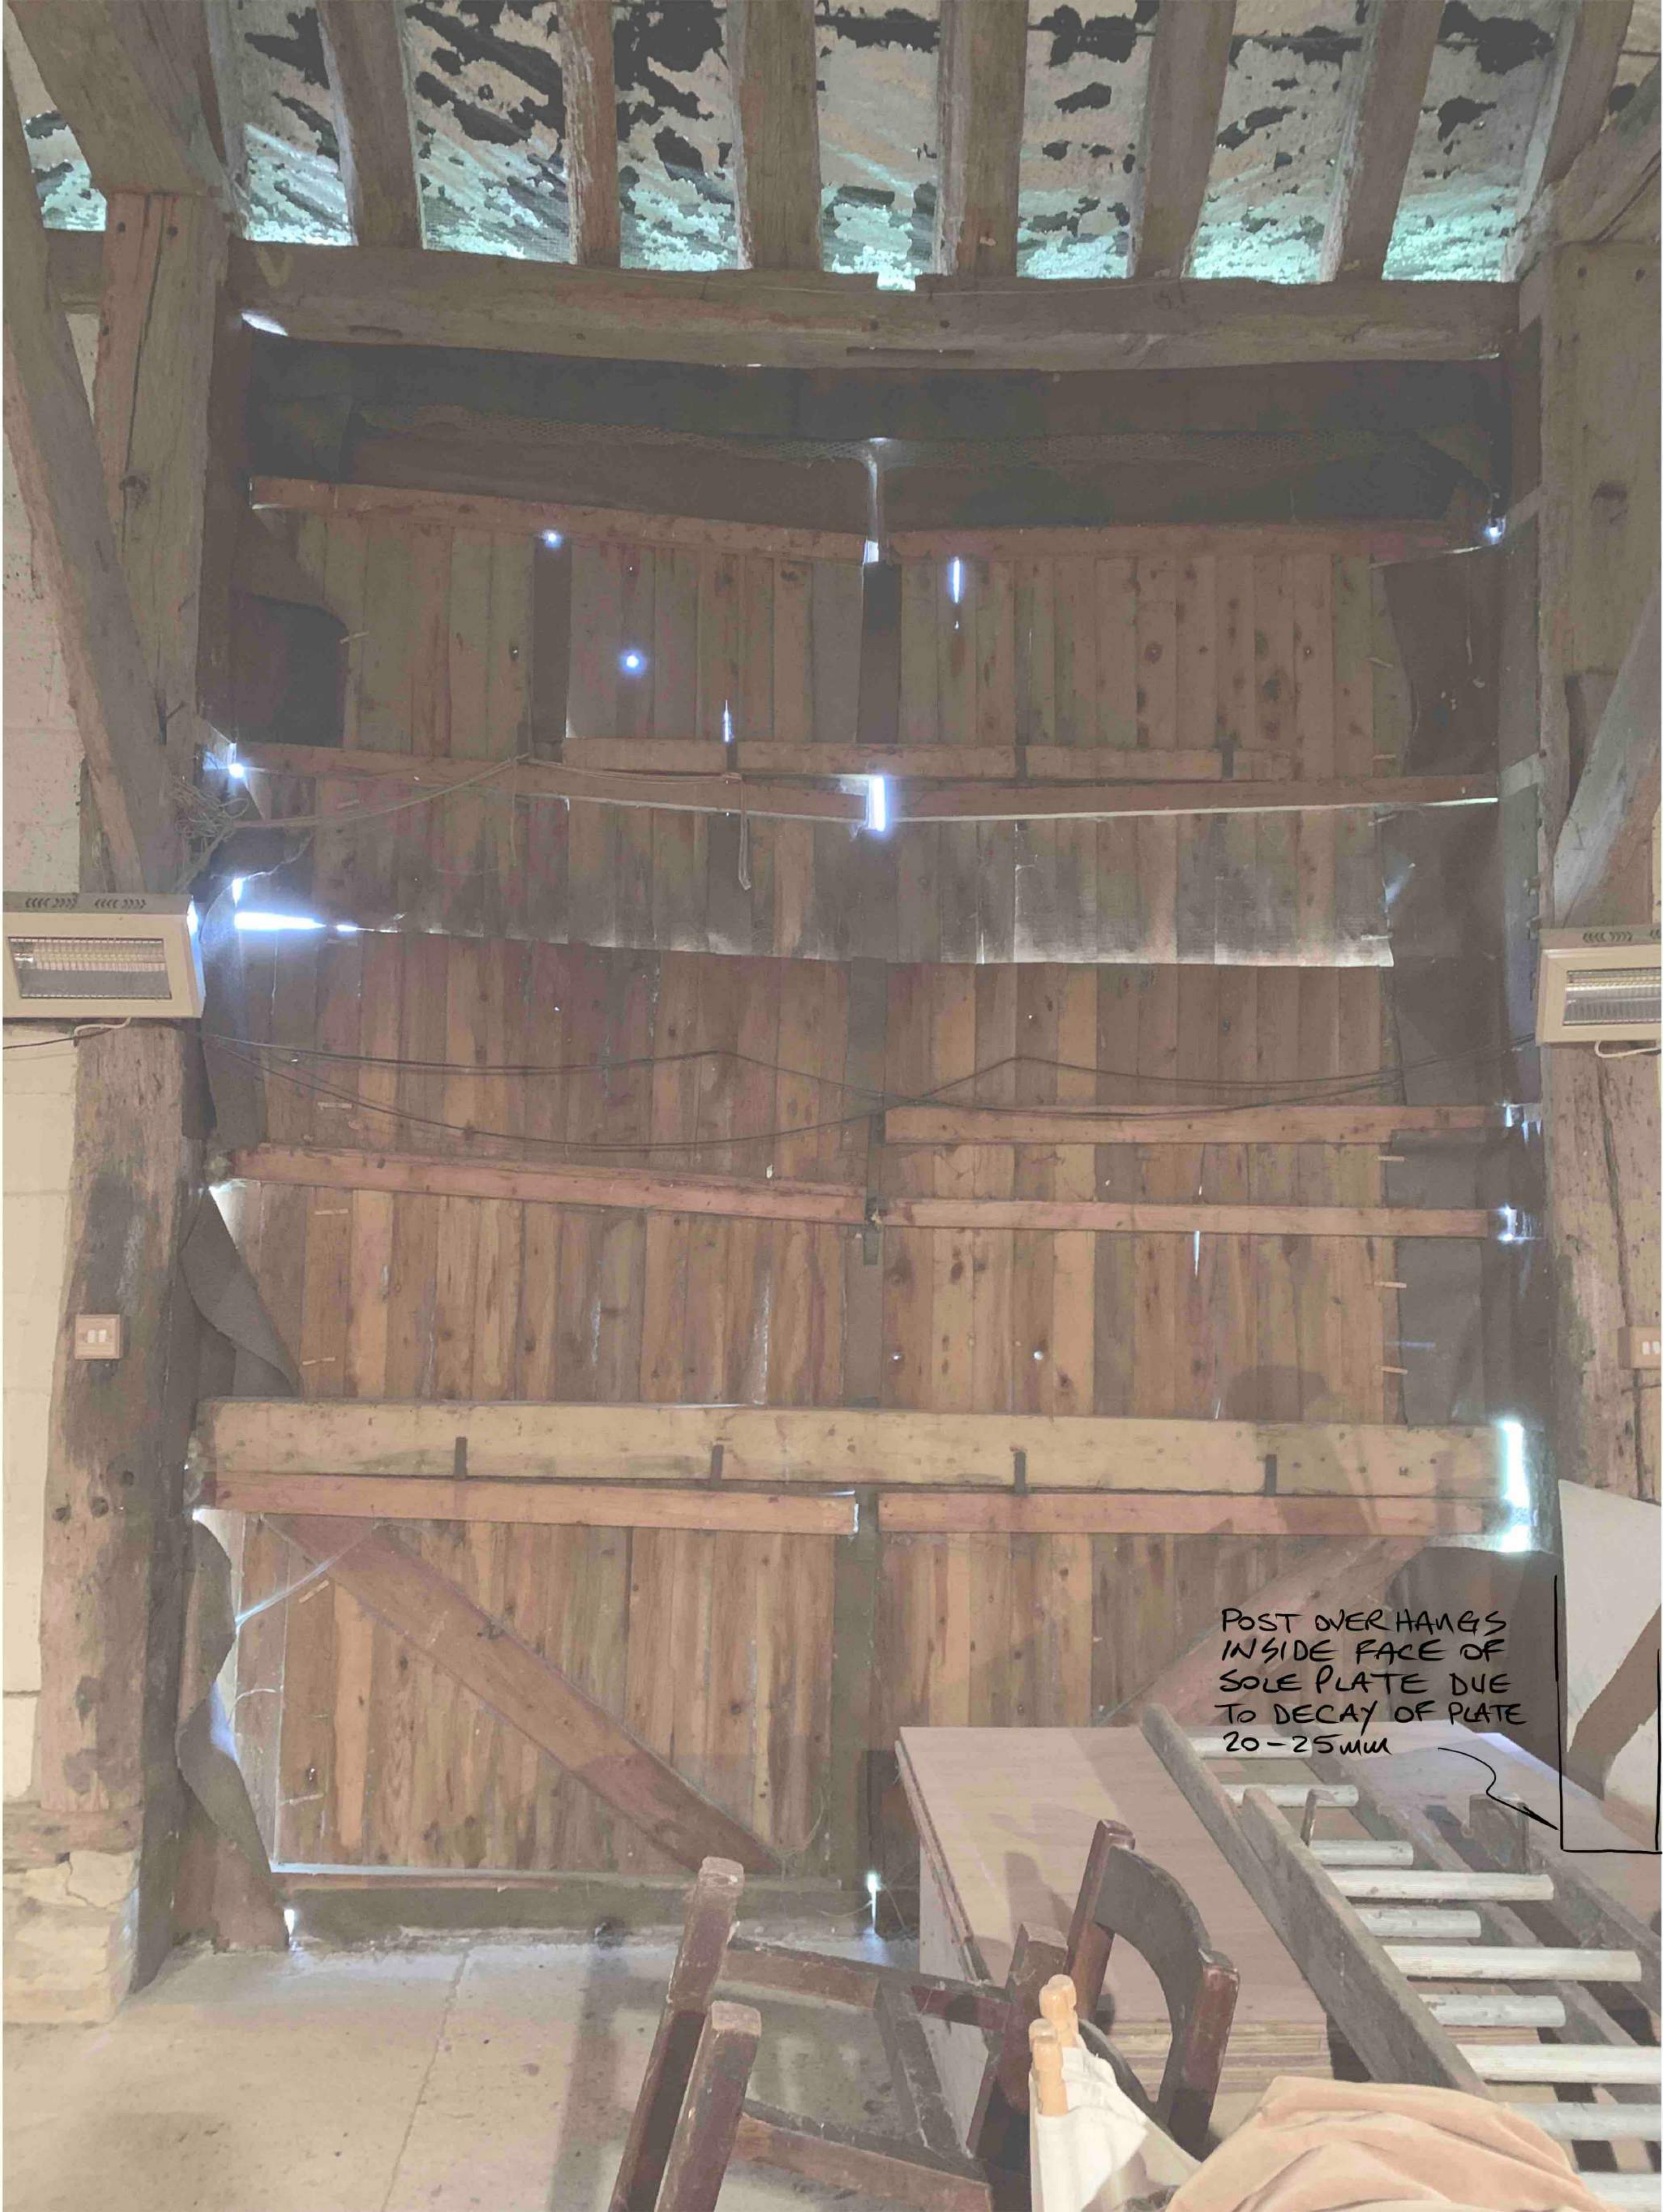
POST OVERHANGS  
INSIDE FACE OF  
SOLE PLATE DUE  
TO DECAY OF PLATE  
20-25mm

MISSING  
KNEE  
BRACE

SPLIT

CRACK TO  
STONEWORK  
UNDER  
SOLE PLATE

MISSING  
WALL PANEL  
BRACE

DECAY TO  
END OF  
STUD

DIAGONAL  
KNEE BRACE  
TO FRAME  
MISSING

PATCH TO OUTER  
HALF OF SOLE PLATE

MAKE  
GOOD  
STONEWORK

NEW DIAGONAL  
BRACE TO WALL  
PANEL

NEW KNEE  
BRACE
