**Title:       Oaklands North**

**Job No:     22515**

**Date:       27 November 2025**

The purpose of our visit was to carry out a visual structural inspection of the existing lounge structure and assess its condition in relation to the proposed works.

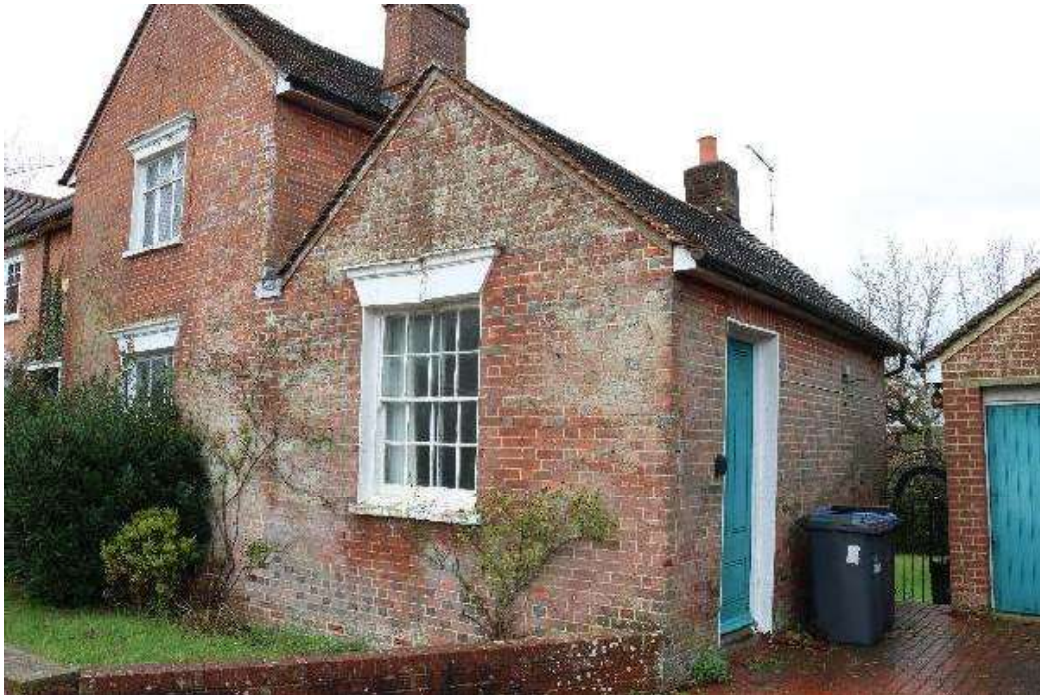
1. External Elevation

- Front window facing the High Street: There is clear evidence of historic external cracking and subsequent repair work, visible both above and below the window opening. The cracking is predominantly vertical and stepped in nature, with widths estimated to be approximately 1–3 mm, occurring along the existing mortar bed.

- Area above the front window: Externally, stepped diagonal cracking is visible, with sections of open mortar present. These cracks generally measure 1–2 mm in width and follow the existing mortar bed. In addition, the window exhibits a noticeable drop on the left-hand side exceeding 25 mm, which appears to be historic in nature (refer to Photos 1, 2 & 3).

- Brickwork surrounding the front window: Areas of efflorescence and moisture-related watermarking are evident across sections of the exposed brick surface, presenting as light white salt deposits and darker staining to the brick faces. This indicates historic and/or ongoing moisture migration within the masonry, likely associated with rainwater penetration via the cracked mortar joints and defective pointing previously noted (refer to Photos 1, 2 & 3).

- Investigation of the roof structure to determine any contribution to ceiling or wall distortion.
- Assessment and rebuilding or supporting of dropped lintels, potentially involving bespoke lintel or arch-forming solutions.
- Opening-up works to identify the cause and extent of dampness and implement appropriate remedial measures.
- Ground investigation, including a site investigation report to establish desiccation depth and trial pits to confirm adjacent foundation depths.
- Consideration of underpinning options, potentially including deep underpinning or mini-piling, depending on ground investigation results.
- Rebuilding or strengthening of dropped or distorted wall sections as required.

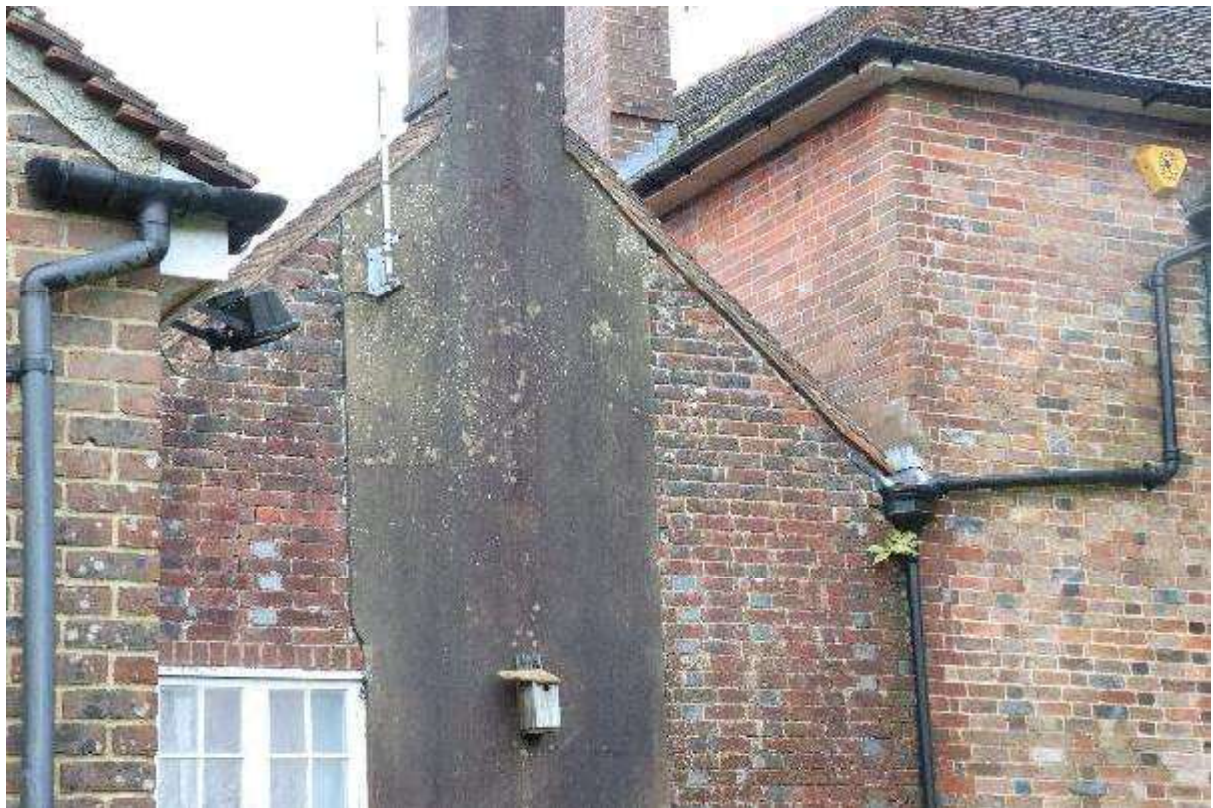
4. Rear Elevation crack detail

- A stepped crack was observed on the rear elevation, following the mortar joints between the eaves level and the chimney junction. The exact width is difficult to determine due to its location. The crack continues across the chimney's rendered weathering/protection, indicating movement affecting both the wall and chimney structure. The crack profile suggests either progressive or historic differential movement within the rear wall construction (Photo 4).

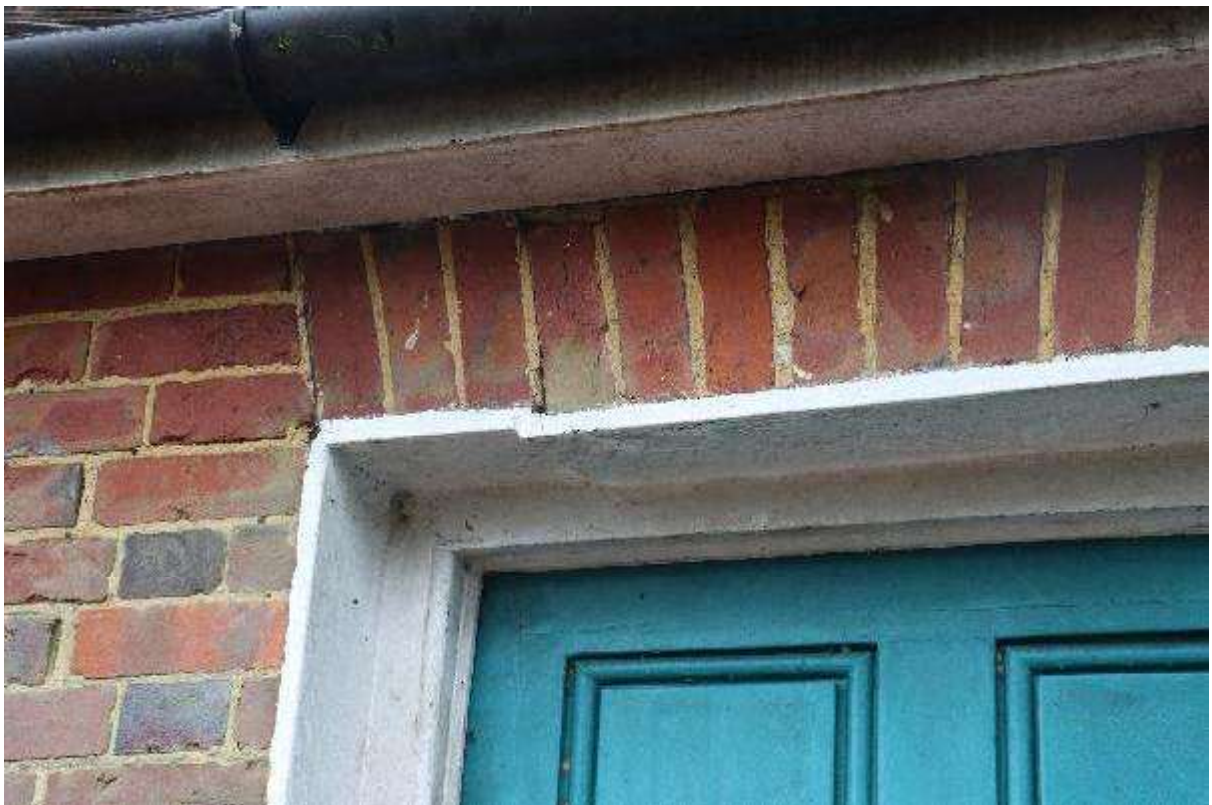
6. Side door lintel drop detail

- Lintel/arch over the side door: Exhibits a noticeable drop of approximately 20–25 mm, with associated minor vertical cracking at the edges of the opening (Photo 6).

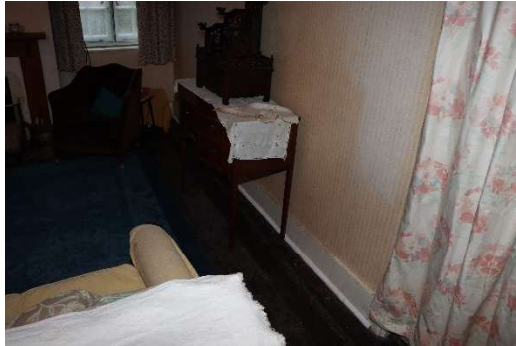
8. External wall

- Damp staining was visible in several locations within the lounge (Photos 8,9,10):
  - Partition wall: extensive staining and moisture marks noted. Given their position, these may be consistent with possible roof water ingress, but this cannot be confirmed from visual inspection alone.

- Rear chimney breast and adjacent wall surfaces: moisture staining noted.
  - Lower rear wall: damp patches noted near floor level.
- The cause(s) of dampness remain uncertain. Multiple sources may be contributing, including roof covering defects, failed flashings—particularly at the valley gutter where the lounge roof abuts the first-floor wall—high external ground levels, lack of a damp-proof course, leaking drains, or defects within

the wall construction. Further investigation would be required to determine the exact moisture pathway, although it is likely that several mechanisms are involved.

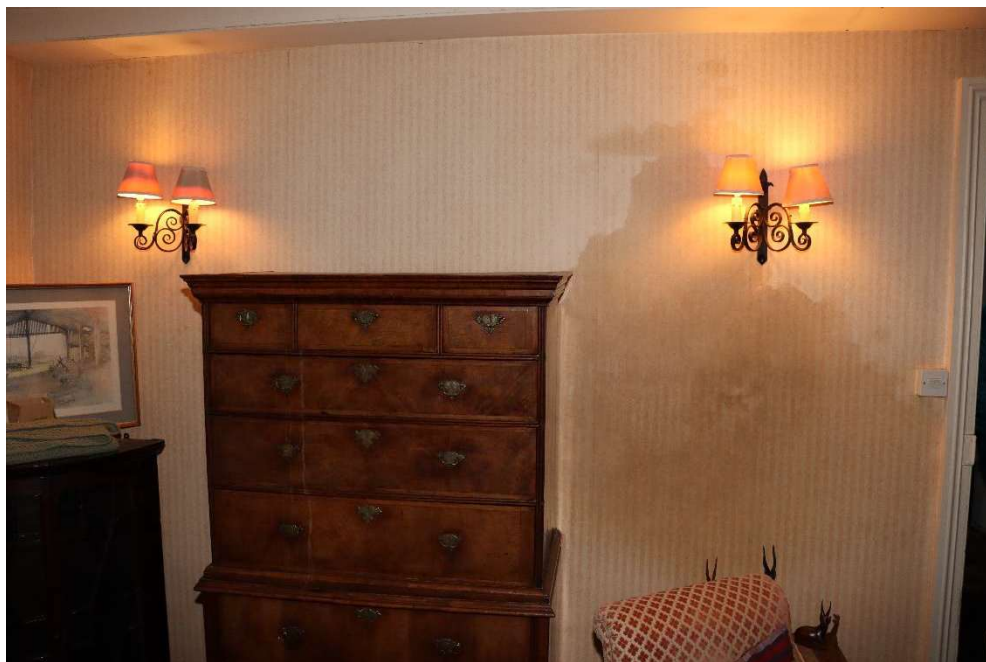
10. Internal partition

Paper surface damp- hand touch

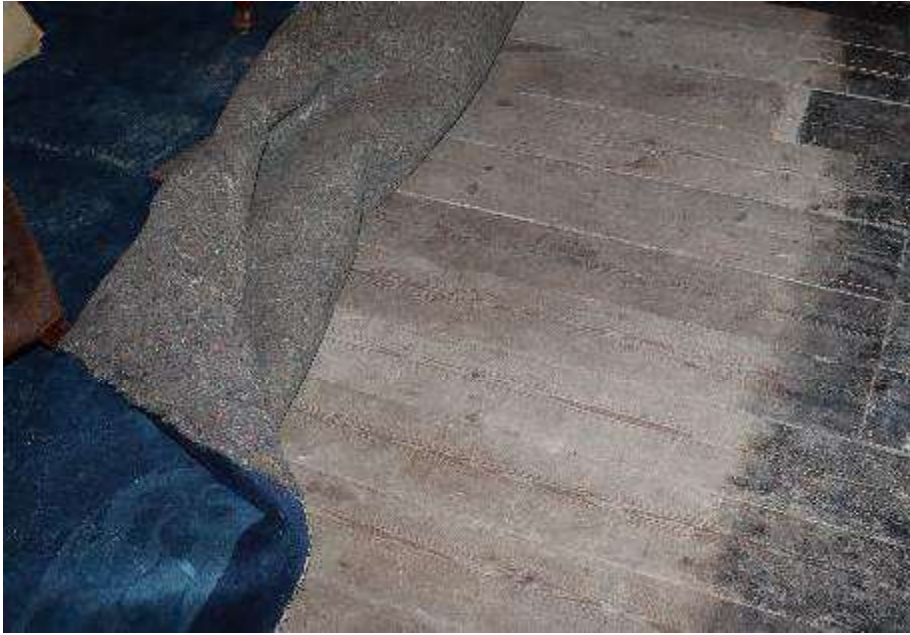
11. Floorboards

- The ceiling shows a continuous horizontal opening along the wallpaper joint. It is unclear whether this represents delamination caused by structural movement or simply wallpaper separation associated with possible dampness. No definitive downward deflection of the ceiling lining was observed. There was no access to the roof void above, so the condition of the structure above the ceiling could not be confirmed.
- Floorboards appear aged and locally uneven.
