**Project****Project Name:** Eastlands Farmhouse - SW**Project Description:** CCTV Survey, trace & plot**Project Status:** Complete**Project Date:** 05/10/2025**Inspection Standard:** MSCC5 Sewers & Drainage GB (SRM5 Scoring)

# **EYES ON DRAINAGE**

## **CCTV-Trace-Plot-Map-Repair**

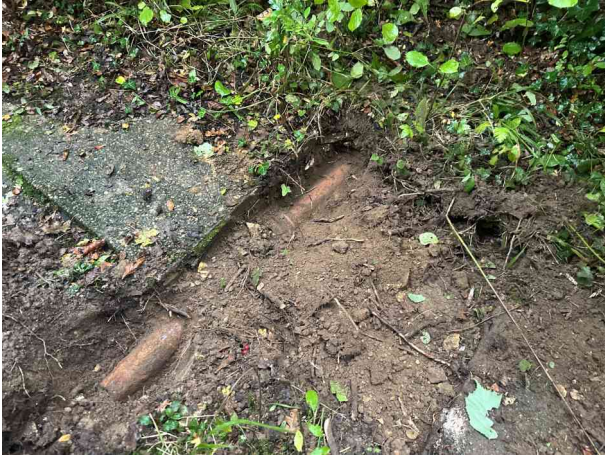
1, 0.00 m

Start node, manhole, reference: RWP, Exposed to confirm route.

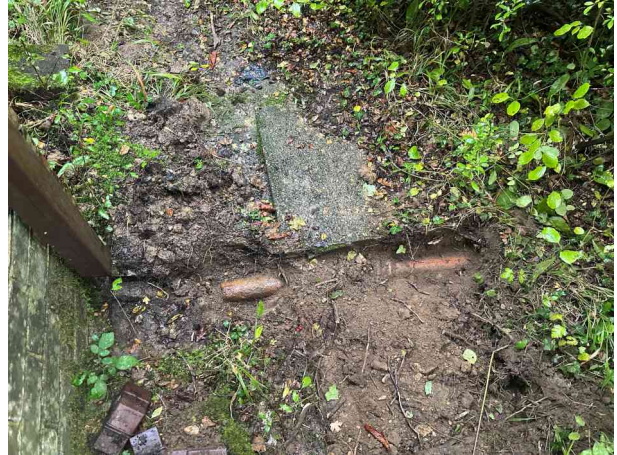
2, 0.00 m

Start node, manhole, reference: RWP, Exposed to confirm route.

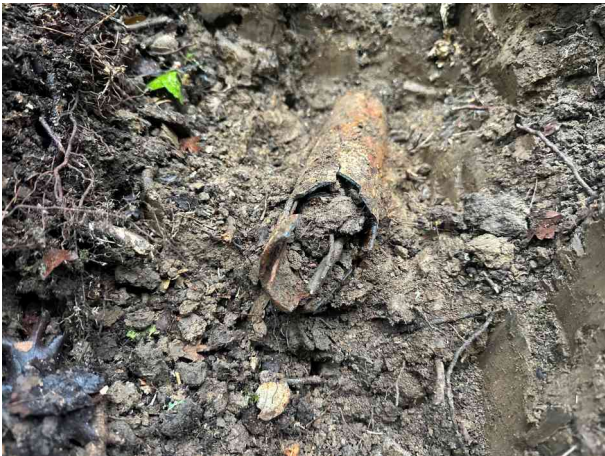
3, 00:00:02, 0.00 m

| Section | PLR | Grade | Description |
|---|---|---|---|
| 1 | RWPX | 5 | Roots, mass, 100% cross-sectional area loss |

<table><tr><td>0.00</td><td>MH</td><td>Start node, manhole, reference: RWP: Exposed to confirm route.</td><td>1, 2</td><td></td><td></td><td></td></tr><tr><td>0.00</td><td>RM</td><td>Roots, mass, 100% cross-sectional area loss: Continuous</td><td>00:00:02</td><td>3</td><td>5</td><td></td></tr></table>

Roots, mass, 100% cross-sectional area loss, Continuous

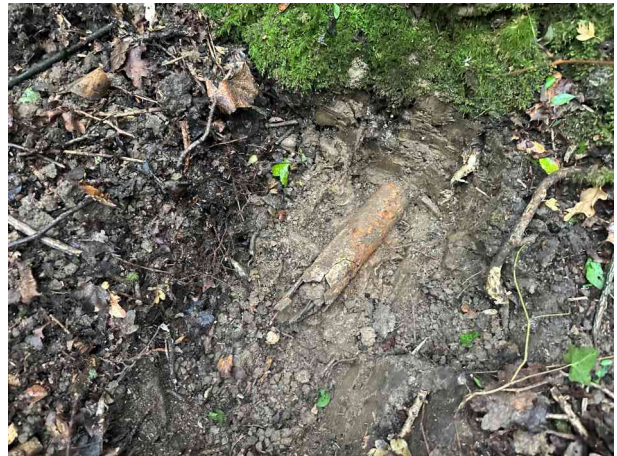
4, 3.00 m

| Section | PLR | Grade | Description |
|---|---|---|---|
| 1 | RWPX | 5 | Collapsed drain or sewer, 100% cross-sectional area loss |

<table><tr><td>0.00</td><td>MH</td><td>Start node, manhole, reference: RWP: Exposed to confirm route.</td><td>1, 2</td><td></td><td></td><td></td></tr><tr><td>3.00</td><td>XP</td><td>Collapsed drain or sewer, 100% cross-sectional area loss</td><td>4</td><td>5</td><td></td><td></td></tr><tr><td>3.00</td><td>SA</td><td>Survey abandoned: Unable to continue, assumed to discharge to pond</td><td></td><td></td><td></td><td></td></tr></table>

Collapsed drain or sewer, 100% cross-sectional area loss

Grade 5: Best practice suggests that this pipe is at risk of collapse at any time. Urgent consideration should be given to repairs to avoid total failure.

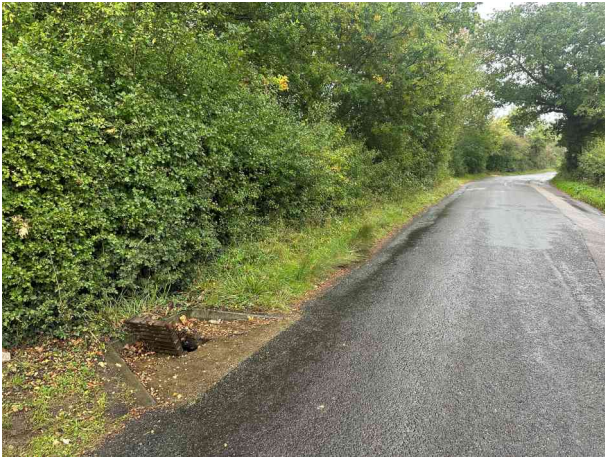
1, 0.00 m  
Start node, gully, reference: RG

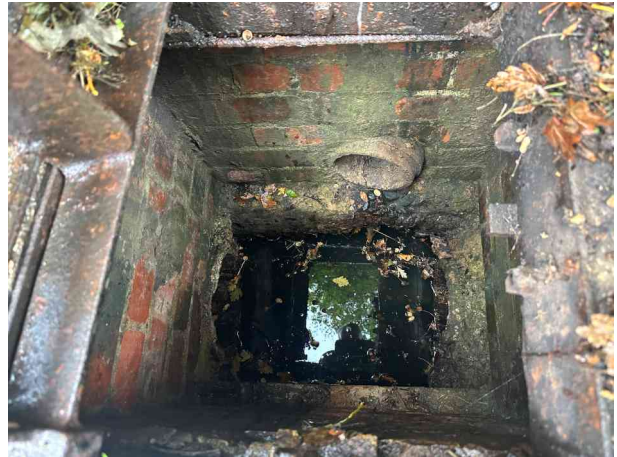
2, 0.00 m  
Start node, gully, reference: RG

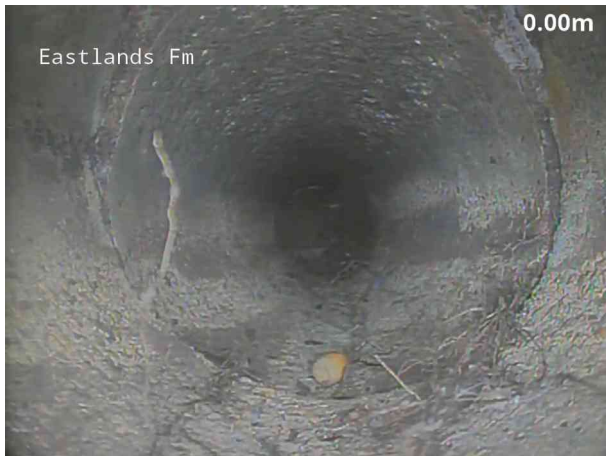
3, 00:00:00, 0.00 m  
Water level, 0% of the vertical dimension

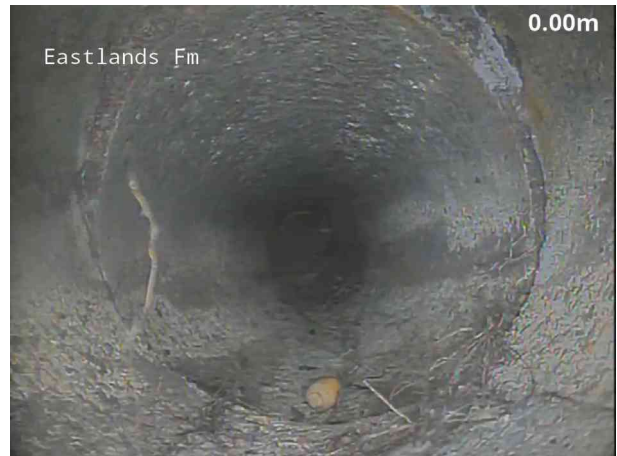
| Scale: | 1:50 | Position [m] | Code | Observation | MPEG | Photo | Grade |
|---|---|---|---|---|---|---|---|
| | | 0.20 | RFJ | Roots, fine at joint | 00:00:20 | 4 | 2 |

4, 00:00:20, 0.20 m  
Roots, fine at joint

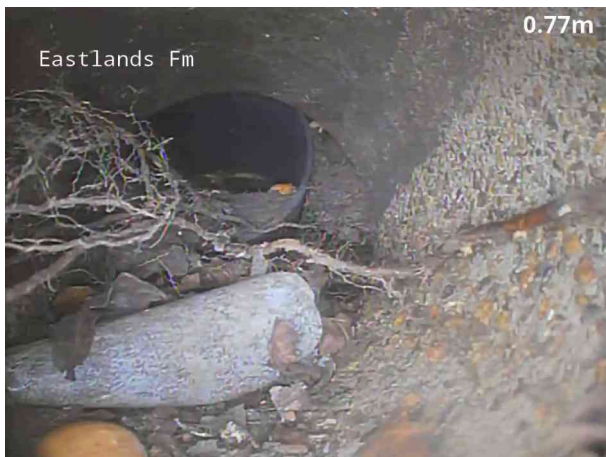
| Scale: | 1:50 | Position [m] | Code | Observation | MPEG | Photo | Grade |
|---|---|---|---|---|---|---|---|
| | | 0.90 | DER | Settled deposits, coarse, 20% cross-sectional area loss | 00:00:33 | 5 | 4 |

5, 00:00:33, 0.90 m  
Settled deposits, coarse, 20% cross-sectional area loss

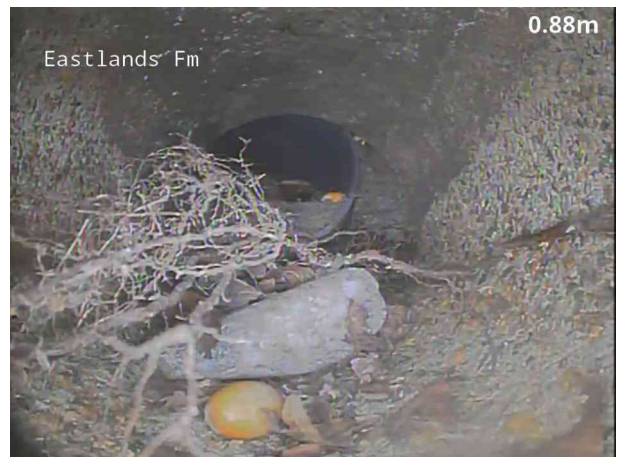
| Scale: | 1:50 | Position [m] | Code | Observation | MPEG | Photo | Grade |
|---|---|---|---|---|---|---|---|
| | | 0.90 | RT | Roots, tap | 00:00:42 | 6 | 4 |

6, 00:00:42, 0.90 m  
Roots, tap

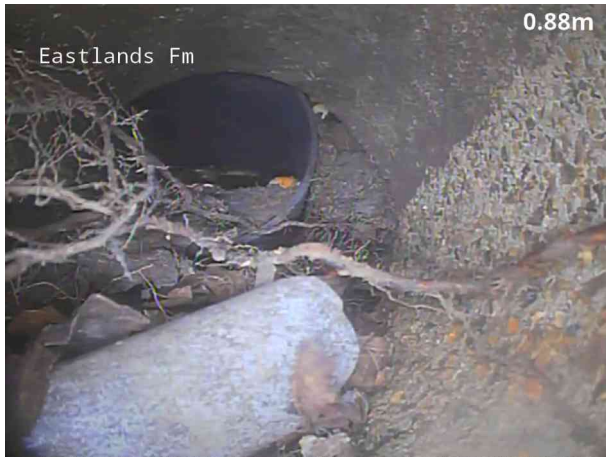
7, 00:00:46, 1.00 m  
Finish node, outfall, reference: Outfall 2, Buried
