### Resistograph Test of T01 Quercus Rubra (Red Oak).

Mr Daniel Ford  
Tower House Close  
Cuckfield  
Haywards Heath  
East Sussex  
RH17 5EQ

Wednesday 04<sup>th</sup> December 2024

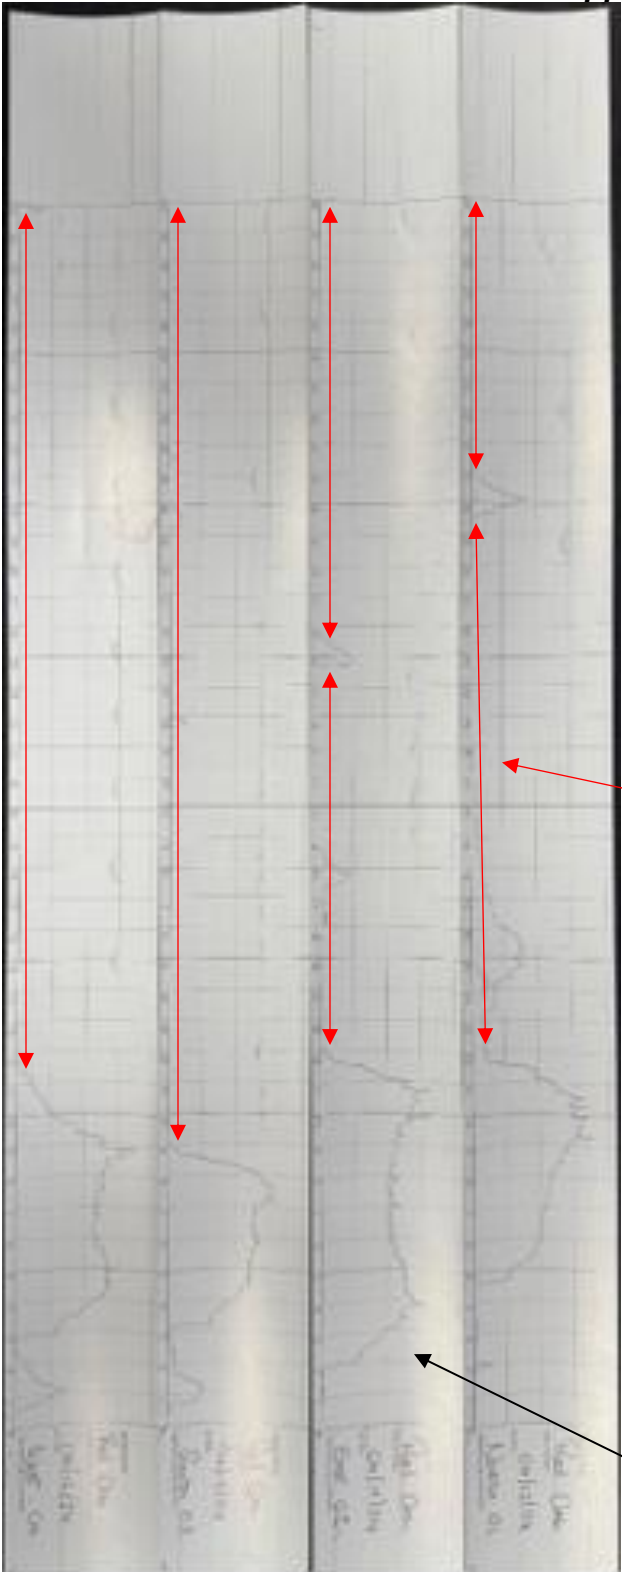
The readings show a significant reduction in wood strength in the central main stem from the bark layer heading into the centre of the main stem of tree as shown in appendix 1 form all orientations.

- 4.2 There is significant decay in the main stem of the tree as can be seen in Appendix 1 the Resistograph carried out in the main stem, high levels of decay at the old pruning points and decay at the bifurcated stem union.

- 4.4 Following interpretation of the data from the test drillings I would recommend. Carefully felling to near ground level as the levels of decay are beyond that of a safe level to retain with remedial safety works i.e. reduction, pollard, monolith etc. The target area for this tree is considered high.

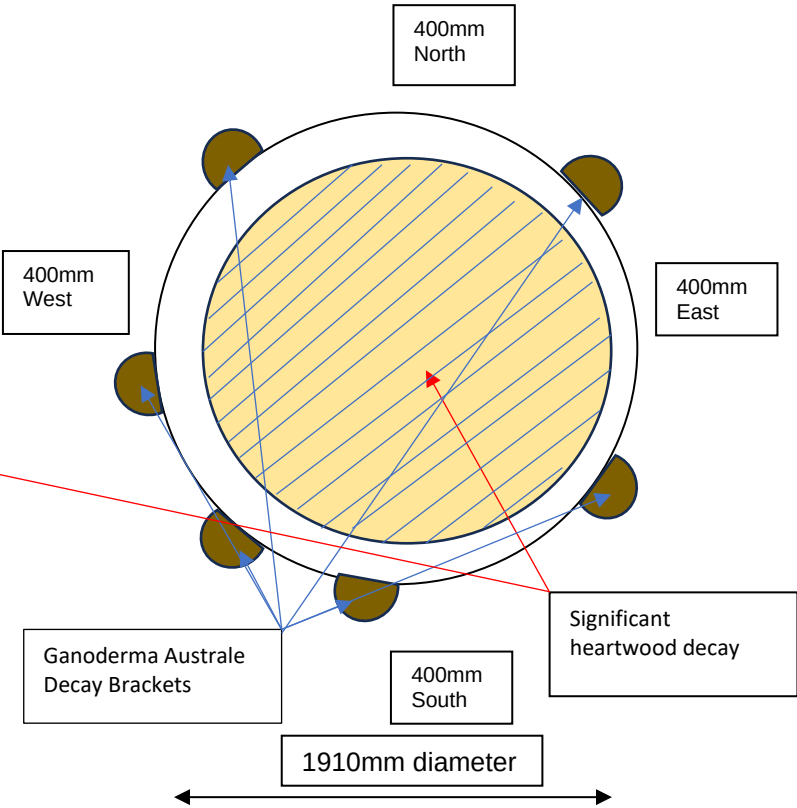
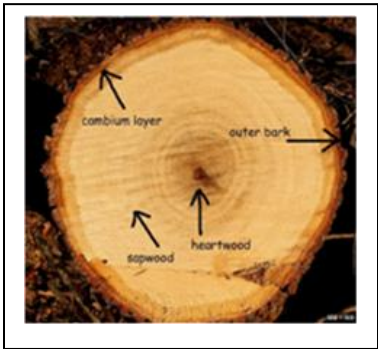
Drilling Around the main stem.

1. North at 400mm on the main stem from ground level.
2. East at 400mm on the main stem from ground level.
3. South at 400mm on the main stem from ground level.
4. West at 400mm on the main stem from ground level.
