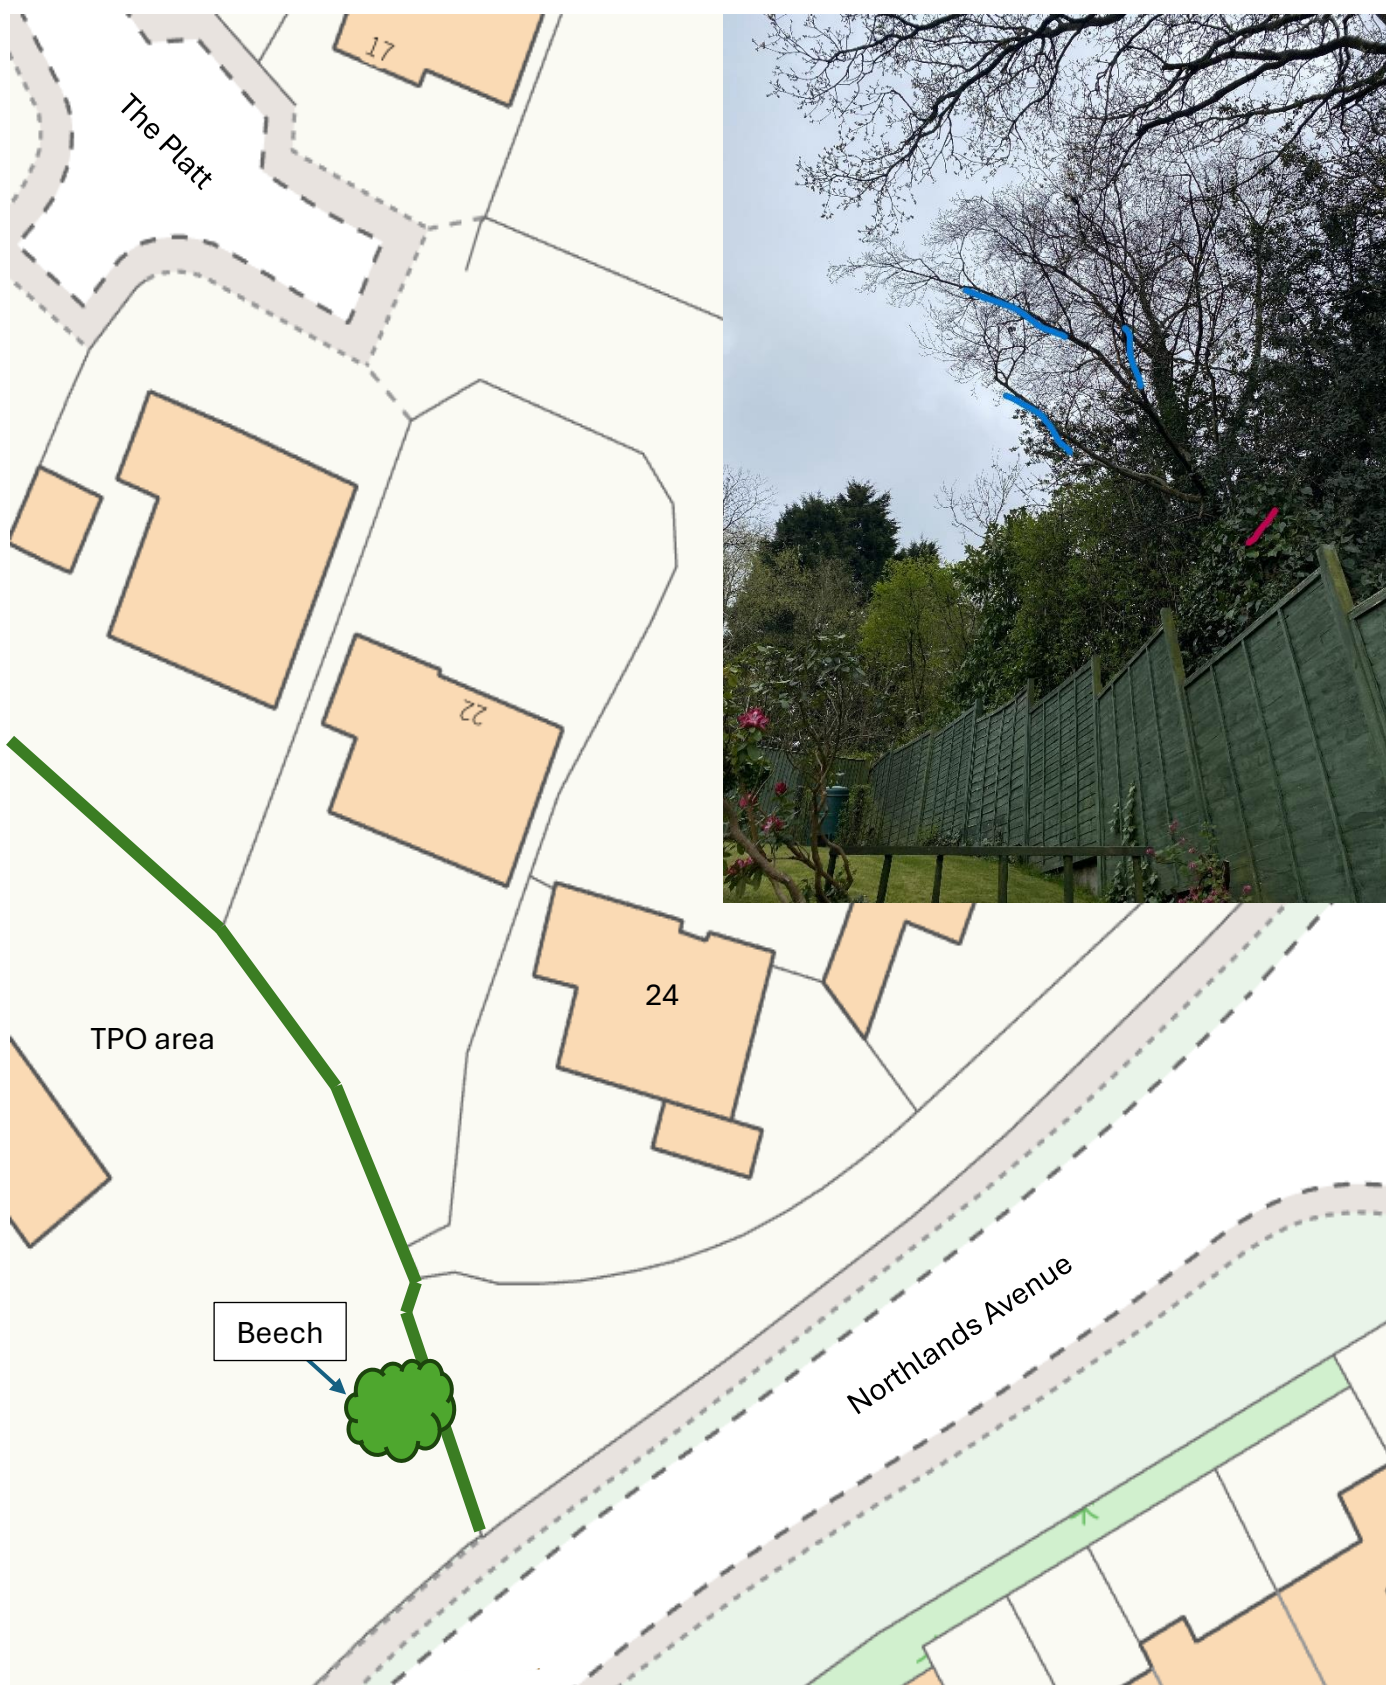
Low overhanging limb coming from adjacent Beech which is in the TPO area.

The works are part of a regular maintenance programme to retain the tree at a suitable size for its location.

The works would not be detrimental to the trees health nor affect the amenity value of the area.
