## East Boundary Wall at Sackville College

# Structural Engineering Report

Sackville College

*Document reference:* 0180/REPORT 01

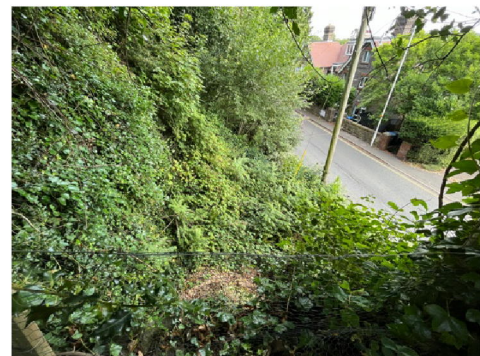
**Image 3.2.1c**

By the boundary with the plot of land to the north, there is a wire fence (see image 3.2.1c). This is unlikely to act as an effective safety barrier to protect against someone falling from height.

- vi. As the stability of the coursed stonework on the north corner of wall section A appears to rely partly on the return wall that runs back along the edge of the plot of land to the north, repairs to this return wall should be carried out too. The vegetation hiding this wall face prevents the condition of this wall being established at this time but repairs similar to those highlighted above are anticipated. The wire fence on top of this section of wall should be addressed too, to provide a more effective safety barrier.

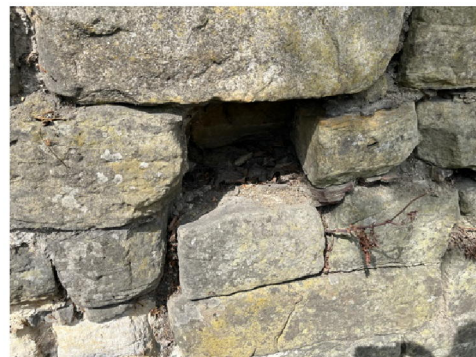
*Image 3.3.2*

- 3.3.2 At low level, a stone block is missing from the face of the wall. This may have fallen out in the past.

Mortar repairs are visible above this area. It appears a hard cement-based mortar has been used.

- iii. Where practical, remove hard cementitious mortar from the face of the wall and make good using a low-strength lime mortar.
- iv. Localised sections of brickwork can be retained where the condition of the brickwork is reasonable, but otherwise potentially unstable brickwork should be removed and replaced with local natural stone.

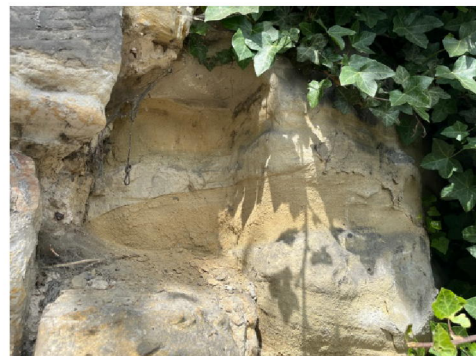
*Image 3.3.3*

- 3.3.3 On the right hand side of the wall section, one stone block has a noticeable weathered front face, which is now set back from the general wall face.

Some stone blocks at low level also have weathered faces, although not as significant.

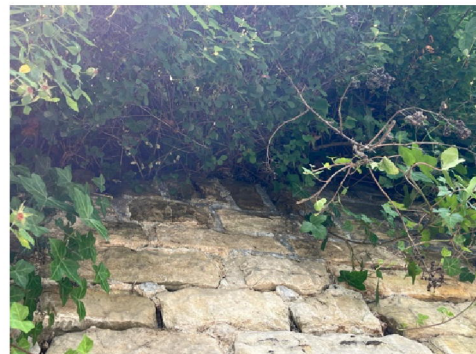
*Image 3.3.4*

- 3.3.4 Vegetation is growing across the wall, both at high level and across the righthand side. The vegetation at the top of the wall is dense, and some further mortar repairs are visible.

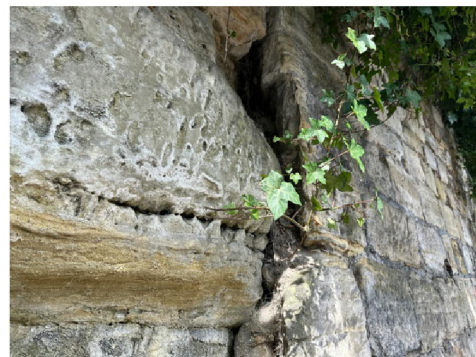
*Image 3.4.2*

- 3.4.2 At the junction of the bedrock, with the coursed stonework (of wall section A), there is a gap in the wall face. This provides a potential route for water ingress behind the wall face.

Some vegetation is growing on the wall at this interface. An root (possible dead) is visible in the central part of the wall section, by the righthand end of the brick panel.

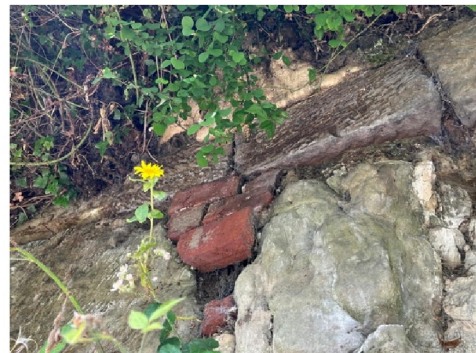
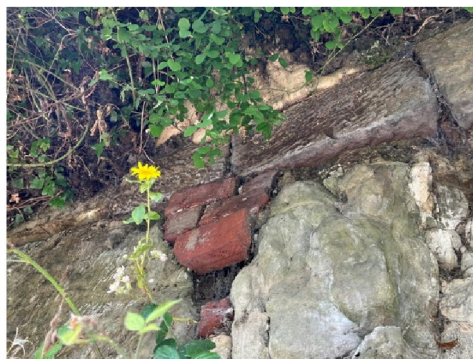
*Image 3.4.3a*

- 3.4.3 A localised brick repair is located at high level within the middle part of this wall section. The lowest brick is not securely bonded to the wall face and does not have a robust support.

A rootball is visible above this area – possible associated with a holly bush.

In addition, there are a few isolated examples which are also considered potential health and safety concerns. These are the fragile brickwork noted in image 3.4.3a, the projecting stone block noted in image 3.4.3b, the distorted brickwork noted in image 3.5.2, and the slightly projecting stone block in image 3.7.2. These areas are illustrated again in images 4.2 to 4.5 below.

If time is required to help fund and plan these works in greater detail, the items identified as potential health and safety concerns should not be delayed and addressed promptly. A mason should check the areas of concern. Possible emergency repairs could include the introduction of additional mortar to secure bricks that potentially lack support, adding temporary timber props below projecting stone blocks, or removing the brick or stone block causing the concern, if practical to do so. It would be prudent to discuss these urgent works with the conservation officer to understand what forms of approval will be necessary.

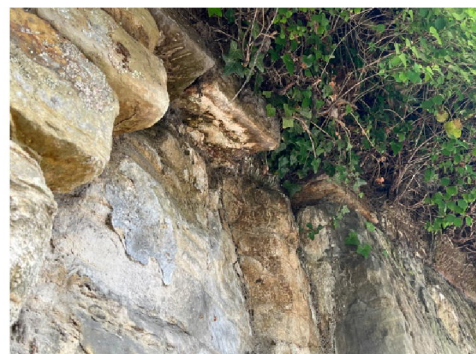
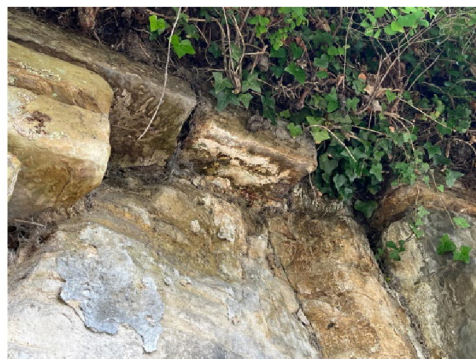
*Image 3.4.3b*

On the lefthand side of this wall section at high level, one stone block is projecting from the wall face. The arrangement suggests stone blocks may have fallen away from below.

Dense vegetation and soil sit above and overhang the wall face. To the right of this area, a further stone block is rotating outwards very slightly. This may be linked with outward pressure from the roots of vegetation growing and expanding.

- i. Allow for rebuilding the top stone course along the length of the wall. At some locations, the rebuilding work may need to extend down a further stone course or two to remove roots at a lower level or to resupport sections of masonry which are currently projecting from the face of the wall.

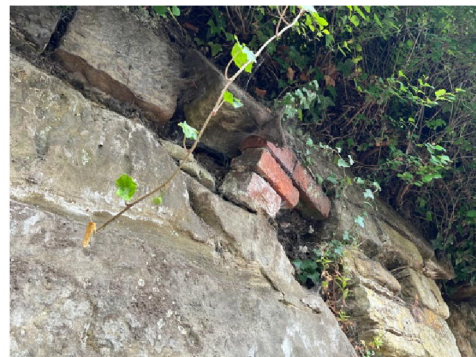
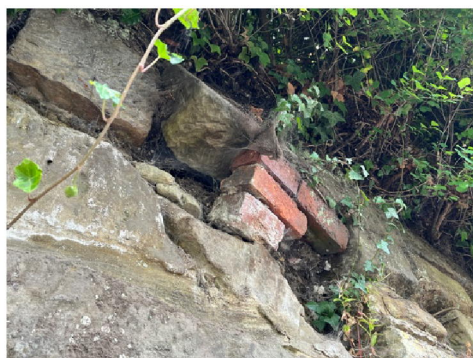
*Image 3.5.2*

- 3.5.2 A localised brick repair is located at high level on the righthand side of this wall section. The brickwork and the stonework above has distorted and is not securely supported.

Dense vegetation and soil sit above and overhang the wall face.

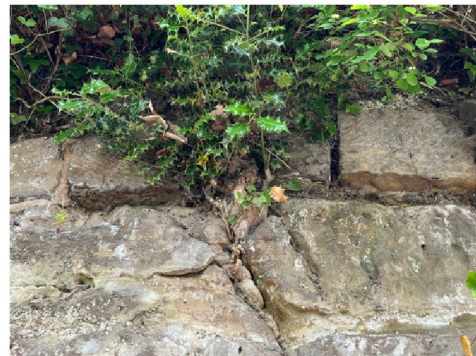
*Image 3.5.3*

- 3.5.3 A small holly bush is growing out of the wall towards the righthand side of this wall section. This has a noticeable root ball. The joints in the surrounding masonry have lost sections of mortar.

- v. Remove all loose mortar and make good joints across coursed stonework using a low-strength lime mortar.

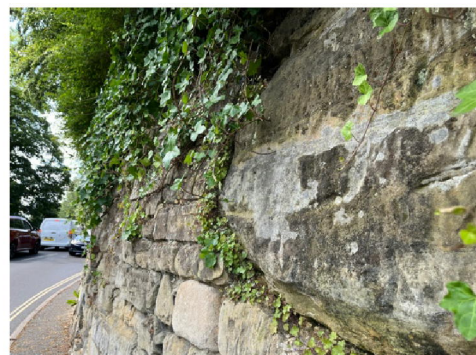
*Image 3.5.4*

- 3.5.4 Across much of the wall face, vegetation is growing. Some of this occurs at the junctions between the bedrock and coursed stonework.

The face of the coursed stonework towards the lefthand side of this wall section has a potential slight bulge. The joints between the stone blocks have lost sections of mortar.

In summary, whilst many sections of the wall appear to be in an average condition for their age and type, some sections are in a poorer condition. These cover the apparent bulging in the wall, as discussed in sections 3.5.4, 3.6.3, and 3.8.2, and the distorted shaped and projecting stonework across the top stone course across much of the length of the wall.

- ii. Allowance should be made for locally rebuilding the bulged sections of the wall, as noted in sections 3.5.4, 3.6.3, and 3.8.2. A mature tree sits close to the apparent bulging noted in section 3.6.3 and so the rebuilding works here needs to consider how the stability of the tree is maintained. The rebuilt sections can reuse the stone removed from the wall and be laid in a low-strength lime mortar. Drainage pipes can be introduced through the rebuilt wall face to help drain water from behind the wall face.

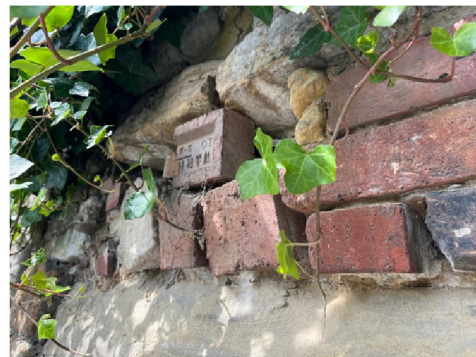
*Image 3.6.2*

- 3.6.2 Within the section of brickwork within the middle of the wall section, some of the bricks appear to have been laid in a random pattern. Mortar is missing from around some of the bricks. The stonework above this area is also slightly distorted.

As with the other wall sections, dense vegetation and soil sit above and overhang the wall face.

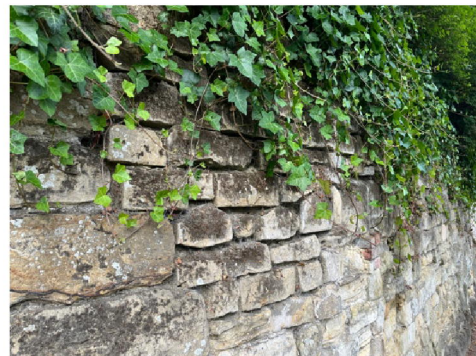
*Image 3.6.3*

- 3.6.3 The face of the coursed stonework towards the righthand side of this wall section has a potential slight bulge. The joints between the stone blocks have lost sections of mortar. This area is located about 3-4m south of the bulging noted in section 3.5.4 above.

Ivy is growing across the face of the wall at high level.

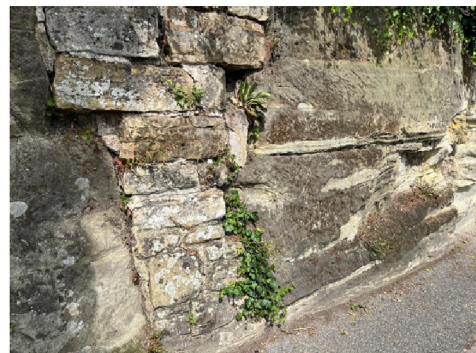
*Image 3.6.4*

- 3.6.4 Across sections of the wall face, vegetation is growing off the wall. This often occurs at the junctions between the bedrock and the coursed stonework, where gaps have opened up.

Some weathering of the face of the bedrock is visible at low level.

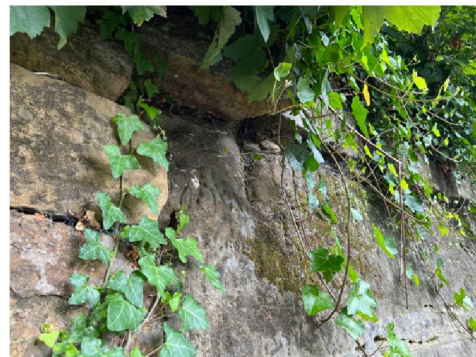
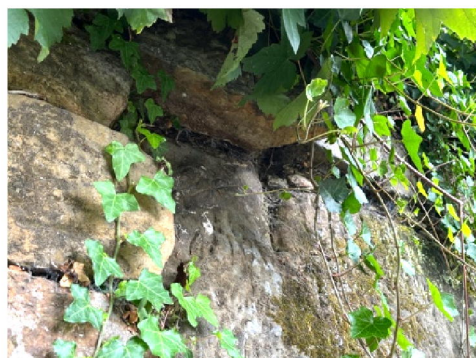
*Image 3.7.2*

#### 3.7.2 As with the other wall sections, dense vegetation and soil sit above and overhang the wall face.

Within the middle section of the wall at high level, one stone block projects slightly. The joints in the stonework at high level are also open, suggesting mortar has fallen out.

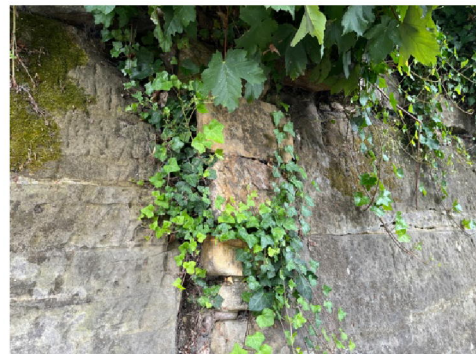
*Image 3.7.3*

#### 3.7.3 Ivy and other vegetation is growing across the face of the wall at high level.

Vegetation is also growing on the wall face. Often, this occurs at the junctions between the bedrock and the coursed stonework, where gaps have opened up.

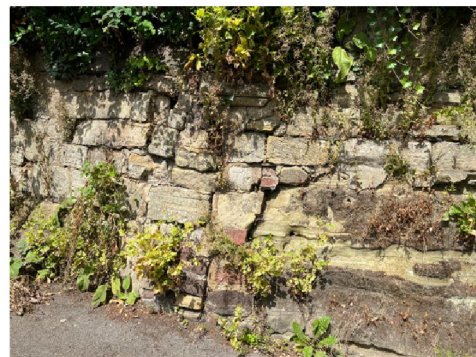
*Image 3.8.2*

- 3.8.2 Within the middle portion of this wall section, the coursed stonework is bulging slightly and mortar from the joints has fallen out.

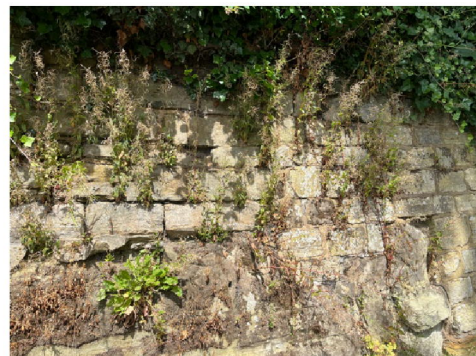
*Image 3.8.3*

- 3.8.3 Vegetation is growing across sections of the wall face. Some of this occurs at the junctions between the bedrock and the coursed stonework where gaps have opened up in the wall face.

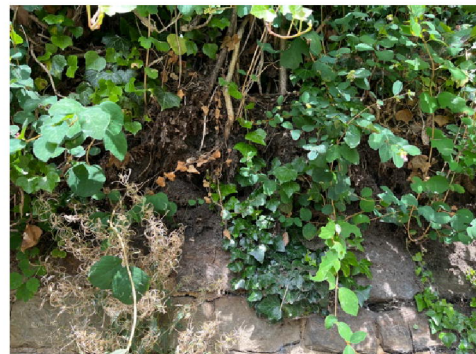
*Image 3.8.4*

- 3.8.4 As with the other wall sections, dense vegetation and soil sit above and overhang the wall face.
