# ROAVR | GROUP

**Project:** 25\_5837\_10\_87  
**Site:** Woodside Grange, Woodland Road, Hassocks, BN6 8EX  
**Client:** Trevor Lock

| Report Type: | Tree survey, arboricultural impact assessment and arboricultural method statement |
| Site Address: | Woodside Grange Woodland Road Hassocks BN6 8EX |

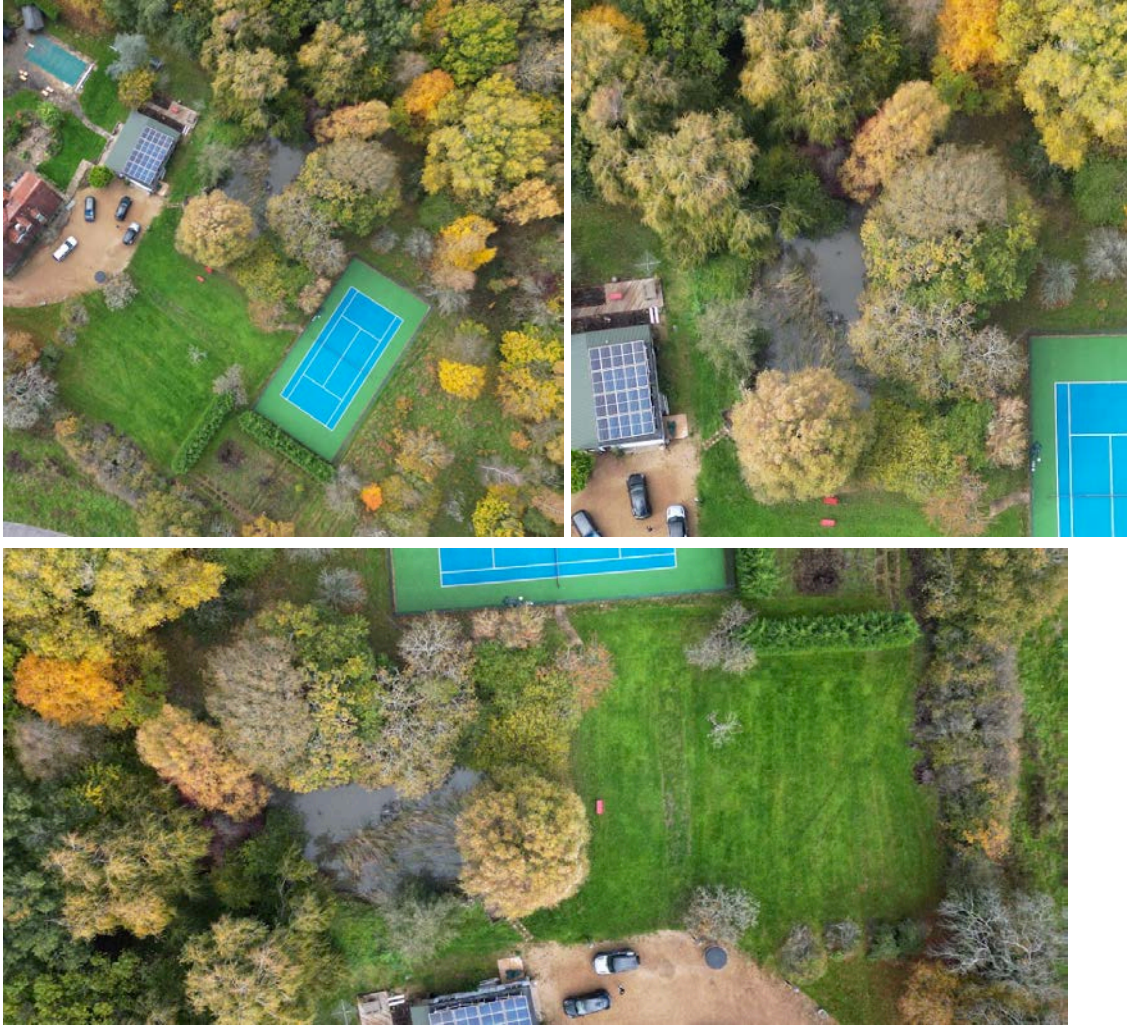
*Aerial image plates showing the existing site and pond. (ROAVR, 2025)*

- The plan marks an area of existing vegetation, including selected trees and the existing pond, to be removed (shown by red dashed lines) to create space for the two plot footprints and access infrastructure

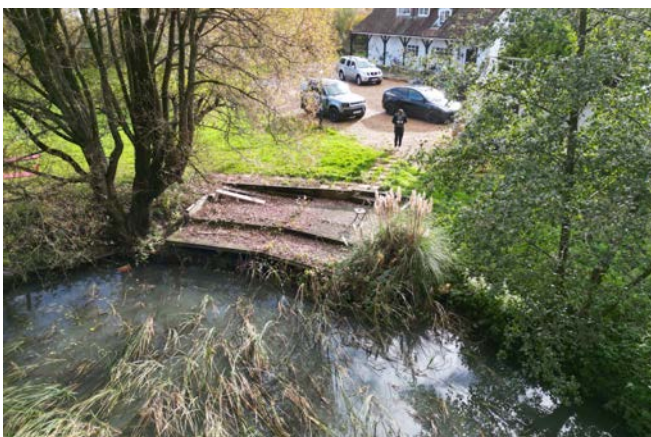
*Aerial image plate showing T29 Willow (left) and T28 Alder (right). (ROAVR, 2025)*

| T29 | <i>Salix fragilis</i> (Crack Willow) | EM | 200,150,1<br>60,100,90,<br>230,400 | 5(1) | 5 | 3 | 5 | 5 | Fair | 10+ | Multistemmed broadleaf | Leaning West. | None | 6.78 | C1 |

- H1 – Removal required.
- T8 – Removal required.
- T9 – Removal required.
- T10 – Removal required.
- T13 to T16 – Removal required.
- T23 to T26 – Removal required.
- T29 to T33 – Removal required.

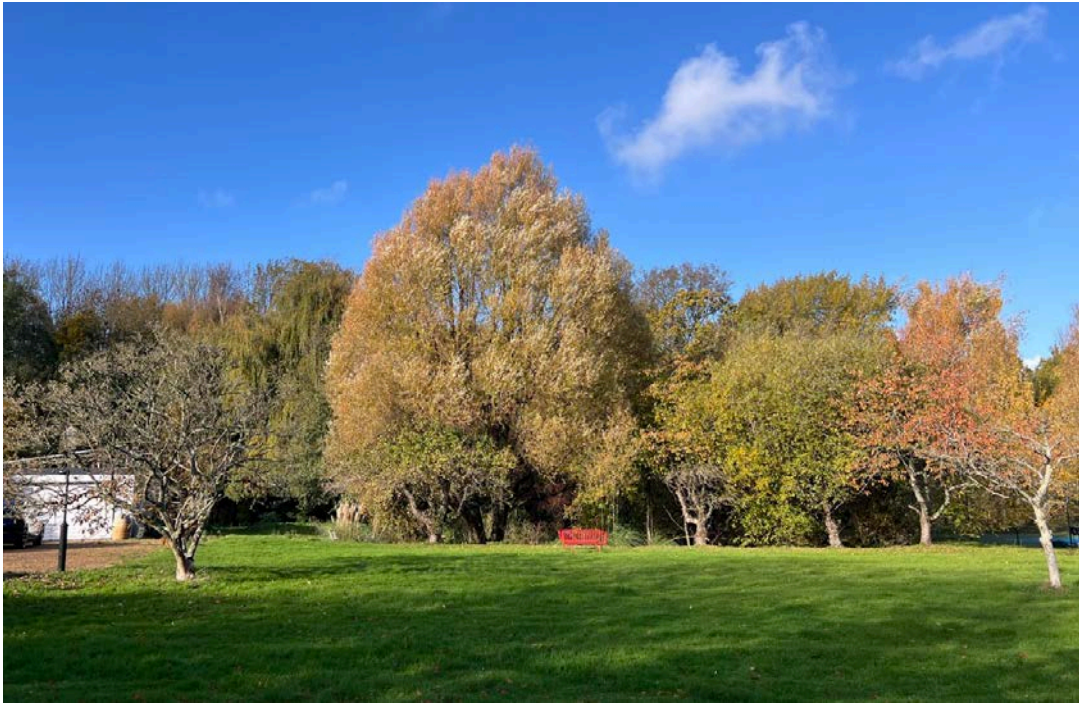
*Photographic plate showing T8 Magnolia (left) and T9 Ash (right) with the pond area and surrounding trees in the background. (ROAVR, 2025)*

| Tree No. | Species | Reason for Removal | Notes |
|---|---|---|---|
| T8 | Magnolia | Conflict with Plot 1 footprint | Stump to be ground out |
| T9 | Ash | Conflict with Plot 2 footprint | Poor condition |

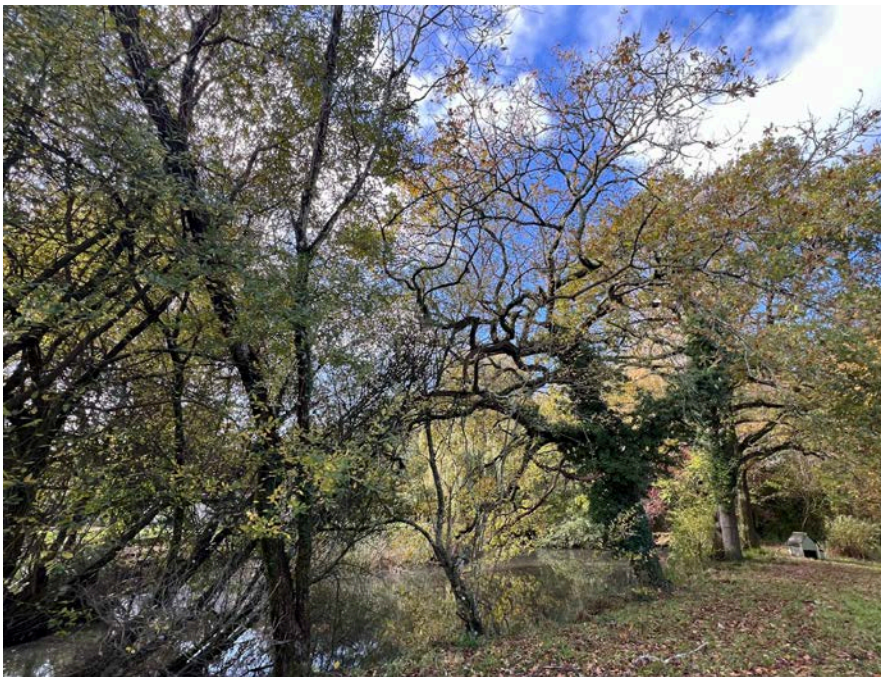
*Photographic plate showing the northern edge of the pond, and surrounding trees. (ROAVR, 2025)*

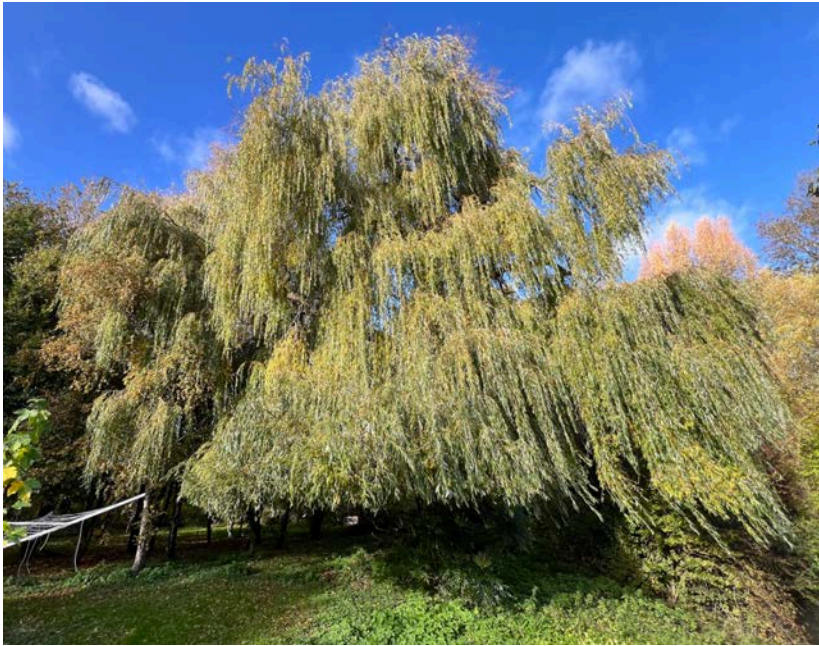
*Photographic plate showing T26 Willow. (ROAVR, 2025)*

| Tree Number | Species | Age Class | DBH | Height (crown height) | N | E | S | W | Condition | Life Expectancy | Physical Description | Comments | Managment Recommendations | RPA offset from stem. | Category Rating |
|---|---|---|---|---|---|---|---|---|---|---|---|---|---|---|---|
| T26 | <i>Salix X chrysocoma</i> (Weeping Willow) | EM | 600 | 15(1) | 9 | 9 | 5 | 9 | Good | 20+ | Good quality mature broadleaf | Leaning North. Broken branches in crown. | None | 7.2 | B1 |

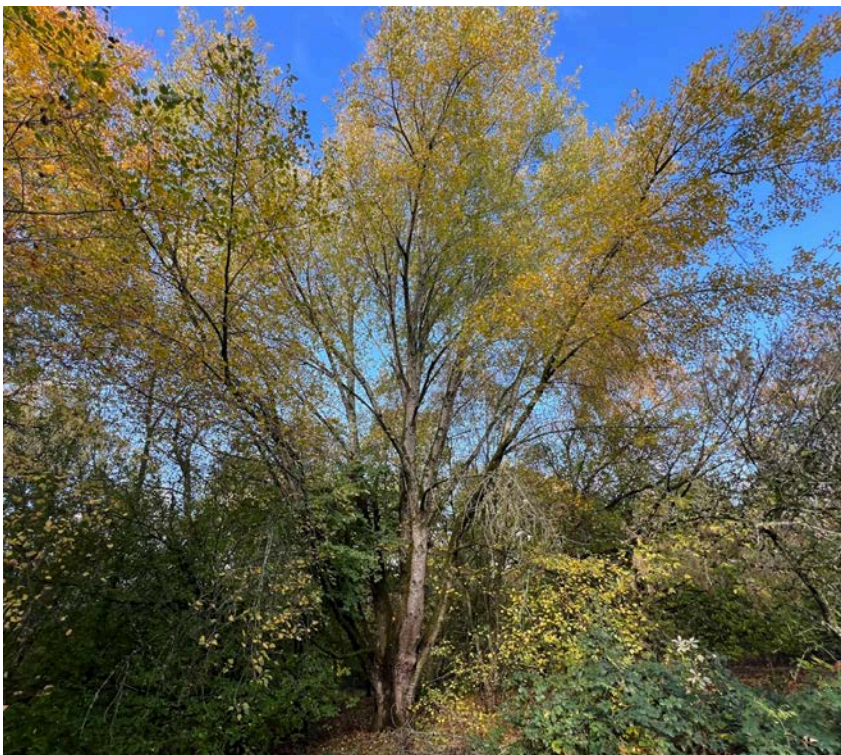
*Photographic plate showing T35 Poplar. (ROAVR, 2025)*
