## EXISTING REAR LAYOUT

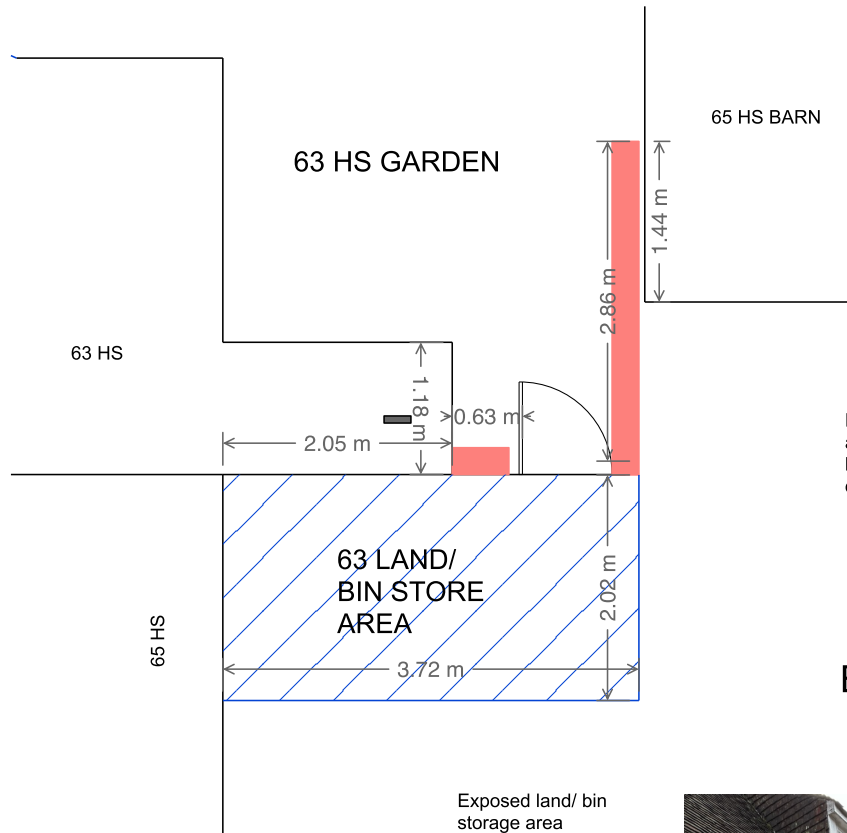
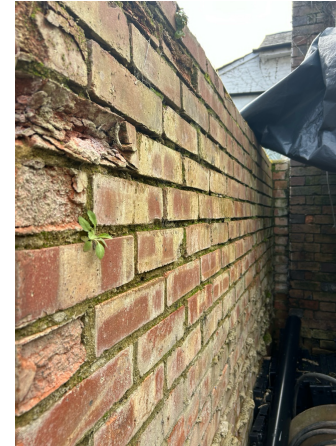
Existing rear wall is  
severely damaged and in  
poor condition. The  
footings are unstable and  
the wall is bowing.

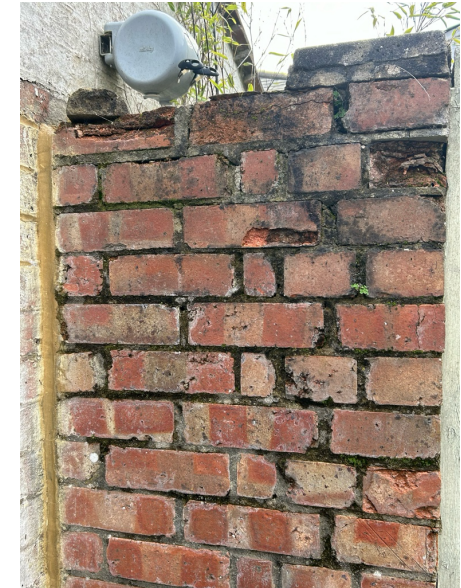
Existing small section of wall is in poor condition and has detached from the wall of 63. It has been temporarily reattached to avoid further damage or injury.

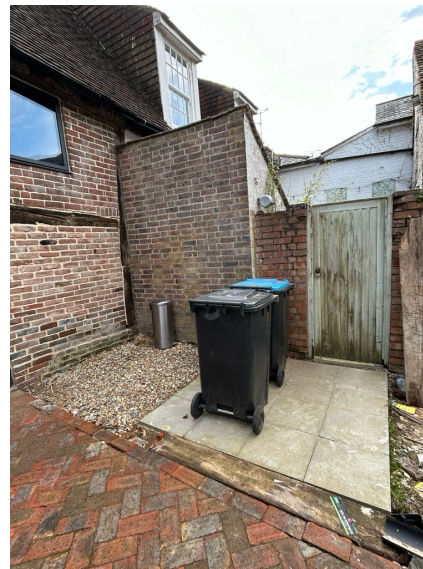
Exposed land/ bin  
storage area  
belonging to 63  
visible in the rear  
garden of 65/65a
