## STRUCTURAL ENGINEERING NOTE 06

Barn at Brook Farm, Cuckfield, West Sussex

### Design Statement on Foundations to Stable

Drawing ref: 0142-06      Design drawing – Stable Foundations and Ground Floor

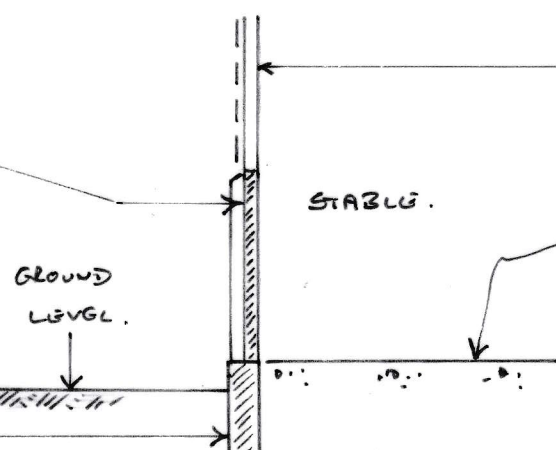
SECTION X-X. (~1:50)  
(AS EXISTING)

BRICK PLINTH.  
PROBABLY ONE-BRICK  
THICK. CONFIRMED AS  
EXTENDING 450mm  
BELOW GROUND  
LEVEL, BORING ON  
TO WADHURST CLAY.

BASED ON FINDINGS  
OF LAND SCIENCE  
SITE INVESTIGATION,  
TRIAL PIT 05.

ORIGINAL TIMBER  
FRAME ABOVE.

EXISTING CONCRETE  
FLOOR - (20TH  
CONSTRUCTION.

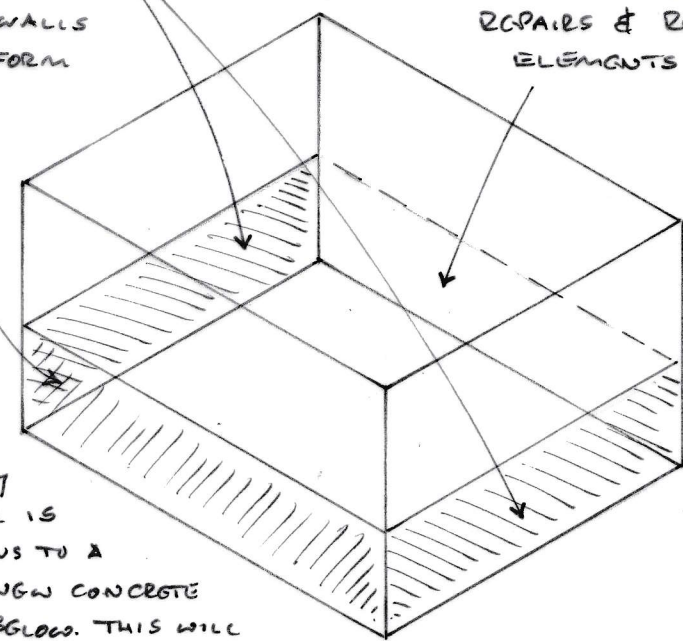
ISOMETRIC OF EXISTING TIMBER FRAMED WALLS.

(20TH BRICK WALLS REPLACED)  
ORIGINAL TIMBER FRAME  
AT LEAST ALONG EAST,  
WEST & SOUTH WALLS.  
REMOVING THESE WALLS  
CREATES ROOM TO FORM  
NEW FOUNDATIONS  
PRIOR TO TIMBER  
FRAMING BEING  
REINSTATED.

CONDITION OF TIMBER FRAME  
ALONG NORTH WALL (SHARED WITH  
LEAN-TO) EXPECTED TO BE POOR AT  
LOW LEVEL & EXPECTED TO REQUIRE  
REPAIRS & REPLACEMENT OF TIMBER  
ELEMENTS.

GIVEN GROUND  
CONDITIONS,  
STATE OF EXISTING  
MASONRY PLINTH, &  
POTENTIAL CONCERNS  
WITH SOIL INSTABILITY  
NEAR SURFACE, PROPOSAL IS  
TO EXTEND FOUNDATIONS TO A  
GREATER DEPTH WITH NEW CONCRETE  
FOOTINGS AS NOTED BELOW. THIS WILL  
HELP CONSERVE THE TIMBER FRAME  
INTO THE FUTURE, & PERMIT FOOTINGS  
TO COMPLY WITH BUILDING REGULATIONS.
