**Asbestos Refurbishment Survey  
Inspection Report  
Rutherford Kitchen  
Worth School and Abbey**

# **Asbestos Refurbishment Survey Inspection Report**

### **Rutherford Kitchen Works Worth School and Abbey West Sussex**

**Survey Date: 04 February 2025**

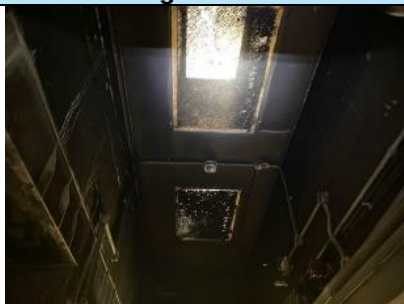
| Area Presumed | Reason | Refer to Image |
|---|---|---|
| Room EXC 1, GF Freezer Corridor - Above High Level Ceilings | Not safe to access with ladders - too high. Ceiling material has been sampled and confirmed as no asbestos. | |

The following areas could not be accessed on the day of the survey and therefore must be presumed to contain asbestos. UL Solutions strongly recommends that these areas be revisited and surveyed in order to confirm whether or not asbestos is present.

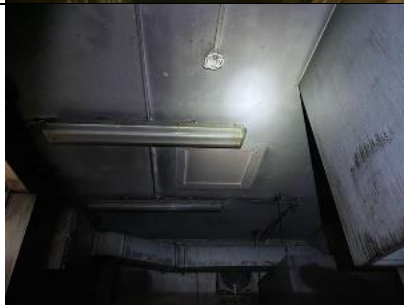
| Area Presumed | Reason | Refer to Image |
|---|---|---|
| Room EXC 2, GF Large Kitchen Area Wash Up/ Store Ceiling | High level ceiling not accessed due to height and floor conditions. | |

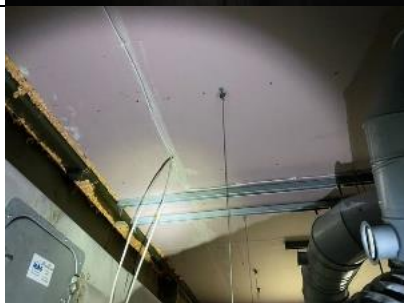
| Area Presumed | Reason | Refer to Image |
|---|---|---|
| Room EXC 3, GF Large Kitchen Area - Above High Level Plasterboard Ceilings | Too high to access safely. | |

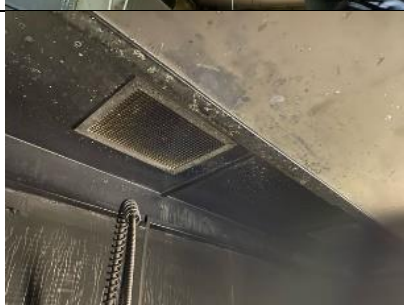
| Area Presumed | Reason | Refer to Image |
|---|---|---|
| Room EXC 4, GF Large Kitchen Area - Above Wash Up Area Ceiling | Ceiling above fixed ceiling is too tight to access safely due to fixed kitchen units. Modern plasterboard can be seen directly above this area. | |

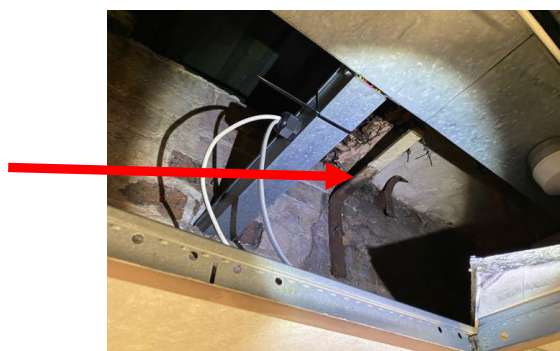
#### 7.2.1 Room 1, GF Corridor by Drinks Cupboard, Residue to Walls and Hangers, Insulation

| Item Ref | Relevant Report Section | Location, Description | Result | Material Assessment Algorithm | Material Extent | HSE Licensable Material? |
|---|---|---|---|---|---|---|
| S 001 | 7.2.1 | Room 1, GF Corridor by Drinks Cupboard, Residue to Walls and Hangers, Insulation | Amosite / Chrysotile | 11 - High | Small Pieces Seen To Entire Length of Wall (25m) | Yes |

**Comments** Insulation residue was seen to wall above ceiling tiles. Residue is present to old hangers and redundant pipework which runs across the entire length of corridor and leads into the kitchen office.

**Recommendations** We advise this material be removed.

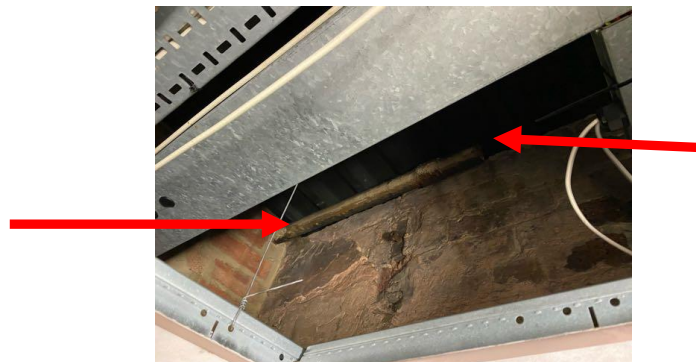
| Item Ref | Relevant Report Section | Location, Description | Result | Material Assessment Algorithm | Material Extent | HSE Licensable Material? |
|---|---|---|---|---|---|---|
| S 002 | 7.2.2 | Room 1, GF Corridor by Drinks Cupboard, Residue and Debris to Wall and Pipework, Insulation | Amosite | 11 - High | Small Pieces Seen To Entire Length of Wall (25m) | Yes |

**Comments** Insulation residue was seen to wall above ceiling tiles. Residue is present to old hangers and redundant pipework which runs across the entire length of corridor and leads into the kitchen office.

**Recommendations** We advise this material be removed.

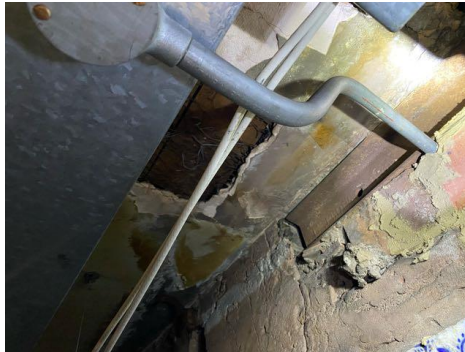
| Item Ref | Relevant Report Section | Location, Description | Result | Material Assessment Algorithm | Material Extent | HSE Licensable Material? |
|---|---|---|---|---|---|---|
| S 003 | 7.2.3 | Room 1, GF Corridor by Drinks Cupboard, Above Mesh Plaster - Concrete, Cement | No Asbestos Detected | 0 - N/A | 1m2 | N/A |

**Comments** Taken to discount.

**Recommendations** No asbestos was detected.

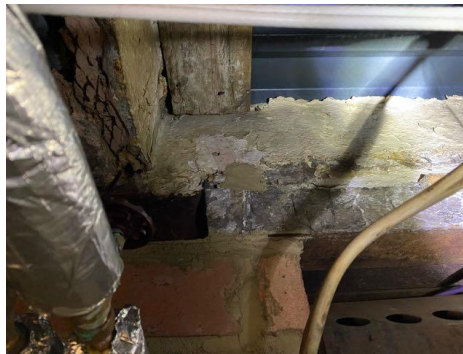
| Item Ref | Relevant Report Section | Location, Description | Result | Material Assessment Algorithm | Material Extent | HSE Licensable Material? |
|---|---|---|---|---|---|---|
| S 004 | 7.2.4 | Room 1, GF Corridor by Drinks Cupboard, Ceiling and Walls Near Metal Duct, Textured Coating | No Asbestos Detected | 0 - N/A | 5m2 | N/A |

**Comments** Taken to discount.

**Recommendations** No asbestos was detected.

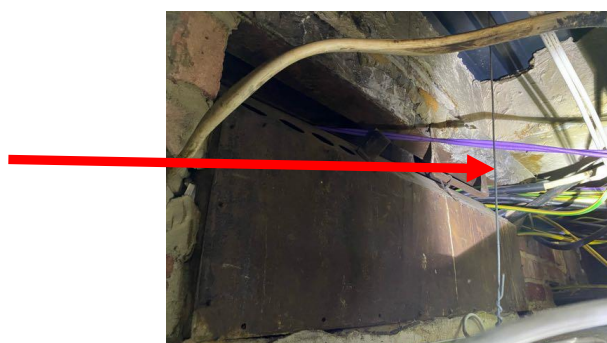
| Item Ref | Relevant Report Section | Location, Description | Result | Material Assessment Algorithm | Material Extent | HSE Licensable Material? |
|---|---|---|---|---|---|---|
| S 005 | 7.2.5 | Room 1, GF Corridor by Drinks Cupboard, Residue to Wall and Metal Vent, Insulation | Amosite / Chrysotile | 11 - High | Small Pieces Seen | Yes |

**Comments** Insulation residue was seen to wall above ceiling tiles. Residue is present to old hangers and redundant pipework which runs across the entire length of corridor and leads into the kitchen office.

**Recommendations** We advise this material be removed.

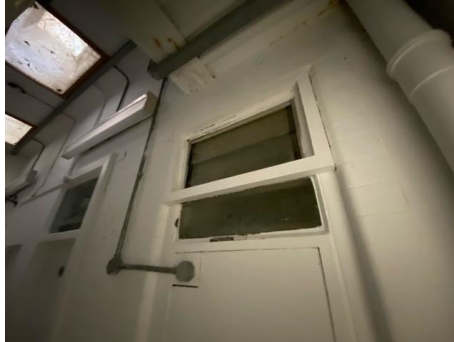
| Item Ref | Relevant Report Section | Location, Description | Result | Material Assessment Algorithm | Material Extent | HSE Licensable Material? |
|---|---|---|---|---|---|---|
| S 006 | 7.2.6 | Room 1, GF Corridor Lobby by Toilets, Window Surrounds, Mastic | No Asbestos Detected | 0 - N/A | 5lm | N/A |

**Comments** Taken to discount.

**Recommendations** No asbestos was detected.

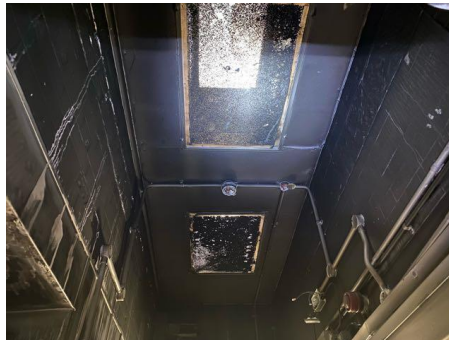
| Item Ref | Relevant Report Section | Location, Description | Result | Material Assessment Algorithm | Material Extent | HSE Licensable Material? |
|---|---|---|---|---|---|---|
| S 007 | 7.2.7 | Room 5, GF Freezer Corridor, Ceiling, Insulating Board | No Asbestos Detected | 0 - N/A | 4m2 | N/A |

**Recommendations** No asbestos was detected.

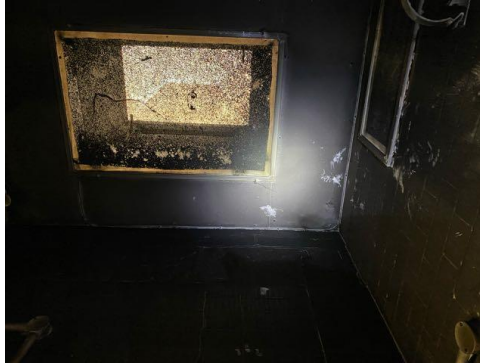
| Item Ref | Relevant Report Section | Location, Description | Result | Material Assessment Algorithm | Material Extent | HSE Licensable Material? |
|---|---|---|---|---|---|---|
| S 008 | 7.2.8 | Room 5, GF Freezer Corridor, Ceiling, Insulating Board | No Asbestos Detected | 0 - N/A | 4m2 | N/A |

**Recommendations** No asbestos was detected.

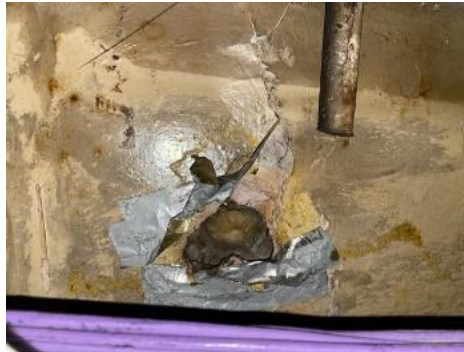
| Item Ref | Relevant Report Section | Location, Description | Result | Material Assessment Algorithm | Material Extent | HSE Licensable Material? |
|---|---|---|---|---|---|---|
| S 009 | 7.2.9 | Room 3, GF Large Kitchen Areas, Within Ceiling Void - Debris, Insulation | No Asbestos Detected | 0 - N/A | Small | N/A |

**Recommendations** No asbestos was detected.

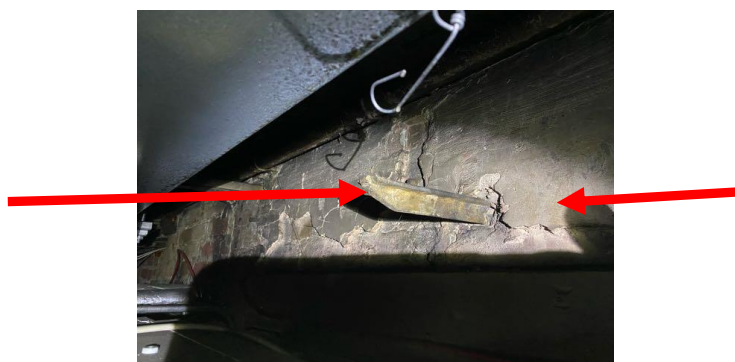
| Item Ref | Relevant Report Section | Location, Description | Result | Material Assessment Algorithm | Material Extent | HSE Licensable Material? |
|---|---|---|---|---|---|---|
| S 010 | 7.2.10 | Room 3, GF Large Kitchen Areas, Wall and Hanger Residue , Insulation | Amosite | 11 - High | Small Pieces Seen To Entire Length of Wall | Yes |

| <b>Comments</b> | Insulation residue was seen to wall above ceiling tiles. Residue is present to old hangers and redundant pipework which runs across the entire length of corridor and leads into the kitchen office. | | |

| <b>Recommendations</b> | We advise this material be removed. | | |

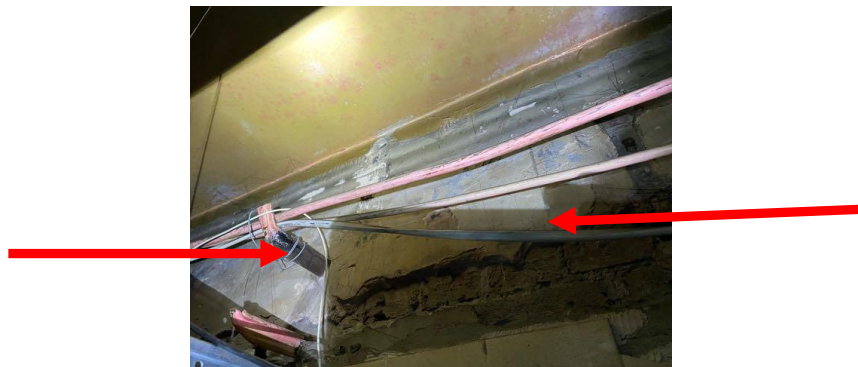
| Item Ref | Relevant Report Section | Location, Description | Result | Material Assessment Algorithm | Material Extent | HSE Licensable Material? |
|---|---|---|---|---|---|---|
| S 011 | 7.2.11 | Room 4, GF Large Kitchen Office, Wall and Hanger Residue , Insulation | Amosite / Chrysotile | 11 - High | Small Pieces Seen To Entire Length of Wall | Yes |

| <b>Comments</b> | Insulation residue was seen to wall above ceiling tiles. Residue is present to old hangers and redundant pipework which runs across the entire length of corridor and leads into the kitchen office. | | |

| <b>Recommendations</b> | We advise this material be removed. | | |

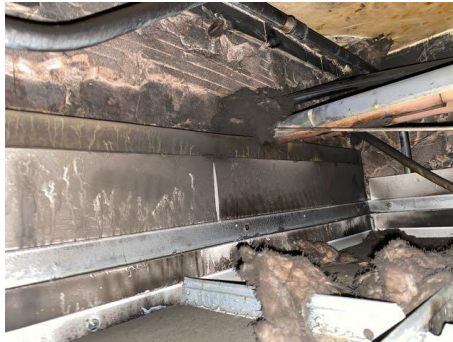
| Item Ref | Relevant Report Section | Location, Description | Result | Material Assessment Algorithm | Material Extent | HSE Licensable Material? |
|---|---|---|---|---|---|---|
| S 012 | 7.2.12 | Room 3, GF Large Kitchen Areas, Original Ceiling Grid Supports, Insulating Board | No Asbestos Detected | 0 - N/A | 12m | N/A |

**Comments** Taken to discount.

**Recommendations** No asbestos was detected.

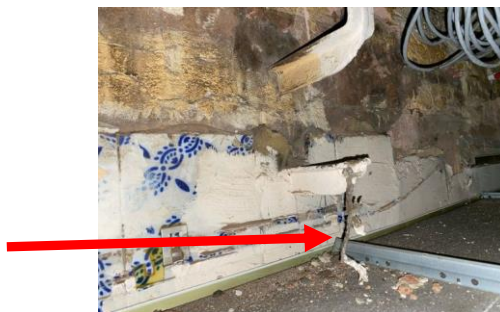
| Item Ref | Relevant Report Section | Location, Description | Result | Material Assessment Algorithm | Material Extent | HSE Licensable Material? |
|---|---|---|---|---|---|---|
| S 013 | 7.2.13 | Room 1, GF Corridor by Drinks Cupboard, Pipe Hanger Near Drinks Store - Rope Residue, Textile | Chrysotile | 8 - Medium | Small | No |

**Comments** A large amount of asbestos rope was removed as part of the sample. There is still residue left on the hanger.

**Recommendations** We advise this material be removed.

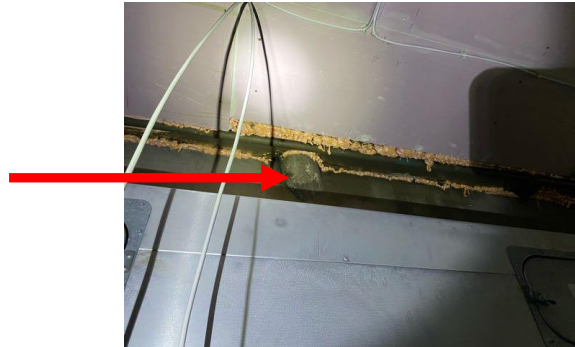
| Item Ref | Relevant Report Section | Location, Description | Result | Material Assessment Algorithm | Material Extent | HSE Licensable Material? |
|---|---|---|---|---|---|---|
| P 001 | 7.2.14 | Room 3, GF Large Kitchen Areas, Above Ceiling Tiles - Large Pipe , Cement | Presumed to contain Chrysotile | 6 - Low | 0.5m | No |

**Comments** Material is too high to access safely. Presumed to be cement down pipe.

**Recommendations** This material can continue to be managed in situ and should be inspected annually. No specific remedial action is recommended at this time.

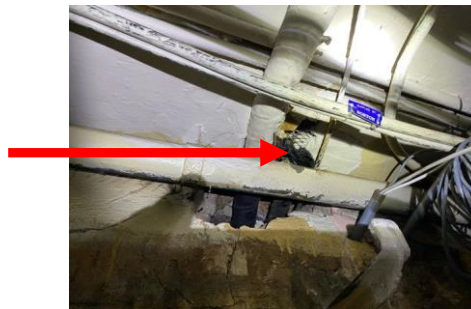
| Item Ref | Relevant Report Section | Location, Description | Result | Material Assessment Algorithm | Material Extent | HSE Licensable Material? |
|---|---|---|---|---|---|---|
| P 002 | 7.2.15 | Room 1, GF Corridor by Drinks Cupboard, Cable Wrap Above Ceiling, Bitumen | Presumed to contain Chrysotile | 3 - Very Low | 1m | No |

**Recommendations** This material can continue to be managed in situ and should be inspected annually. No specific remedial action is recommended at this time.
