## The Castle, Hickstead

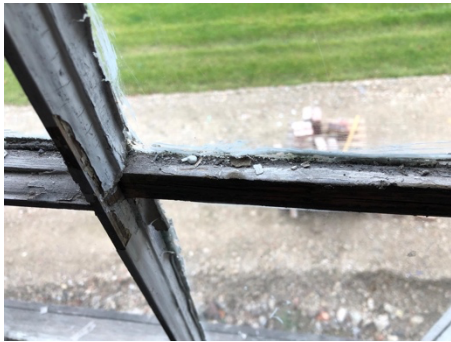
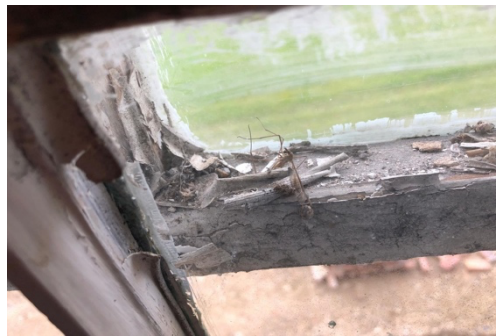
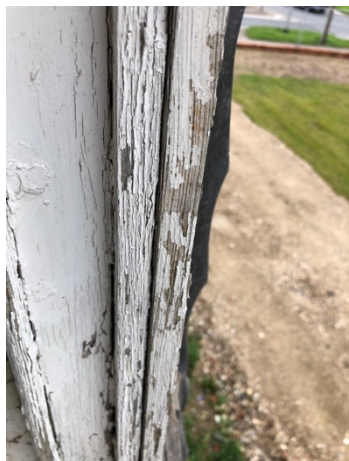
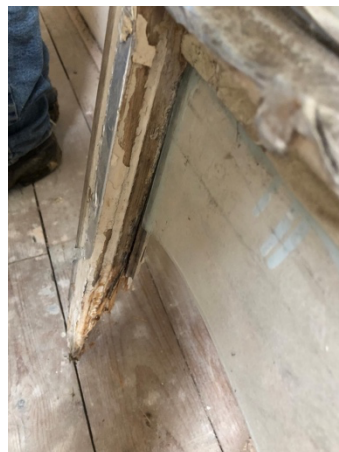
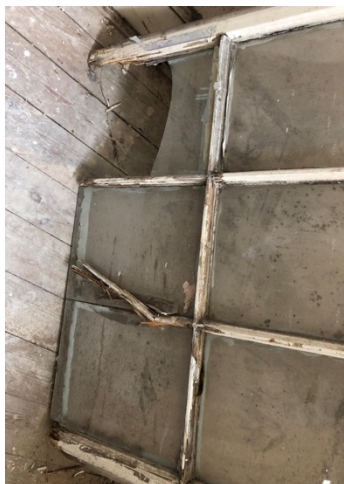
**Window FF7** - *The cill has completely gone, 4" x 5/8" timber has been planted to outside face & top of cill in an attempt to conceal the rot. Pulley stile on left viewed from inside is completely rotten, again linings have been put over original linings to make them look good. The bottom rail is non-existent, the meeting rail on the top sash is rotten. Some of the glazing bars on the bottom sash have no moulding whatsoever. The top of the window is out of square by about 1 ½" on the left.*
