# AN ARCHAEOLOGICAL INTERPRETIVE STUDY FOR THE OLD COACH HOUSE, 8 CUCKFIELD ROAD, HURSTPIERPOINT, WEST SUSSEX, BN6 9RU.

Report number: ASL 351-25

## SUMMARY

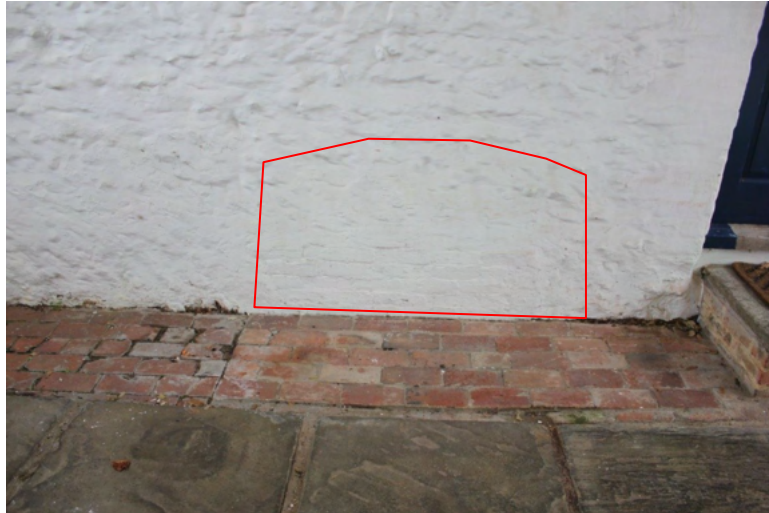
The ceiling of the Carriageway is high and rendered so the ceiling timbers are not exposed. There are two modern ventilation blocks in the south wall with one original, cast iron block. There are two further cast iron ventilation bricks at a high level in the north wall and a blocked cellar aperture (Plate 9) which has a sliding chute for coal deliveries inside.

**Plate 9. Blocked coal chute aperture in the south elevation.**

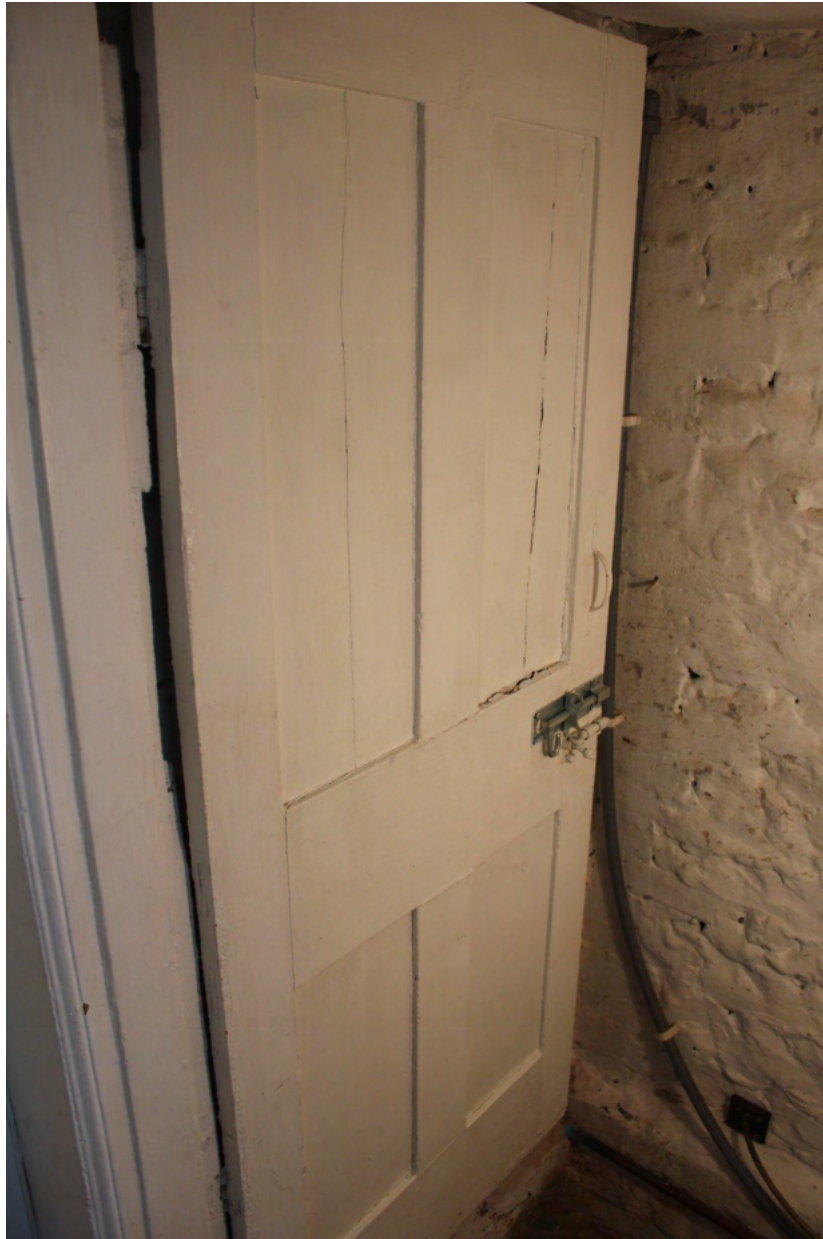
- 5.1 The cellar is present below Room G1 alone, rather than the full depth of the building and is accessed via a narrow four panel, original pine door in the south-east corner of Room G2 (which matches the rear door) with the original architrave still present. This opens up to a set of brick stairs below the main stairwell (Plate 20), which have a very slight curve to them and the north wall of the stairwell is made from lime washed plank and muntin boards which are an original feature.

**Plate 20. The cellar door.**

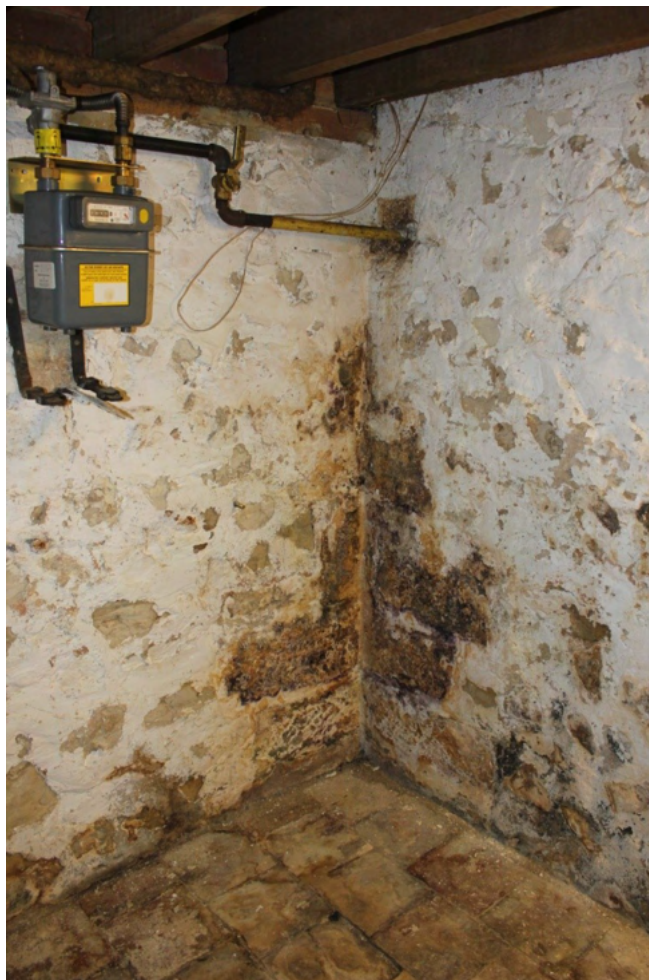
- 5.2 The south side wall is solid flint and the floor of the cellar is laid with thick quarry tiles, also original, which are very cracked. There are some stone quoins in the south-west corner (Plate 21) and although the walls are heavily lime washed, there are areas exposed which appear to show clunch (chalk) blocks in the north wall and possibly the east wall. Elsewhere it appears to be mostly flint.

**Plate 21. Quoin stones in the south-west corner.**

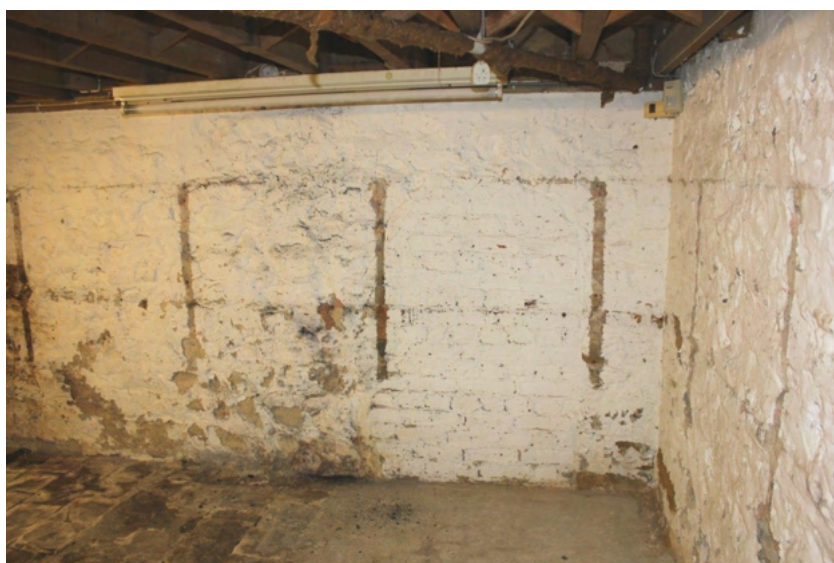
- 5.3 There is a blocked doorway leading into the No.10 on the north side (Plate 22), with a large raft of concrete in the floor in front of the blocked aperture. The relieving arch and hearth of the fireplace above have been removed, when the whole floor was replaced in the 20<sup>th</sup> century, with the joists and floorboards all modern and inserted into the original joist mortices and bricked in-between.

**Plate 22. Blocked doorway in the north wall, adjacent to the hearth above.**

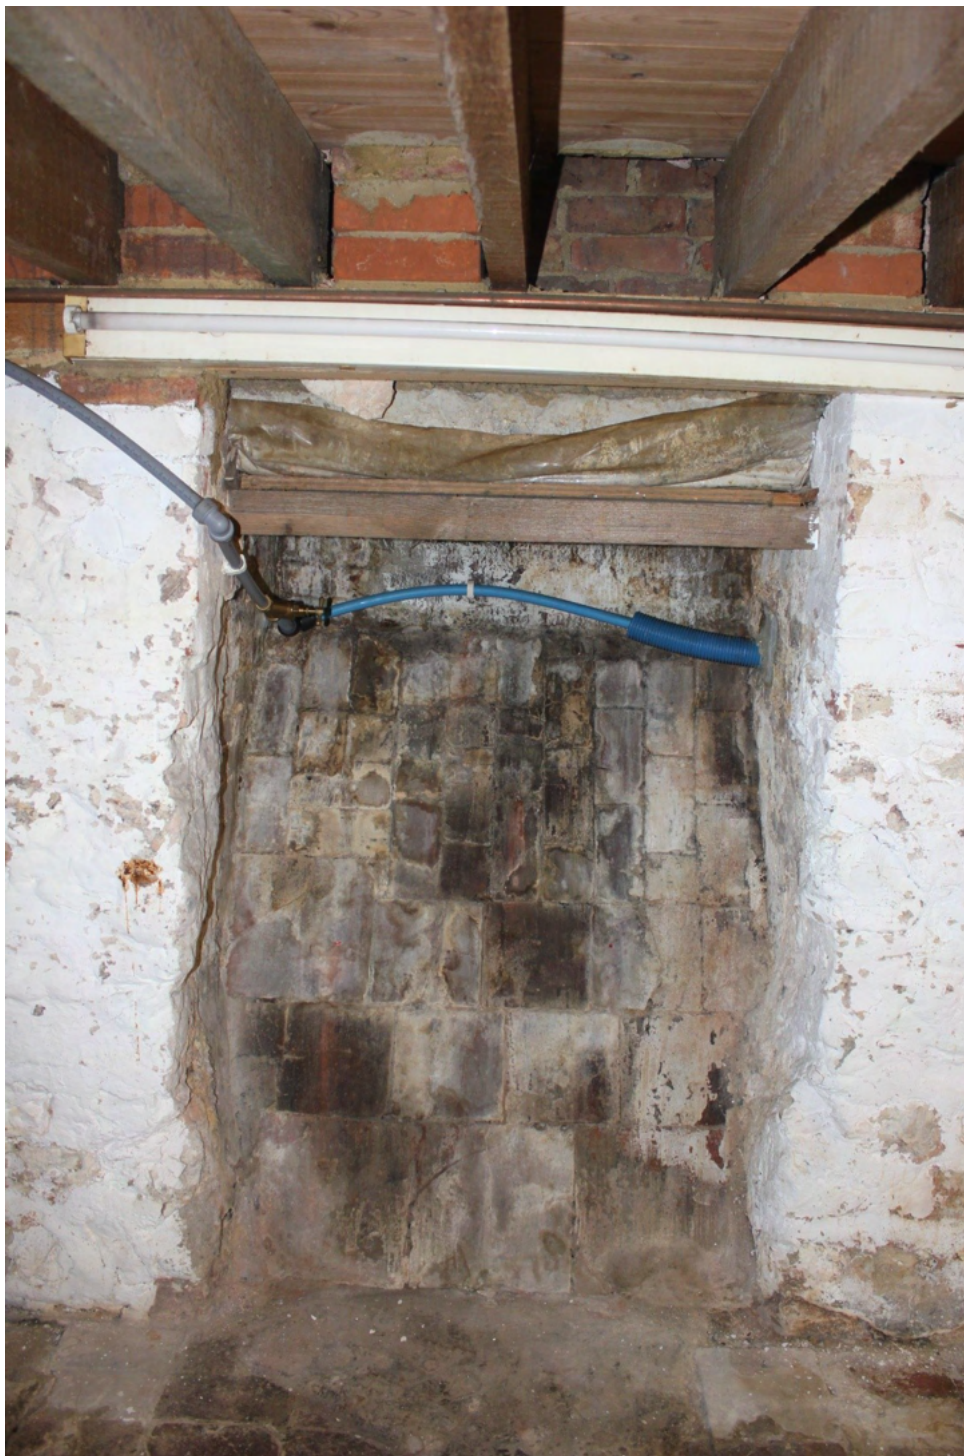
**Plate 23. Coal chute in the southern wall.**

- 5.4 There is an original coal/barrel chute (plate 23) which was accessed from the south wall within the Carriageway although the aperture has since been blocked.
- 5.5 There is a small patch of original joists which remain *in-situ* over part of the stairs which are lime washed, although the floorboards above the joists forming the base of the stairs leading to the first floor have been replaced. The underside of the stairs in the floor above are covered with original lath and plaster (Plate 24).

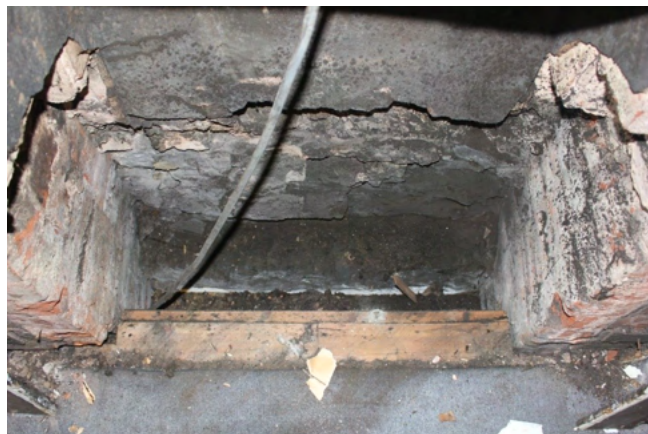
Once inside, the floor is carpeted but has modern replacement joists and boards as seen in the cellar. The ceiling is covered with thick, embossed Anaglypta type wallpaper which has been painted with gloss paint so the surface under this is not exposed. The walls are plaster applied directly to the masonry and appear to be lime, at least in the west and south side. The fireplace has been significantly modified, with a replacement surround, missing hearth (Plate 26) and brickwork which has been hacked back in places.

**Plate 26. Removed hearth.**

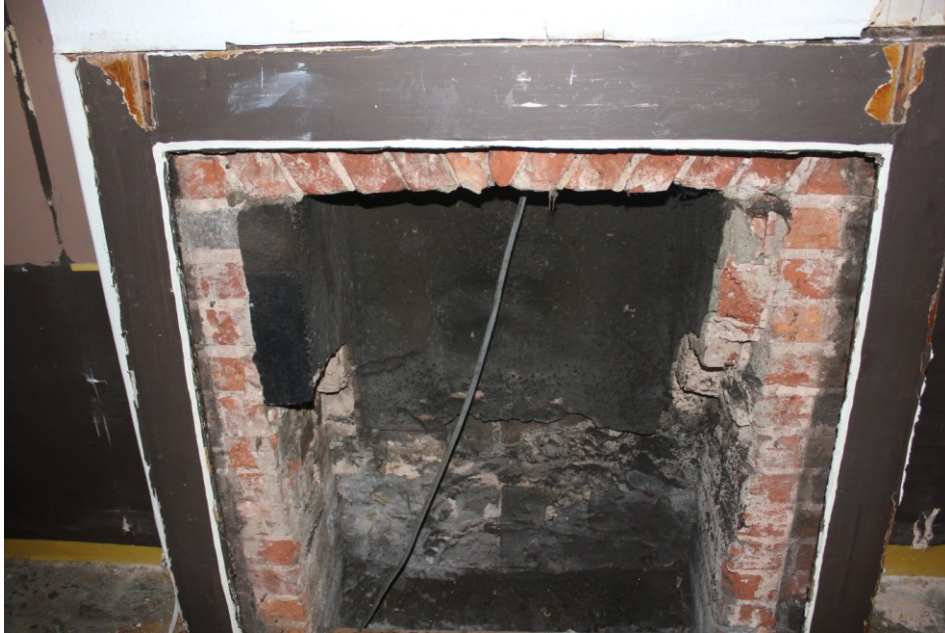
The gauged brick lintel is exposed and a painted, softwood fascia plate (Plate 27) is present which was once attached around the outside of the fire surround. This has some age to it which could be original although it was attached with cut nails and is no longer attached. However, it is plain and not of high significance. The two arches either side of the stack (Plate 28) are very flimsy and made from softwood studwork so are not original. Neither are the modern pelmets which contain lighting cables. The removal of these would be beneficial.

**Plate 27. Possible original fire fascia with alterations to the aperture.**

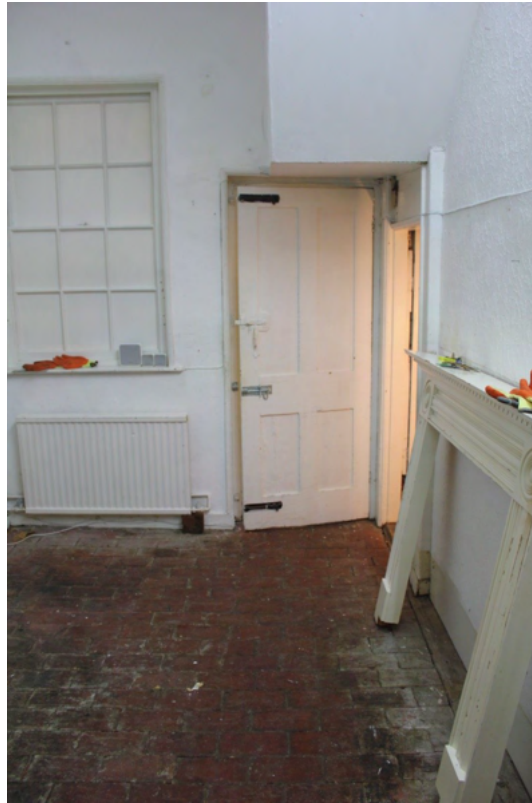
There is an original brick floor and a six over six sliding sash window without horns in the rear, east wall with lamb's tongue glazing bars, sash cords still present and the original architrave. The window has been painted over (Plate 31).

**Plate 31. Original brick floor, door into lean-to and painted rear window in Room G2.**

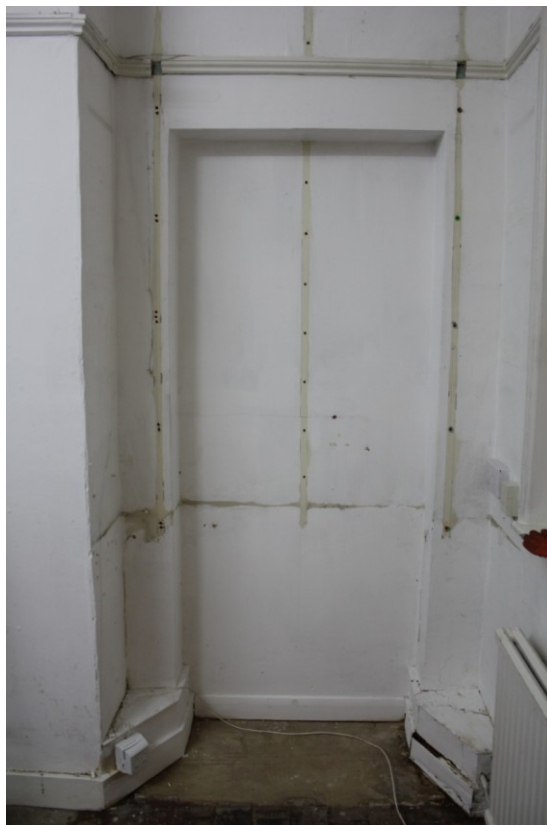
There is a blocked doorway in the west side of the north wall next to the chimney which would have given access into the adjacent house, which has a concrete raft in front of the doorway, possibly suggesting steps were removed (Plate 33). There are blocked doors on every level so it is clear that the two buildings were occupied concurrently, perhaps when it was a public house. The fireplace is missing although there are glazed green tiles on the hearth (Plate 34), an early 20<sup>th</sup> century addition typical of the Arts and Crafts Movement and the skirting boards are squared and not original.

**Plate 33. Blocked doorway in north wall of Room G2.**

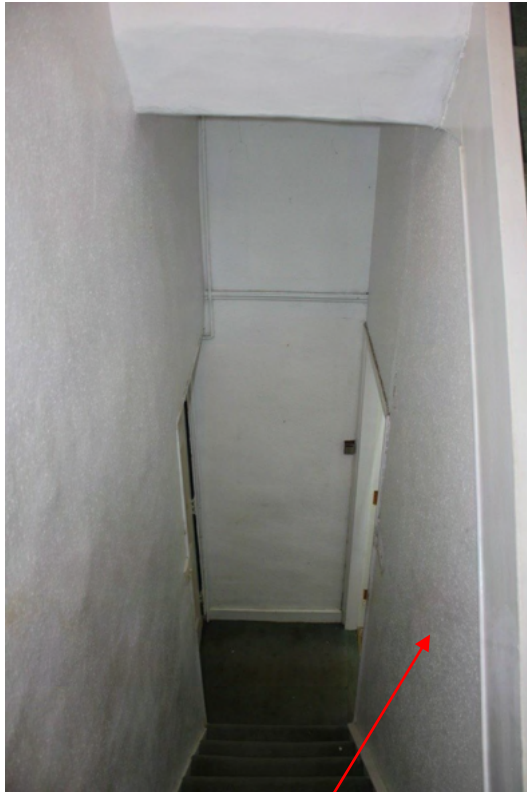
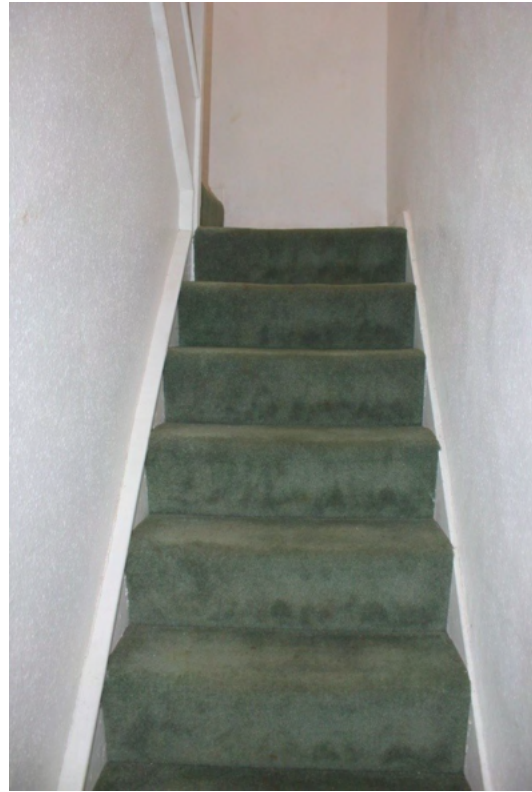
There is a very small lobby area within the side entrance to the south, which is entered through a replacement door as previously described. The floor below the carpet is softwood replacement boarding as seen below in the cellar. The lobby is boxed in with modern plasterboard (Plate 35) and it is likely that there was never a lobby originally, with the stairwell forming part of Room G2 with open balustrades (Plate 36). The underside of the stairs are lath and plastered.

**Plate 35. Stairwell with modern partition.     Plate 36. Plain walls, stringer and handrail.**

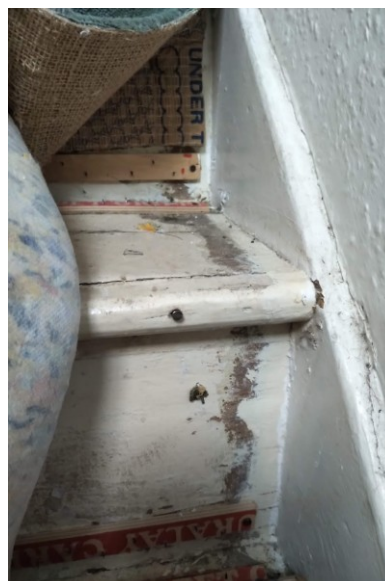
**Plate 37. 20<sup>th</sup> century, bull-nosed stair treads.**

This suggests the whole staircase was replaced, although the original handrails survive throughout and have been re-positioned with the balustrades removed. The nail holes for the original balustrades can be seen underneath the rail and there is one small section remaining *in-situ* on the second floor. The stringers are also modern.

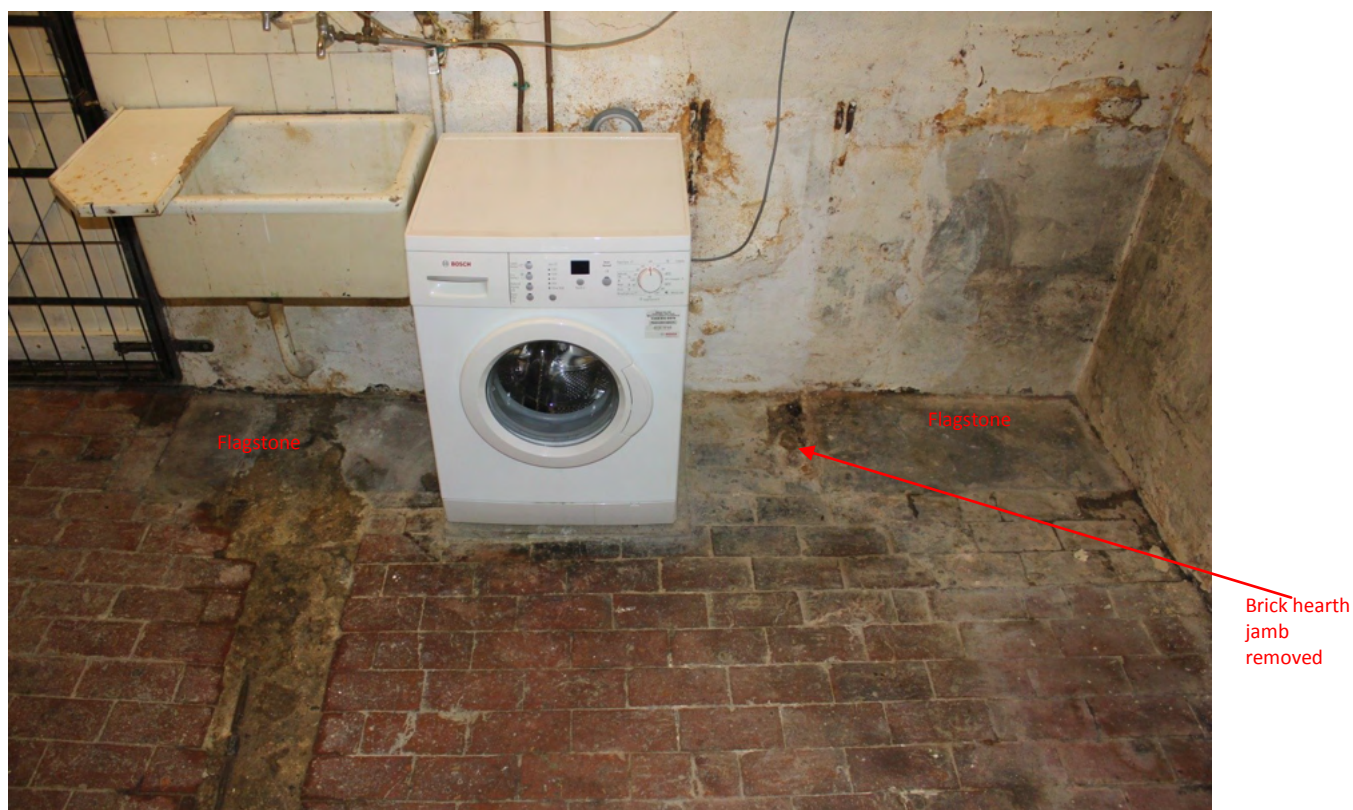
**Plate 39. Scars of a missing fireplace and chimney stack.**

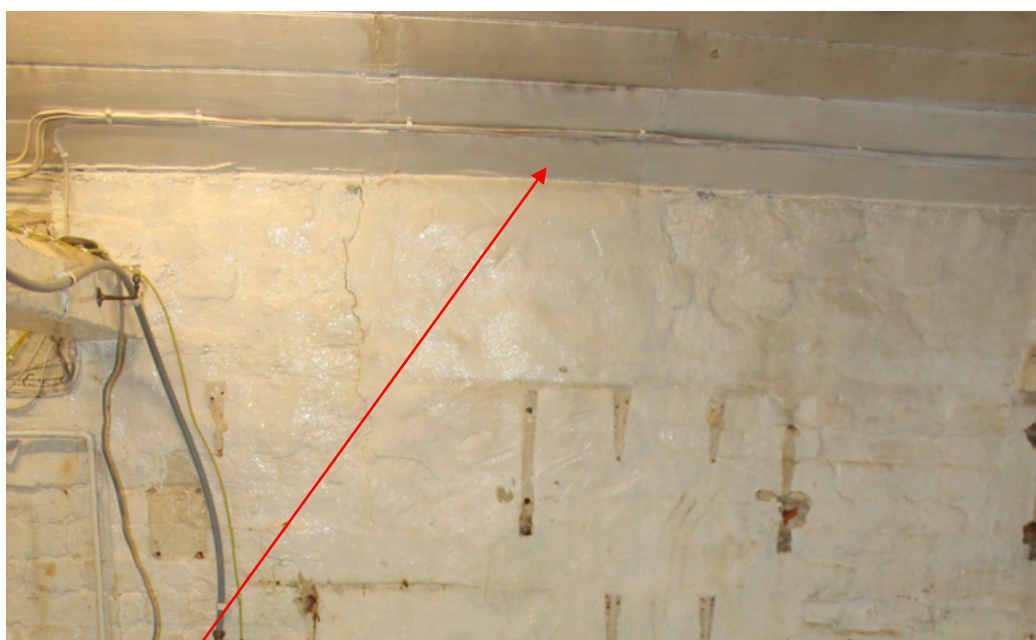
**Plate 40. Patch in roof for removed stack and rendered wall showing former stack outline.**

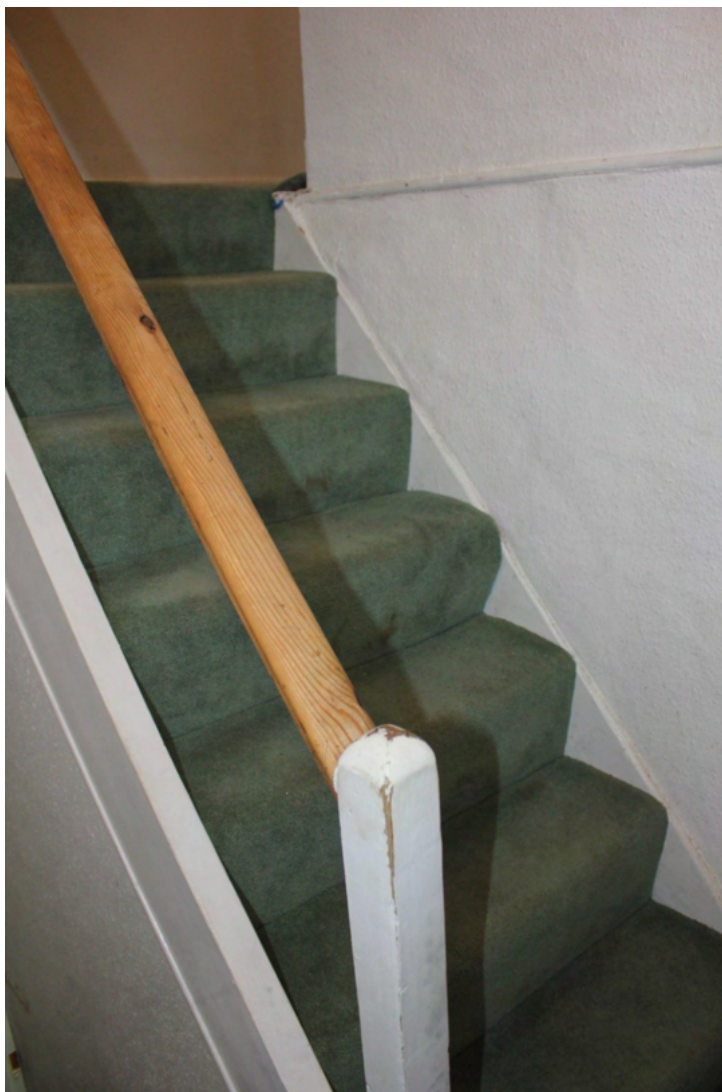
The first floor is access via the stairwell on the south side of the building (Plate 44). As previously discussed, this has been replaced and is mostly a mid-20<sup>th</sup> century insertion.

**Plate 44. 20<sup>th</sup> century newel post and stairs with re-used handrail.**

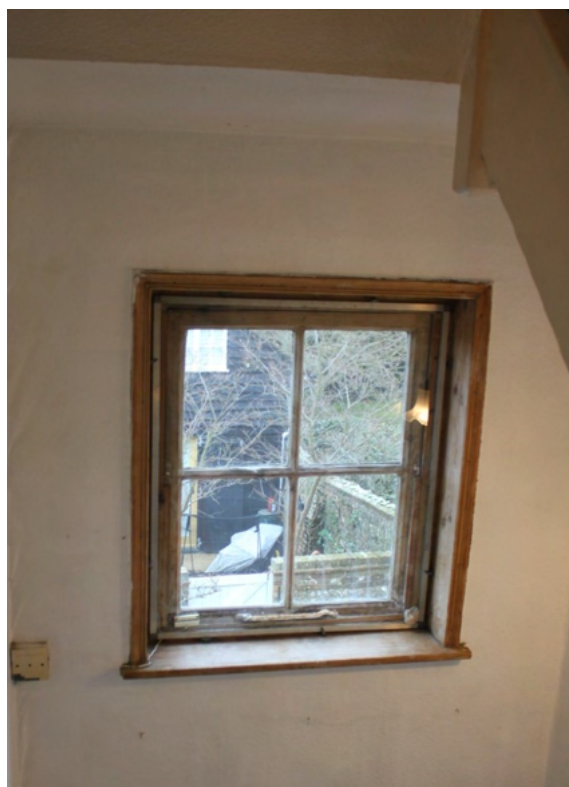
The stairs have a half landing between the two floors which is lit by a four light, pivoting casement window (Plate 45) with lamb's tongue glazing bars with bull-nosed cill and nailed architrave nailed with round headed nails and the paint has been stripped. The window is possibly original but the architrave and cill has been replaced.

**Plate 45. Landing window between ground and first floor levels.**

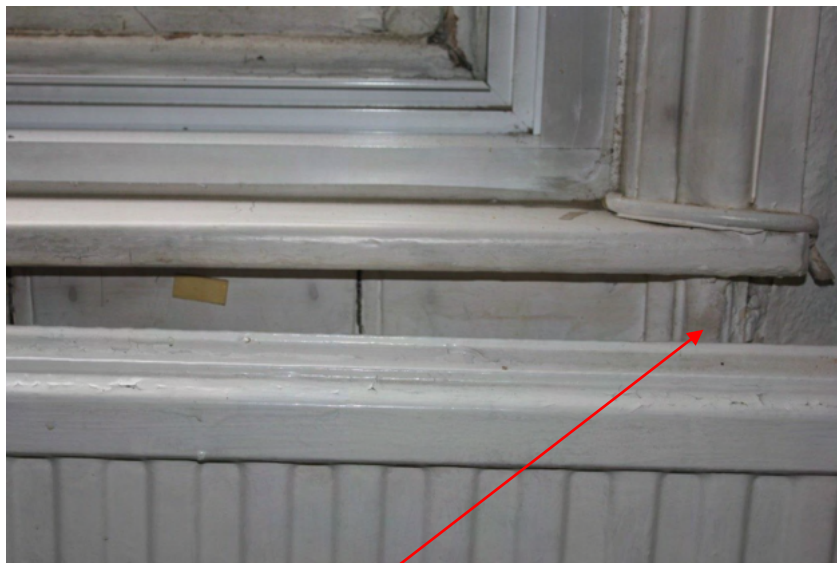
**Plate 50. Different architrave and boarding glimpsed below the window.**

Although this cannot be fully inspected easily, it is suggested that the jambs mark the edges of a once taller window or possibly even French doors which opened up onto the Juliette balcony and have since been replaced. A shorter window was re-positioned in the later Victorian period as these windows should match the six over six sliding sash windows (without horns to the rear). The larger glazed lights marks the transition to cheaper glazing in the later 19<sup>th</sup> century, which needed horns at the side to act as a form of bracing for the heavier glass panels, which were not needed in the earlier windows. There are three original glass panels surviving *in-situ*. The fireplace in the north wall is blocked and the ceiling appears to be original lath and plaster.

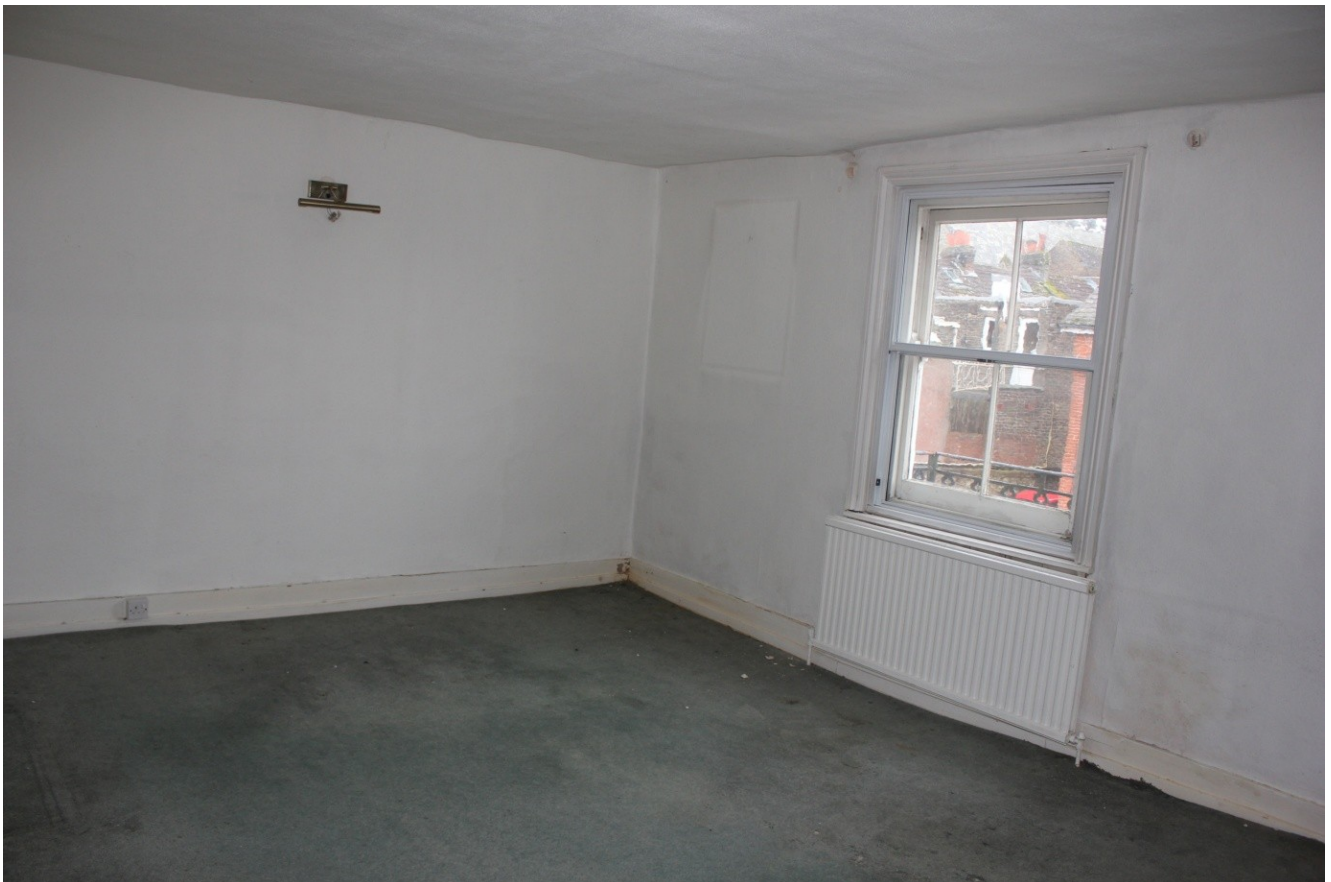
**Plate 51. Bow in the floor of Room F4.**

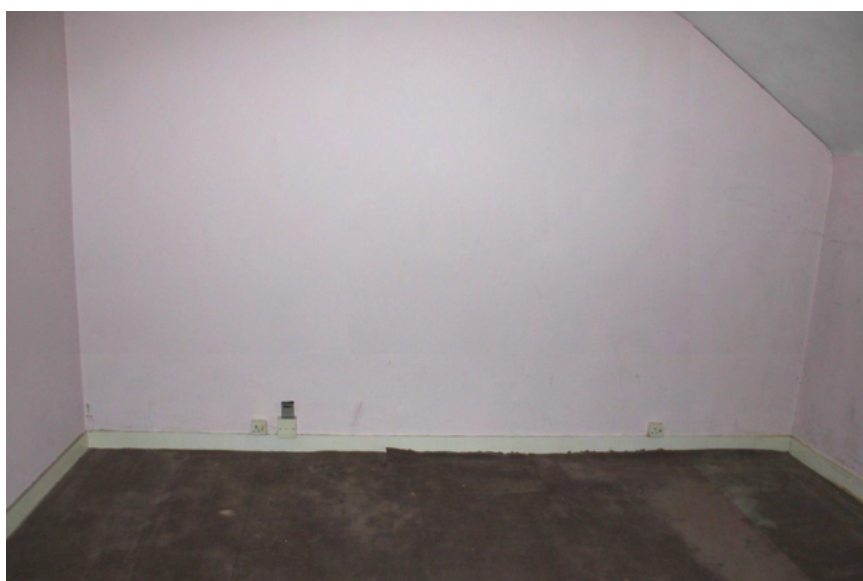
**Plate 64. No evidence for a fireplace in the south wall of Room S4.**
