# Arboricultural Report BS5837 (AIA)

Our Reference  
**229607**

Site  
**5 Watermead, Balcombe, Haywards Heath, RH17  
6EY**

Survey Date  
**21-04-2026**

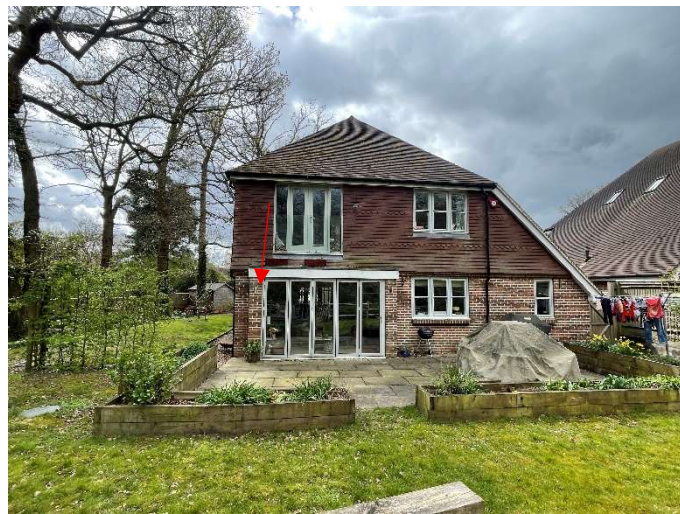
Image of the rear façade and location of single-story extension

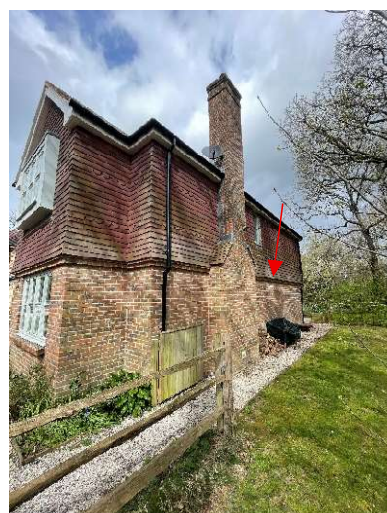
Image showing location of side extension

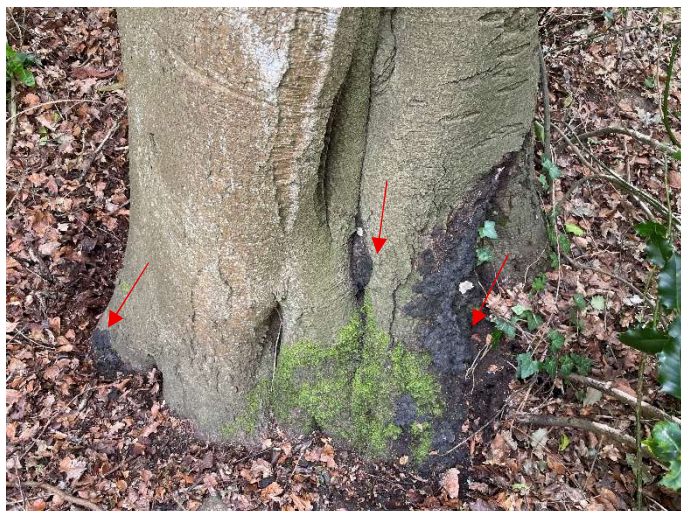
T017 is located within the communal nature pond area and lies within striking distance of both the application site and adjacent third-party properties. The tree exhibits significant structural decline, with *Kretzschmaria deusta* (brittle cinder fungus) observed on the buttress roots around multiple cardinal points. The buttress exhibits a notable change in resonance when sounded with a nylon-tipped mallet, consistent with internal decay and compromised structural integrity.

The tree possesses a large and extended crown, which, in combination with its compromised condition, increases the potential for unpredictable stem failure. Given its condition, the tree is considered unsuitable for retention in its current form. It is recommended that T017 be reduced to approximately 6m in height (pollarding) and retained solely for its potential habitat value, subject to ongoing monitoring and management where appropriate.

Image of *Kretzschmaria deusta* at the base of T017

No trees are proposed for removal to facilitate the development. However, one Category U tree (T017 – Beech) has been identified as being in a condition unsuitable for retention irrespective of the proposed works. It is recommended that this tree be subject to a pollarding to approximately 6m in height to reduce risk and retain potential habitat value, subject to appropriate arboricultural management and ongoing monitoring.

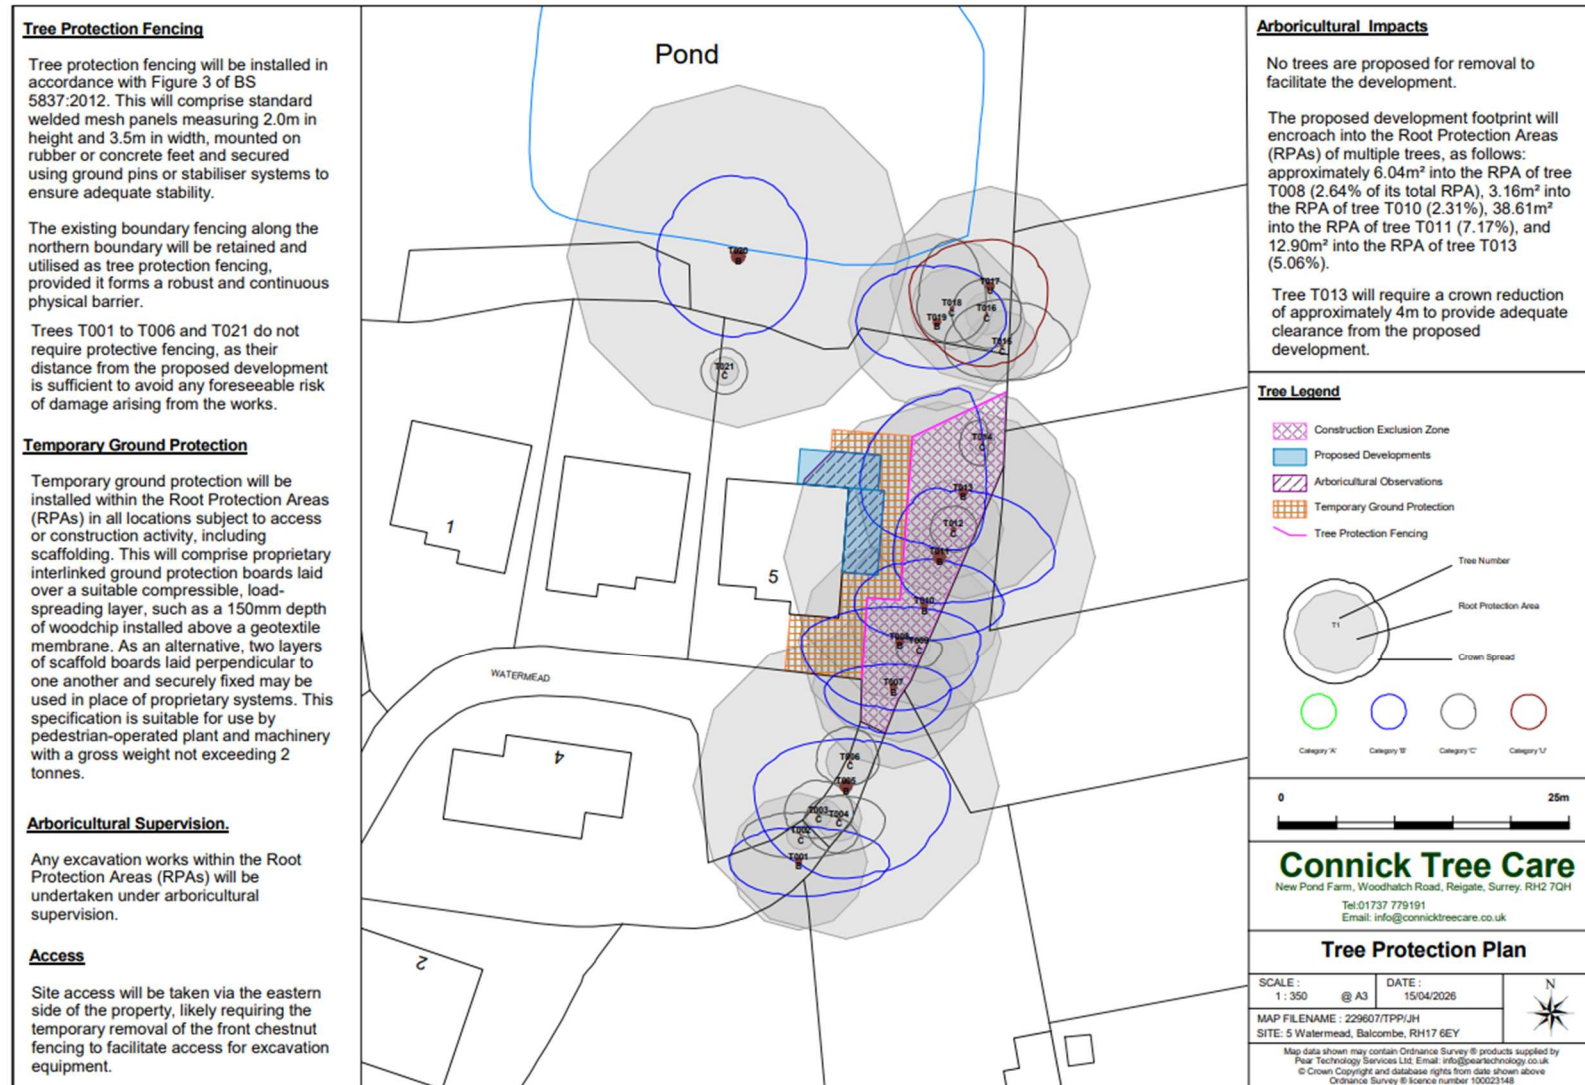
## TREE PROTECTION PLAN

The survey process and the Tree Protection Plan (Appendix III) has indicated the extent of the theoretical Root Protection Areas (RPA) and crown spreads of the surveyed trees and identifies the potential impacts upon these trees resulting from the proposal. The details of the impacts caused by each construction stage is identified within Table 1 below:

All necessary protection measures are identified within the Tree Protection Plan attached as Appendix III.
