**1<sup>ST</sup> STOREY TANK ROOM – BLOCK B1 AT**

**SOUTHWAY JUNIOR SCHOOL**

**SOUTHWAY, BURGESS HILL**

Report No. BSS24991

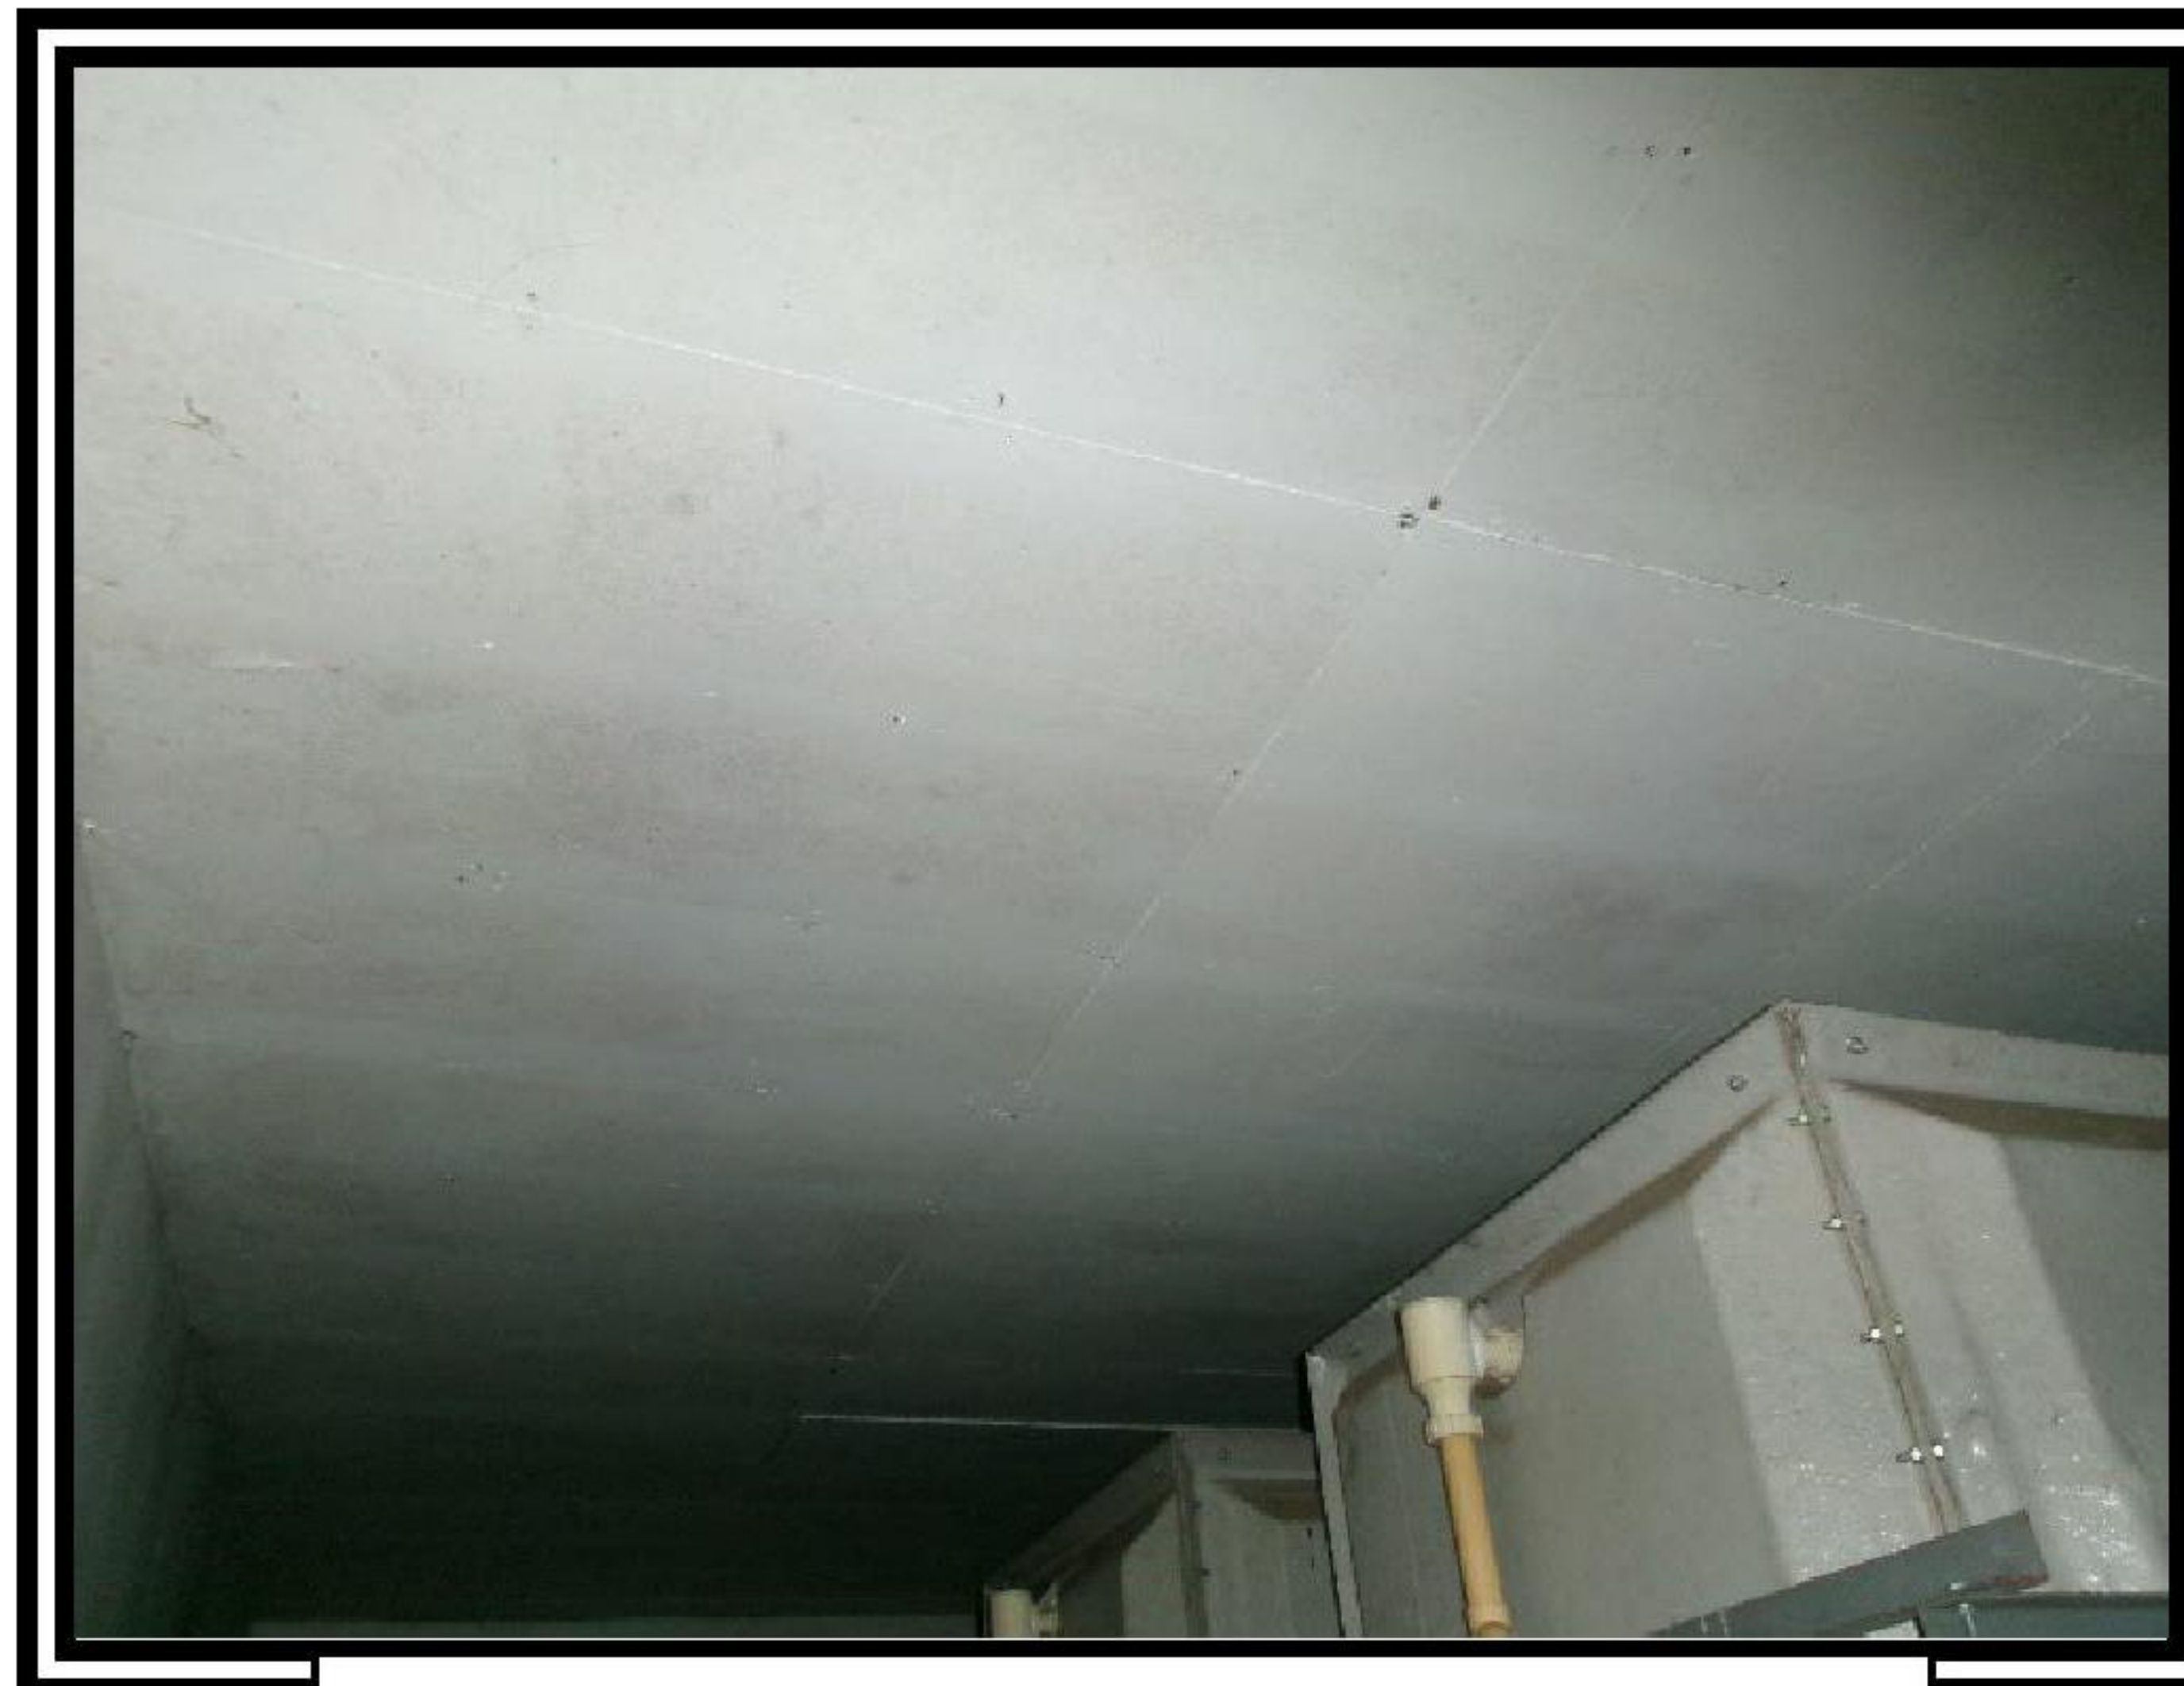
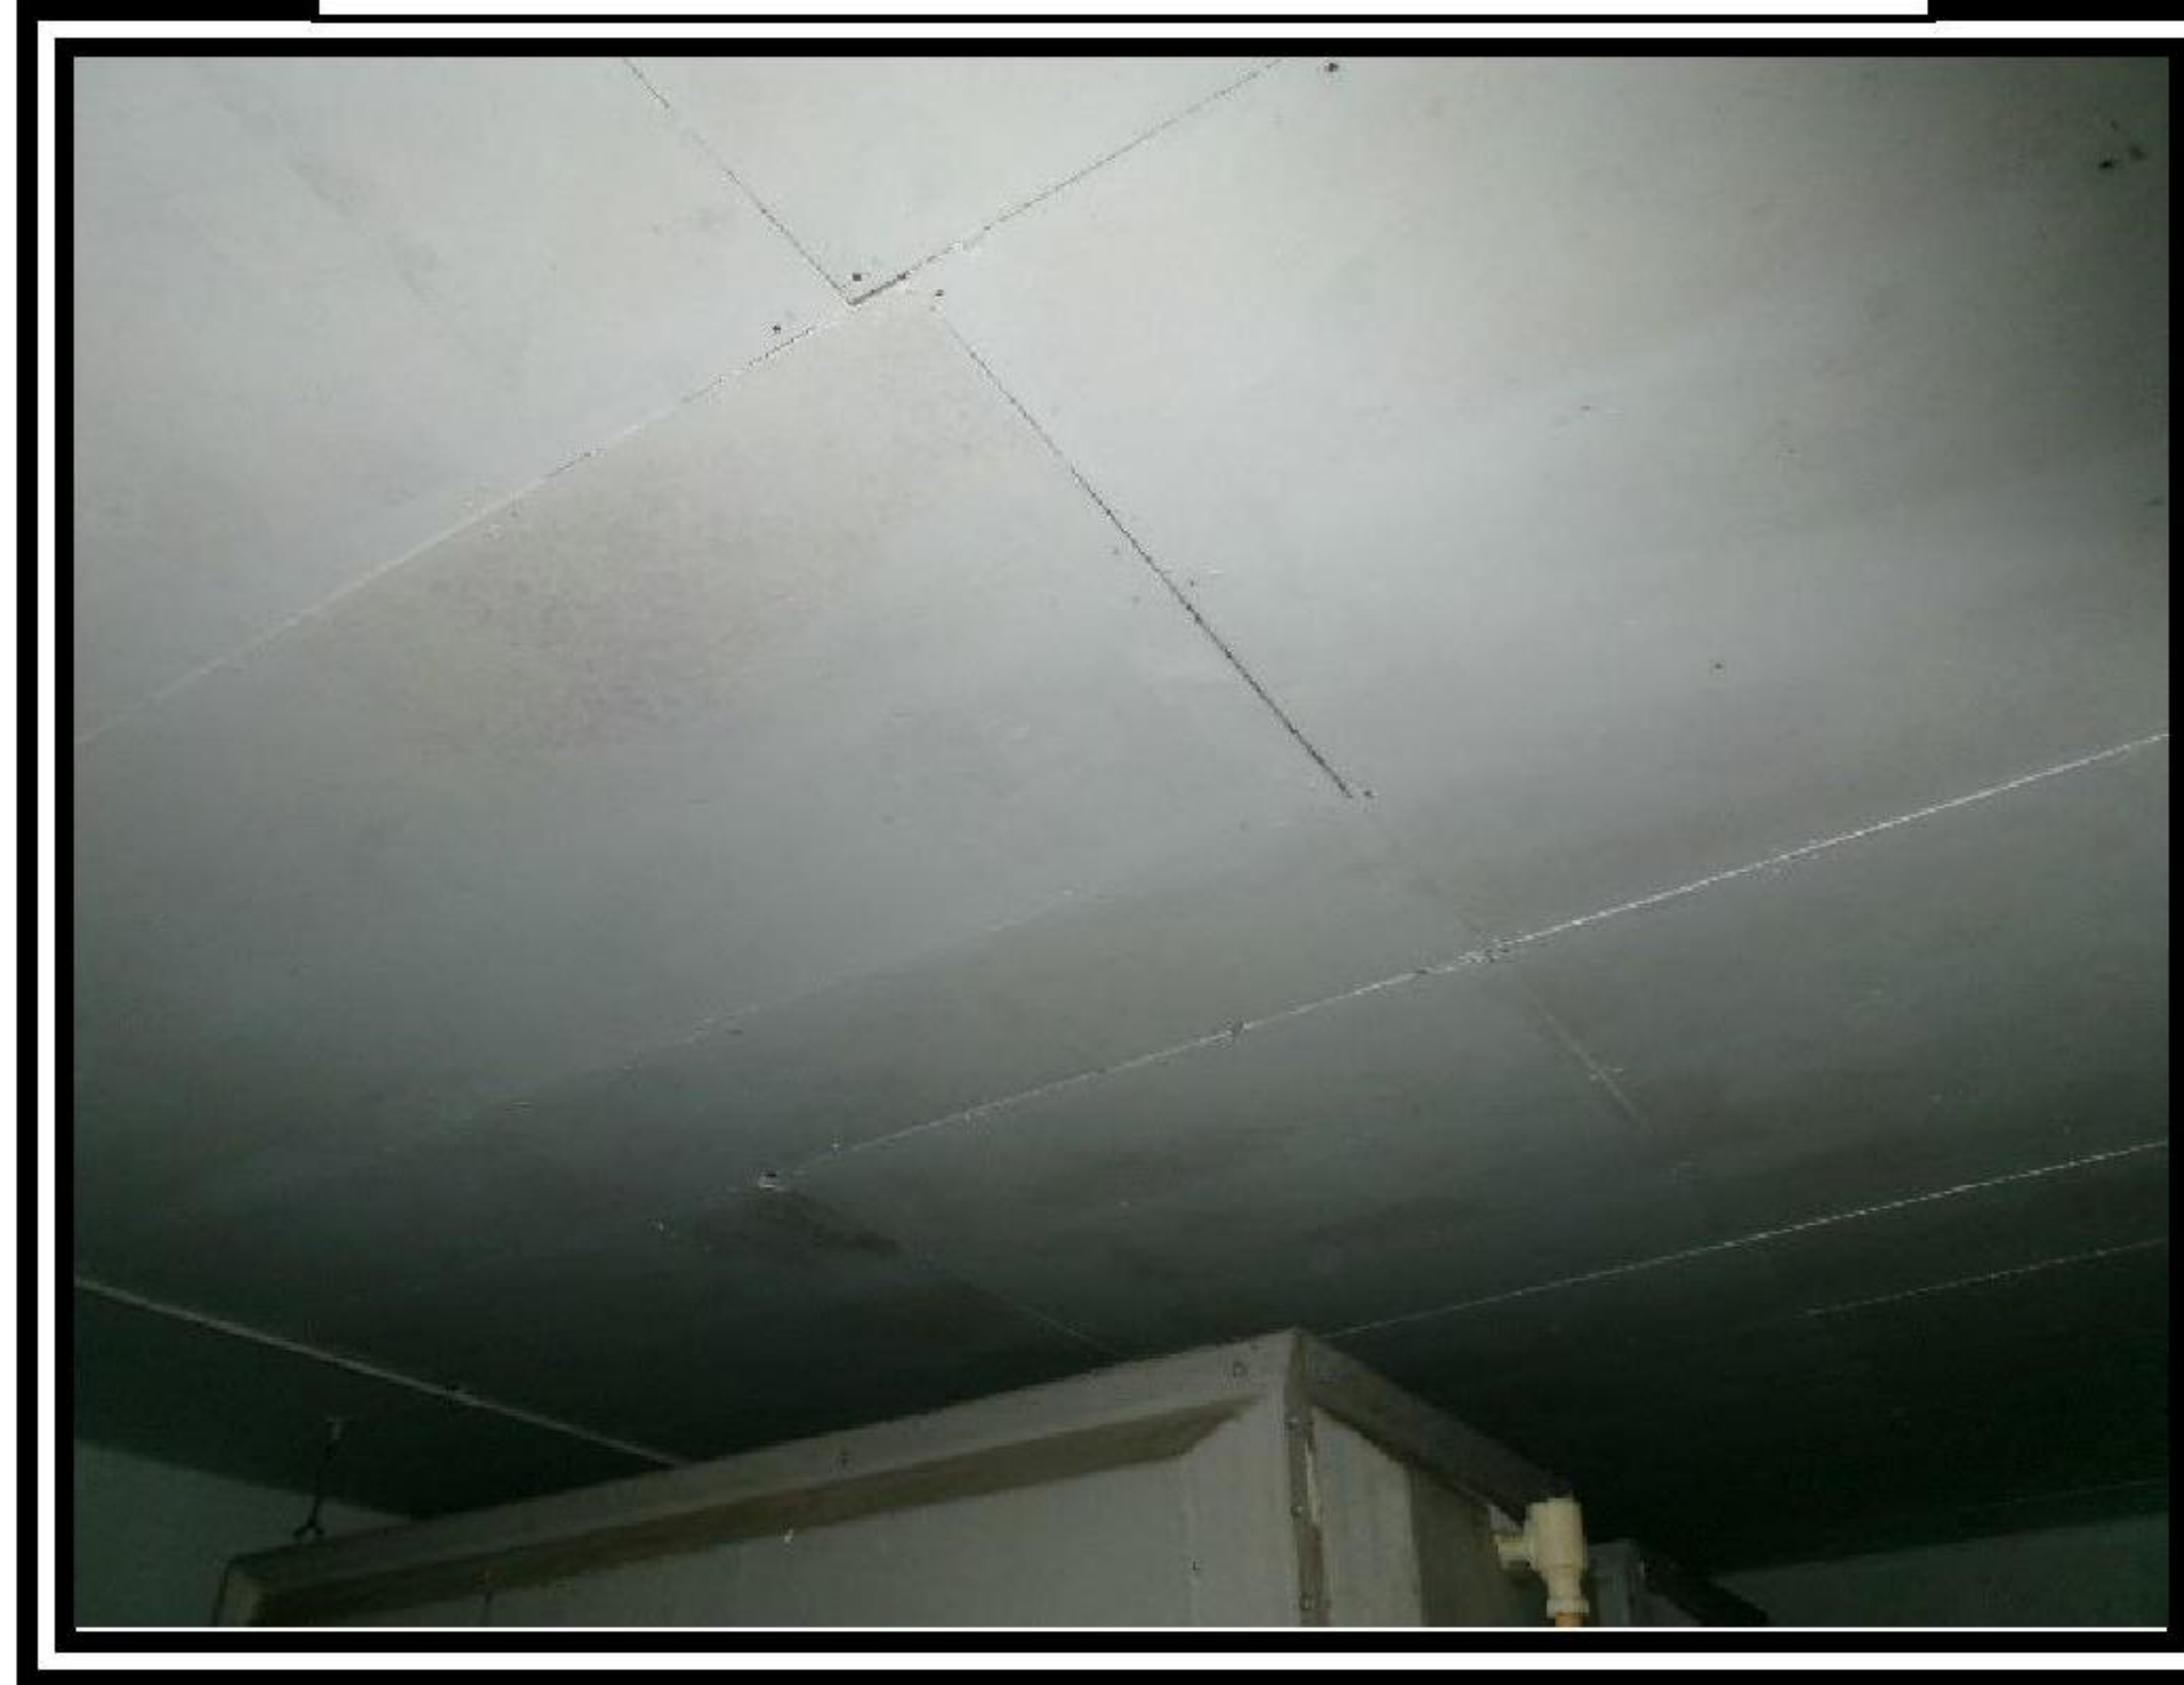
Asbestos insulating board ceiling panels were found to be present in Block B1 – Loc. 1 – 072 Tank Room.

<b>Site Address</b>	<b>Southway Junior School Southway, Burgess Hill</b>
<b>Photograph No.</b>	<b>1</b>
<b>Sample Reference No.</b>	<b>BSS24991</b>
<b>Location</b>	<b><u>Block B1</u> Loc. 1 – 072 Tank Room</b>
<b>Asbestos Type</b>	<b>Amosite &amp; Chrysotile</b>
<b>Condition</b>	<b>Low damage, sealed</b>

Asbestos insulating board ceiling panels

**Recommendation: Remove under controlled conditions.**

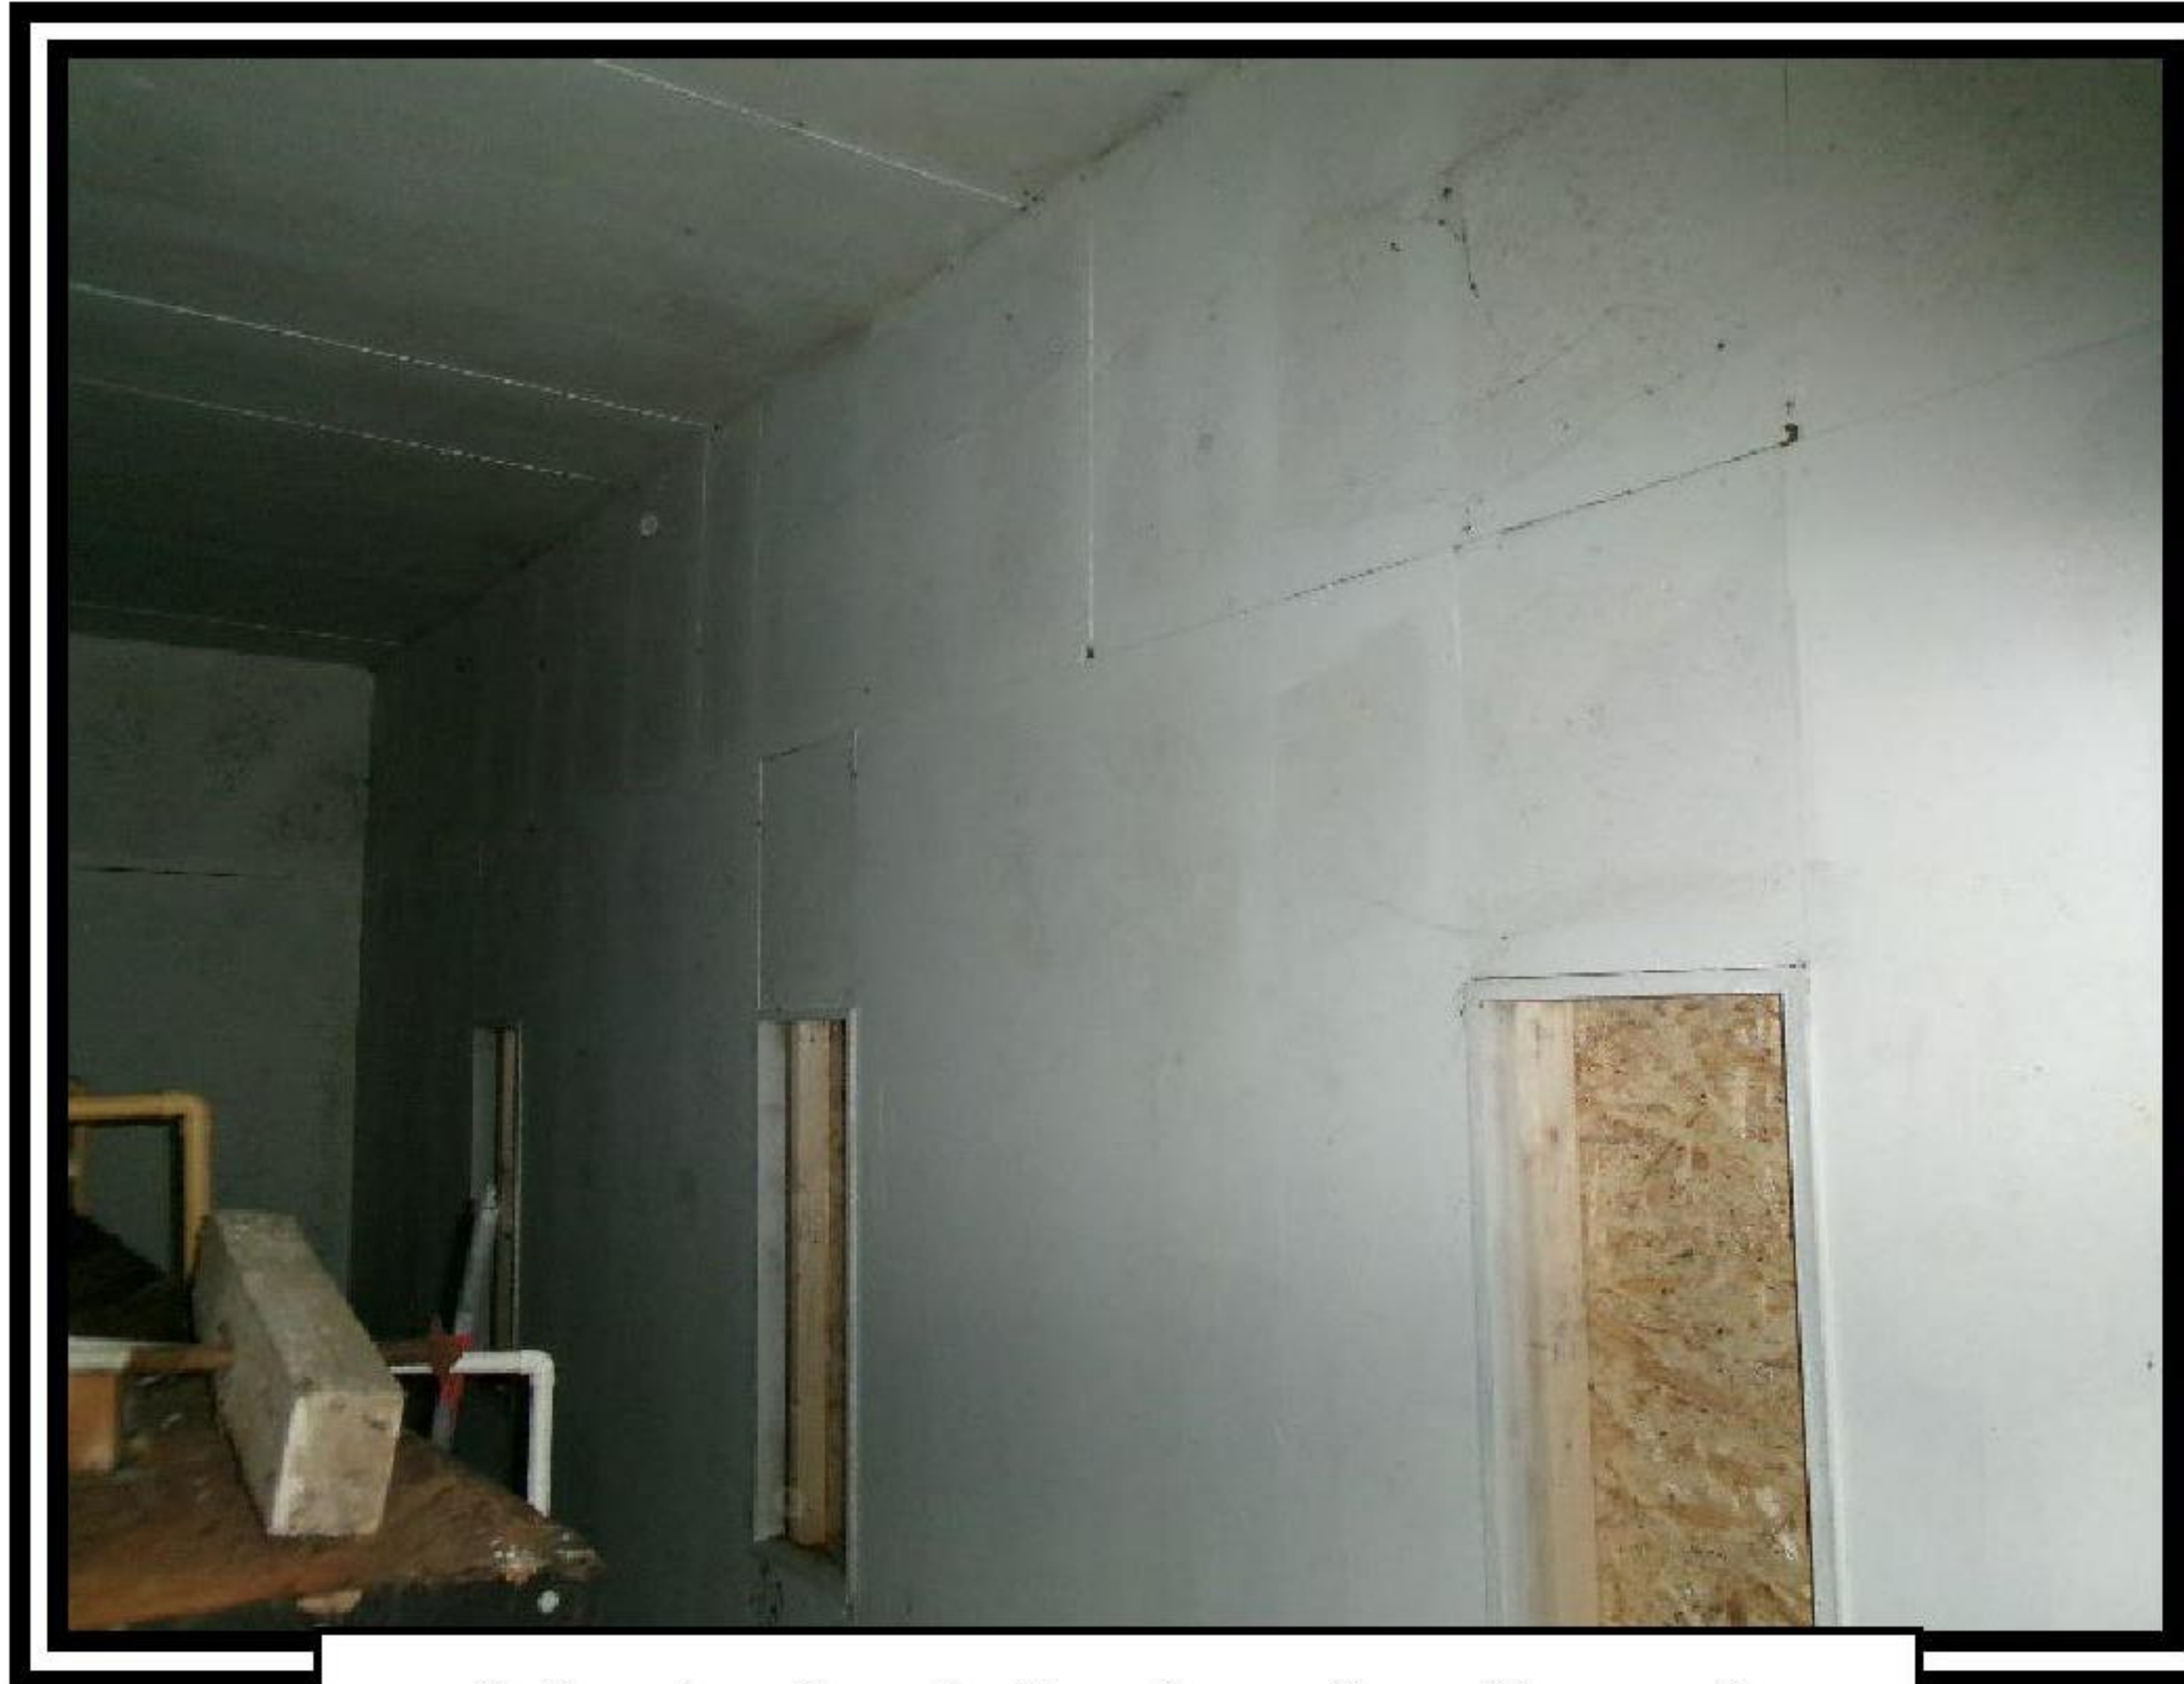
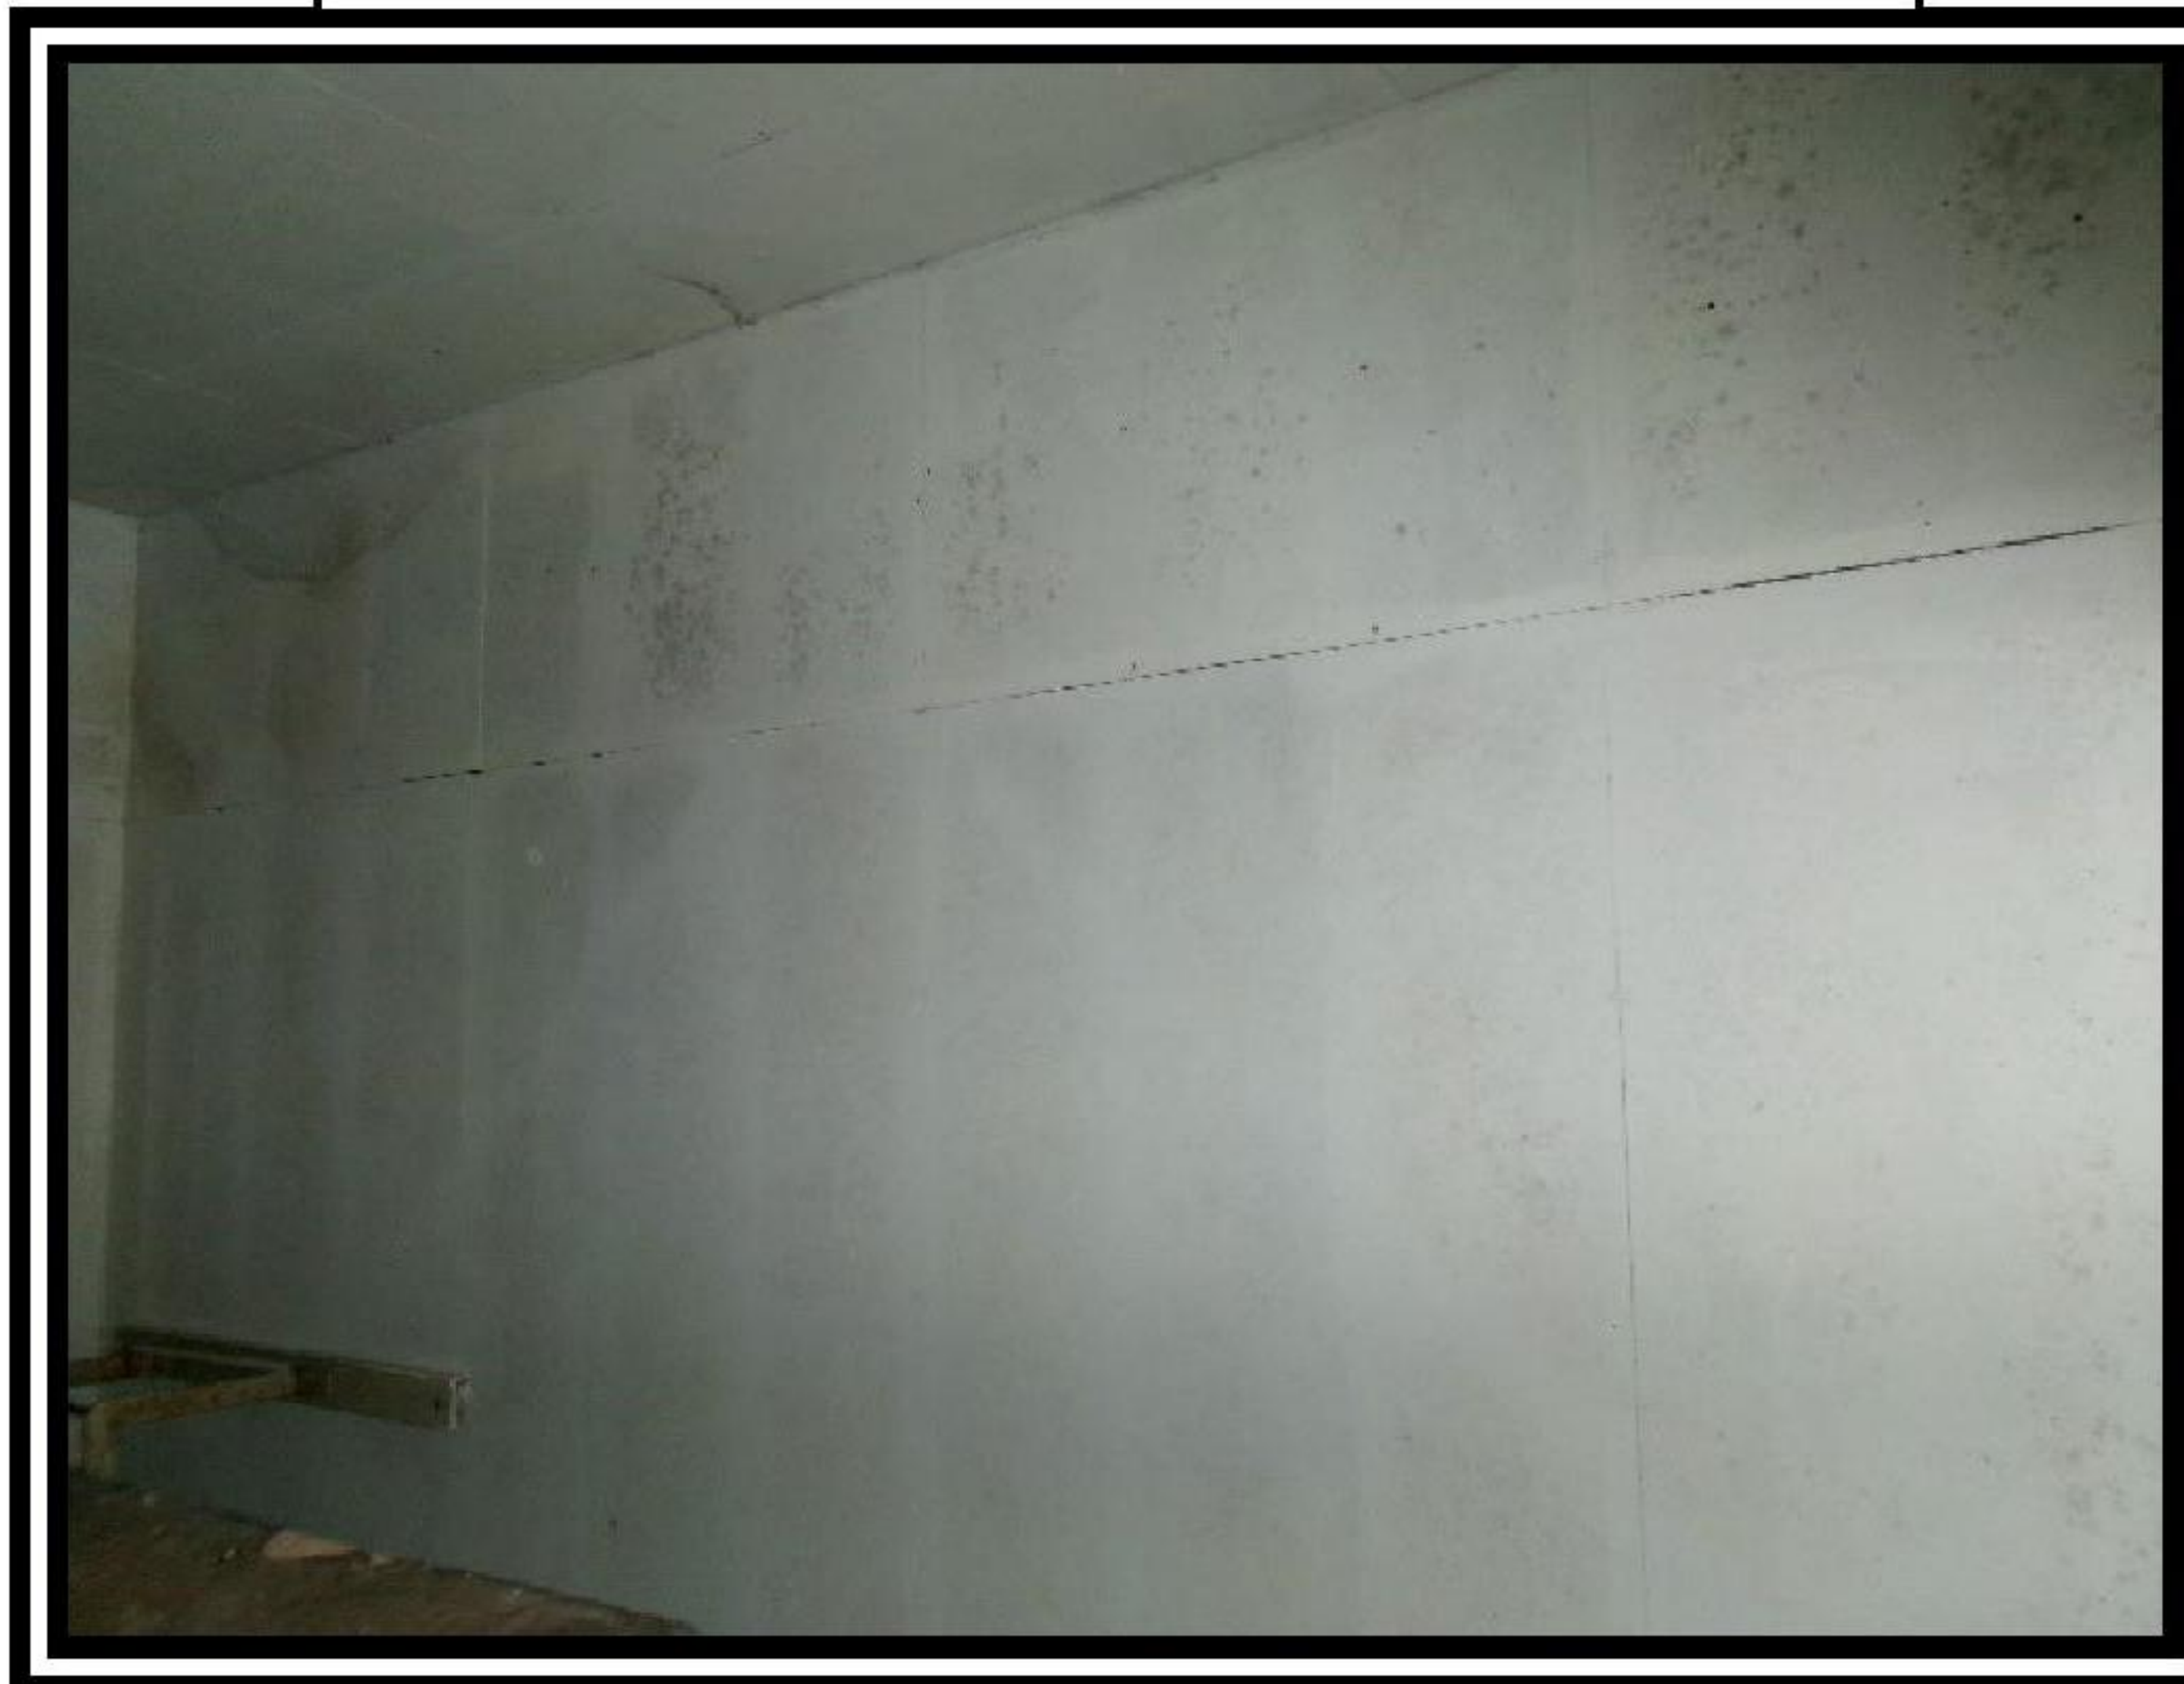
Asbestos insulating board wall panels were found to be present in Block B1 – Loc. 1 – 072 Tank Room.

<b>Site Address</b>	<b>Southway Junior School Southway, Burgess Hill</b>
<b>Photograph No.</b>	<b>2</b>
<b>Sample Reference No.</b>	<b>BSS24992</b>
<b>Location</b>	<b><u>Block B1</u> Loc. 1 – 072 Tank Room</b>
<b>Asbestos Type</b>	<b>Amosite &amp; Chrysotile</b>
<b>Condition</b>	<b>Low damage, sealed</b>

Asbestos insulating board wall panels

**Recommendation: Remove under controlled conditions.**

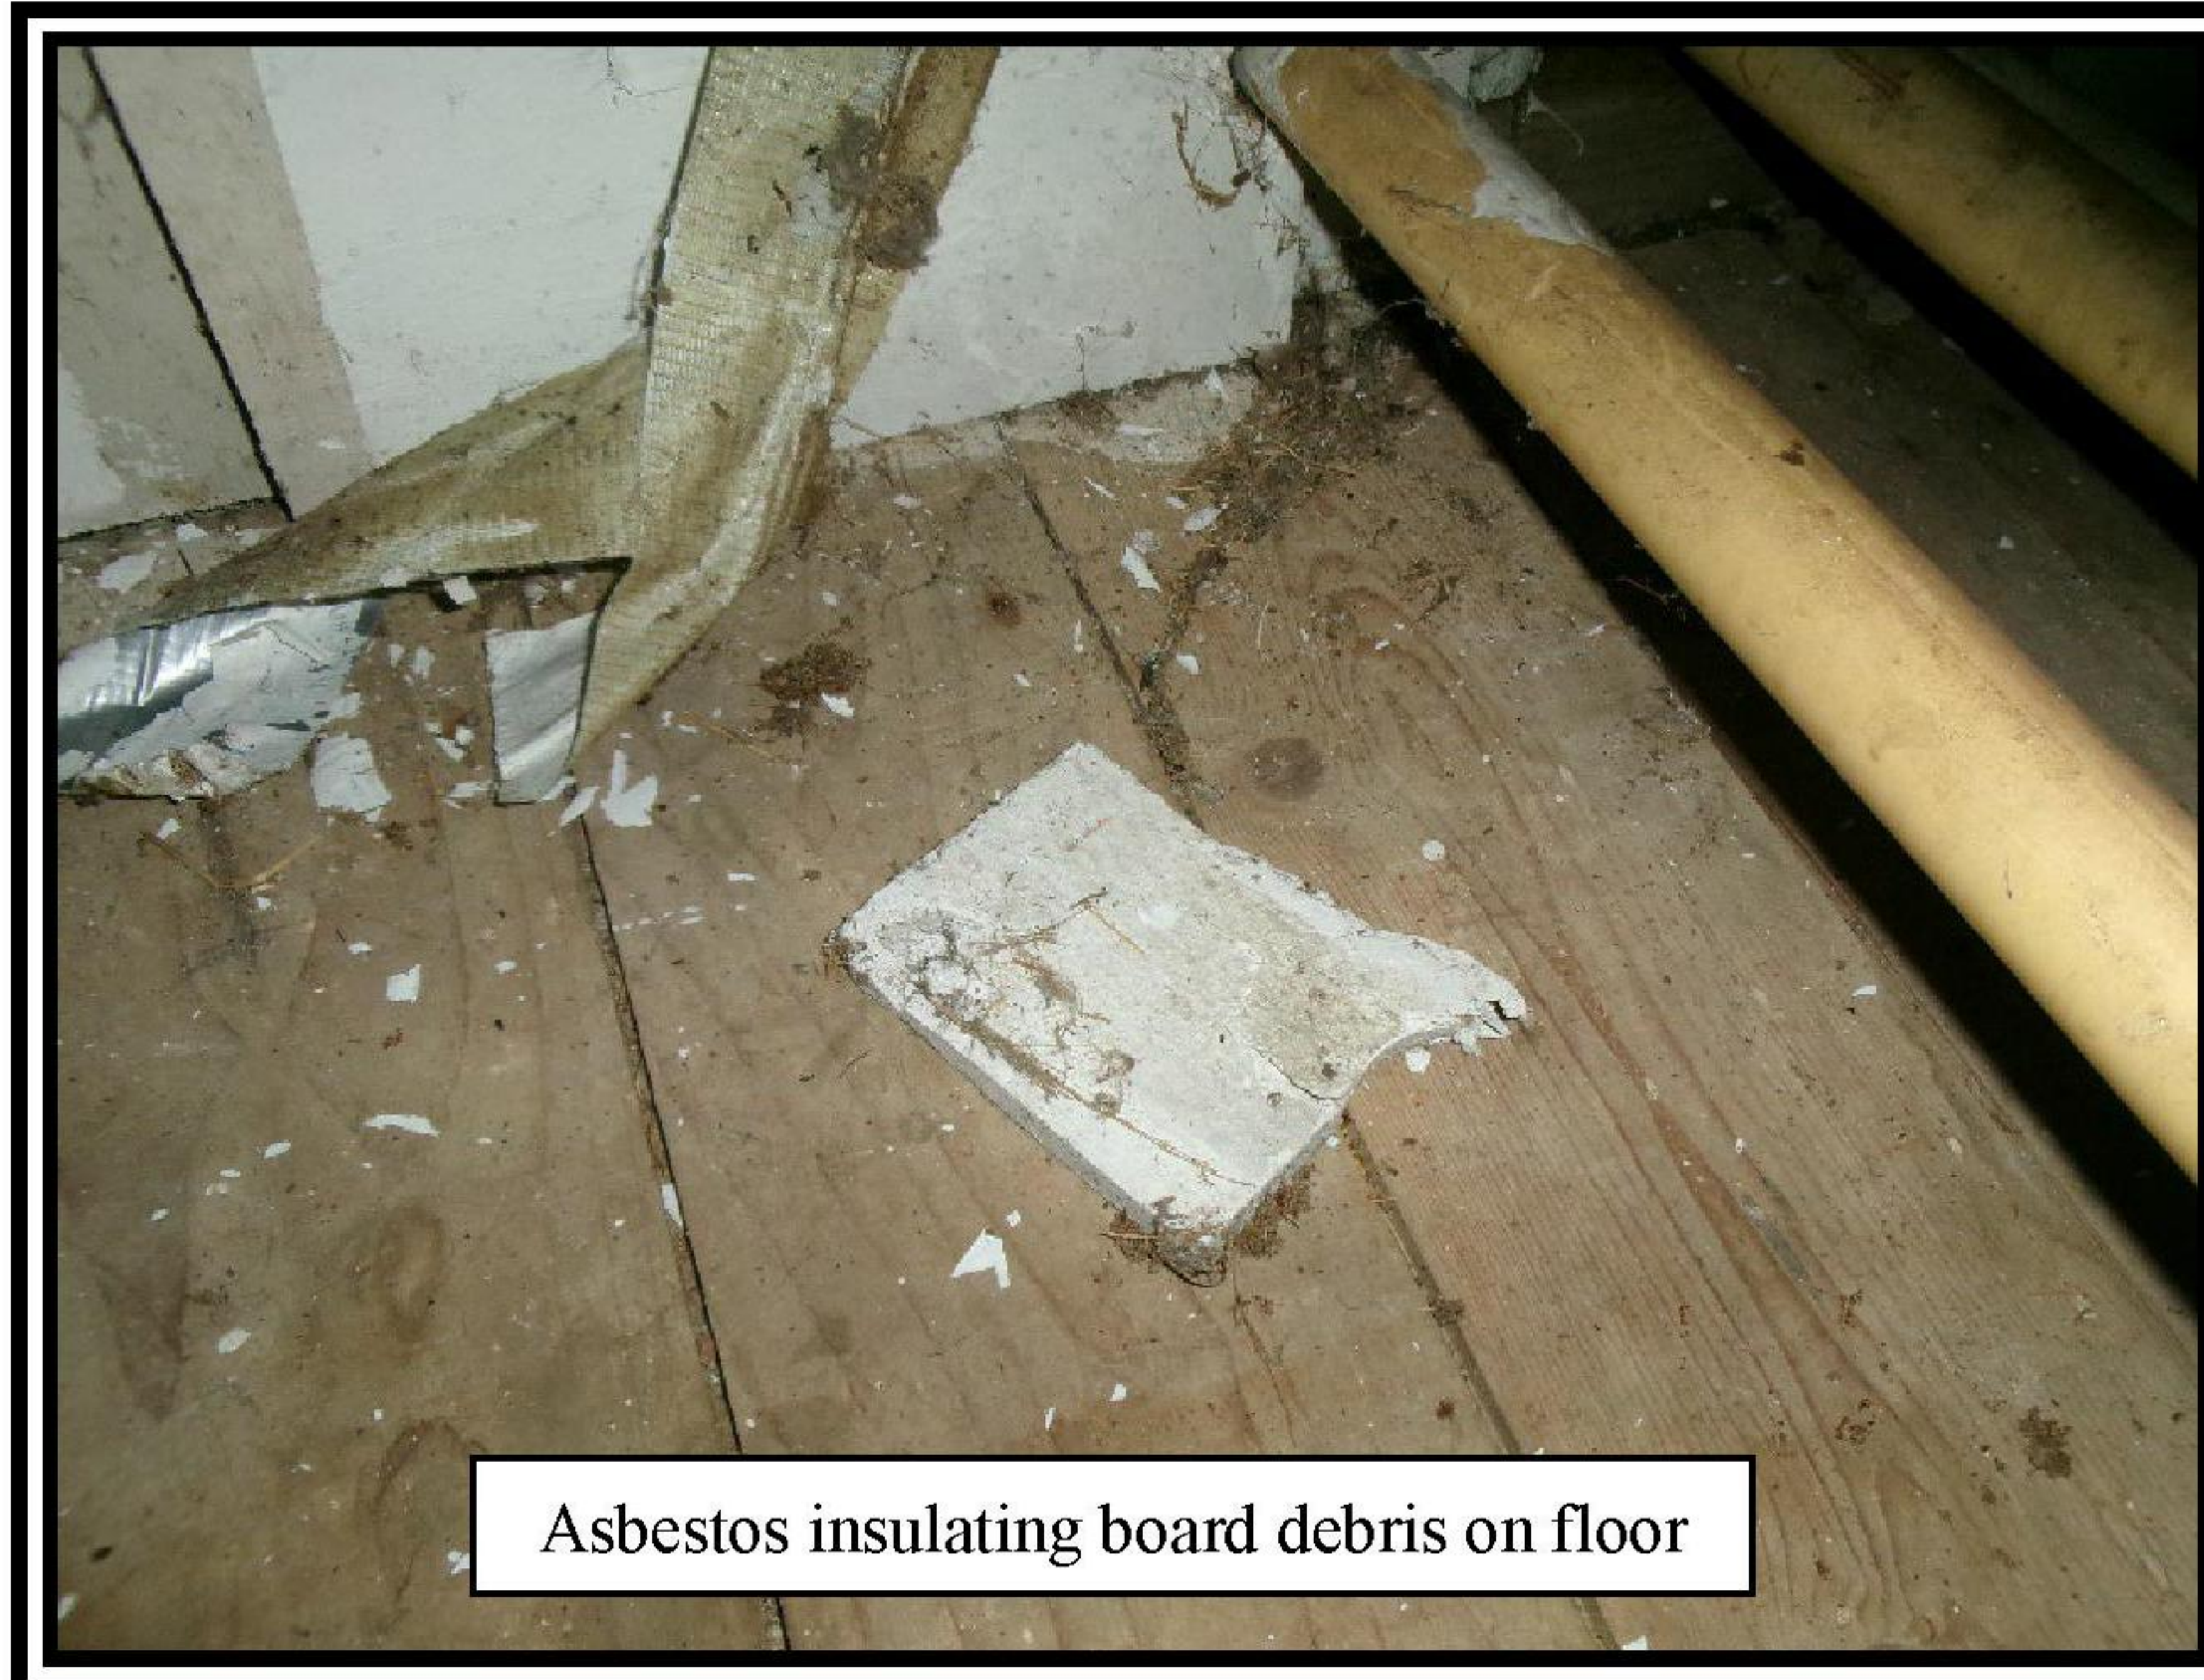
Asbestos insulating board debris on floor was found to be present in Block B1 – Loc. 1 – 072 Tank Room.

<b>Site Address</b>	<b>Southway Junior School Southway, Burgess Hill</b>
<b>Photograph No.</b>	<b>3</b>
<b>Sample Reference No.</b>	<b>BSS24993</b>
<b>Location</b>	<b><u>Block B1</u> Loc. 1 – 072 Tank Room</b>
<b>Asbestos Type</b>	<b>Amosite &amp; Chrysotile</b>
<b>Condition</b>	<b>Medium damage, partially sealed</b>

**Recommendation: Remove under controlled conditions.**

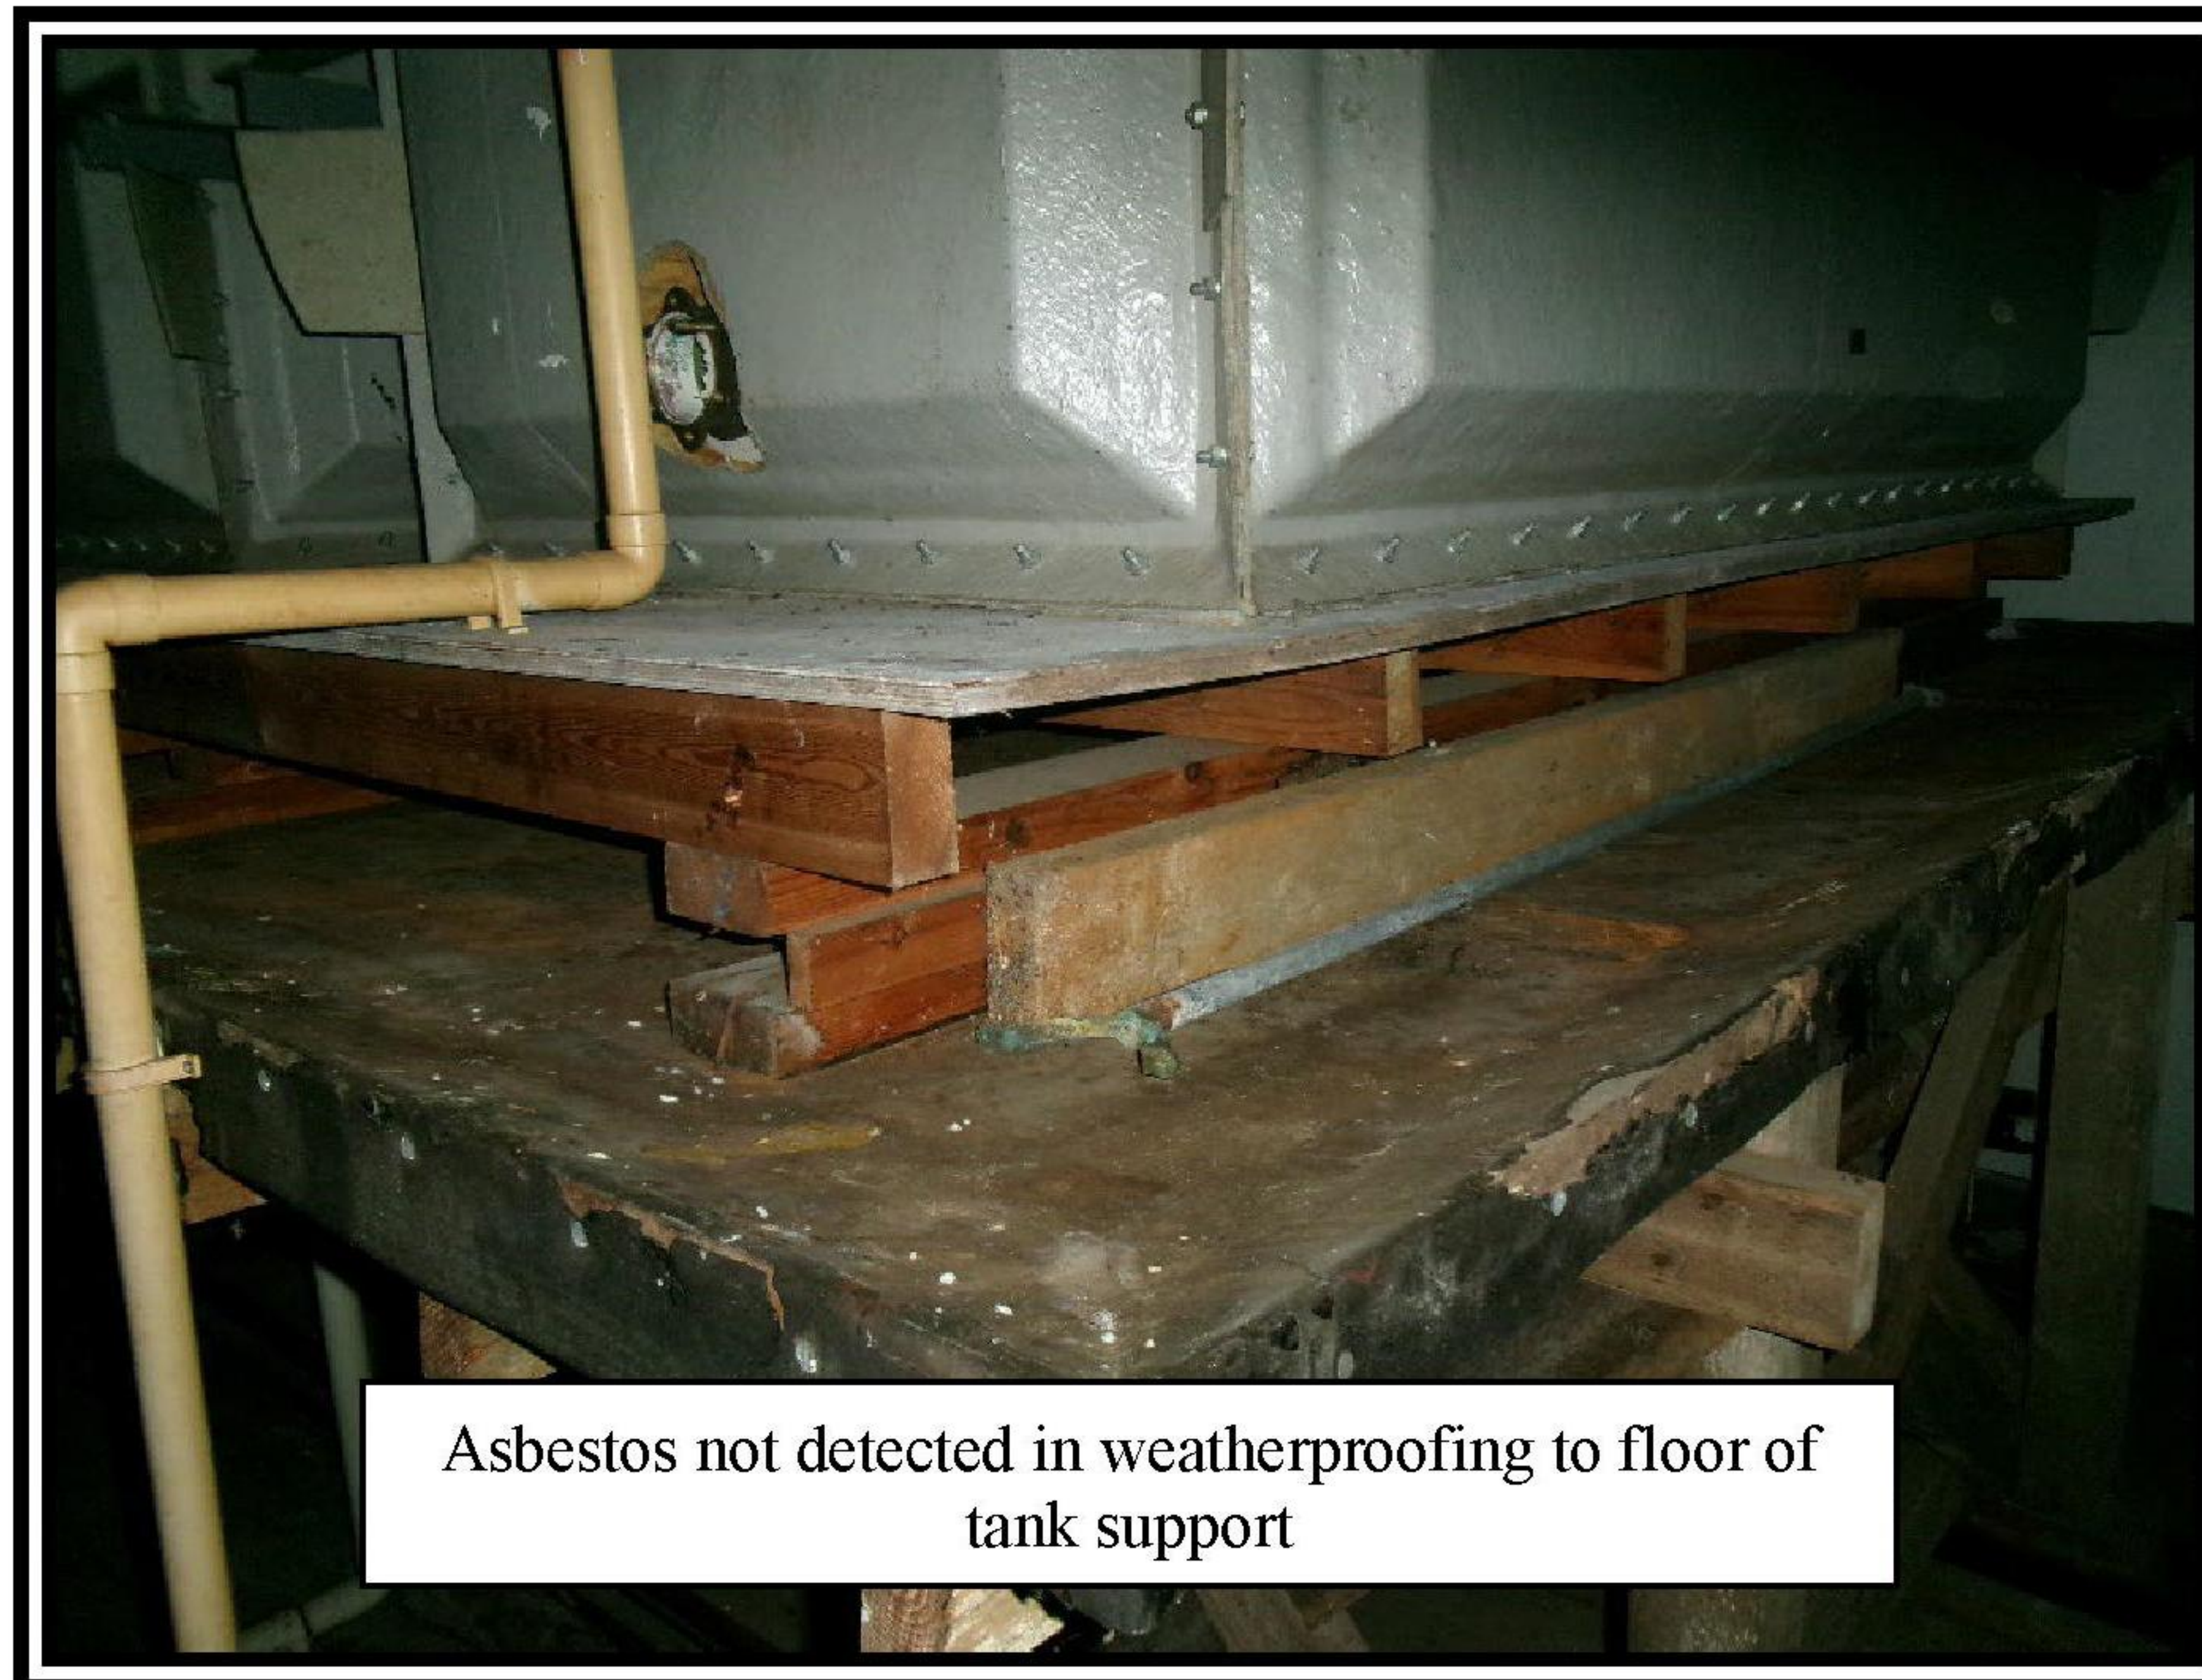
<b>Site Address</b>	<b>Southway Junior School Southway, Burgess Hill</b>
<b>Photograph No.</b>	<b>4</b>
<b>Sample Reference No.</b>	<b>BSS24994</b>
<b>Location</b>	<b><u>Block B1</u> Loc. 1 – 072 Tank Room</b>
<b>Asbestos Type</b>	<b>Asbestos not detected</b>
<b>Condition</b>	<b>N/A</b>
