**1<sup>ST</sup> STOREY TANK ROOM – BLOCK B1 AT**

**SOUTHWAY JUNIOR SCHOOL**

**SOUTHWAY, BURGESS HILL**

Report No. BSS24991

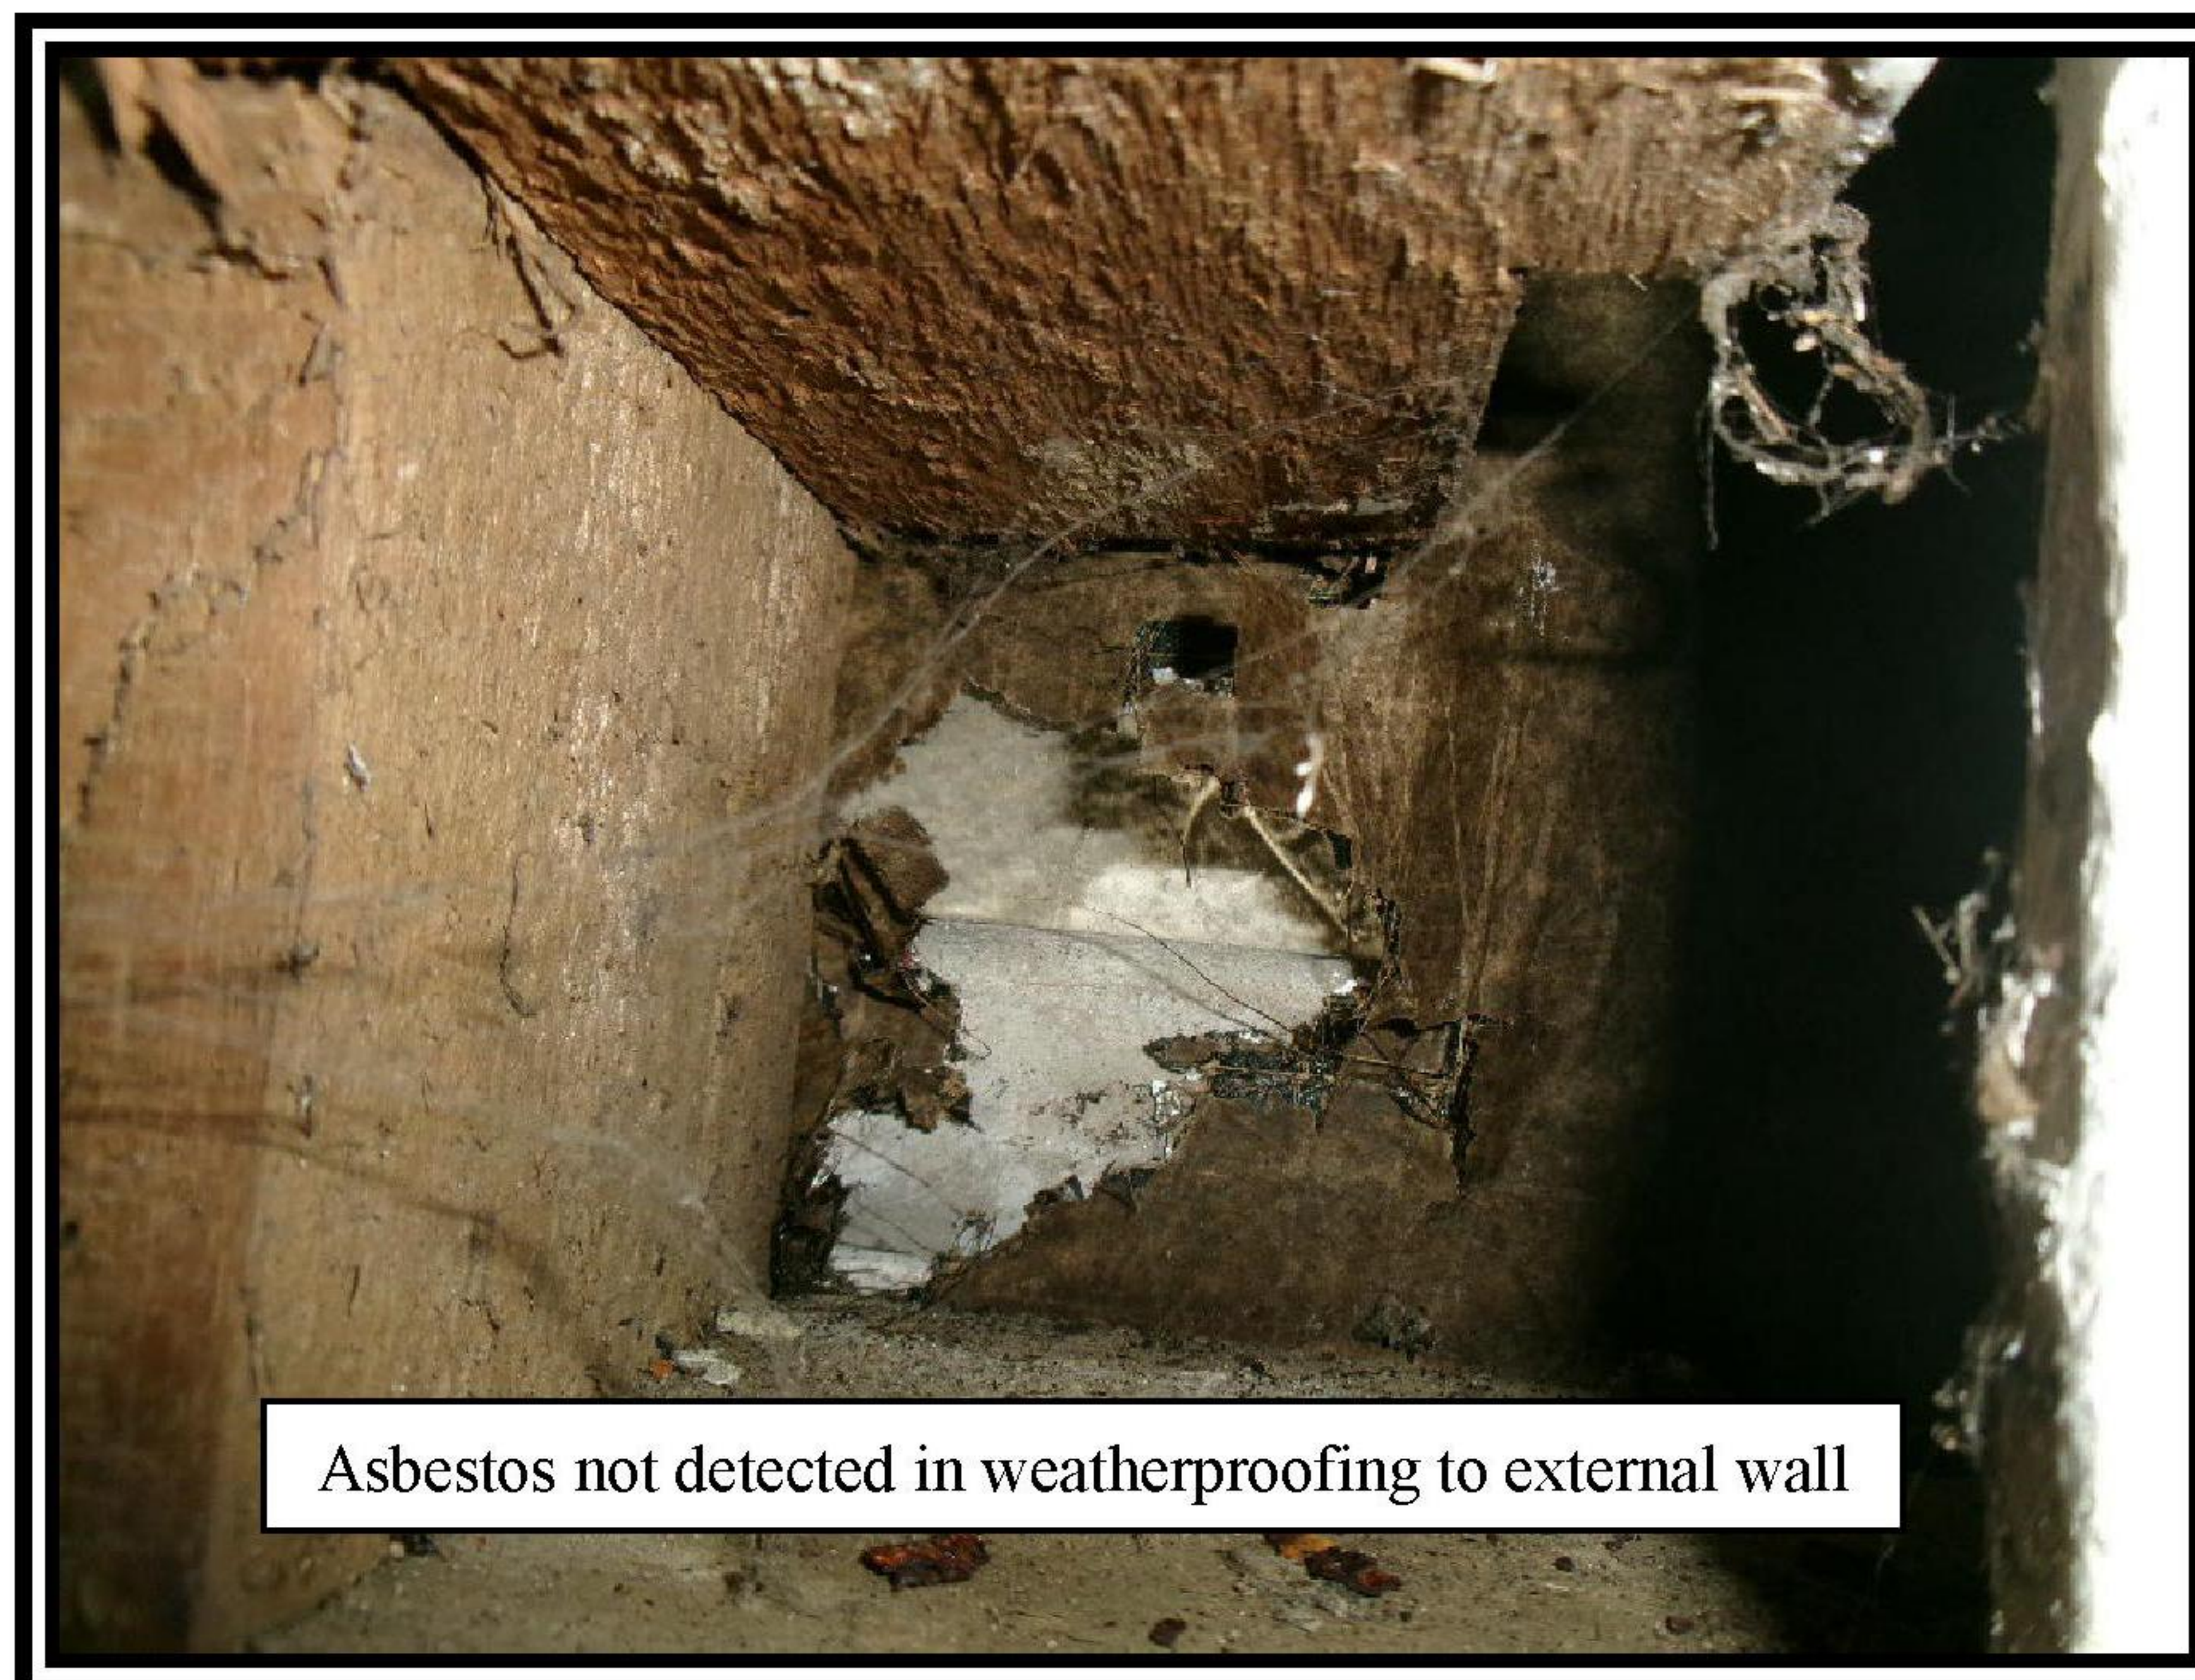
<b>Site Address</b>	<b>Southway Junior School Southway, Burgess Hill</b>
<b>Photograph No.</b>	<b>5</b>
<b>Sample Reference No.</b>	<b>BSS24995</b>
<b>Location</b>	<b><u>Block B1</u> Loc. 1 – 072 Tank Room</b>
<b>Asbestos Type</b>	<b>Asbestos not detected</b>
<b>Condition</b>	<b>N/A</b>

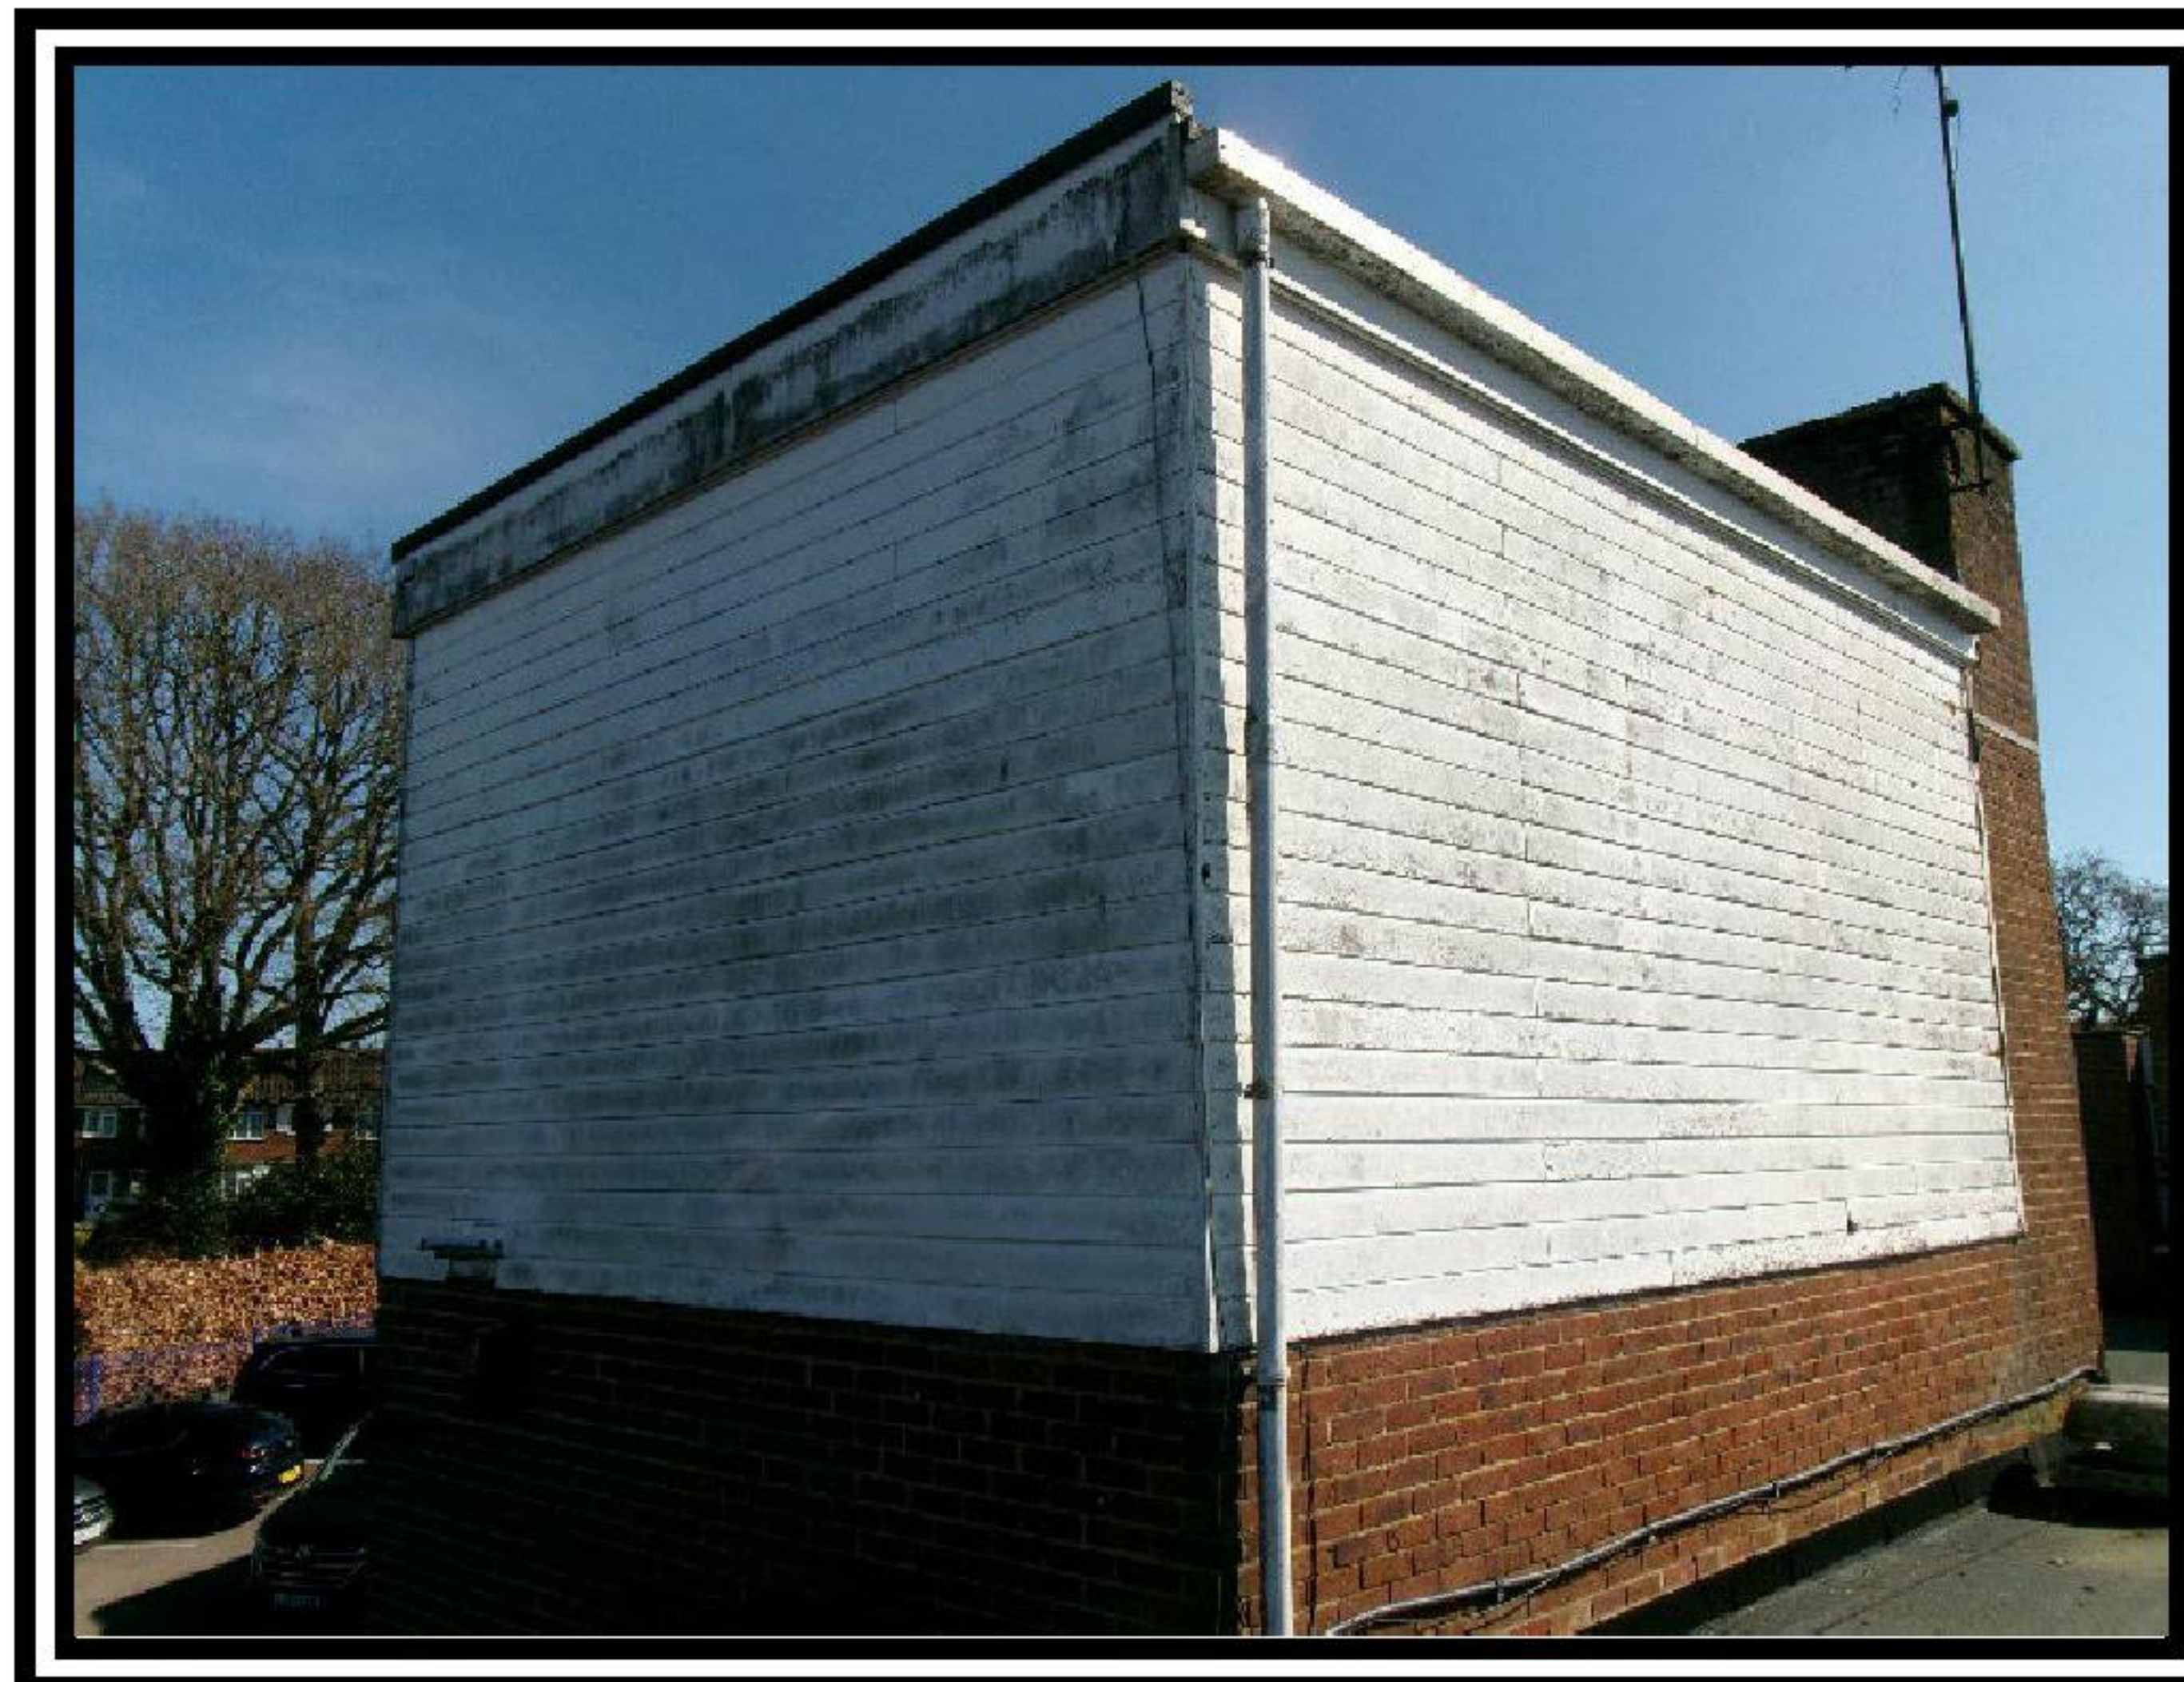
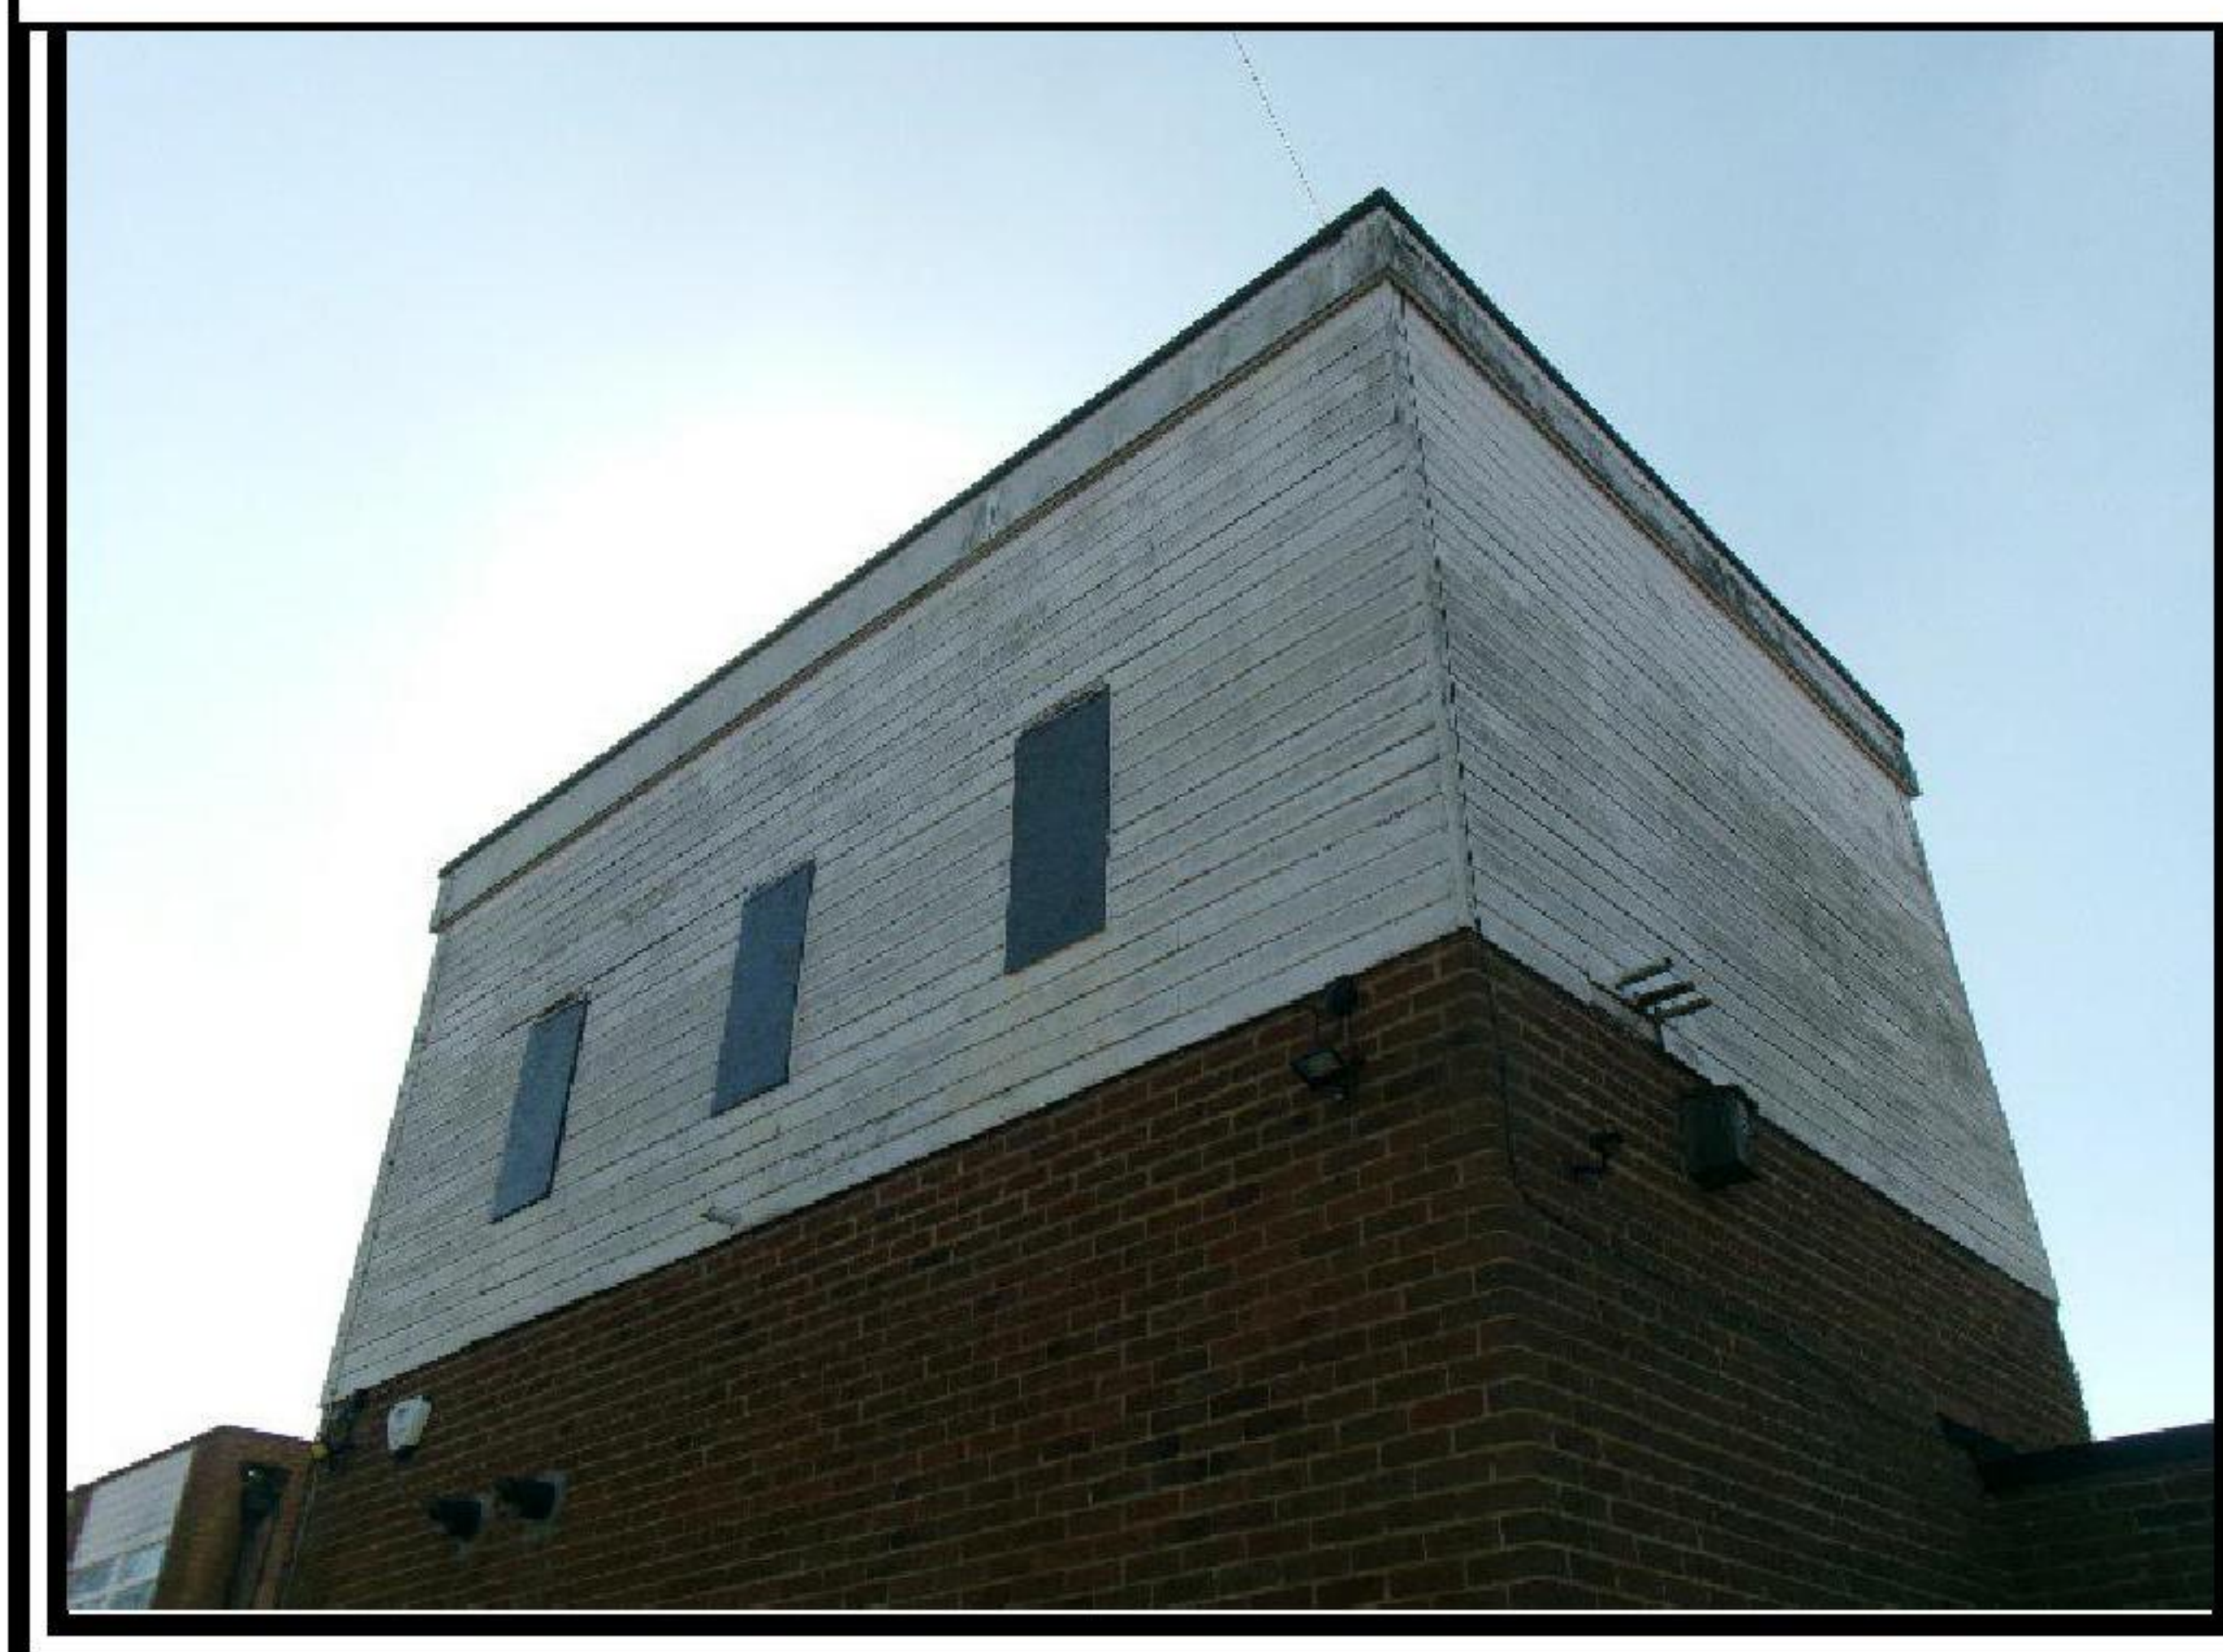
Asbestos cement shiplap panels to 072 Tank Room were found to be present in Block B1: Loc. 3 – External.

<b>Site Address</b>	<b>Southway Junior School Southway, Burgess Hill</b>
<b>Photograph No.</b>	<b>6</b>
<b>Sample Reference No.</b>	<b>BSS24996</b>
<b>Location</b>	<b><u>Block B1</u> Loc. 3 – External</b>
<b>Asbestos Type</b>	<b>Chrysotile &amp; Crocidolite</b>
<b>Condition</b>	<b>Low damage, partially sealed</b>

Asbestos cement shiplap panels to 072 Tank Room

**Recommendation: Remove under controlled conditions.**

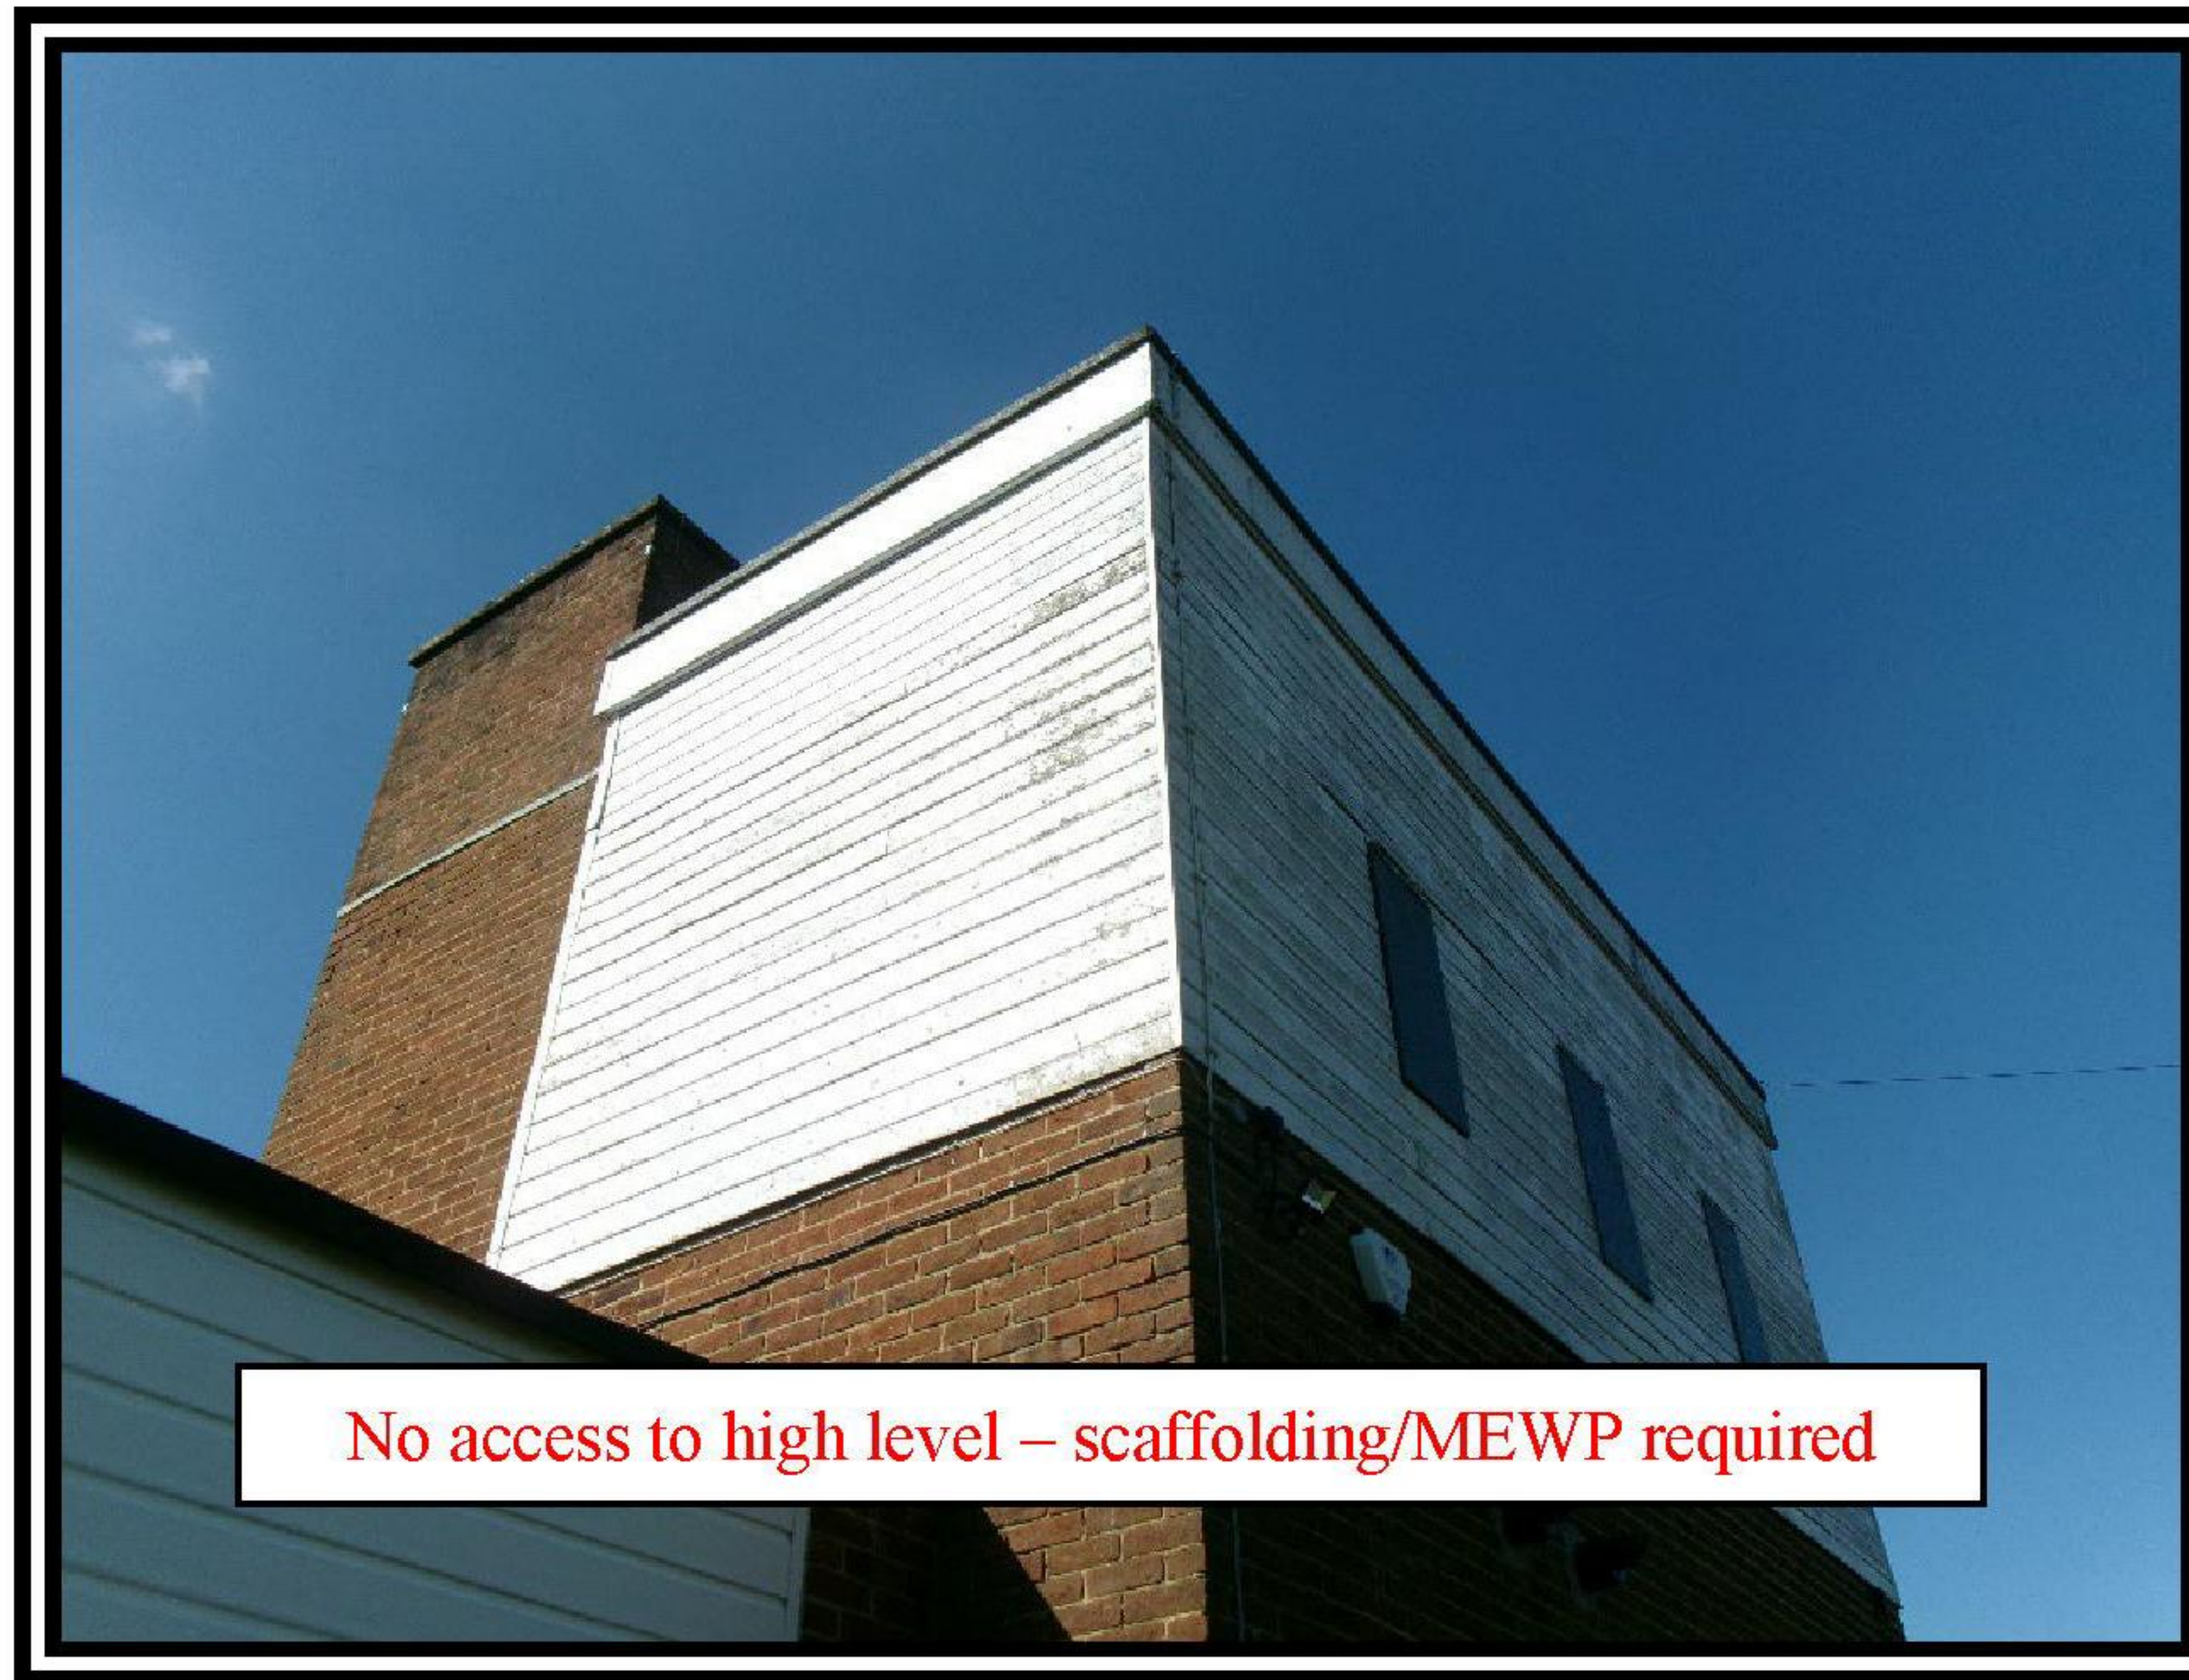
3	External		No access to high level - scaffolding/MEWP required									7

<b>Site Address</b>	<b>Southway Junior School Southway, Burgess Hill</b>
<b>Photograph No.</b>	7
<b>Sample Reference No.</b>	N/A
<b>Location</b>	<b><u>Block B1</u> Loc. 3 – External</b>
<b>Asbestos Type</b>	N/A
<b>Condition</b>	N/A
