ARBORICULTURAL REPORT

**42 Hurst Road
Hassocks**

Prepared by: Mr Saul Heath FdScArb TechArborA

Date: 12-09-23 & 09-04-24 (see addendum 1.) **18-07-25**

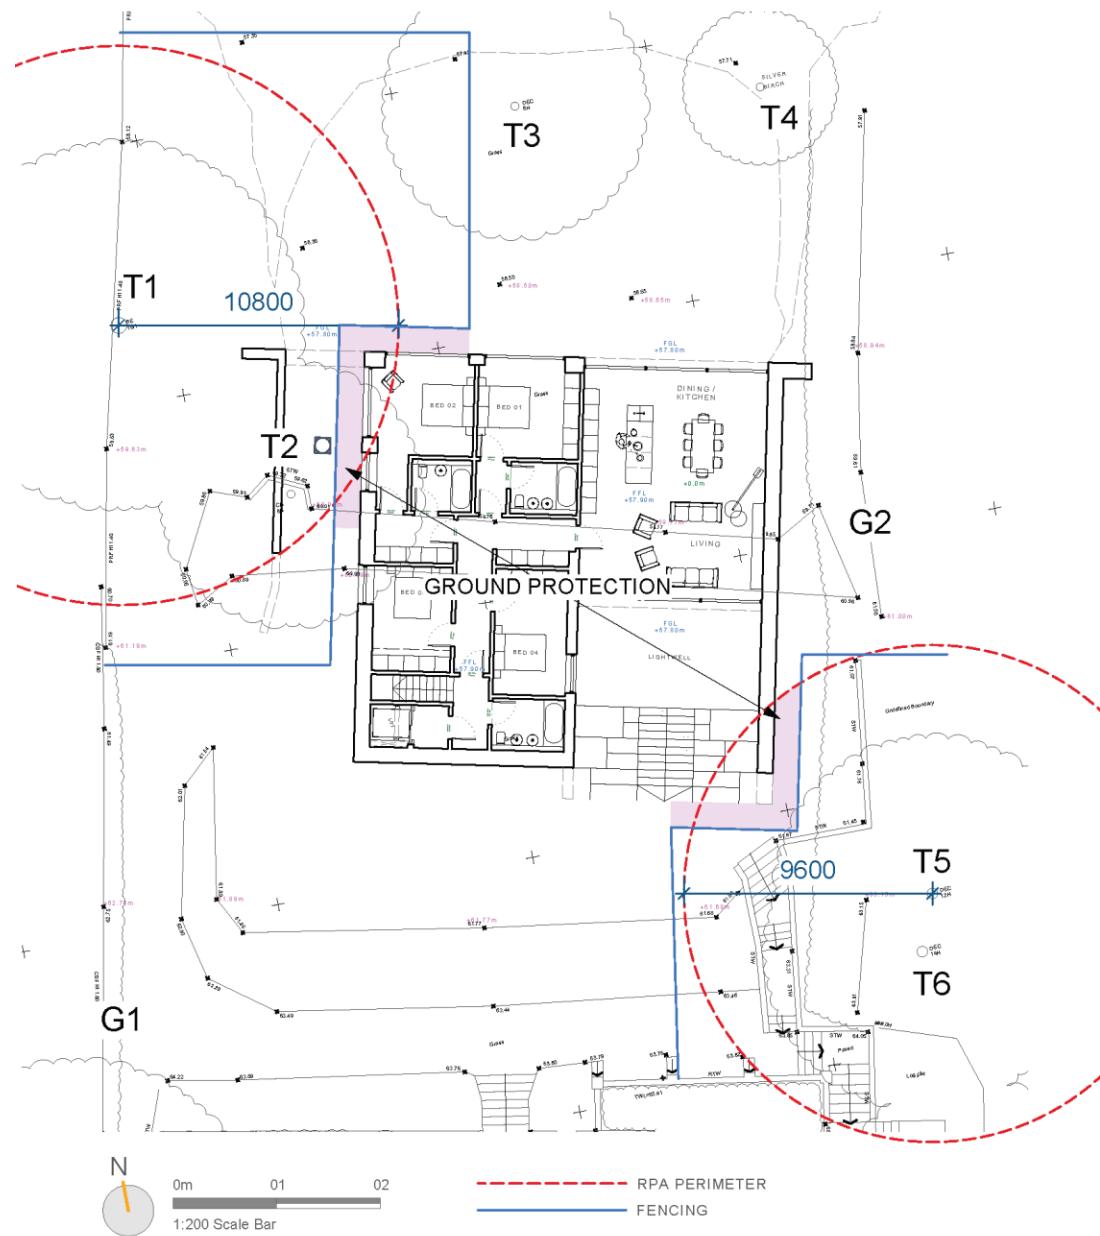
APPENDIX 3. TREE PROTECTION PLAN

4.1. There is one large, mature Beech (T1) located in the rear garden; the tree appears healthy with good vigour.

4.2. T5 is a large, mature Oak, located in the neighbouring garden of No. 40 Hurst Road, again the tree appears healthy.

4.3. The Cherry (T2) is in decline and should be felled.

4.4. The Cypress in the front garden (T7) should be removed to facilitate the extension. A new native species should be planted elsewhere in the grounds to mitigate its loss.

8.1. Fencing will be installed to protect the root protection area (RPA's) of T1 & T5 before any works commence; the fencing will be constructed in accordance with BS 5837: 2012 (*Appendix 1.*) The areas enclosed by the fencing will be considered complete exclusion zones; there will be no vehicles, equipment or machinery within the fenced off areas. Under

8.2. A Geo-textile three dimensional confinement system (*Appendix 2.*) will be laid before any work commences (shown as Ground Protection on the Tree Protection Plan). The system will minimize the potential for soil compaction. The confinement system should be filled with no-fines gravel, washed aggregate or cobbles. Materials with a high-fines content should not be used due to their almost impermeable texture when consolidated. This will be used as a permanent base for both the access track and car-port.

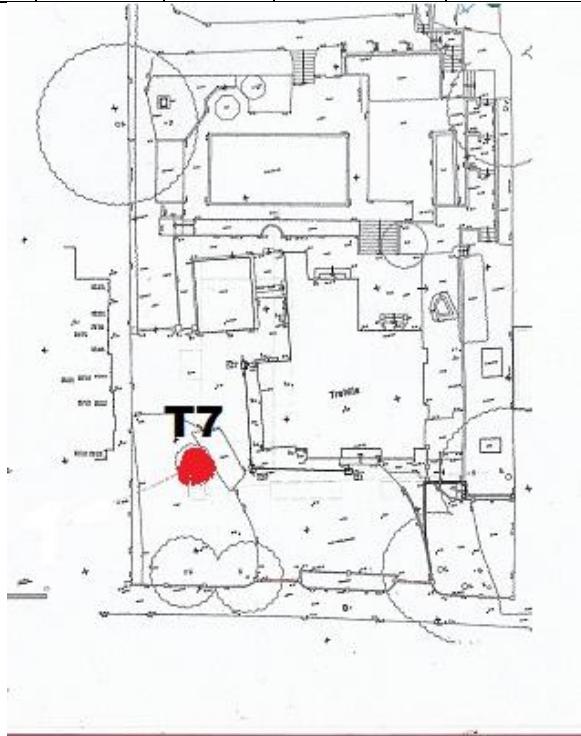
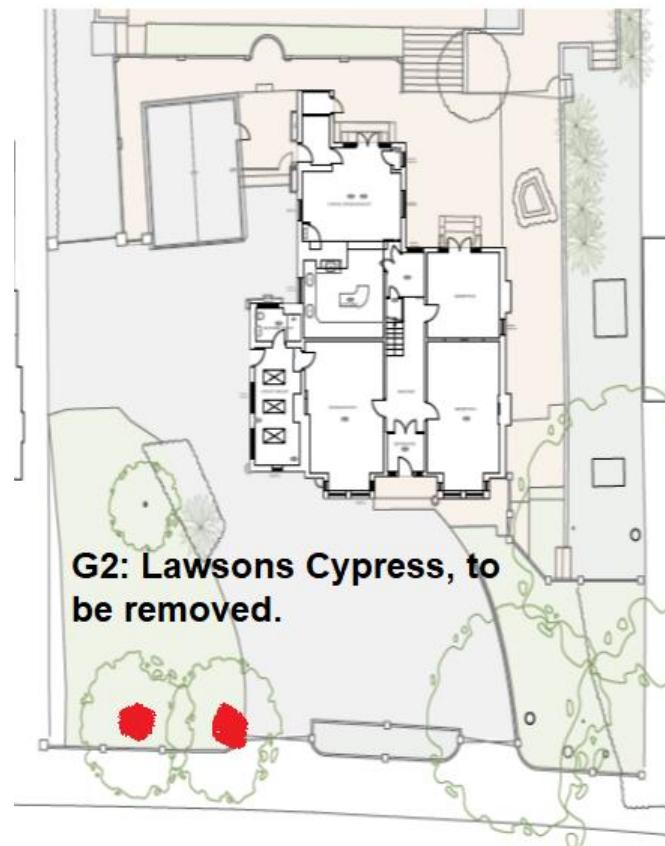
Addendum 1: Trees to be removed to facilitate the new driveway.

T7	Cypress	10	150+140	N 3 E 2 S 2 W 2	Canopy 0.5 Fsb 0.1 Direction NESW	Mature	Unsuitable for retention	Poor	Remove to facilitate the extension	-10	U
G2	Lawsons Cypresses	5 to 8	130 to 180	N 2 E 2 S 2 W 2	Canopy 0.5 Fsb 0.1 Direction NESW	Mature	Low quality trees	Poor	Remove to facilitate the driveway	-10	C3
