# Arbotom<sup>®</sup> Sonic Tomography Report

| <b>Client:</b> | <b>Blackcap Contracts</b> |
| Tree Species: | Oak <i>Quercus sp.</i> |
| Location: | 14 Hill House Close, Turners Hill |

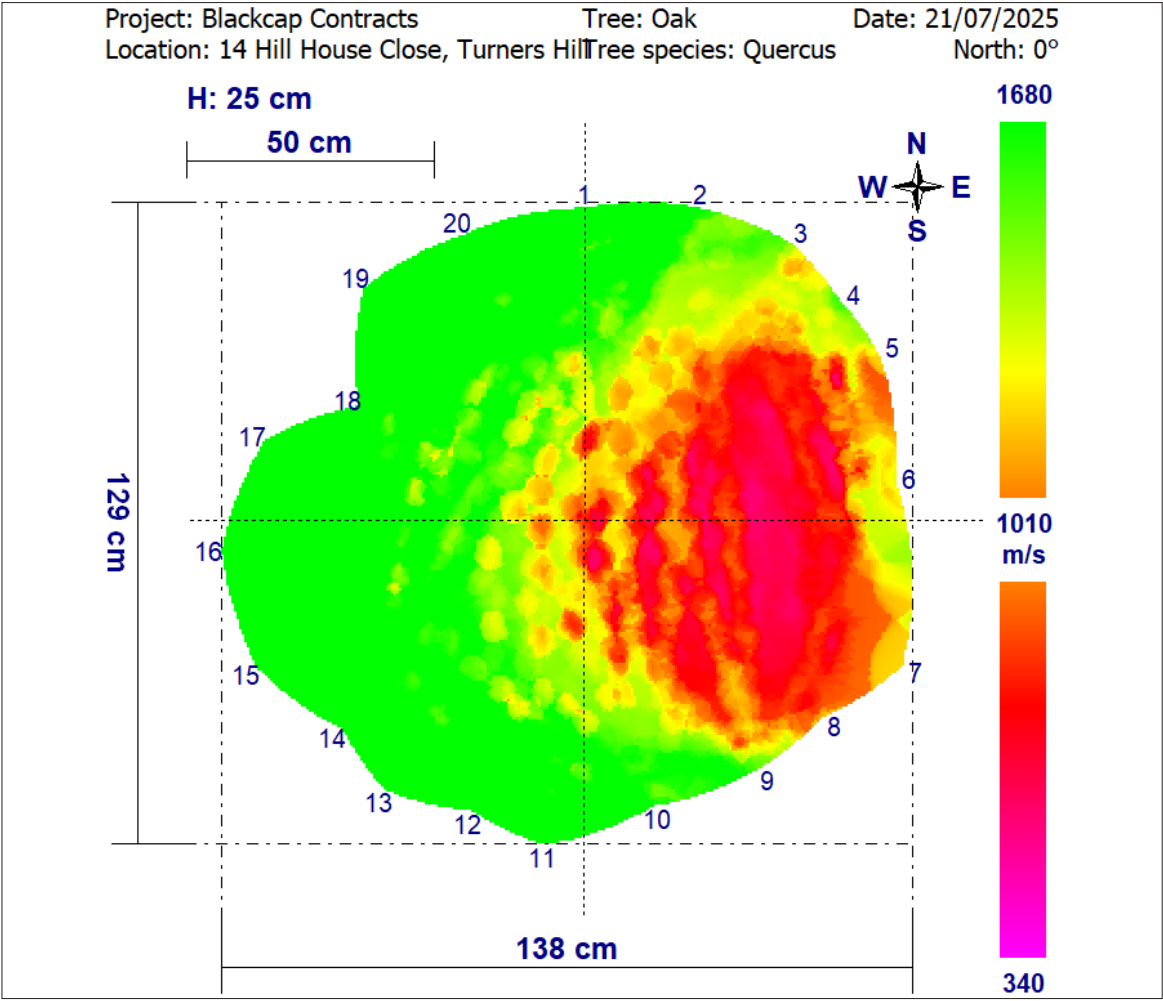
Figure 1. Tomogram - Figures around the circumference indicate each measuring point.

The tomogram (Figure 1) indicates that there is a eccentric column of advanced decay and/or hollowing (coloured purple and red) on the eastern side of the trunk at this height. The decay appears to extend out to the bark between sensor 5 and 9. Fruiting bodies, consistent with those of the fungus *Ganoderma sp.*, were observed at the base on the north-northeast, east and southeast. It is likely that this fungus is the primary causal agent of the decay.

There appear to be small, fragmentary zones of decay on the periphery of the main decay column, particularly towards the centre of the trunk. This is likely to indicate that the decay is not yet compartmentalised and has the potential to progress further.

Specialist online software 'TreeCalc' was used to evaluate the fracture stability of the trunk. The estimated safety factor for stem fracture (based on the degree of strength loss computed in the Arbotom software) was calculated to be approximately 7.2 at this height. This exceeds the desired minimum threshold of 1.5. On this basis no remedial works are required at present to improve the fracture stability of the main stem at this height. However, significant decay was observed on the south-southeast, below the height of the test. The current investigation is not able to assess the stability of the trunk and root plate below the height that the test was undertaken. Therefore, it would be prudent to either reduce the height of the tree by approximately 1.5-2m or consider removing it.

It is recommended that, if the tree is retained, it should be inspected visually annually. Sonic tomography testing of the main trunk should be repeated within two years to check that the situation has not deteriorated.

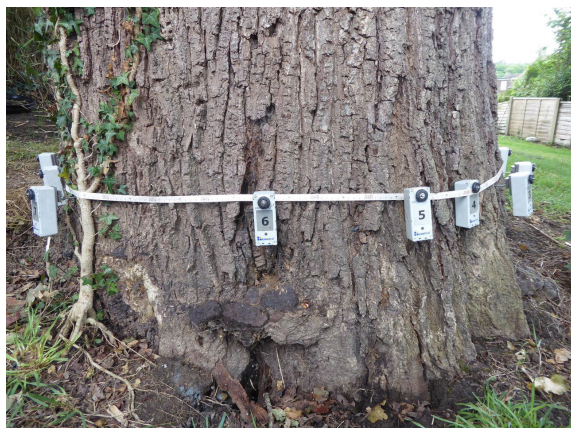
Figure 2. East side of trunk - sensors indicate height of test.

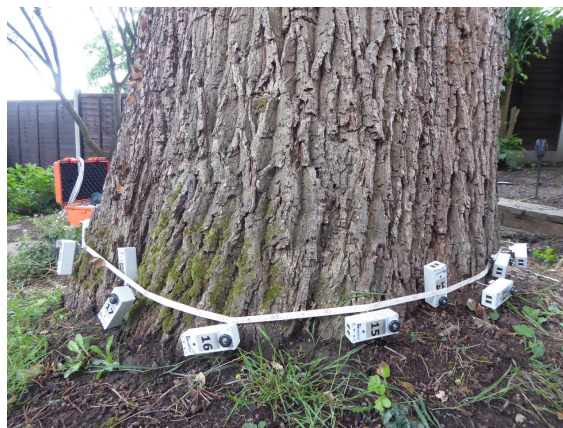
Figure 3. West side of trunk - sensors indicate height of test.

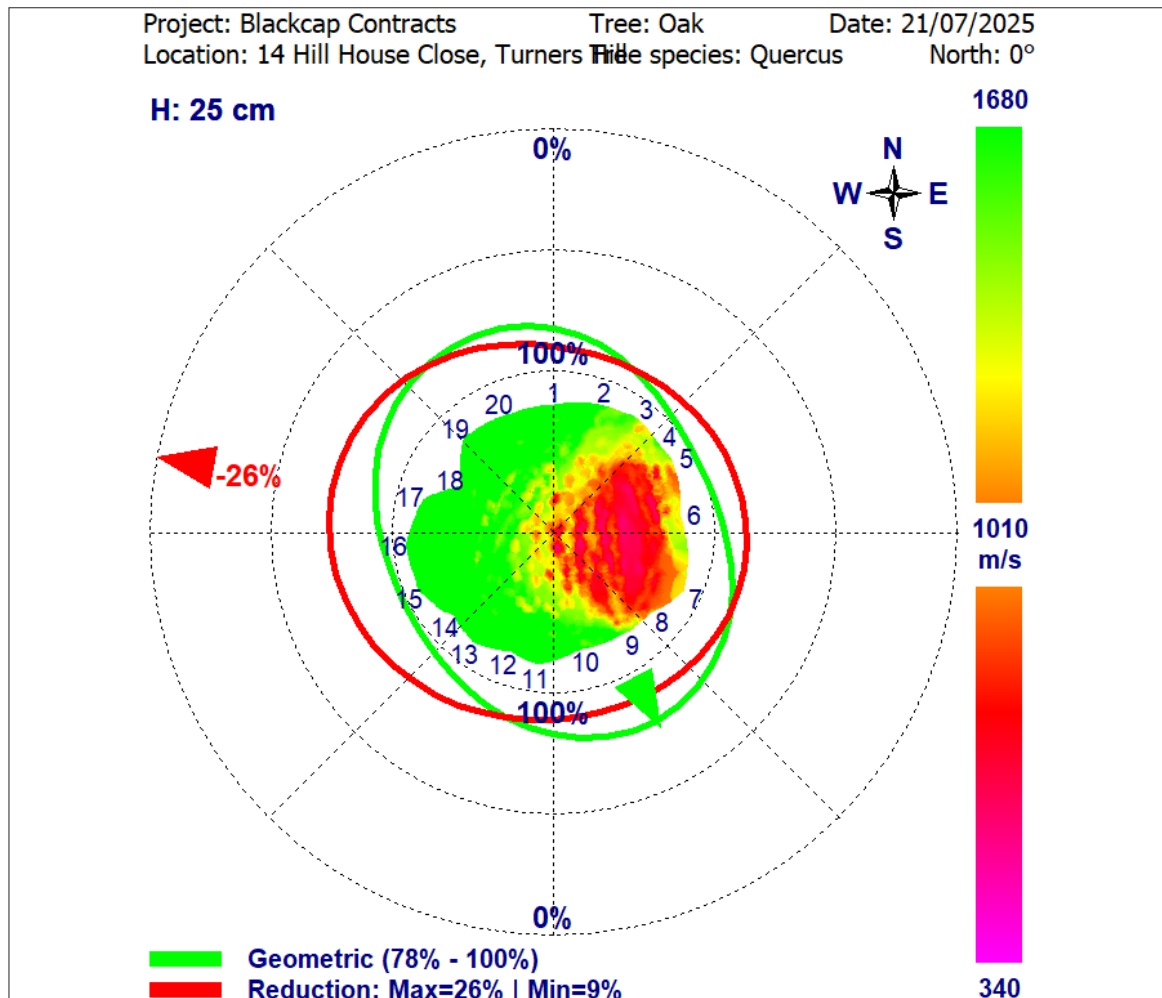
The software that accompanies the Arbotom equipment calculated the strength loss associated with the decay to be approximately 26% at this height (Figure 4 - Page 3).

Figure 4. Mechanic graph - Showing the bending resistance of the trunk without consideration of internal decay (green) and with consideration of internal decay (red).

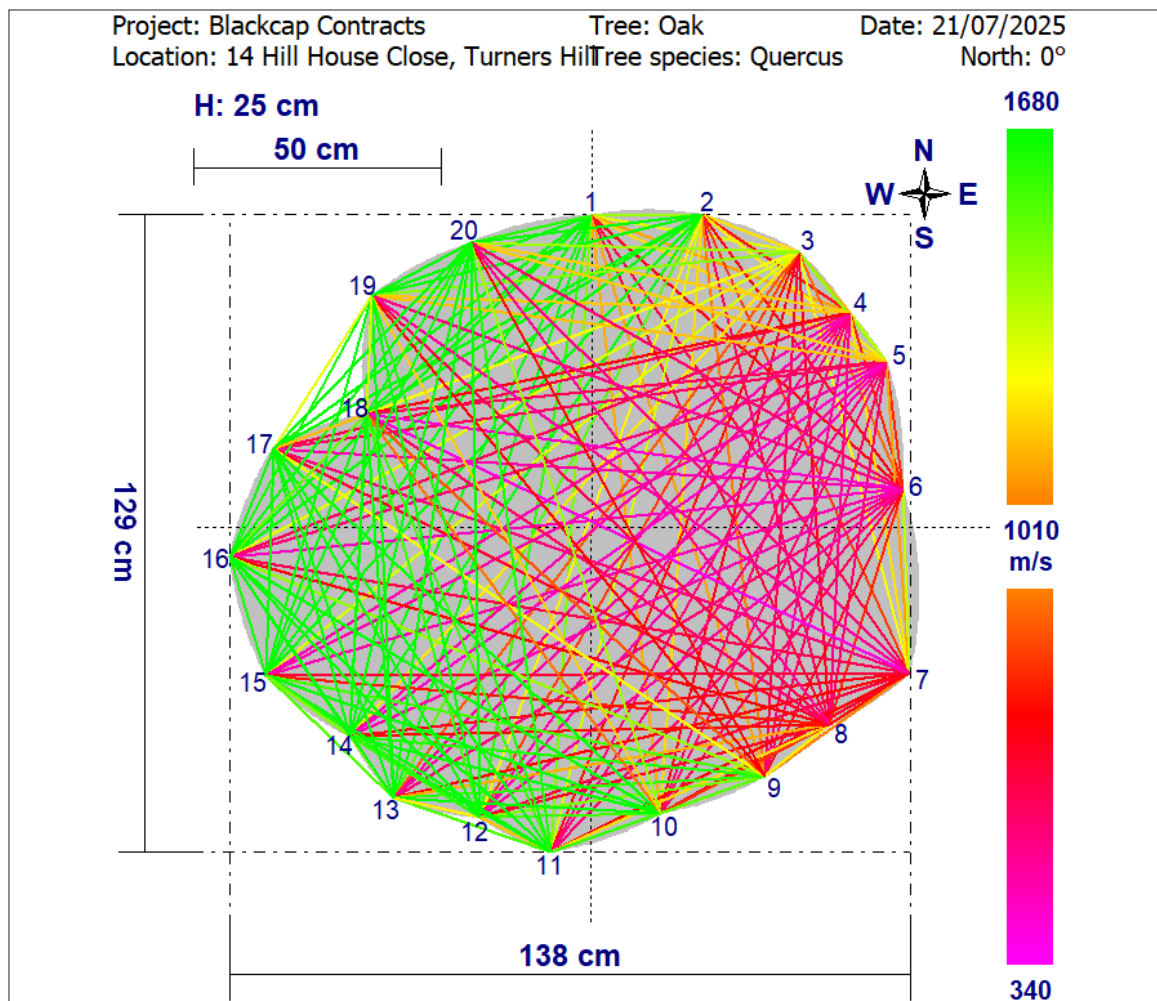
Figure 5. Line graph - Showing the velocities measured between each sensor.

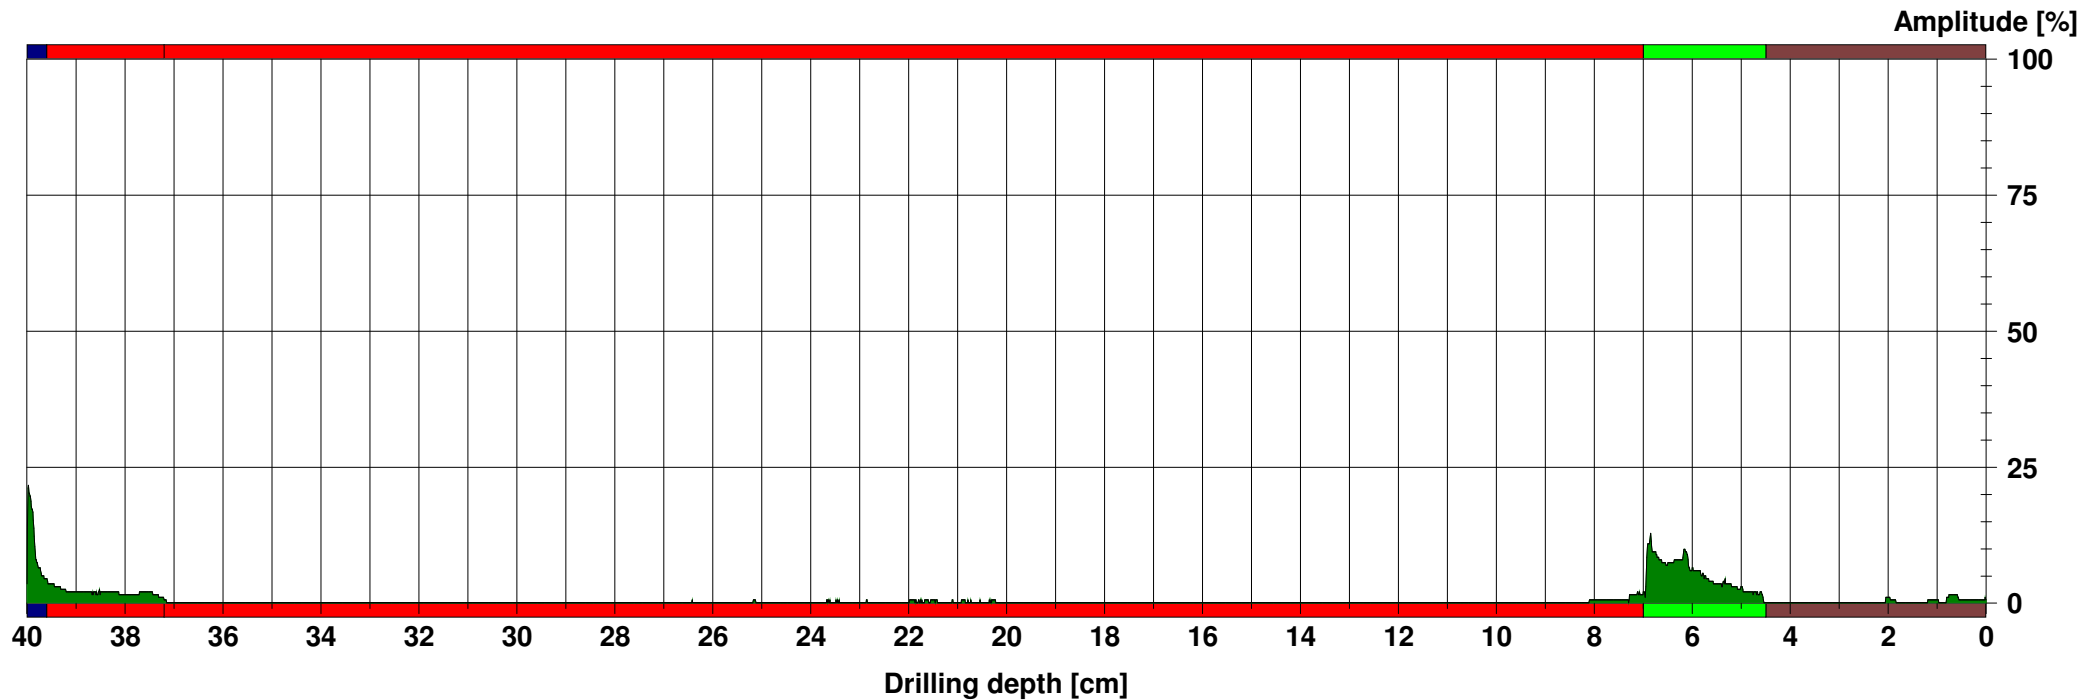
A Resistograph drill was used to measure the integrity of the wood at sensors 6 & 16 (pages 5 & 6). These measurements corroborate the results of the tomography.

| From | 0,0 cm | to | 4,5 cm | : | Bark |
| From | 4,5 cm | to | 7,0 cm | : | Residual wall |
| From | 7,0 cm | to | 37,2 cm | : | Cavity |
| From | 37,2 cm | to | 39,6 cm | : | Advanced decay |
| From | 39,6 cm | to | 40,0 cm | : | Sound wood |

Measurement taken at same position as sensor 6

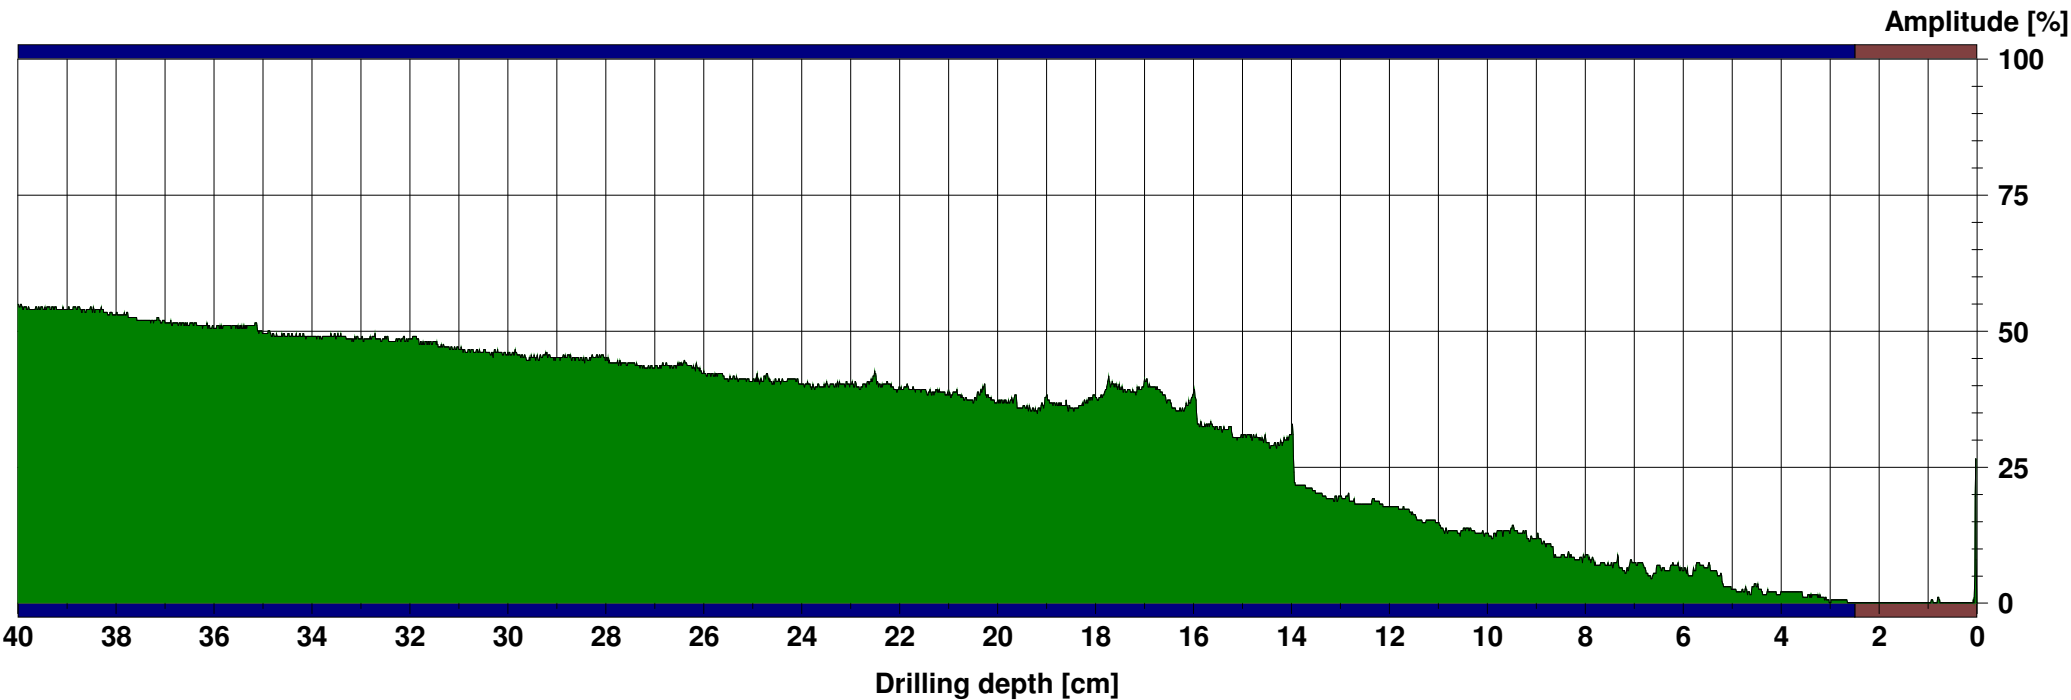
| From | 0,0 cm | to | 2,5 cm | : | Bark |
| From | 2,5 cm | to | 40,0 cm | : | Sound wood |

Measurement taken at same position as sensor 16
