# ARBORICULTURAL ASSESSMENT REPORT

| | Risk Address: | 22 Wheatsheaf Close, Burgess Hill, West Sussex, RH15 8UT |
| Refs: | OCA Ref: | 70670 |

| Arborist Name: | Sarah MacKinnon | Date: | 31/01/2018 |

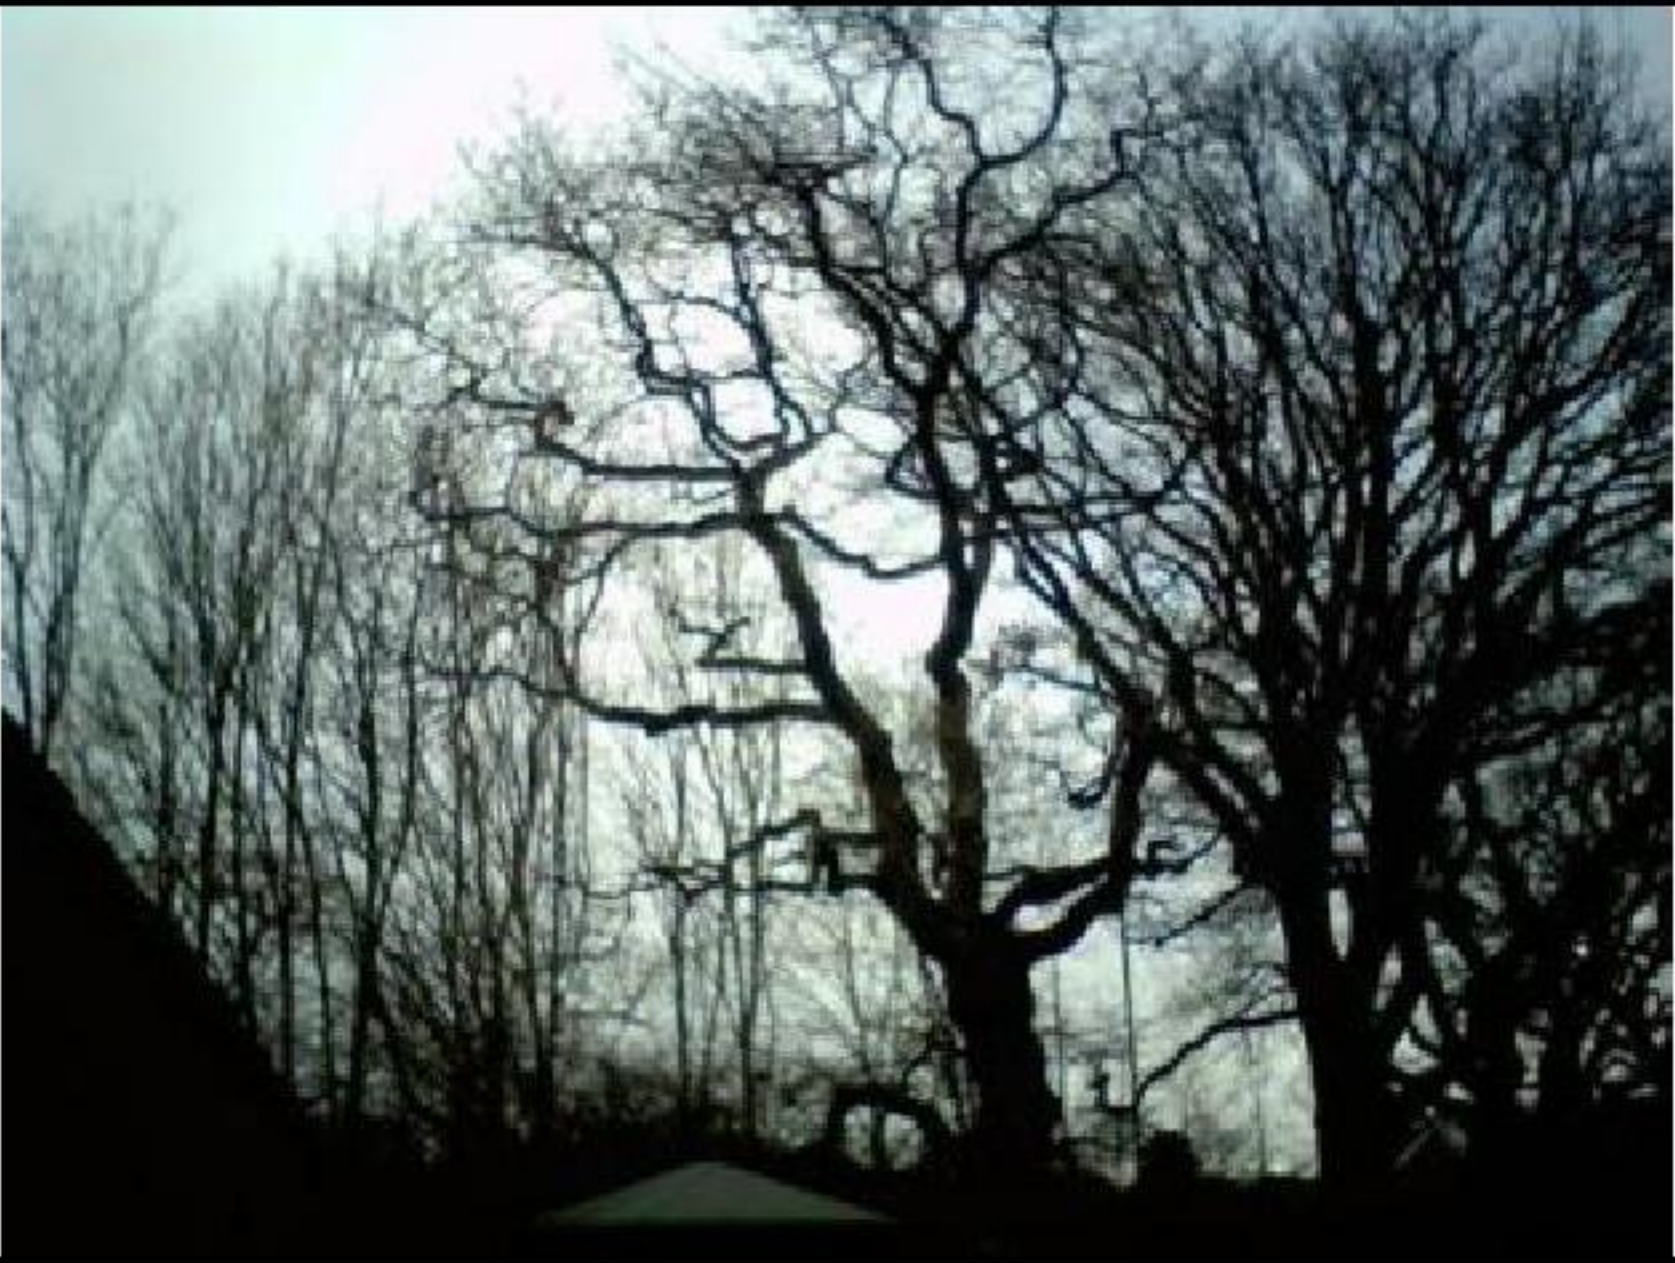
| T1 - Oak (English) | T2 - Oak (English) |

| Tree No | Common Name | Age Class | Condition | Height (m) | Crown Spread (m) | Stem diam. (mm) | Dist to bldg. (m) | Pruning history | Recommendation | Tree work constraints | Notes | Owner address | Owner |
|---|---|---|---|---|---|---|---|---|---|---|---|---|---|
| T1 | Oak (English) | Mature | Fair | 15.5 | 14 | 650 | 10 | No significant recent management. | Fell and treat stump. | | | Crest Homes | C3P |

| Tree No: | Species | Works Required |
|---|---|---|
| T1 | Oak (English) | Fell and treat stump. |

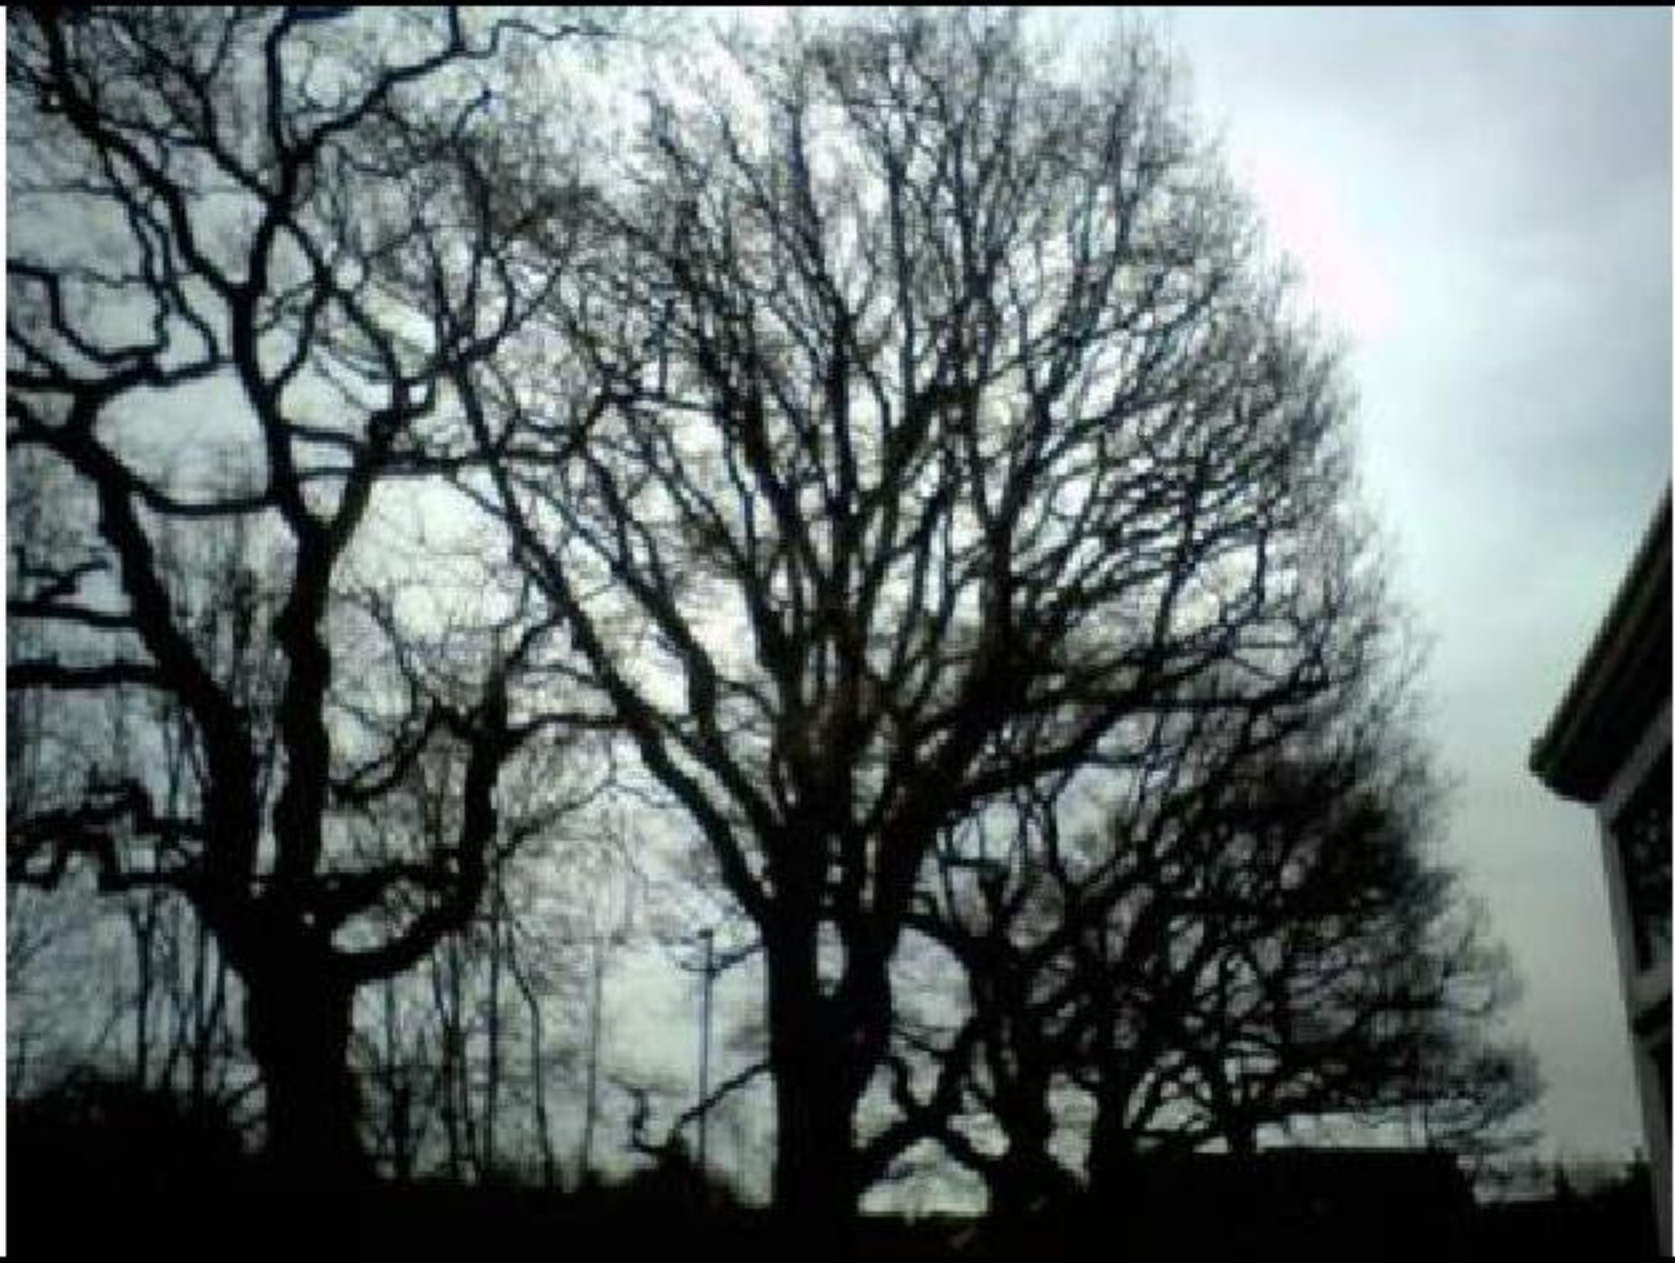
| Tree No | Common Name | Age Class | Condition | Height (m) | Crown Spread (m) | Stem diam. (mm) | Dist to bldg. (m) | Pruning history | Recommendation | Tree work constraints | Notes | Owner address | Owner |
|---|---|---|---|---|---|---|---|---|---|---|---|---|---|
| T2 | Oak (English) | Mature | Fair | 19 | 14 | 750 | 16 | No significant recent management. | Fell and treat stump. | Potential/Identified bat habitat. | | Crest Homes | C3P |

| Tree No: | Species | Works Required |
|---|---|---|
| T2 | Oak (English) | Fell and treat stump. |

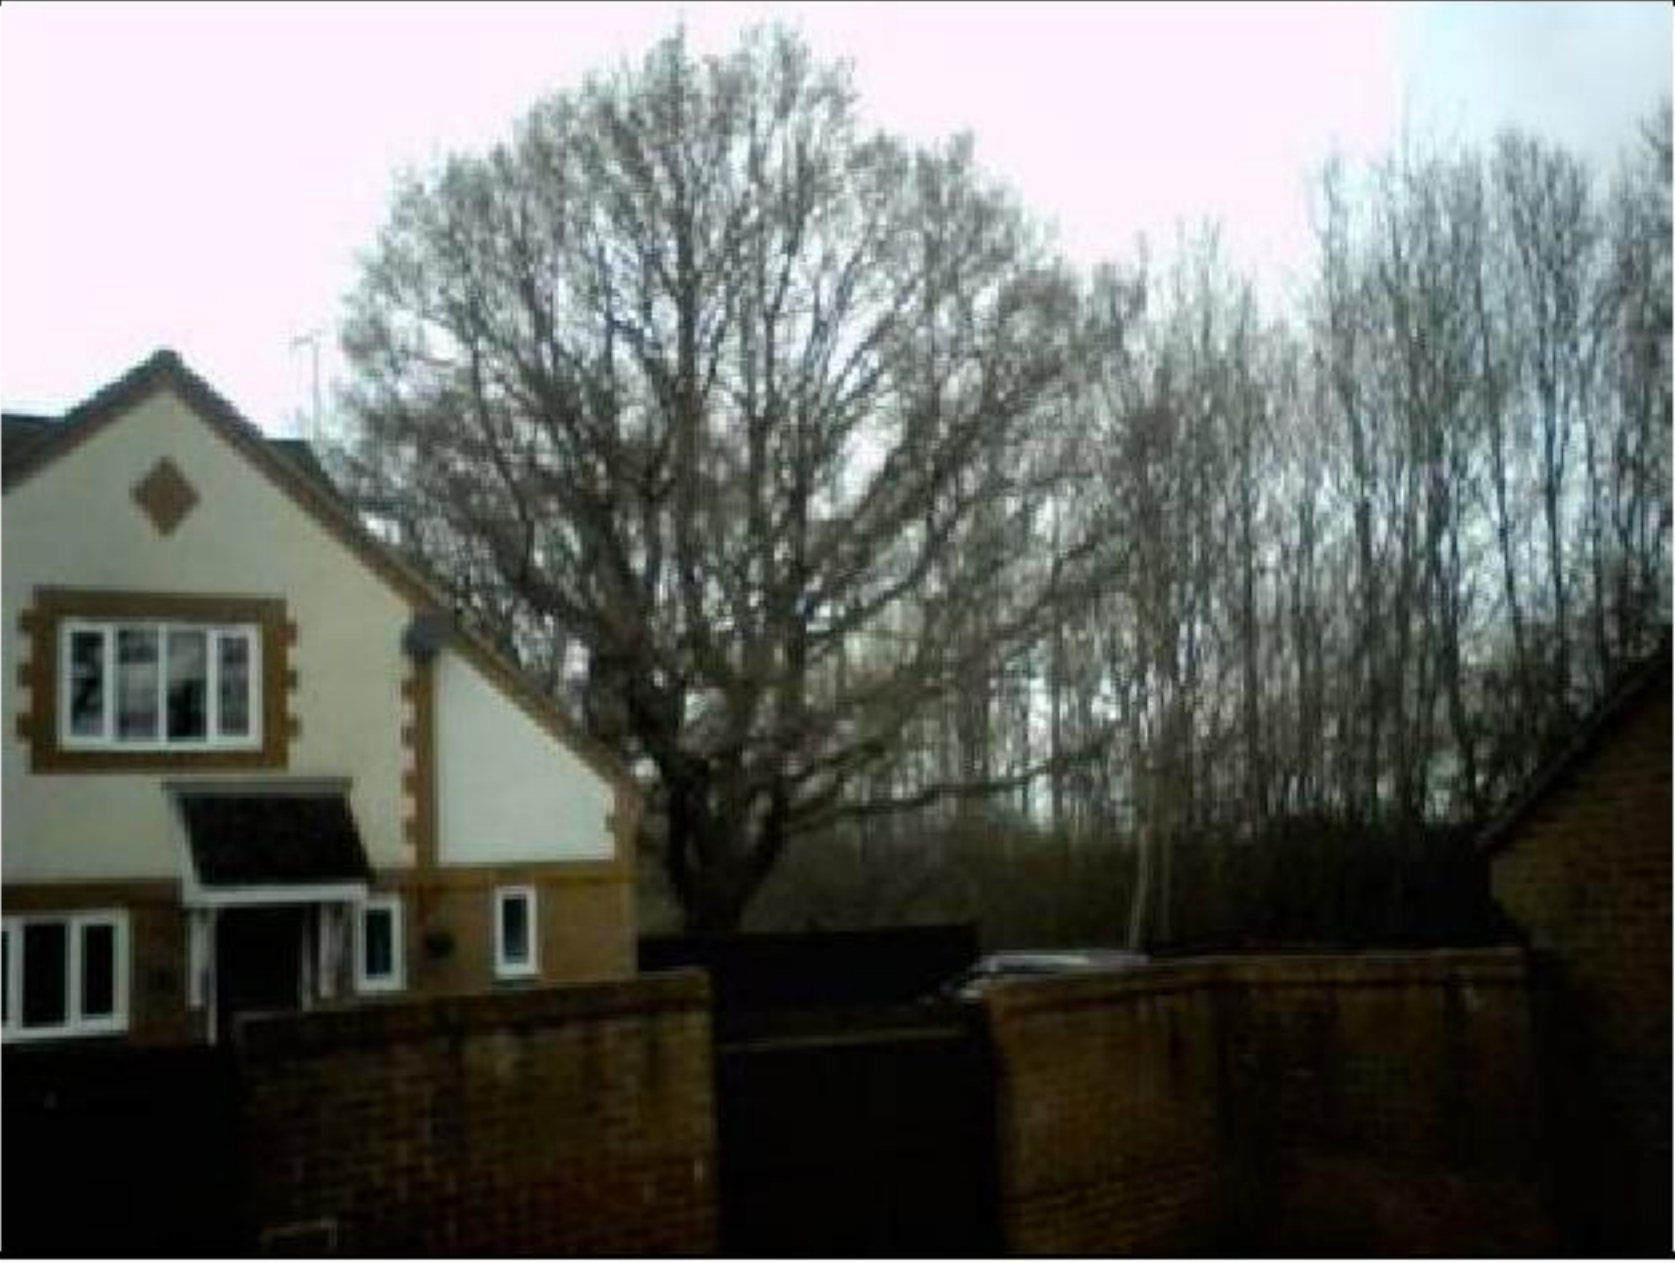
| T4 - Oak (English) | T3 - Oak (English) |

| Tree No | Common Name | Age Class | Condition | Height (m) | Crown Spread (m) | Stem diam. (mm) | Dist to bldg. (m) | Pruning history | Recommendation | Tree work constraints | Notes | Owner address | Owner |
|---|---|---|---|---|---|---|---|---|---|---|---|---|---|
| T4 | Oak (English) | Mature | Fair | 17 | 15.0 | 700 | 19 | No significant recent management. | No work required. | | | Unknown Ownership – Land registry required | UKN |

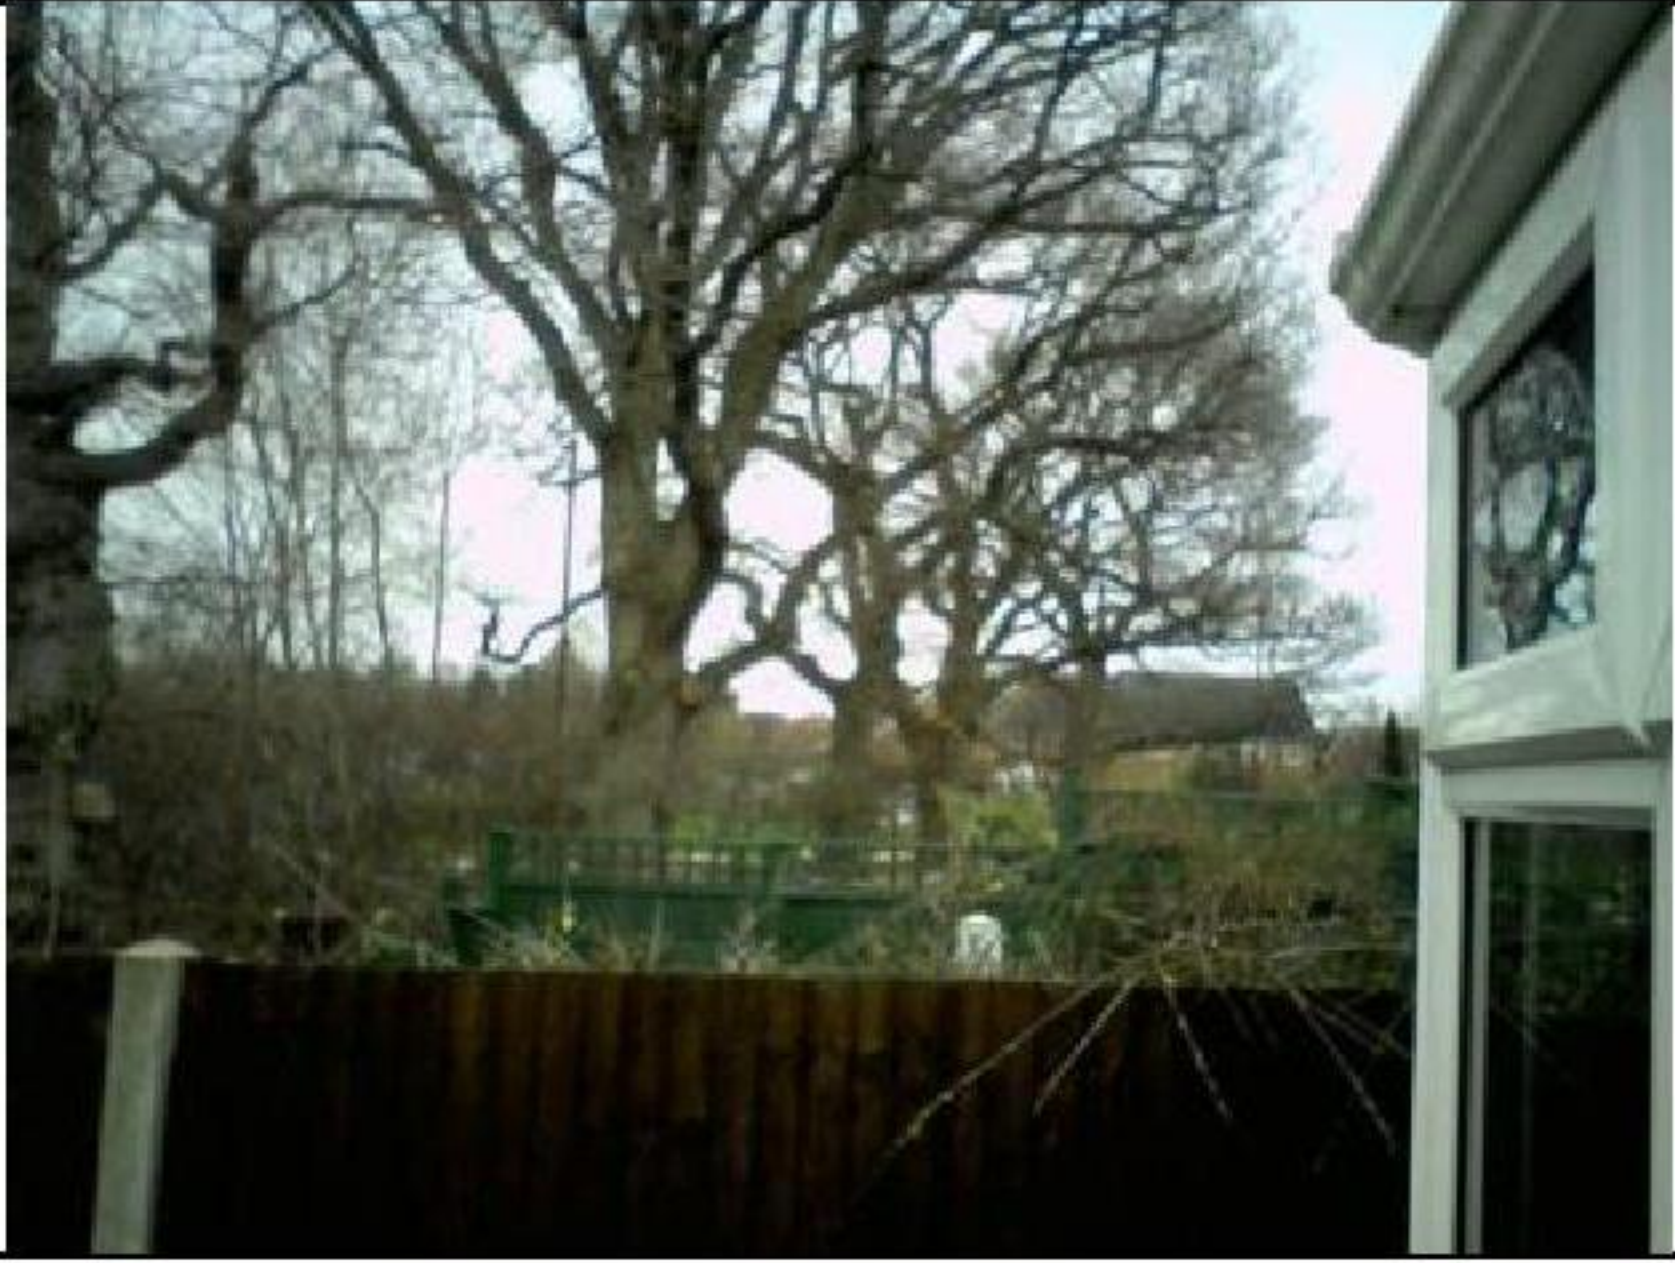
| Tree No | Common Name | Age Class | Condition | Height (m) | Crown Spread (m) | Stem diam. (mm) | Dist to bldg. (m) | Pruning history | Recommendation | Tree work constraints | Notes | Owner address | Owner |
|---|---|---|---|---|---|---|---|---|---|---|---|---|---|
| T3 | Oak (English) | Mature | Fair | 19 | 14 | 750 | 22.5 | No significant recent management. | No work required. | | | Crest Homes | C3P |

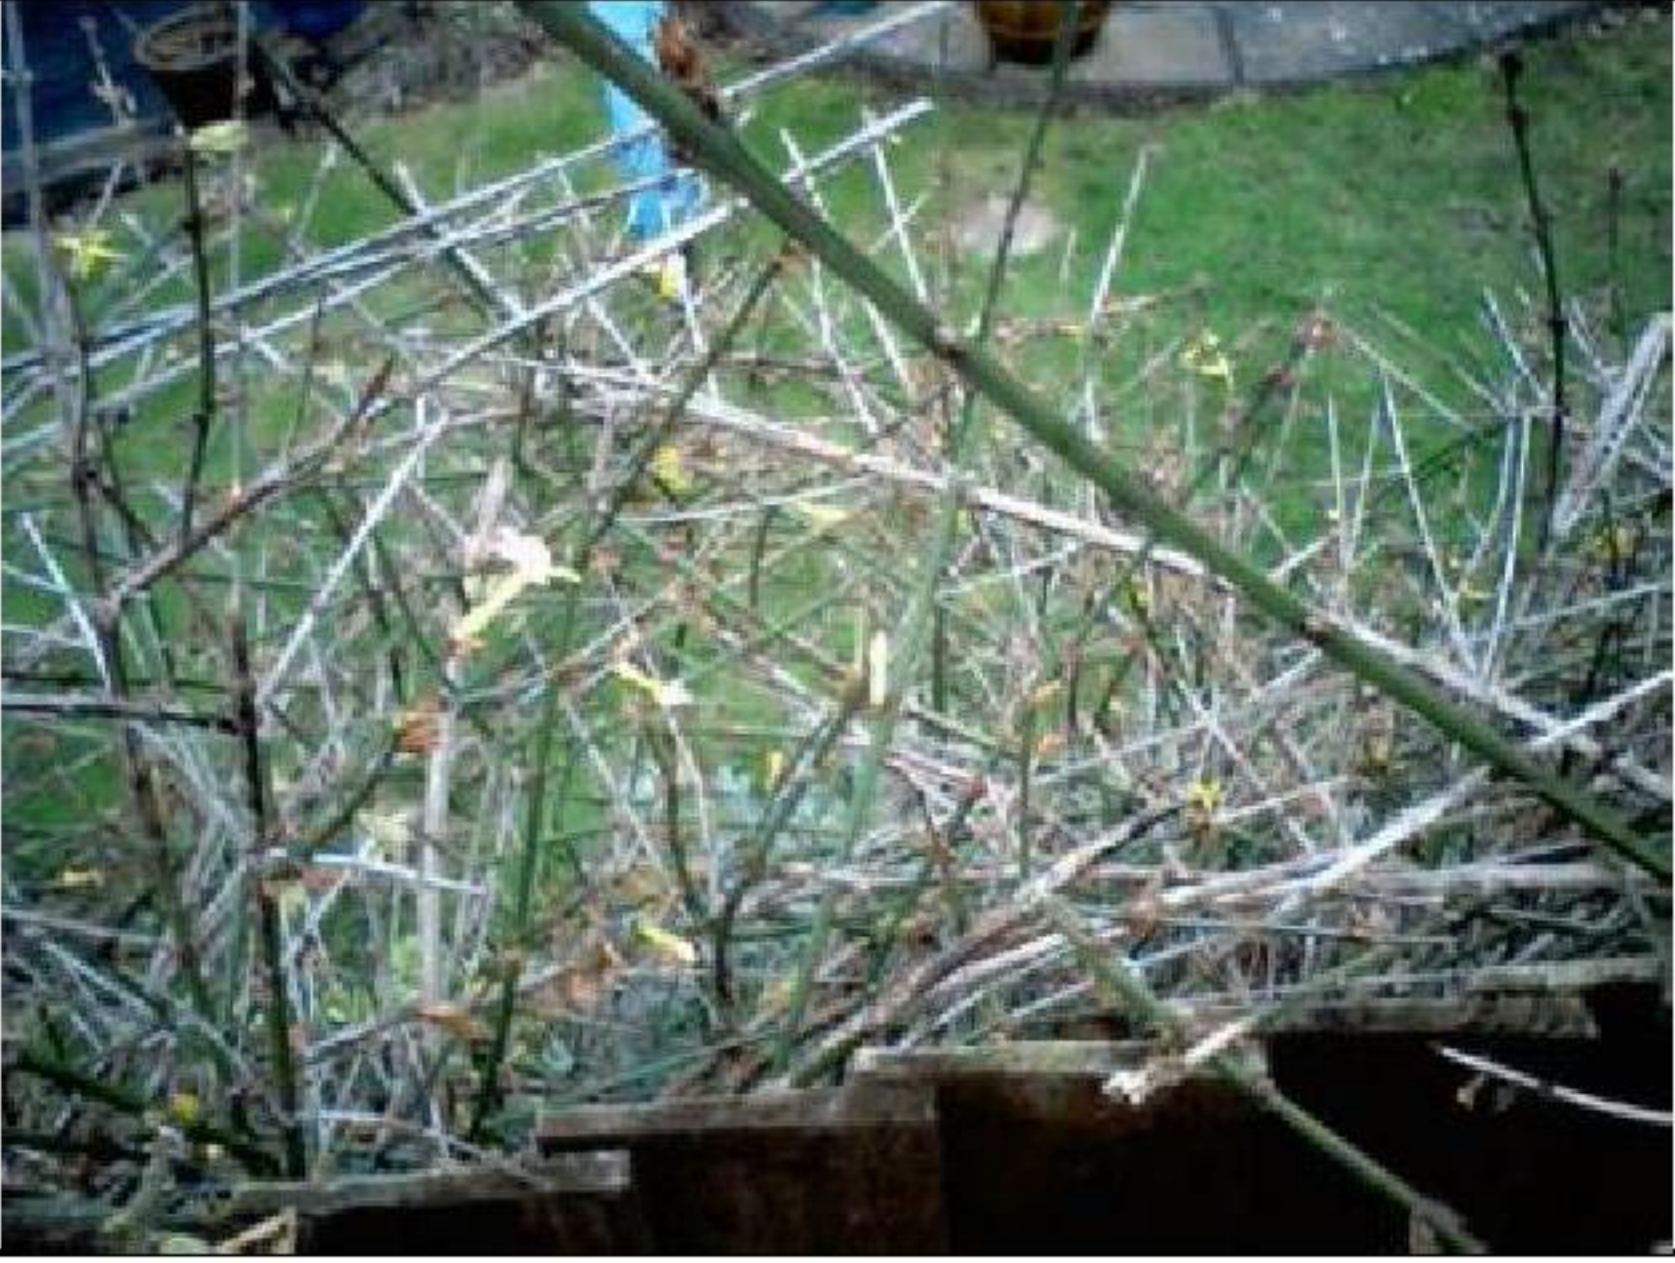
| S1 - Jasmine | TG1 - Mixed species group |

| Tree No | Common Name | Age Class | Condition | Height (m) | Crown Spread (m) | Stem diam. (mm) | Dist to bldg. (m) | Pruning history | Recommendation | Tree work constraints | Notes | Owner address | Owner |
|---|---|---|---|---|---|---|---|---|---|---|---|---|---|
| S1 | Jasmine | Mature | Fair | 1.8 | 1.50 | 15 | 0.5 | Managed as a shrub. | Fell and treat stump. | Access through building. | | 23 Wheatsheaf Close, Burgess Hill, West Sussex, RH15 8UT | P3P |

| Tree No: | Species | Works Required |
|---|---|---|
| S1 | Jasmine | Fell and treat stump. |

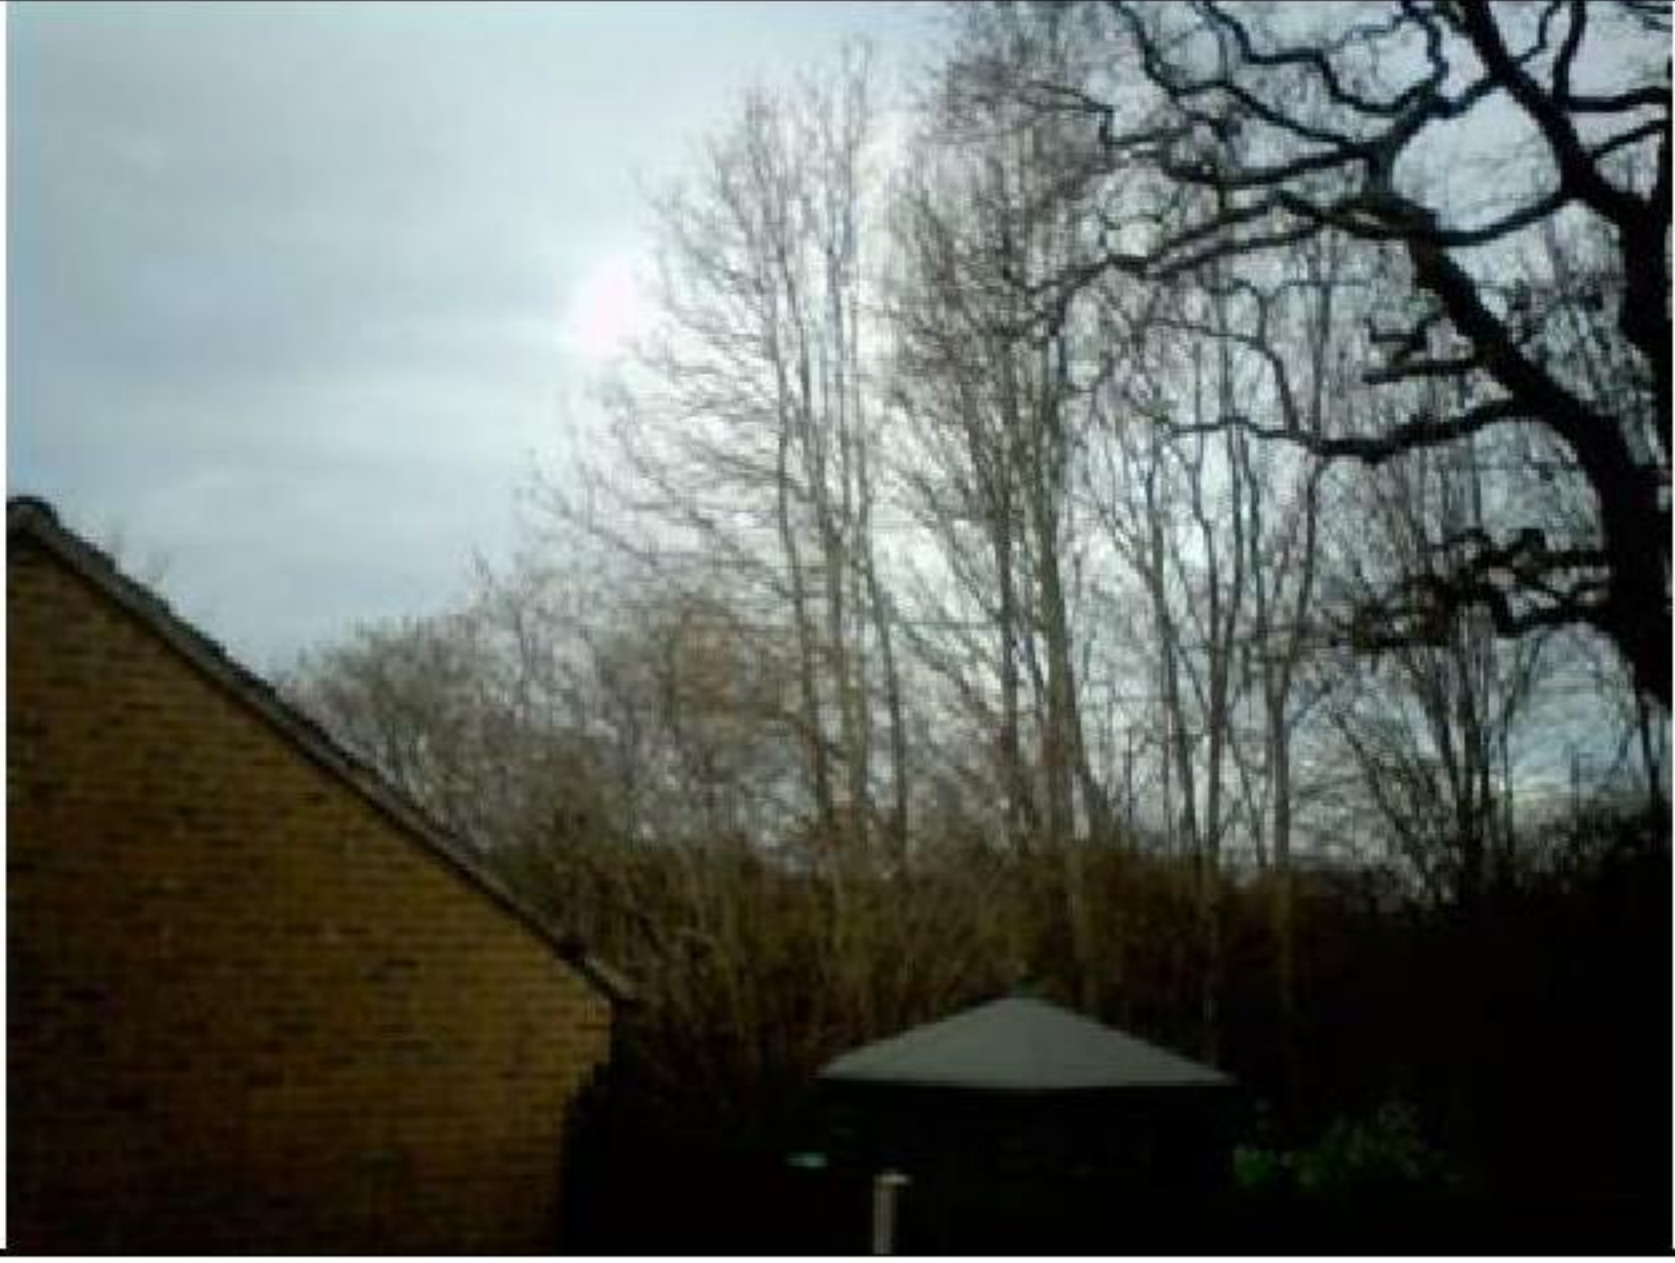
| Tree No | Common Name | Age Class | Condition | Height (m) | Crown Spread (m) | Stem diam. (mm) | Dist to bldg. (m) | Pruning history | Recommendation | Tree work constraints | Notes | Owner address | Owner |
|---|---|---|---|---|---|---|---|---|---|---|---|---|---|
| TG1 | Mixed species group | Mature | Fair | 13 | 7.0 | 200 | 12 | No significant recent management. | No work required. | | Ash and Hazel. | Crest Homes | C3P |
