# ARBORICULTURAL ASSESSMENT REPORT

| | <b>Risk Address:</b> | 22 Wheatsheaf Close, Burgess Hill, West Sussex, RH15 8UT |
| <b>Refs:</b> | <b>OCA Ref:</b> | 70670 |

| <b>Arborist Name:</b> | Sarah MacKinnon | <b>Date:</b> | 31/01/2018 |

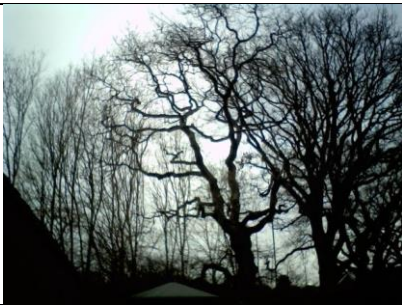
| T1 - Oak (English) | T2 - Oak (English) |

| TP1 (USF) | 1.5mm Quercus spp. | (2 roots). |
| BH1 (to 2.6m depth) | 1mm Quercus spp. | (2 roots). |

Mid Sussex District Councils Online Mapping system has confirmed that T1 and T2 Oak are subject to Tree Preservation Order BH/01/TPO/95.

| Tree No | Common Name | Age Class | Condition | Height (m) | Crown Spread (m) | Stem diam. (mm) | Dist to bldg. (m) | Pruning history | Recommendation | Tree work constraints | Notes | Owner address | Owner |
|---|---|---|---|---|---|---|---|---|---|---|---|---|---|
| T1 | Oak (English) | Mature | Fair | 15.5 | 14 | 650 | 10 | No significant recent management. | Fell and treat stump. | | | Crest Homes | C3P |

| Tree No: | Species | Works Required |
|---|---|---|
| T1 | Oak (English) | Fell and treat stump. |

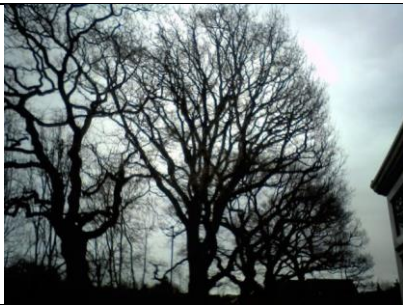
| Tree No | Common Name | Age Class | Condition | Height (m) | Crown Spread (m) | Stem diam. (mm) | Dist to bldg. (m) | Pruning history | Recommendation | Tree work constraints | Notes | Owner address | Owner |
|---|---|---|---|---|---|---|---|---|---|---|---|---|---|
| T2 | Oak (English) | Mature | Fair | 19 | 14 | 750 | 16 | No significant recent management. | Fell and treat stump. | Potential/Identified bat habitat. | | Crest Homes | C3P |

| Tree No: | Species | Works Required |
|---|---|---|
| T2 | Oak (English) | Fell and treat stump. |

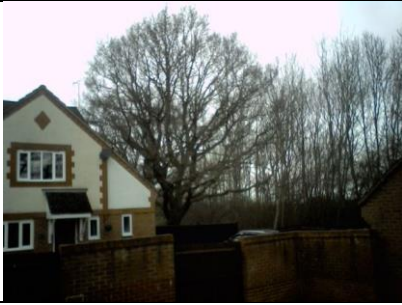
| T4 - Oak (English) | T3 - Oak (English) |

| Tree No | Common Name | Age Class | Condition | Height (m) | Crown Spread (m) | Stem diam. (mm) | Dist to bldg. (m) | Pruning history | Recommendation | Tree work constraints | Notes | Owner address | Owner |
|---|---|---|---|---|---|---|---|---|---|---|---|---|---|
| T4 | Oak (English) | Mature | Fair | 17 | 15.0 | 700 | 19 | No significant recent management. | No work required. | | | Unknown Ownership – Land registry required | UKN |

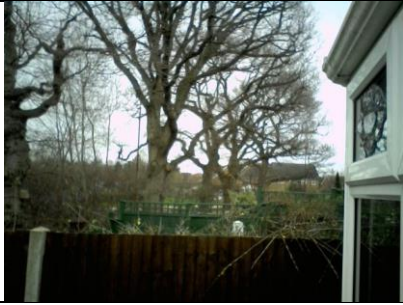
| Tree No | Common Name | Age Class | Condition | Height (m) | Crown Spread (m) | Stem diam. (mm) | Dist to bldg. (m) | Pruning history | Recommendation | Tree work constraints | Notes | Owner address | Owner |
|---|---|---|---|---|---|---|---|---|---|---|---|---|---|
| T3 | Oak (English) | Mature | Fair | 19 | 14 | 750 | 22.5 | No significant recent management. | No work required. | | | Crest Homes | C3P |

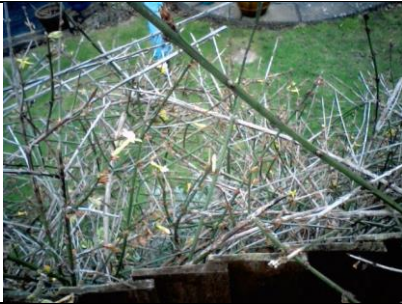
| S1 - Jasmine | TG1 - Mixed species group |

| TP1 (USF) | 1mm Jasminum spp. | (2 roots). |

| Tree No | Common Name | Age Class | Condition | Height (m) | Crown Spread (m) | Stem diam. (mm) | Dist to bldg. (m) | Pruning history | Recommendation | Tree work constraints | Notes | Owner address | Owner |
|---|---|---|---|---|---|---|---|---|---|---|---|---|---|
| S1 | Jasmine | Mature | Fair | 1.8 | 1.50 | 15 | 0.5 | Managed as a shrub. | Fell and treat stump. | Access through building. | | 23 Wheatsheaf Close,<br>Burgess Hill,<br>West Sussex,<br>RH15 8UT | P3P |

| Tree No: | Species | Works Required |
|---|---|---|
| S1 | Jasmine | Fell and treat stump. |

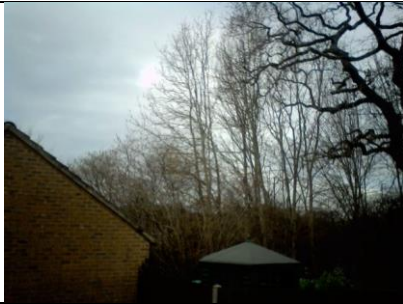
| Tree No | Common Name | Age Class | Condition | Height (m) | Crown Spread (m) | Stem diam. (mm) | Dist to bldg. (m) | Pruning history | Recommendation | Tree work constraints | Notes | Owner address | Owner |
|---|---|---|---|---|---|---|---|---|---|---|---|---|---|
| TG1 | Mixed species group | Mature | Fair | 13 | 7.0 | 200 | 12 | No significant recent management. | No work required. | | Ash and Hazel. | Crest Homes | C3P |
