## Addendum Arboricultural Report

### Subsidence Damage Investigation at:

61 Lodge Lane  
Hassocks  
BN6 8LX

| MWA REF: | SUB220113-9789Rev01 |

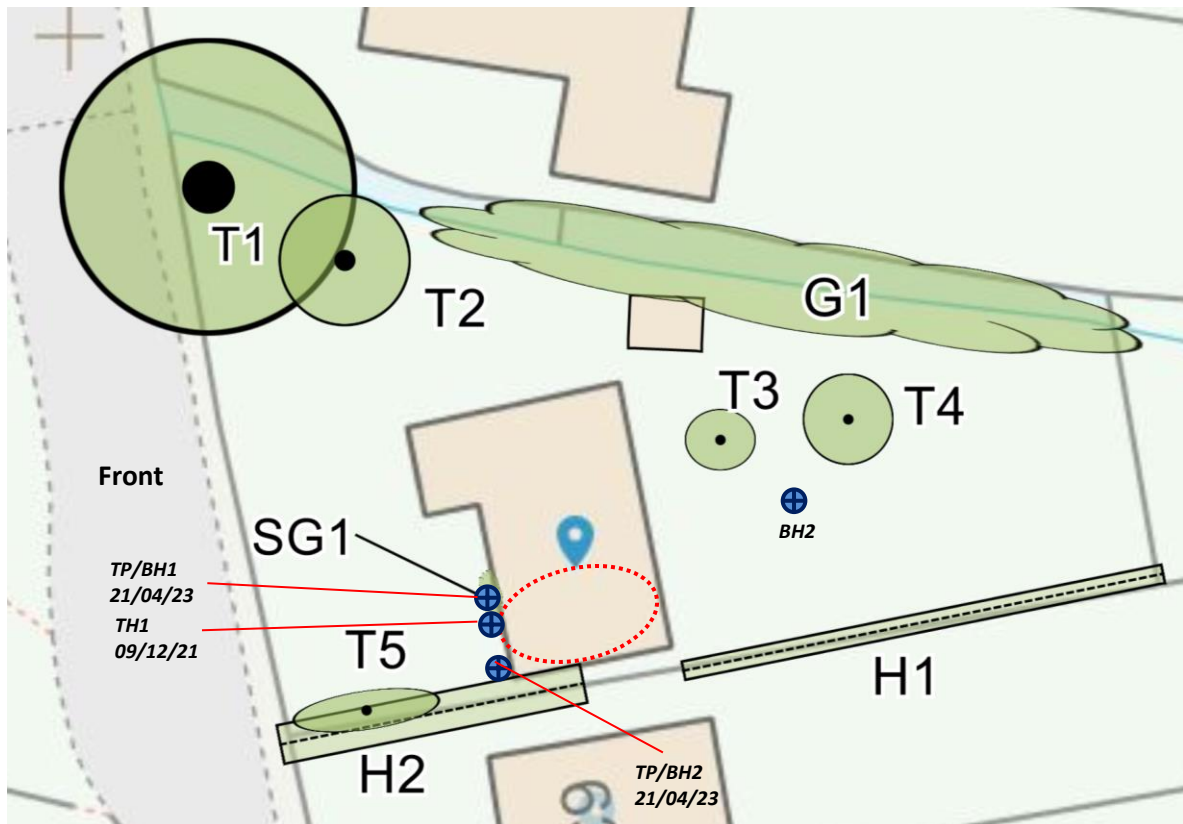
## Site Plan

Approximate areas of damage

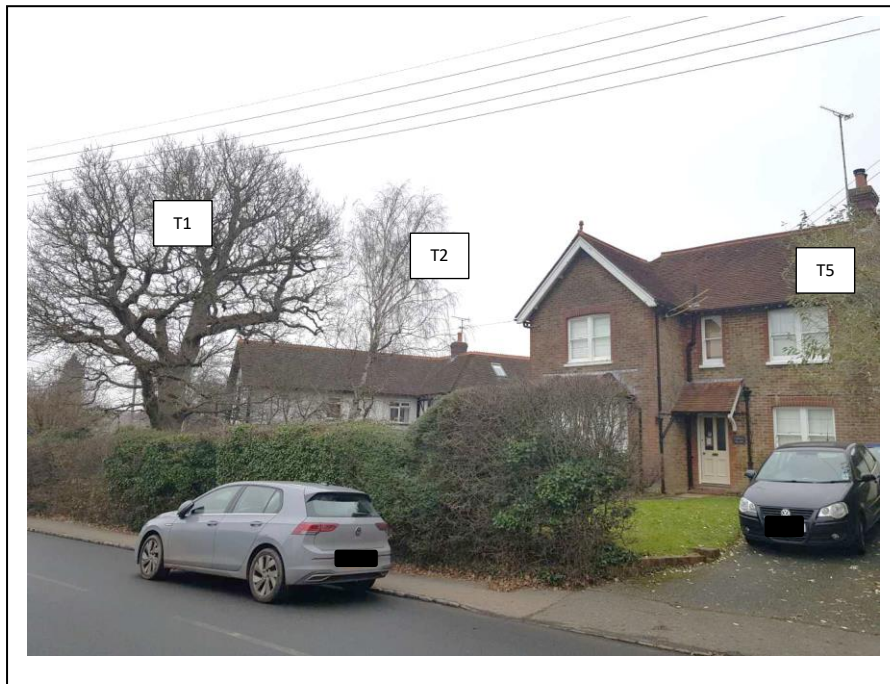
The presence of significant rooting across the whole garden, oak roots identified in the site investigation and the presence of very severe desiccation in as wet a year as 2021 suggests strongly that T1 is a significant factor in the damage.

| Tree No. | Species | Ht. (m) | Dia. (mm) | Crown Spread (m) | Dist. to building (m) | Age Classification | Ownership |
|---|---|---|---|---|---|---|---|
| T1 | English Oak | 13 | 1010 | 10 | 12 | Older than Property | Policy Holder |

View of T1 from front right

If an arboricultural solution is to be implemented to mitigate the influence of the implicated trees/vegetation we still recommend that T1 is reduced to previous pruning points, but that further works are conducted on a shorter rotation in order to minimise the potential for vigorous regrowth to affect the dwelling.

| Tree No. | Species | Ht. (m) | Dia. (mm) | Crown Spread (m) | Dist. to building (m) | Age Classification | Ownership |
|---|---|---|---|---|---|---|---|
| Recommendation | | <b>Original recommendation:</b><br>Reduce to previous pruning points. Repeat reduction on a triennial cycle to maintain at broadly reduced dimensions.<br><b>New recommendation:</b> Reduce to previous pruning points. Repeat reduction on a biennial cycle to maintain at broadly reduced dimensions. | | | | | |

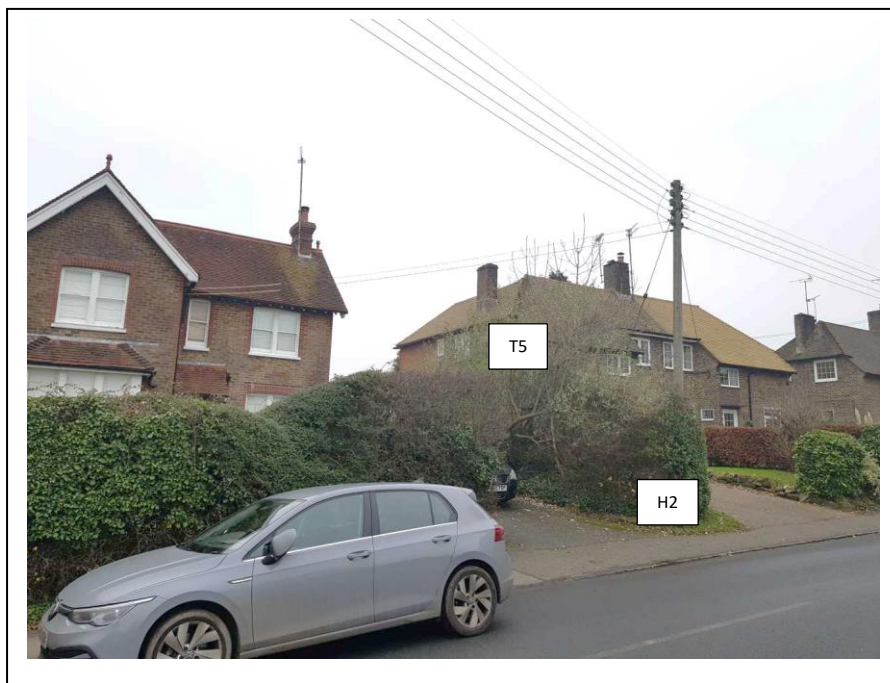
View of vegetation to front right

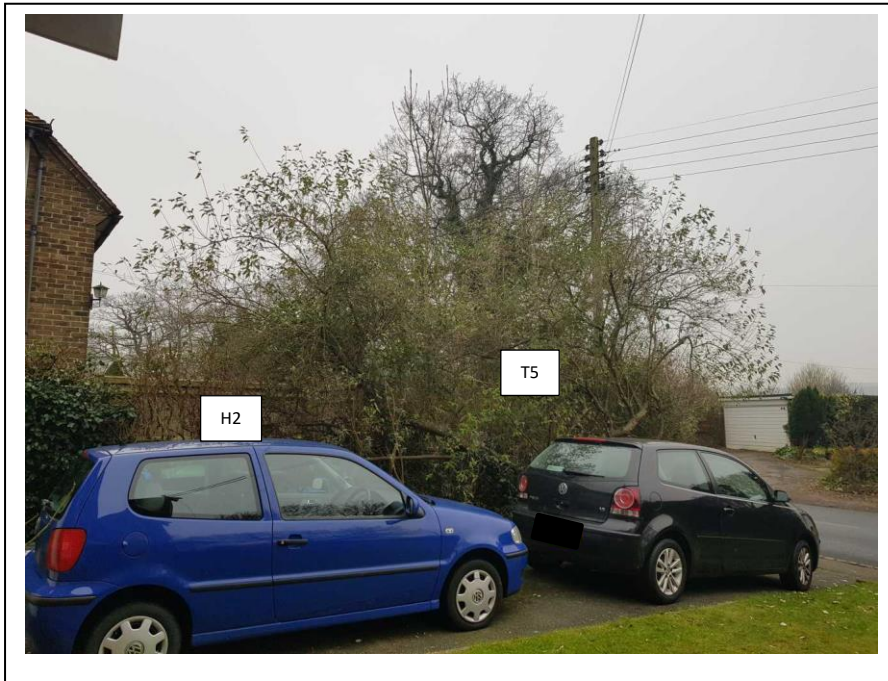
Irrespective of the identification of recovered root samples, the roots of T5 are also likely to be present below foundation level in proximity to the area of movement/damage and influencing soil moisture and volumes. This tree, however, is not considered to be of sufficient size to cause the level of desiccation suggested by the soil suction values.

We understand that the ash within H2 and T5 were removed in June 2022 as per our recommendations, so would not be a factor in the moisture depletion in the latest site investigation. T1 was not subject to works.

View of T5 and H2

| Tree No. | Species | Ht. (m) | Dia. (mm) | Crown Spread (m) | Dist. to building (m) | Age Classification | Ownership |
|---|---|---|---|---|---|---|---|
| Recommendation | | Remove (fell) to near ground level and treat stump to inhibit regrowth.<br><b>Completed June 2022.</b> | | | | | |
| Recommendation | | Remove (fell) ash trees to near ground level and treat stumps to inhibit regrowth. Do not allow remainder to exceed current dimensions.<br><b>Completed June 2022.</b> | | | | | |

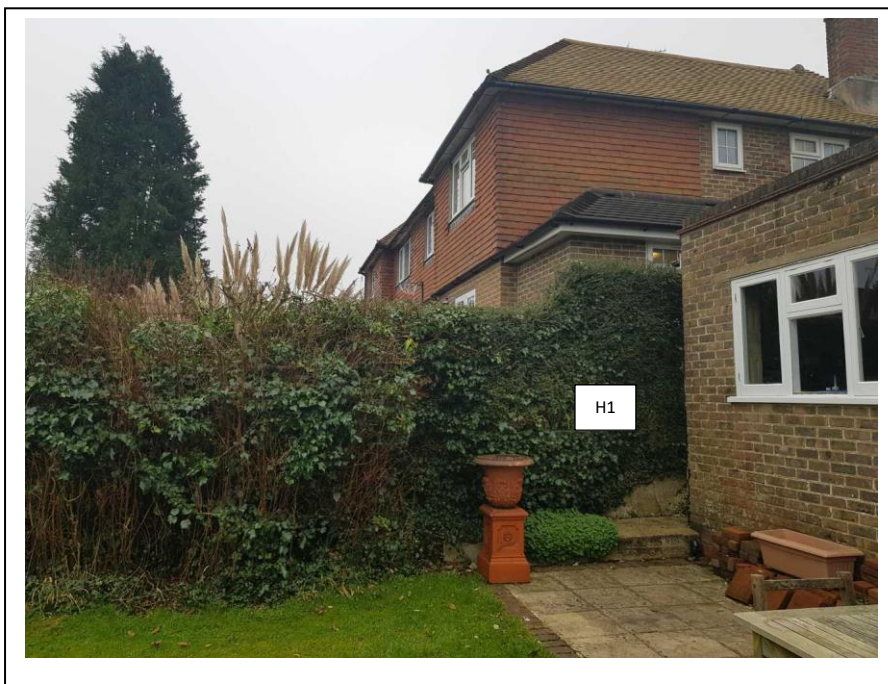
| Tree No. | Species | Ht. (m) | Dia. (mm) | Crown Spread (m) | Dist. to building (m) | Age Classification | Ownership |
|---|---|---|---|---|---|---|---|
| H1 | Includes Honeysuckle, Ivy, Ash | 2.5 | 10 Ms * | 0.5 * | 1 | Younger than Property | Joint Policy Holder & 63 Lodge Lane BN6 8LX |

View of H1

| Tree No. | Species | Ht. (m) | Dia. (mm) | Crown Spread (m) | Dist. to building (m) | Age Classification | Ownership |
|---|---|---|---|---|---|---|---|
| Recommendation | | Do not allow to exceed current dimensions. | | | | | |
